Tim-O-Tree

Tree Retention Plan:

61 Pinehurst

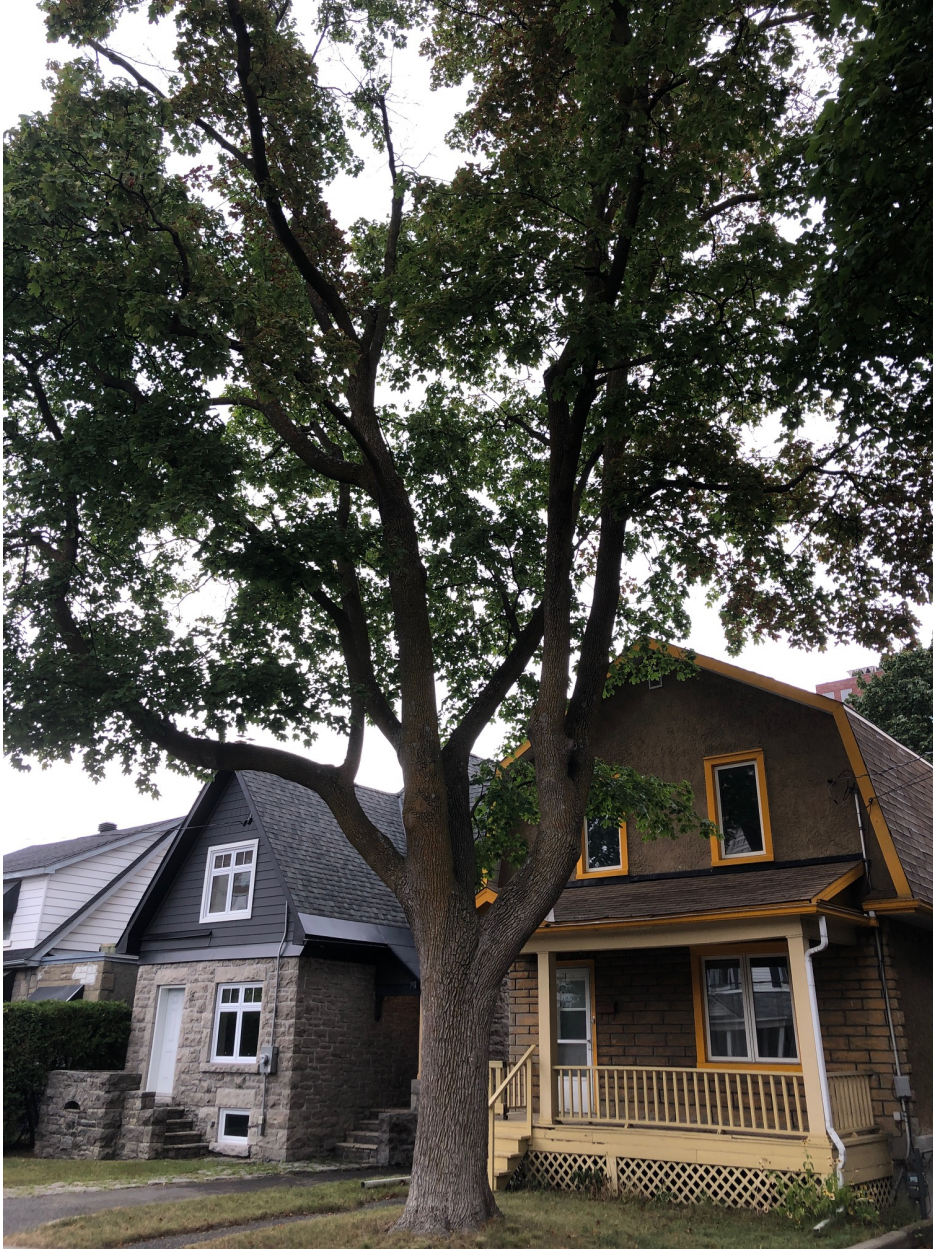
Tree 1: Municipal Norway Maple

There is a Norway maple⁴ in the front yard of 61 Pinehurst. The site plan indicates that the tree is wholly owned by the city of Ottawa. The tree measures 70cm in diameter at breast height (DBH). According to the City of Ottawa's guidelines⁵⁶, the critical root zone (CRZ)⁷ of this tree measures 700cm. It is important to note that this measurement is theoretical and does not necessarily reflect reality, as site conditions limit the expansion of roots. For example, the

distance from the trunk to the foundation of the house is 539cm, much shorter than the extrapolated value of 700cm.

The tree is in good condition, with a full canopy and no evident dieback. The tree has a strong trunk flare, which is unusual for a Norway maple of this age, as they typically girdle as they age. The tree has a sound structure with no evidence of included bark. The only structural flaw is that of the branches has a poor aspect ratio with the trunk, and predictably some cracking is evident at this union due to excessive side-loading. This defect can be addressed with structural supports as well as reduction pruning. In absence of pruning and structural supports, the branch is at moderate to high risk of failing in an extreme load event, such as a storm. Most pruning cuts are completely occluded, indicating good vigour and compartmentalization. There were no evident fruiting bodies or other signs of wood-decaying fungi.

Fencing for the trees in the back yard can be erected in accordance with bylaws without unduly inhibiting construction, however, some variances from guidelines are necessary for the municipal maple in the front yard. The official CRZ calculation of 700cm is not valid for the area between the trunk and foundation of the house, as the distance here is only 539cm and no roots have extended beyond the foundation of the existing dwelling. The value of 700cm also encompasses driveways to the north and south of the yard as well as a sidewalk and part of the road. Fencing off these areas is not practical and is not likely to impact the health of the tree, as these areas are already subject to many of the conditions that fencing is meant to prevent, such as soil compaction, lack of available nutrients, and excavation. The tree has already adapted to these conditions and is unlikely to suffer further adverse effects from activities in these areas.

Therefore, it is appropriate to erect fencing at a shorter distance than the official CRZ measurement of 700cm. To the west of the tree, fencing should be erected along the edge of the sidewalk, as erecting it beyond this distance would unduly restrict pedestrian traffic with no benefit to the tree. To the south, fencing should be erected along the curb, which places it at a distance of 230cm¹⁰. To the north, the fencing will be erected along the curb, at a distance of 400cm from the trunk. To the east, the fencing should be erected at a distance of 417cm from the trunk. This will allow a buffer of 121cm (approximately 4ft) between the fencing and foundation,

which is necessary for a construction crew to work on the foundation and siding of the house. There will be no excavation beyond the current foundation, so there will be no root pruning in the buffer zone—the entirety of the tree’s roots in this area will be preserved. This buffer zone should be padded with wood chips at least 3 inches in depth to mitigate soil compaction from construction activities in this area.

The driveway to the south of the tree will be used as primary access route for construction activities. It is sufficient for construction crews to access the property by foot and with heavy machinery. It is recommended that the asphalt driveway remain intact for the majority of construction, as it will provide some protection to the soil from further compaction and potential root damage by heavy machinery. Removal of the current asphalt driveway is contemplated in the site plan and this should be done as late in the process as possible. Once it is removed, construction activities will have a more significant impact on the soil and the tree’s critical roots.

New services will have to be routed from the road to the south-west corner of the house. These services are approximately 180cm from the trunk, which is below the threshold for root pruning (230cm). According to engineers working for the client, routing the services farther from the trunk is infeasible as it will increase the complexity of the plumbing and could increase the risk of a rupture. Therefore, the services will need to be routed under the root structure of the tree, which likely doesn’t go any deeper than 12 inches (30cm). In order to give the tree the best chance of survival, installation of these services should be completed via air excavation and

burrowing under the root structure of the tree at a minimum depth of 30cm and a recommended depth of 50cm .¹¹ Excavating through roots in this area and pruning roots is not advisable.

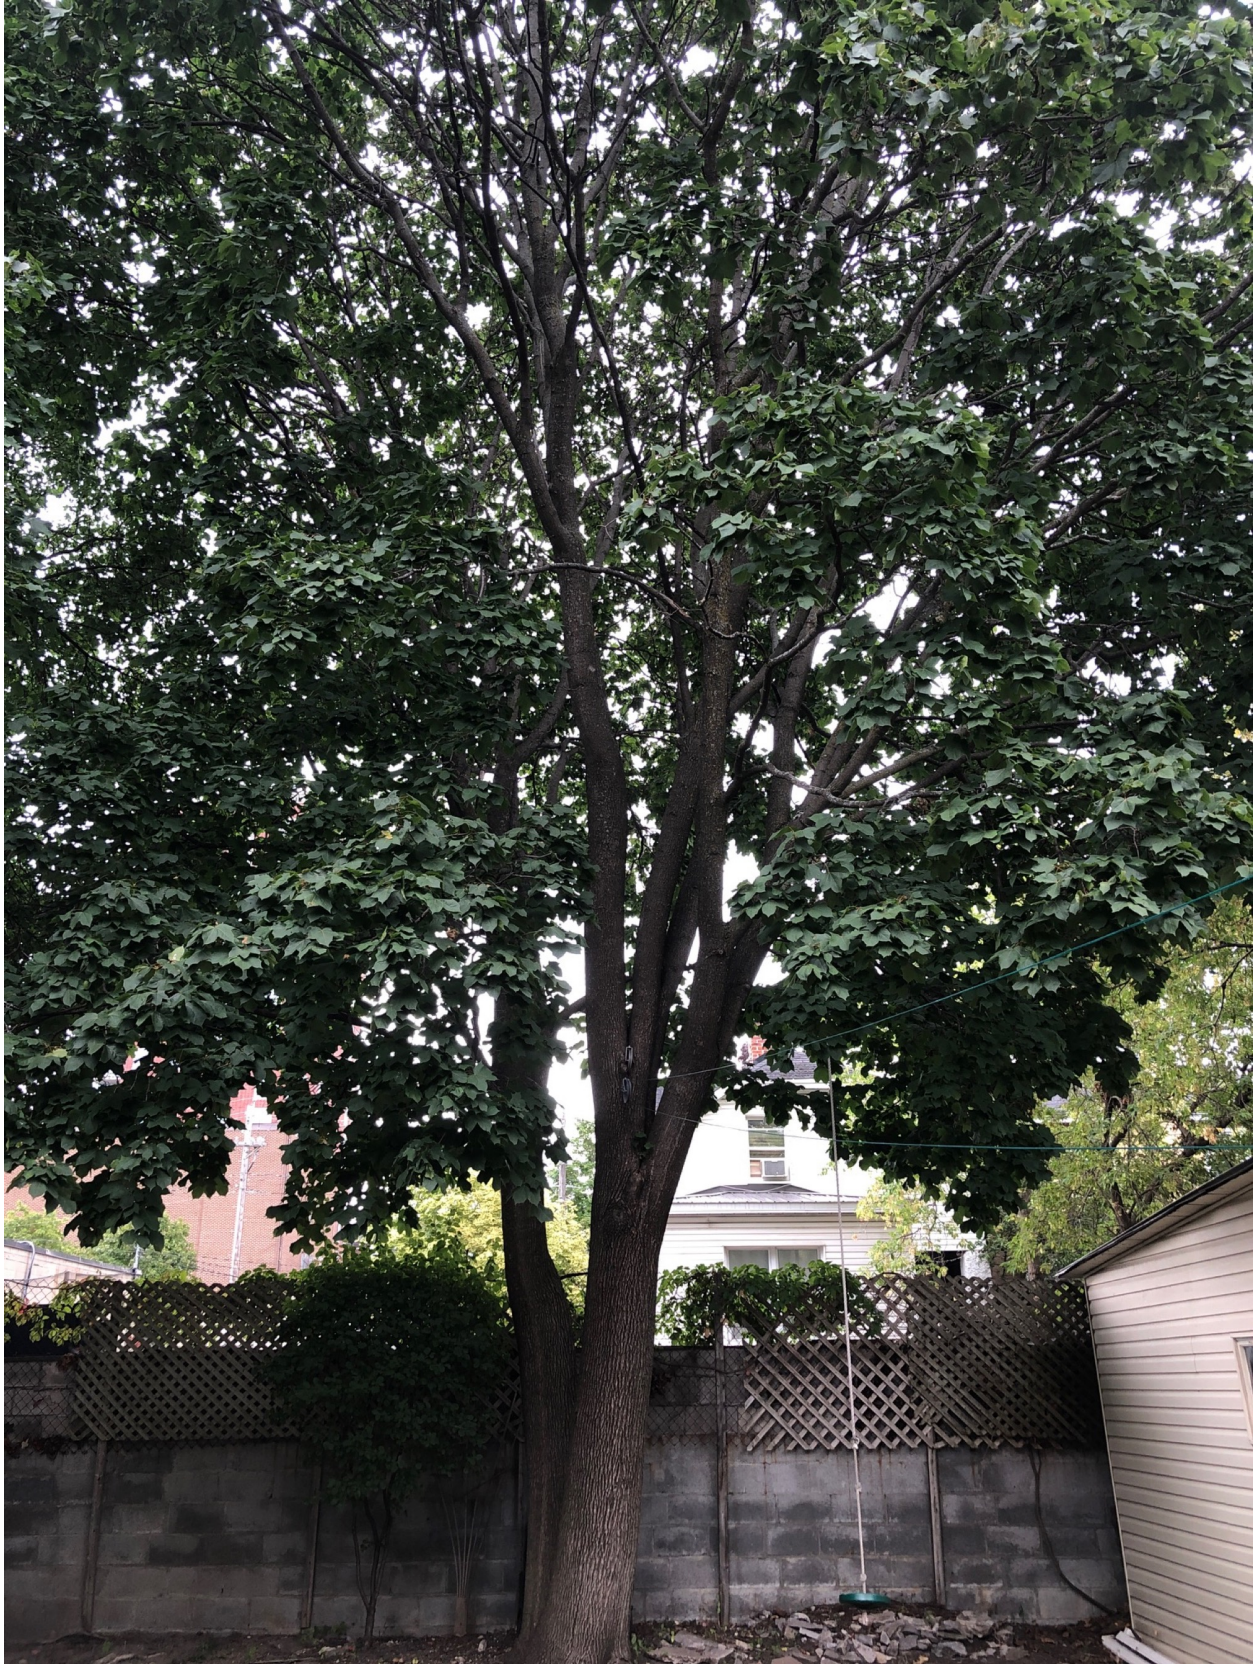
Tree 2 & 3: Norway Maples

There is a Norway maple in the back yard of 61 Pinehurst, next to the eastern edge of the property. It measures 46cm DBH⁸, meaning the critical root zone CRZ) measures 460cm.

The tree is in fair condition. It has a full canopy with few dead branches. It has multiple stems, some with included bark, but no signs of rot or tearing in these unions. The largest codominant stem has an included union with the trunk, but this inclusion is beginning to occlude via inosculation and this occlusion may progress, mitigating the mechanical weakness of the inclusion. The roots of the tree are likely girdled by the tree pressed up against its trunk, which reduces the structural stability of the buttress roots, but not enough to pose a significant hazard. There are two clothesline wheels embedded within the tree, at least one of which is too far gone to retrieve. While this poses a stress for the tree and interferes with potential occlusion of an included union, they do pose enough of a stress to the tree to affect its viability.

The smaller of the two trees measures 38cm DBH, meaning its CRZ is 380cm. The tree is in good condition, with a full canopy, a dominant central trunk and no signs of fungal infection. The tree's root structure is likely impeded by the presence of the adjacent Norway maple, but this does not pose a significant risk.

According to the site plan, at its closest, the foundation will be about 690cm from the trunks of these trees. That is well outside the CRZs of both trees.

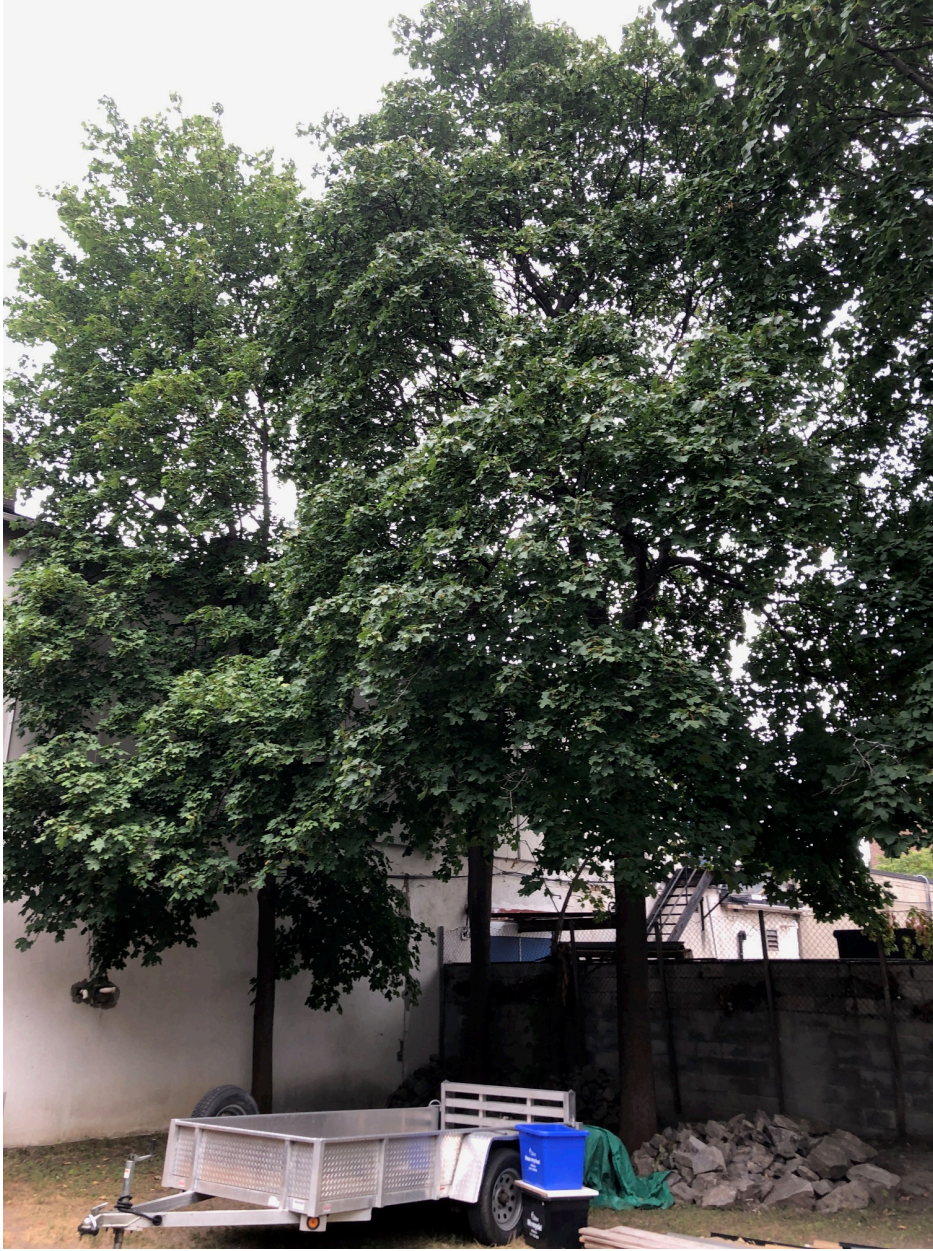
Tree 4 & 5: Norway Maples

In the adjacent back yard of 63 Pinehurst, there are three Norway maples. The smallest of these trees measures 24cm DBH and is therefore not distinctive. The middle tree measures 32cm, meaning its CRZ measures 320cm. The tree farthest to the south (right in photo below) measures 38cm, meaning its CRZ is 380cm.

The excavation, at its closest, will be well outside the CRZs of these trees. No root pruning will be necessary.
