# STAGE II CULTURAL HERITAGE IMPACT STATEMENT & CONSERVATION PLAN

145 Loretta Avenue & 951 Gladstone Avenue,  
Ottawa, Ontario

**PREPARED BY: COMMONWEALTH HISTORIC RESOURCE MANAGEMENT**

**Revision V5 October 2022**

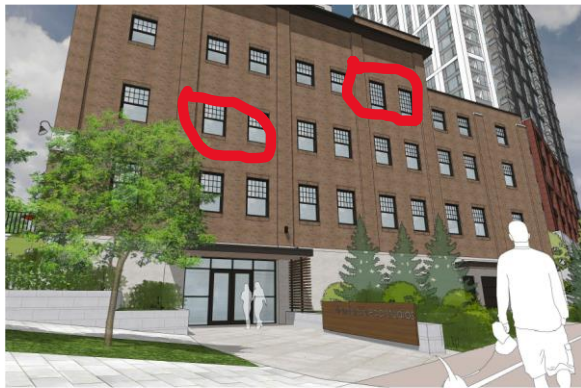
Figure 24 and 25: The fenestration along the east facade follows the profile of the original building as the as-found drawing below illustrates. Highlighted in red are proposed windows replacing doors and the introduction of new windows that were not originally part of the façade.

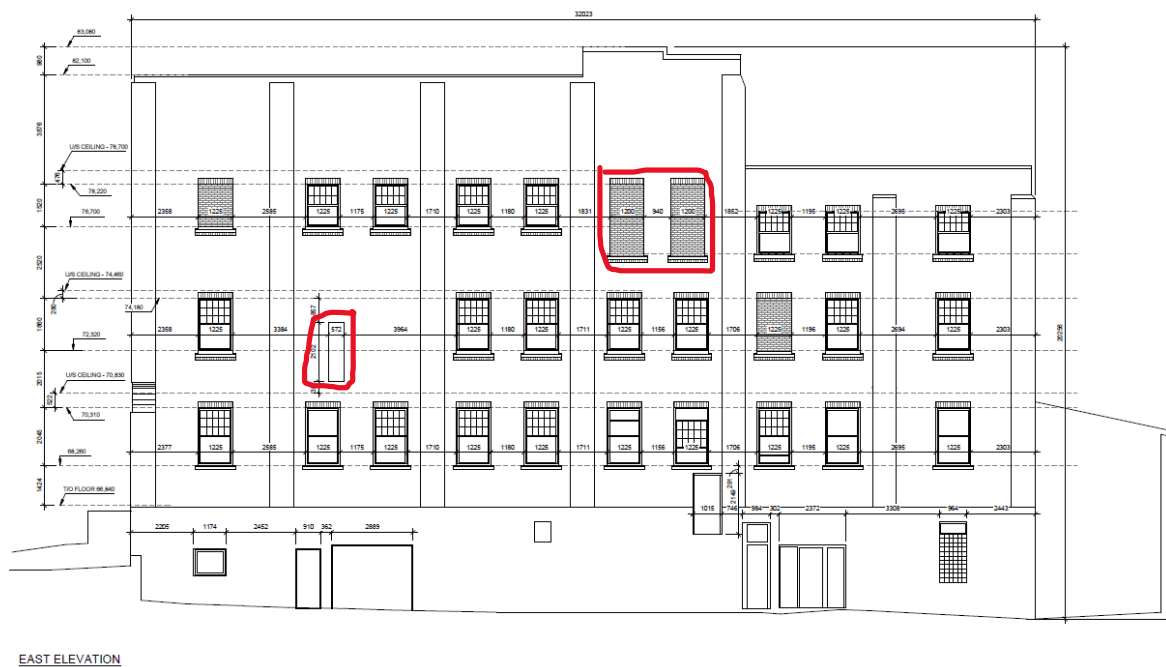
Figure 26: As-Found recording of the east and west elevation illustrating the configuration of windows and openings will provide a guide to the rehabilitation. The two areas highlighted in red are areas that the window configuration is proposed to be changed. Source: Hobin Architecture 2021.

The fenestration pattern on the east elevation overlooking the rail corridor is noted to be a character-defining feature reflecting its industrial use adjacent to a railway siding when constructed in 1924. The existing fenestration pattern will be retained including doors, and windows. At present the drawings illustrate the replacement of doors on the third floor with windows and the introduction of windows that are not original. These are noted on Figure 26.

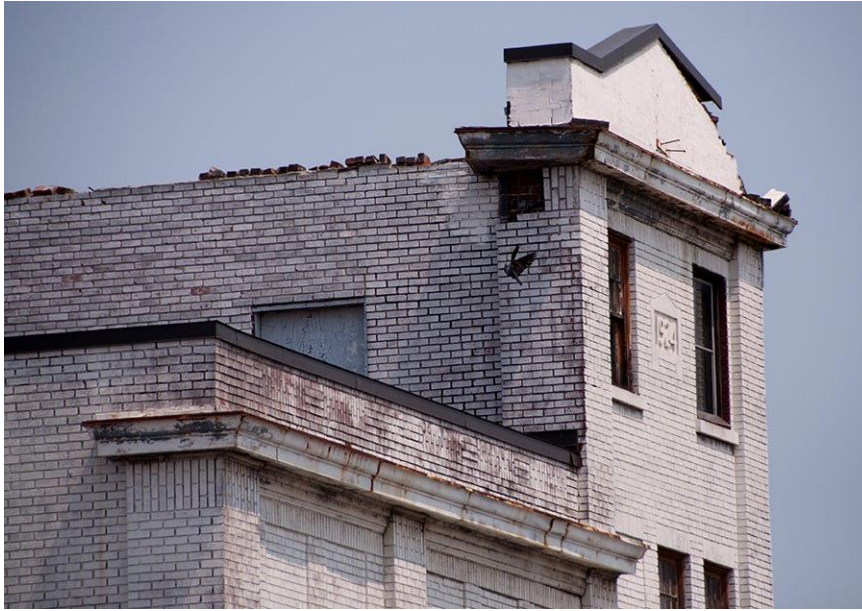
The gabled brick and metal parapets are in poor condition (figure 30) and will require restoration and for whole sections, the flashing and cornice profile details will have to be fabricated based on the photographs and remaining elements.

*Figure 30: The gabled brick and metal parapets will be re-instated to their original form and design. The height of the parapet can be determined from period photos. The original colour of the brick is evident in areas where the paint has worn off. Bricked-in windows will be opened and reglazed retaining the glazing pattern.*

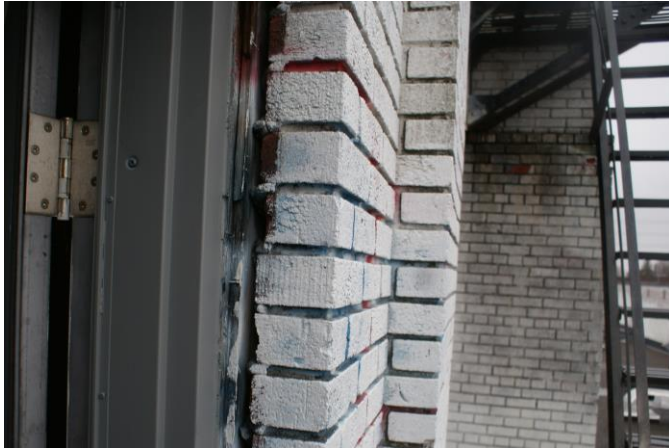
The original pointing mortar mix would appear to be a 1-part Portland, 3 parts sand with an admixture of lime to improve workability and adhesion to the masonry units. The Portland cement mortar mix was in common use when the building was completed in 1924 and is noted in manufacturers specifications for brickwork and terra-cotta tile. The joint profile is a recessed joint with a depth equal to the distance between bricks. The original mortar included a black pigment which has faded over the years where exposed. The pointing is in good condition, except for localized areas.

*Figure 32: View of the exterior brickwork from a second-floor fire escape. Note the highly textured brick surfaces and recessed joint profile. Source: Commonwealth 2021.*

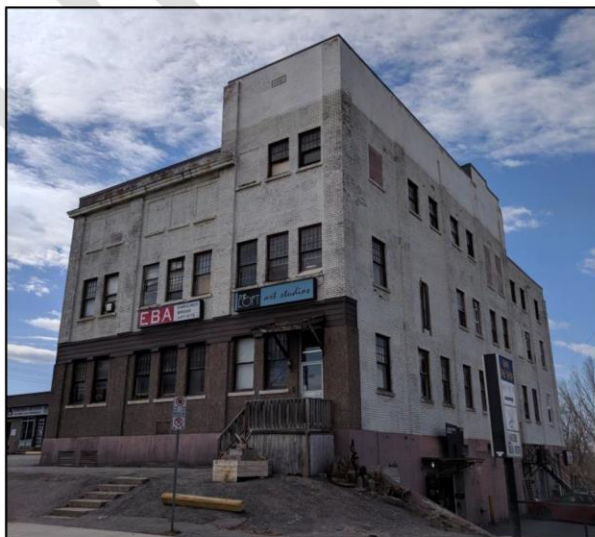
Photo 1: 951 Gladstone Avenue, south and east elevations [JCAL 2018].

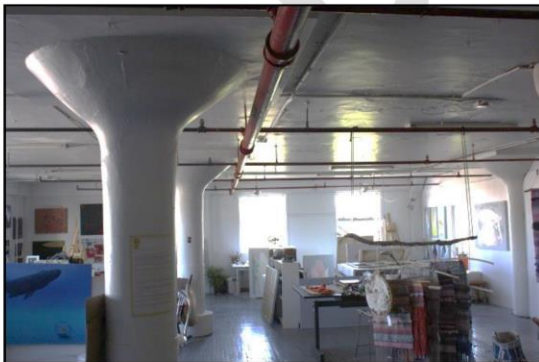
The interior concrete columns and floor slabs appear to be in good condition in general. An area of spalled concrete on the underside of the 3rd floor was observed. Loose concrete has been removed and the corroded rebar is visible. Although this is not an immediate structural concern, it does create a weak point in the floor slab. The deterioration does not appear active and was likely caused by water leakage or elevated moisture levels from previous building operations.

Photo 2: Typical columns inside the building [JCAL 2018].

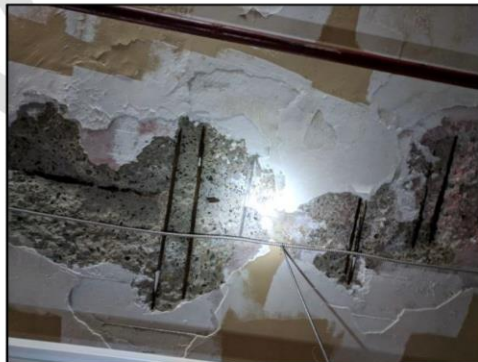
Photo 3: Corroding rebars have caused the concrete to spall on the underside of the third floor. [JCAL]

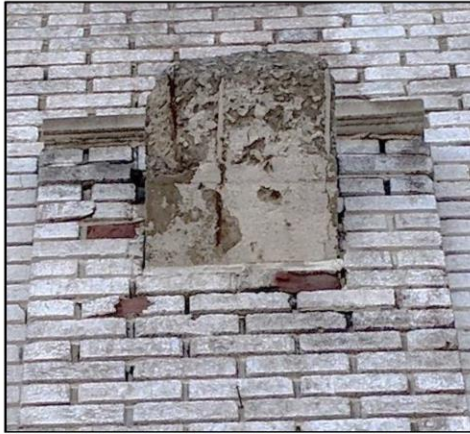
**Photo 4:** Typical corbel on the west elevation. Concrete and bricks are deteriorating [JCAL 2018].

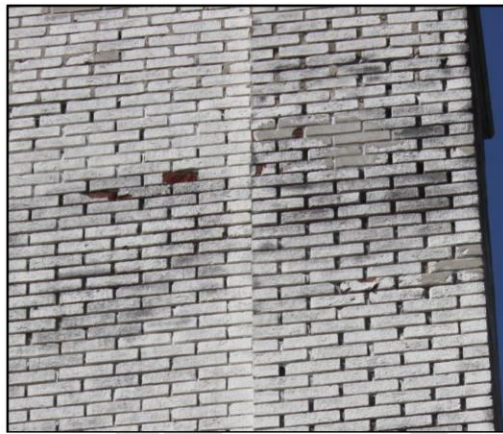
The exterior brick veneer in general is in good condition but does have localized areas of eroded mortar joints and face spalled bricks. These conditions were typically observed below window sills and other areas of high exposure to water, such as on the pilasters on the west and east elevations. Specifically on the west elevation, the bricks adjacent to the concrete corbels are in poor condition. The concrete corbels have minor vertical and horizontal cracks and typically have exposed rebar. Similarly, on the east elevation localized areas of masonry deterioration was observed.

**Photo 5:** Typical localized area of eroded joints and face spalled bricks [JCAL 2018].

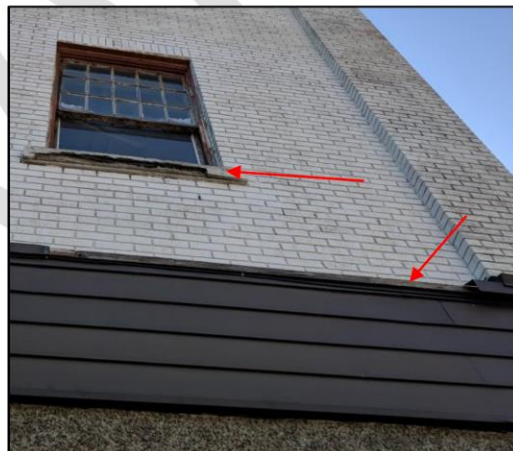
The flashing at the top of the stucco has been damaged at the south end of the west elevation. The stucco appears to be in good condition but the mortar joints in the backup brick may be eroded depending on the length of time the flashing has been damaged. On the east elevation, the southernmost buttresses are not flashed or capped at the top of the wall which could expedite the rate of deterioration of the brick below. Other buttresses were noted to be capped with sloped concrete. At the time of inspection the brick of the fourth floor appeared to be in good condition, however, it does appear that repairs were completed sometime in the past. Past photographs suggest that a large portion of the parapet on the south façade was removed. While undertaking our review, it was suggested by tenant that a windstorm in the past caused much damage to the roof, it is perhaps this event that led to the truncation of the south elevation.

Photo 8: Deteriorated concrete window sill and damaged flashing on west elevation [JCAL 2018].

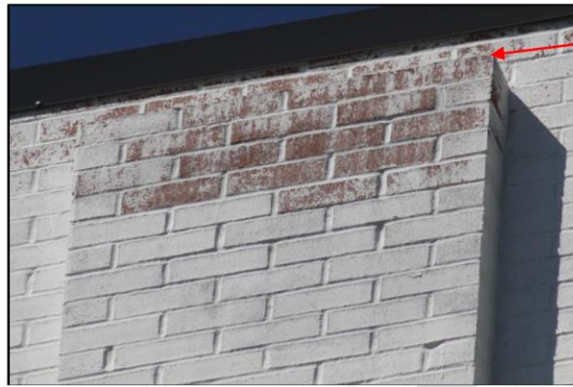
Photo 9: Top of pilaster, on east elevation, with no cap flashing [JCAL 2018].
