**MATT 1321  
Tree Conservation Report  
Stonebridge Golf Course Infrastructure Improvements**

**February 3, 2022**

**KILGOUR & ASSOCIATES LTD.**  
[www.kilgourassociates.com](http://www.kilgourassociates.com)

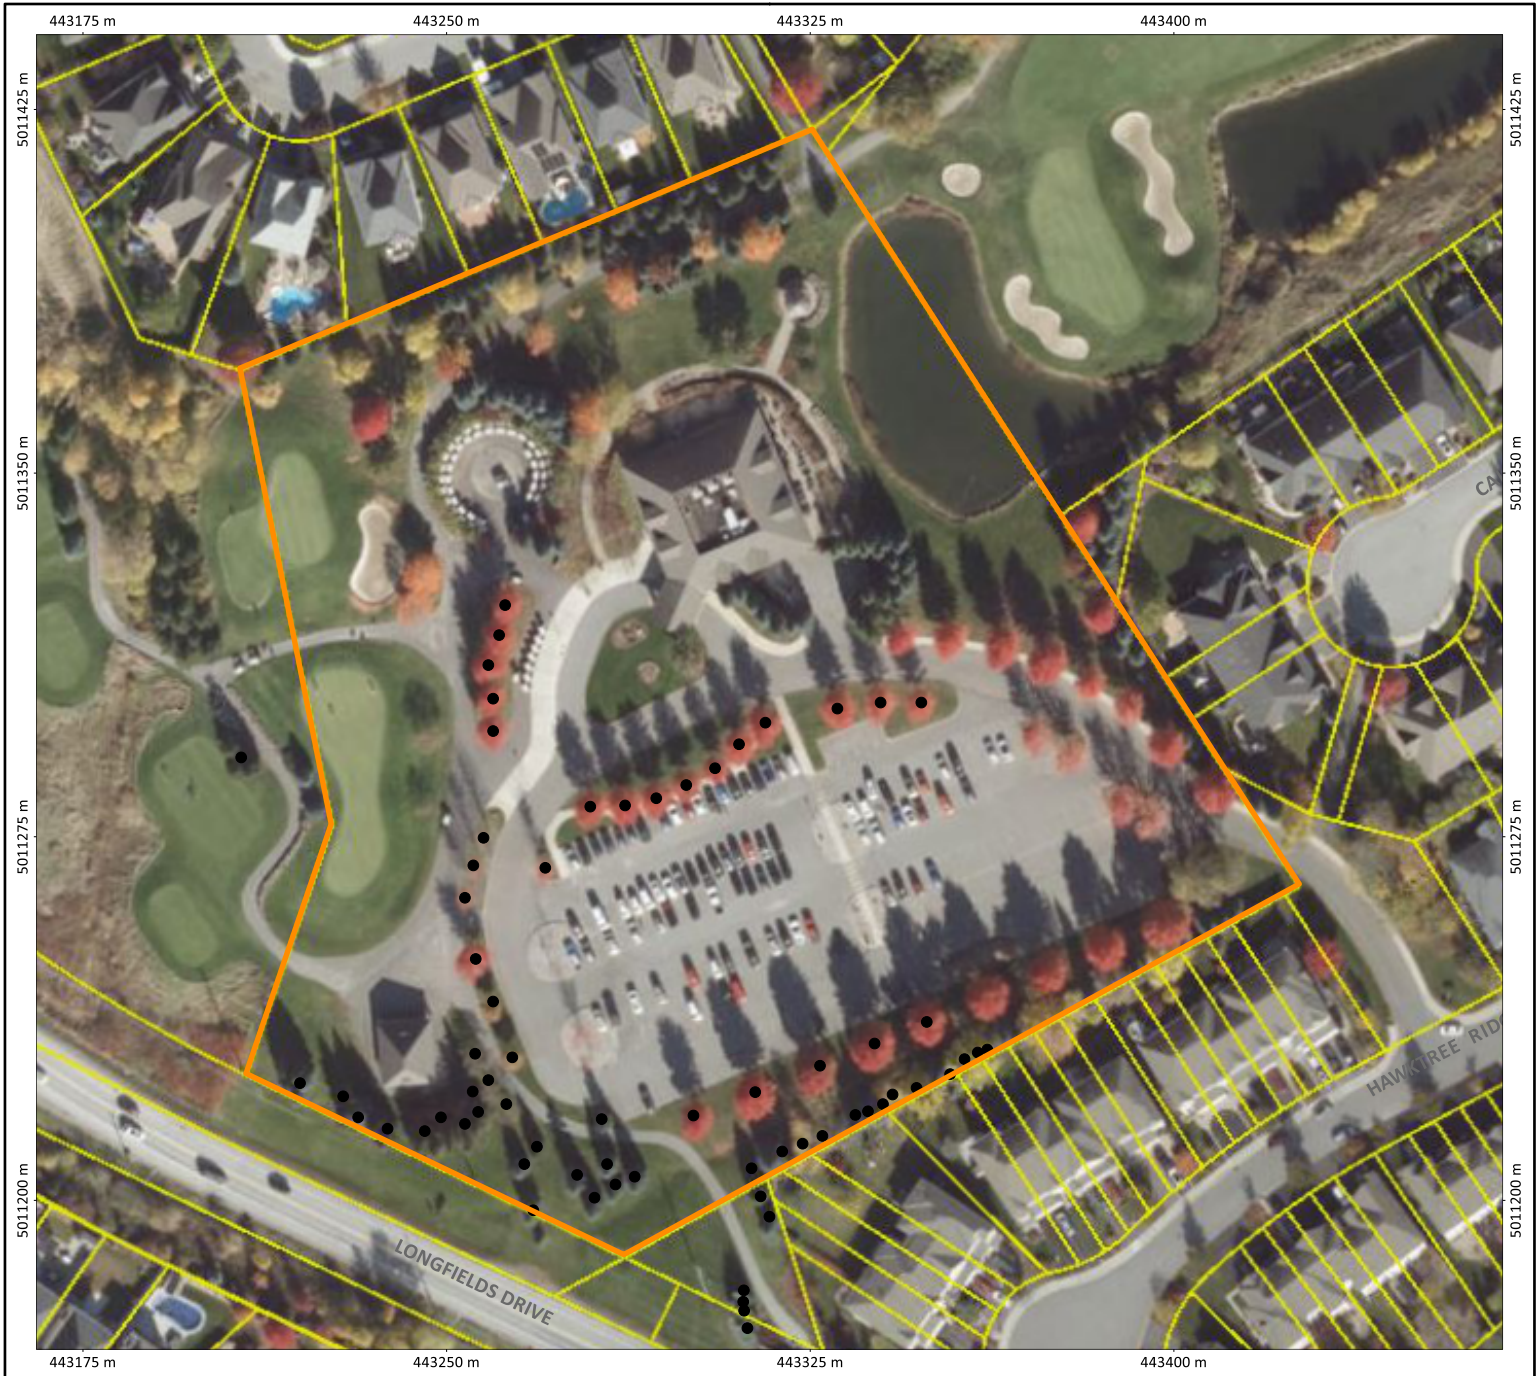
**Figure 1** Site context and tree locations

An inventory of trees on the Site was performed on January 24, 2022, following guidelines set forth by the City of Ottawa (2020). All trees with a DBH  $\geq$  10 cm having a potential to be removed under the proposed

development were identified, enumerated, mapped, their DBH measured, and their general health and condition documented (Appendix A, Figure 1)

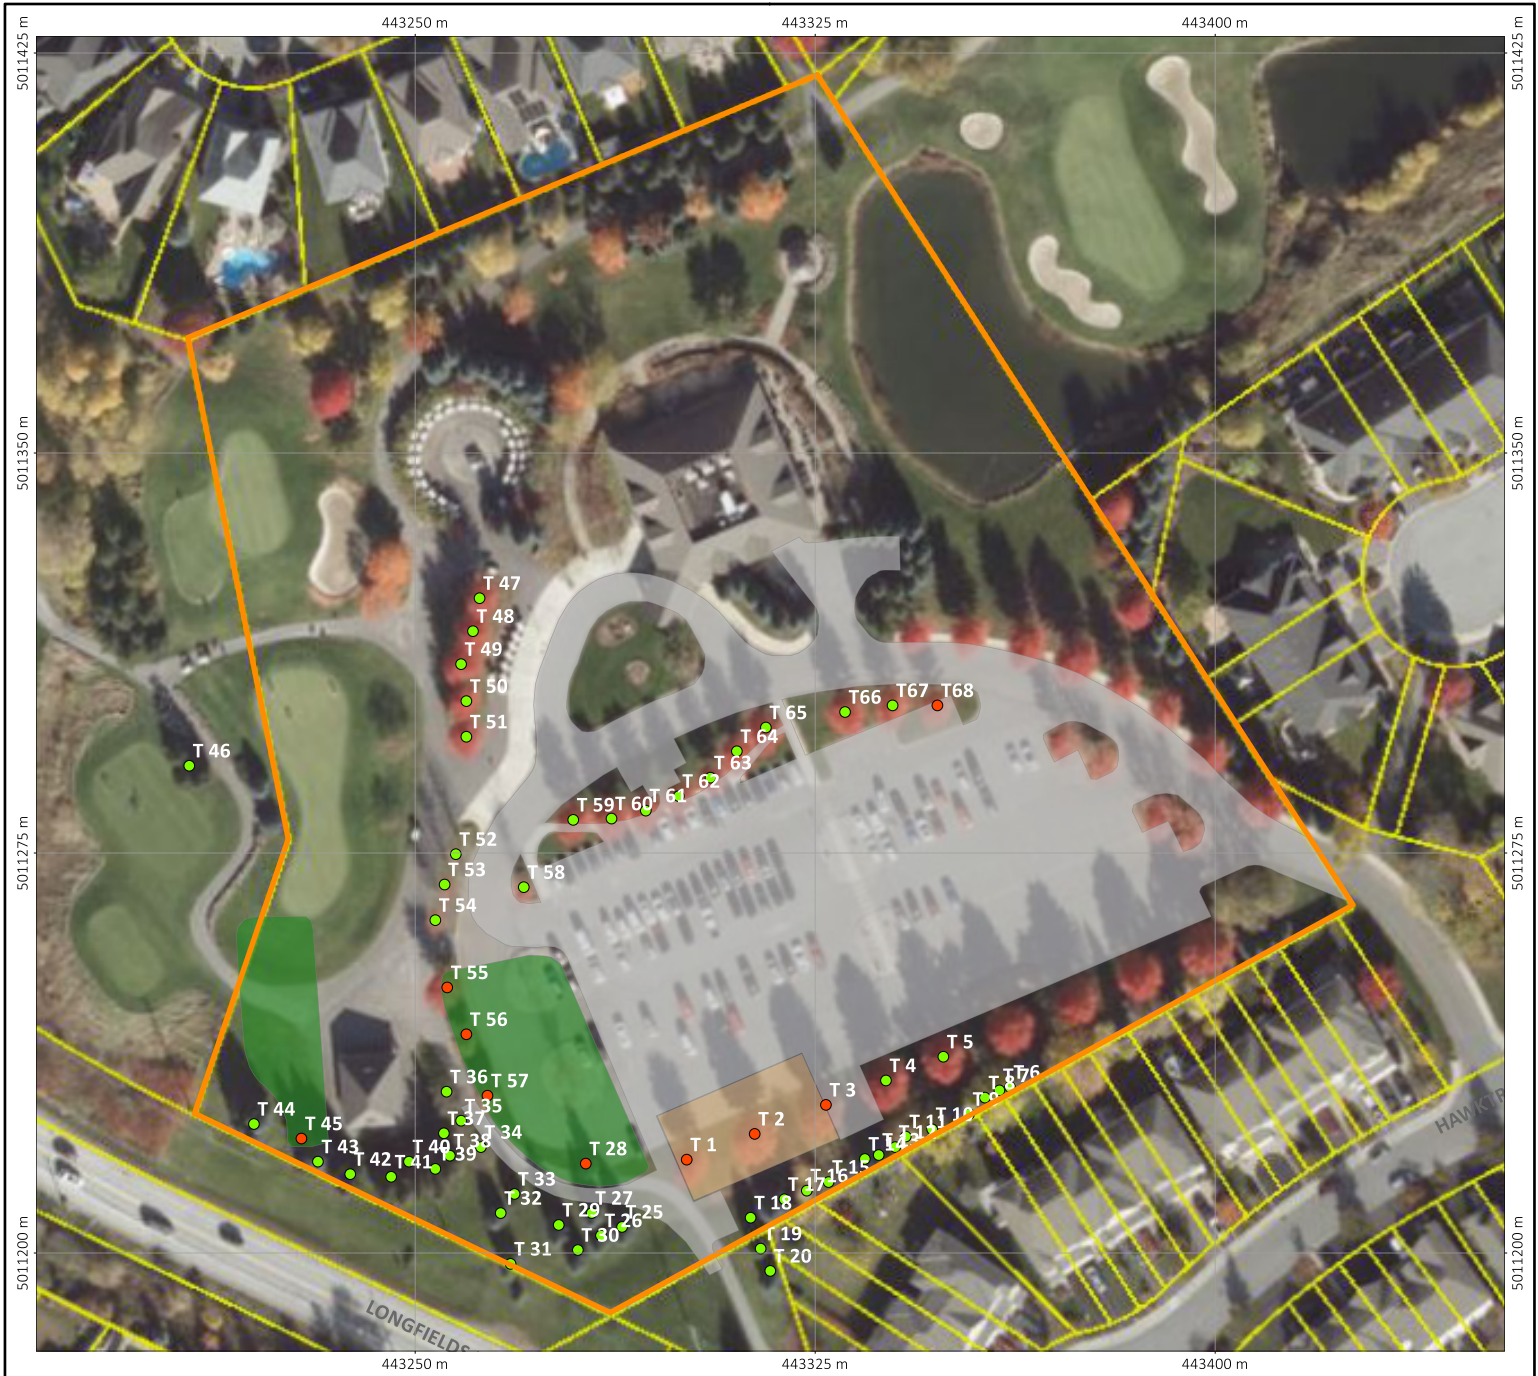
**Figure 2** Proposed development and tree locations.

The proposed development is the construction of a new cart storage building to be located near the southern portion of the Site. Construction of this building will entail alterations to the nearby parking lot and its adjacent walkways and landscaping, which will necessitate the removal of nine trees in these areas (Table 3, Appendix A). Alterations to the existing parking lot, walkways, and landscaping are also anticipated to extend into the CRZ of 12 trees on the site (Table 3, Appendix A). Work occurring within the CRZ of these trees, however, is not anticipated to negatively impact them in a significant manner as the current site conditions already interact with and impede upon their critical root zones (i.e., the trees already abut curbs and the work there will consist primarily of minor adjustments to those curbs).

All other trees on the Site will be retained. Alterations to the golf course layout are also planned, though these are not anticipated to interact with site trees. Site works are planned to commence in the late winter or early spring of 2022.

- Trees adjacent to the Site will not be removed or damaged.
- To minimize impacts to trees to be retained on the Site:
  - Erect a fence beyond the retained trees along the proposed edge of paving. While this fence will fall within the nominal CRZ of the retained trees, the fence in this location will protect roots occurring within the extent that they have grown to date. The fence should be highly visible (orange construction fence) and paired with erosion and sediment control fencing.

Trees to be removed include six Red Maples (*Acer rubrum*), two Blue Spruce (*Picea pungens*) and a Sugar Maple (*Acer saccharum*). Replacement trees should be of the same species and numbers except that White Spruce (*Picea glauca*), a species indigenous to the region, should be used instead of Blue Spruce.
