URBAN FORESTRY & FOREST MANAGEMENT CONSULTING

November 21, 2022

**RE: TREE CONSERVATION REPORT FOR SILVER MAPLE #38 AT 114 RICHMOND ROAD,  
ASHCROFT HOMES' Q WEST DEVELOPMENT**

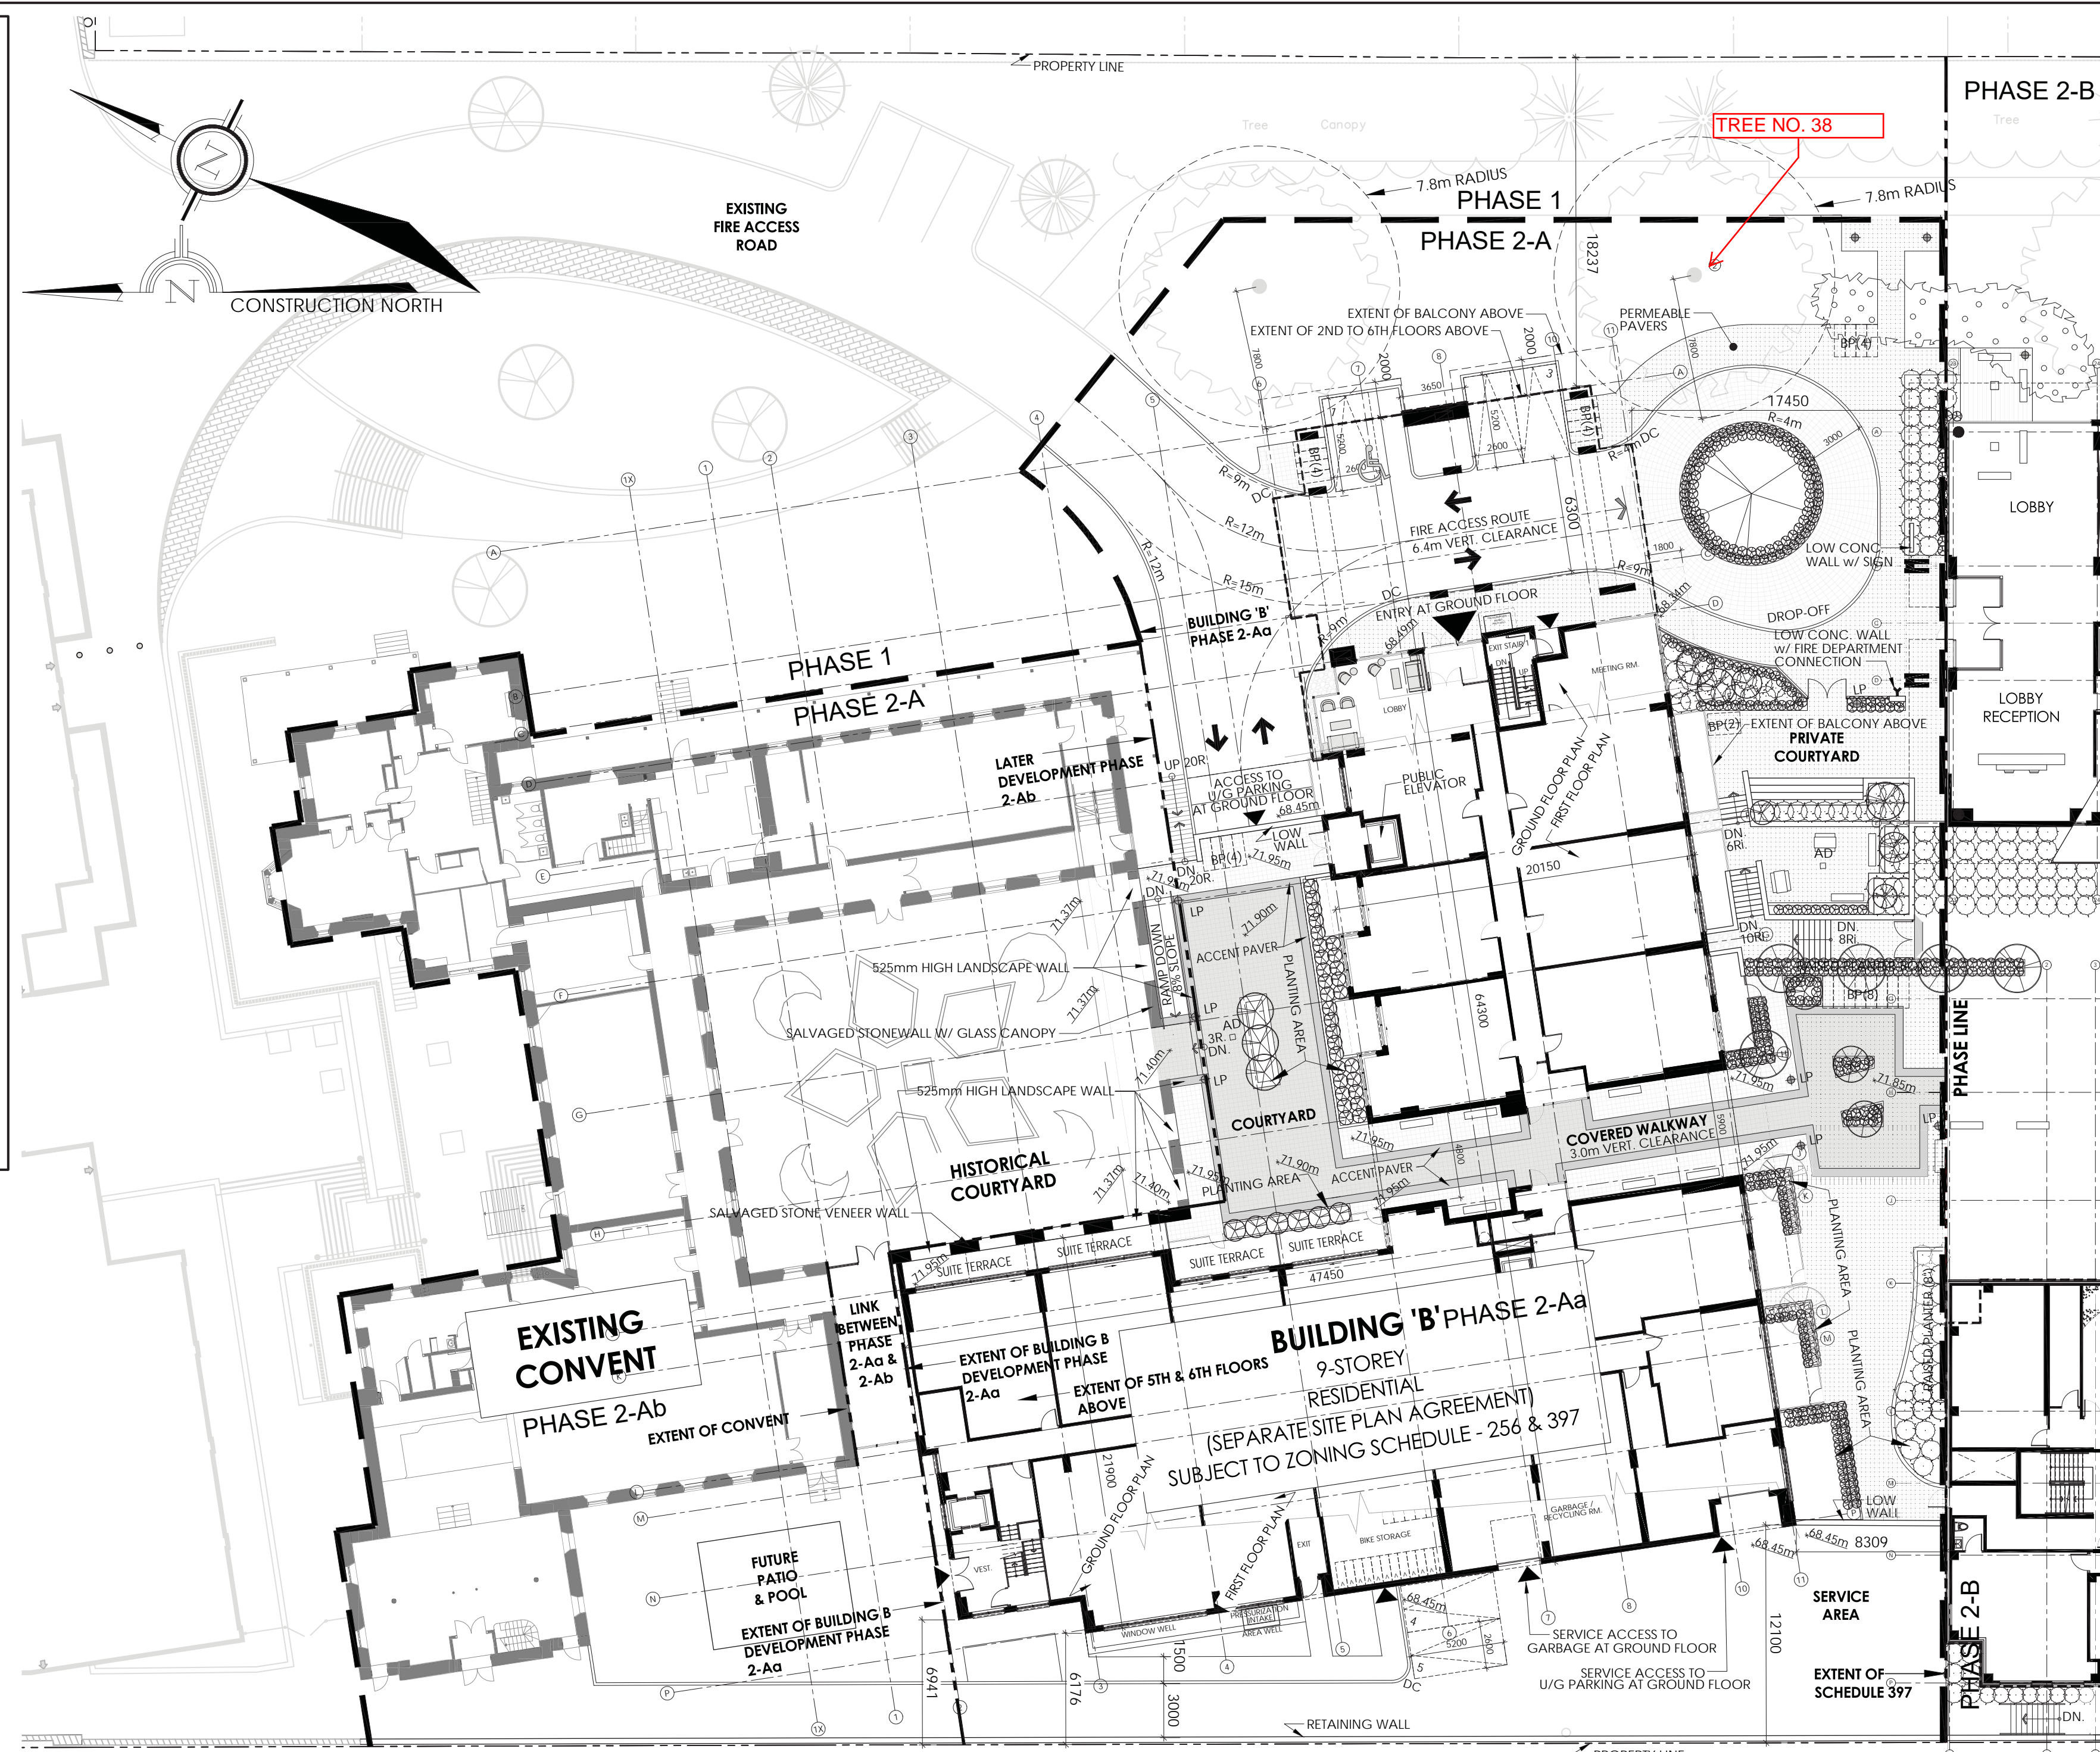
2 BUILDING 'B' PHASE 2-Aa SITE PLAN  
SP-1b / SCALE 1 : 250

This letter report adds to several earlier reports related to trees on this development site. In particular, the preservation of a single, 78cm diameter silver maple (*Acer saccharinum*) impacted by excavation necessary for a fire route and turning circle within its critical rooting zone (see site plan prepared by M. David Blakely Architect on page 2 of this report). This tree is identified as number 38 in all reports.

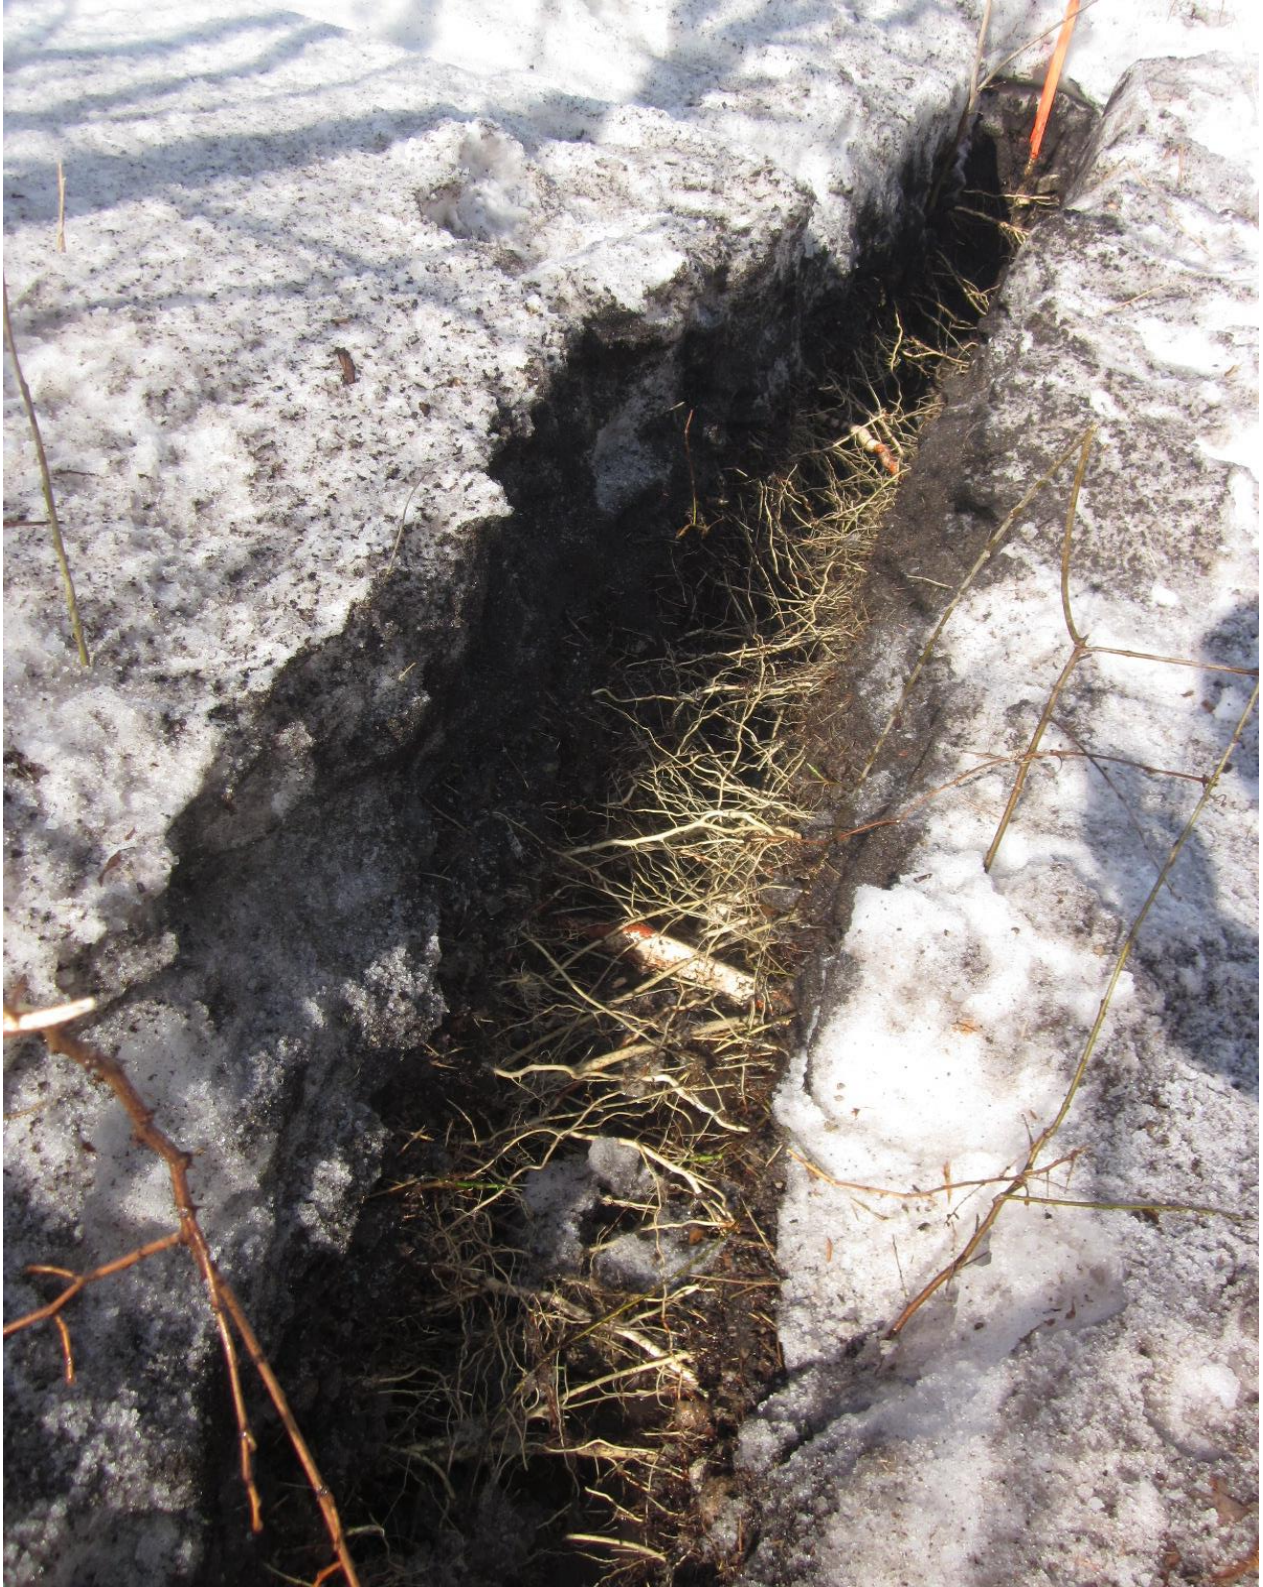
In March 2020, an exploratory hydro excavation was undertaken to determine the number of roots present at a distance of 7.8m from the tree – a distance equal to its critical rooting zone (CRZ). Many fine feeding roots and several larger roots were encountered (see Picture 1 on page 3). Under the present development proposal, the curb of the fire lane is 5.4m away. The inside edge of the turning circle will be roughly half that distance from the tree. In order to lessen the amount of root loss associated with the proposed excavation, the following general construction methods and materials are recommended. An engineer should be consulted for exact design details:

Picture 1. Results of hydro excavation 7.8m from tree #38 (photo taken March 2020).

1. Hydro excavation along the edge of excavation in closest proximity to the tree to carefully expose roots. Exposed roots will then be cleanly cut and sealed with an organic beeswax-based product. Excavation can then resume using traditional mechanical means. Sealing the cleanly cut root ends will help prevent the loss of moisture and facilitate healing. If the excavation is to be left open for any amount of time a covering of at least three layers of moistened burlap is to be draped over the exposed face of excavation. This will help reduce the loss of soil moisture.

3. Following the removal of the tree protection barrier (see details on page 7), the topsoil is to be stripped using a light tracked machine equipped with a ditching bucket. The ditching bucket is to have a sharp cutting edge to minimize pulling on the roots. The excavation is to take place under the direction of an arborist and a geotechnical engineer. The depth of excavation is to be limited to the depth of organic material (approximately 0.25m based on observations from the hydro excavation).

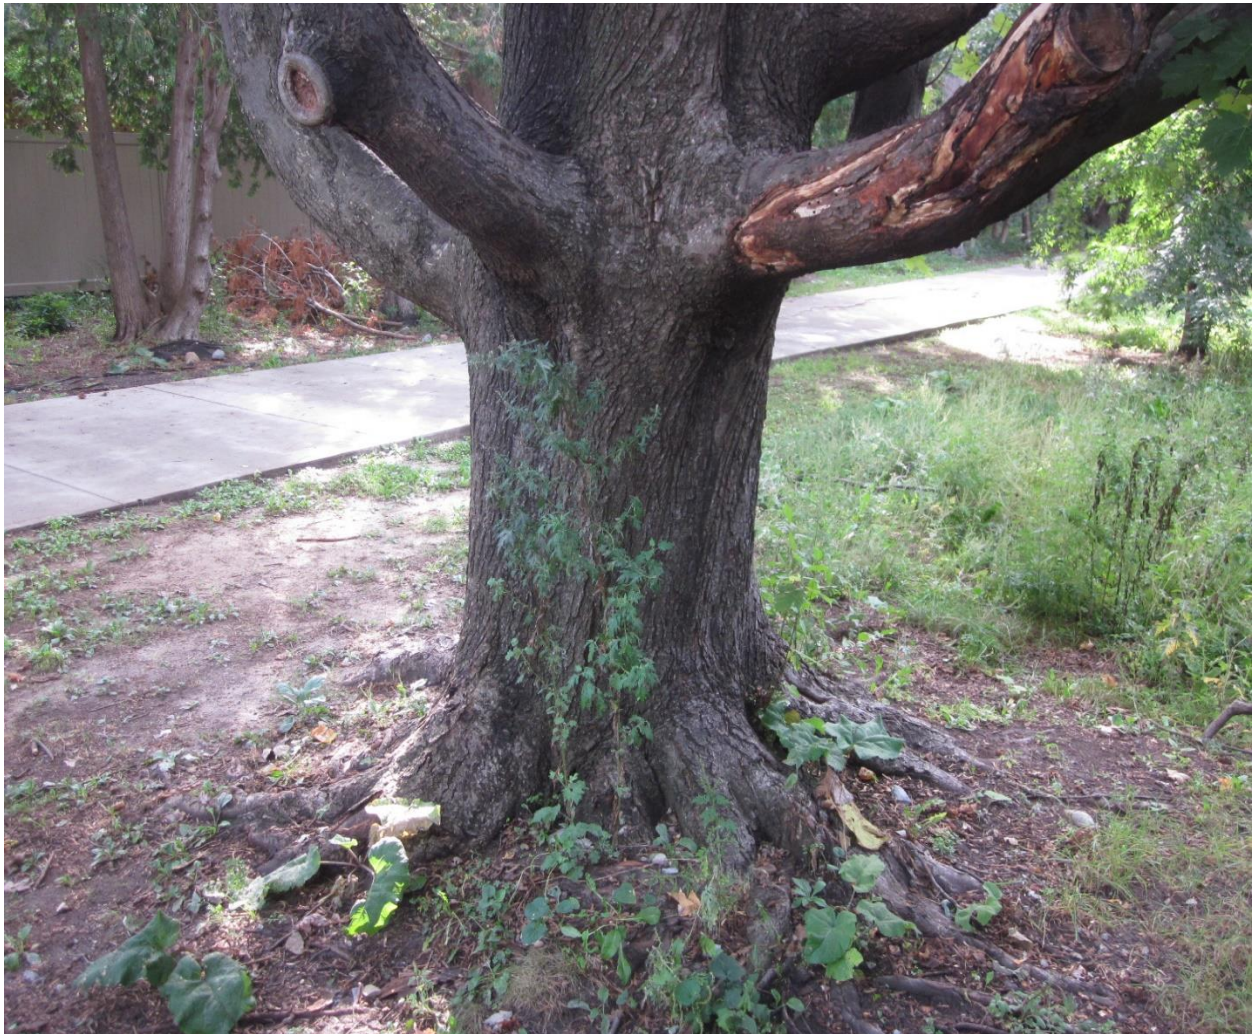
Picture 2. Typical surface conditions beneath silver maple tree line at 114 Richmond Road (photo taken September 2022).
