June 15, 2021

RE: TREE CONSERVATION REPORT FOR 155 IBER ROAD, OTTAWA

This report details a pre-construction tree conservation report (TCR) for the above-noted property in Ottawa. The need for this TCR is related to the proposed construction of a stand-alone single storey warehouse and associated loading zone at the rear of the property. A realigned entranceway into the property, relocated parking spaces and the addition of bicycle parking are also proposed.

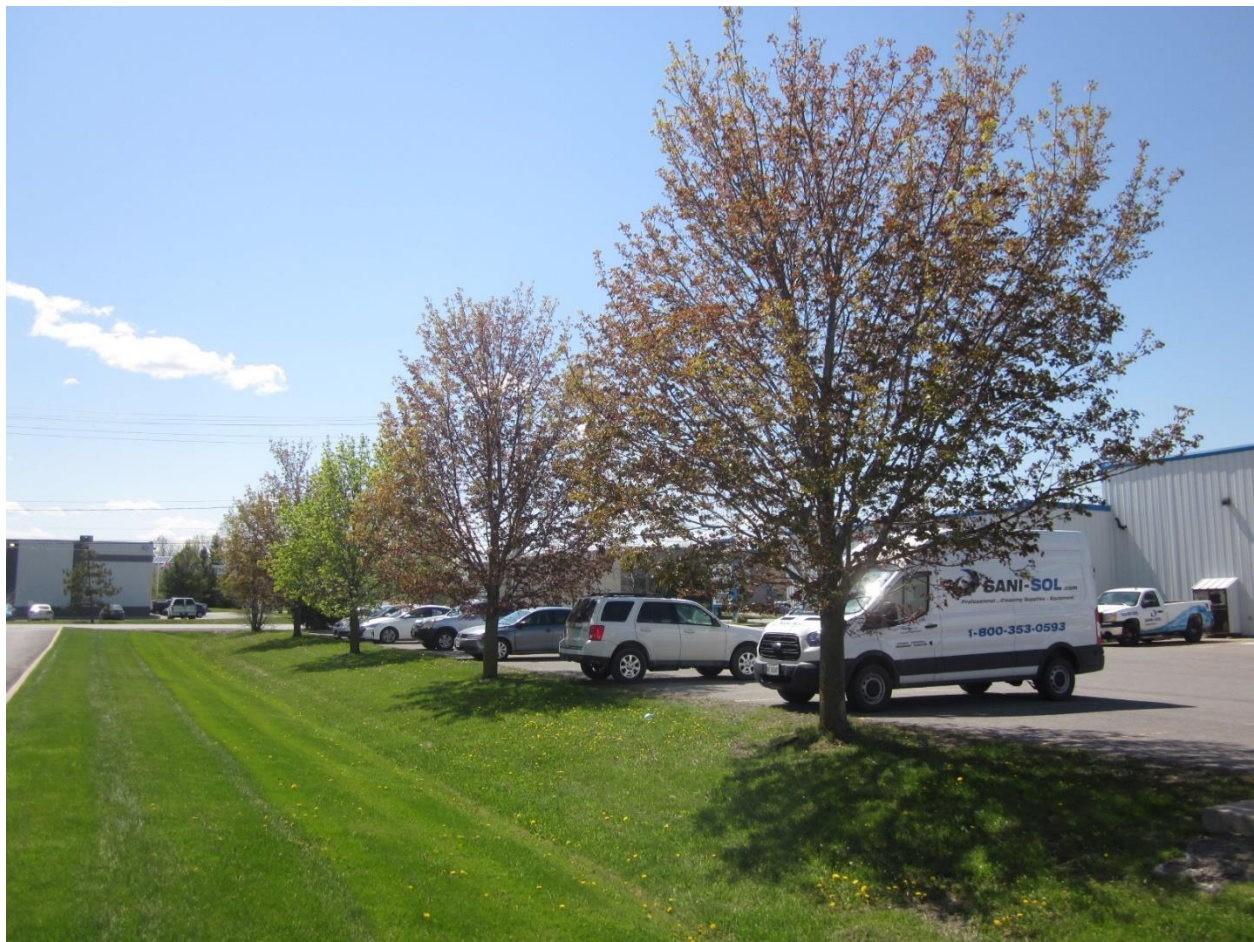
5	Norway maple	Good	27.5	Neighbour	Mature; central main stem with suppressed laterals starting at 1.5m from grade; broad dense crown; spiral seam at 0.1-1.4m on south side of main stem has healed; to be preserved and protected
6	Norway maple	Good	28.2	Neighbour	Mature; central main stem with suppressed laterals starting at 1.5m from grade; broad dense crown; lower lateral on north side broken by snow plow; to be preserved and protected
7	Colorado spruce	Good	23.2	Private	Mature; good crown density, growth increment and needle colour; restricted rooting area close to side of building; to be removed (conflicts with proposed new parking)

Picture 1. Neighbouring trees #2-6 located adjacent to 155 Iber Road

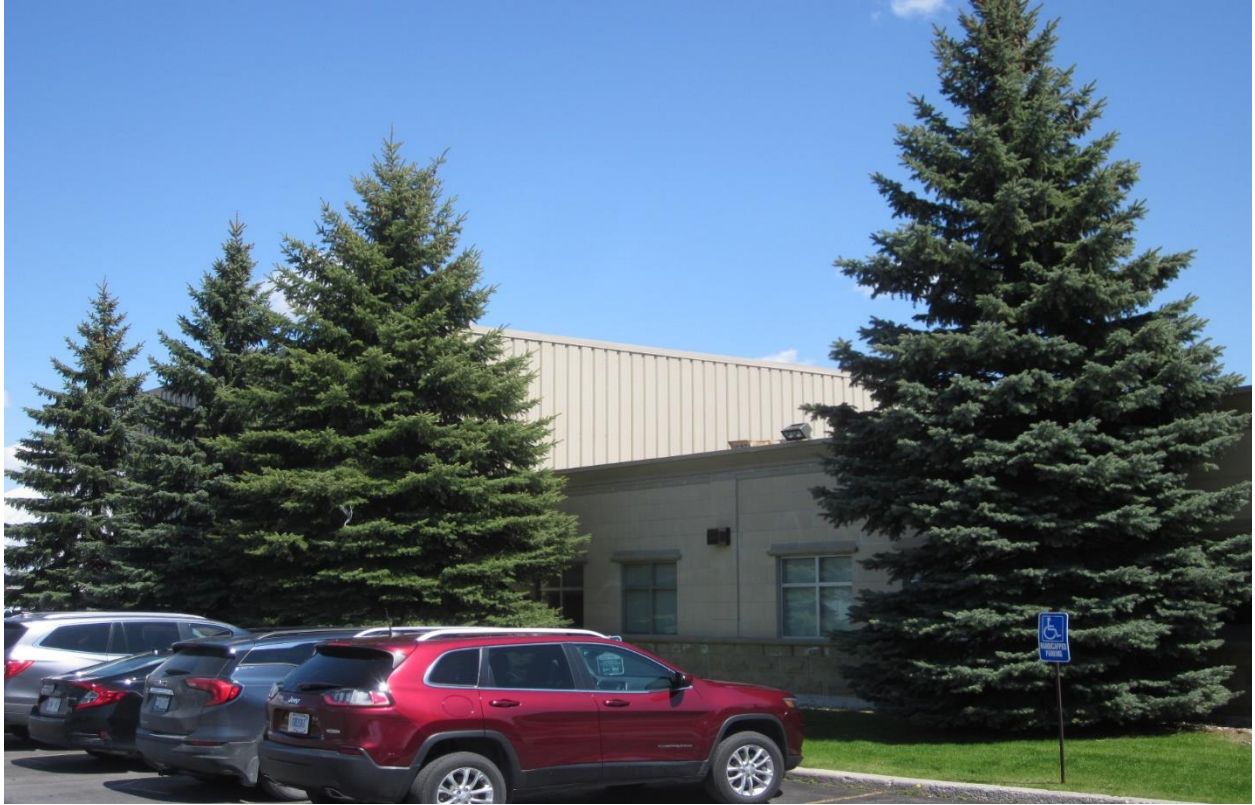
8	Colorado spruce	Good	24.1	Private	Mature; good crown density, growth increment and needle colour; restricted rooting area close to side of building; to be removed (conflicts with proposed new parking)
9	Colorado spruce	Good	29.3	Private	Mature; good crown density, growth increment and needle colour; moderately restricted rooting area close to corner of building; to be removed (conflicts with proposed new parking)
10	Colorado spruce	Good	27.7	Private	Mature; good crown density, growth increment and needle colour; restricted rooting area close to building – has been clearance pruned in past; to be removed (will not survive root loss associated with installation of new curb and concrete pad for bicycle parking)
11	Amur maple (<i>Acer tataricum</i> subsp. <i>ginnala</i>)	Poor	15.3	Private	Mature; 'standard' variety; crown form very divergent towards north due to influence of trees #12 and 13; suppressed growth; introduced invasive species; to be removed (conflicts with proposed new entranceway)

Picture 2. Trees #7-10 located at 155 Iber Road

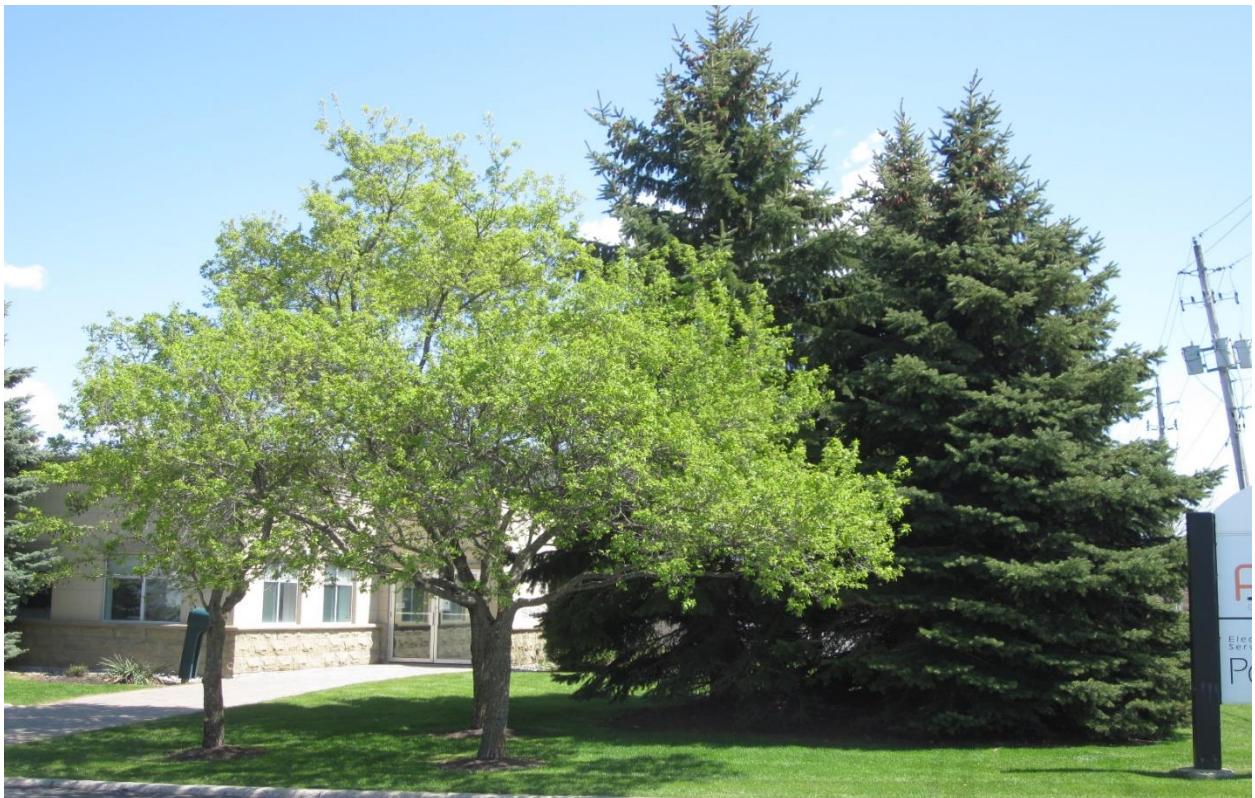
12	Amur maple	Fair	17.6	Private	Mature; 'standard' variety; crown form divergent towards southwest due to influence of trees #11 and 13; to be removed (conflicts with proposed new entranceway)
13	Amur maple	Good	20.2	Private	Mature; 'standard' variety; crown form divergent towards east due to influence of trees #11 and 12; to be removed (misshapen form and having a negative influence on nearby trees)
14	Colorado spruce	Good	26.7	Private	Mature; good crown density, growth increment and needle colour; lower crown asymmetric due to intercompetition with trees #15 and 16; to be preserved and protected

Picture 3. Trees #11-16 located at 155 Iber Road

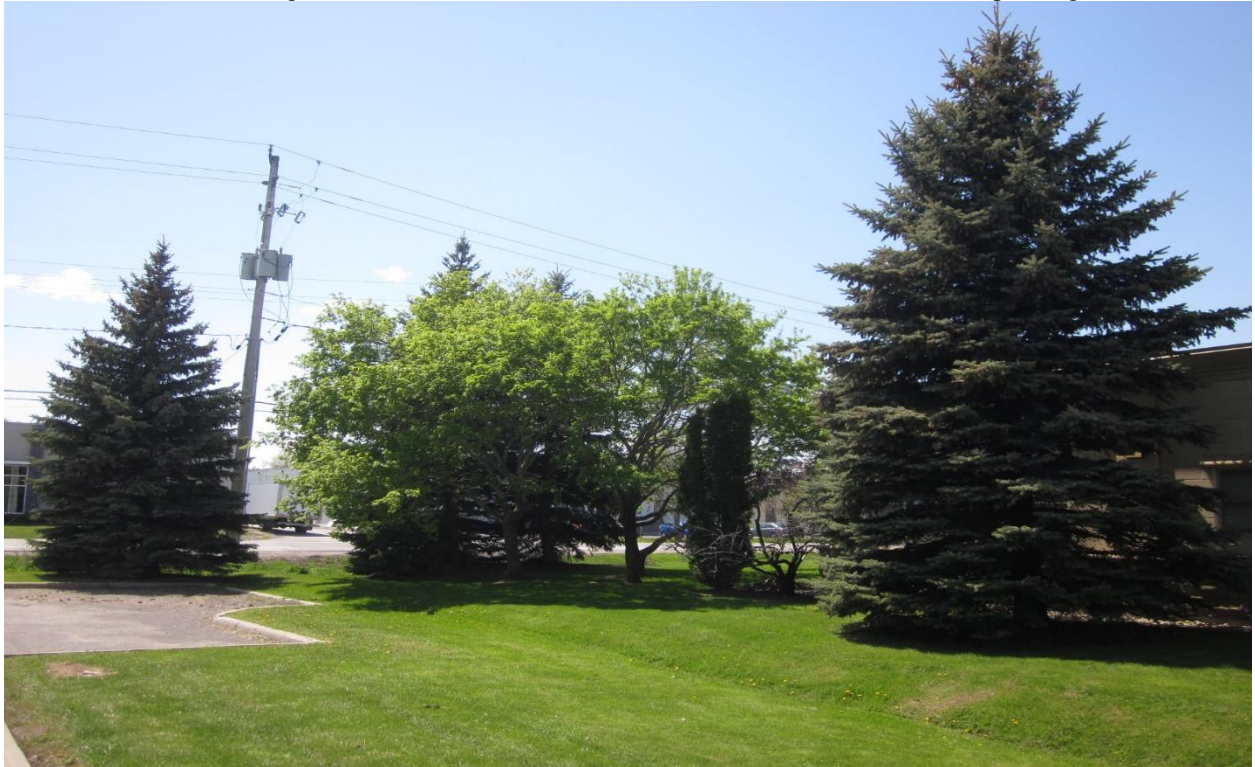
15	Colorado spruce	Good	24.9	Private	Mature; good crown density, growth increment and needle colour; lower crown asymmetric due to intercompetition with trees #14 and 16; to be preserved and protected
16	Colorado spruce	Good	25.2	Private	Mature; good crown density, growth increment and needle colour; lower crown asymmetric due to intercompetition with trees #14 and 15; to be preserved and protected
17	Colorado spruce	Very good	31.3	Neighbour	Mature; very good crown density, growth increment and needle colour; to be preserved and protected
18	Colorado spruce	Good	23.8	Private	Mature; good crown density, growth increment and needle colour; lower crown asymmetric due to intercompetition with trees #19 and 20; to be preserved and protected
19	Colorado spruce	Good	25.1	Private	Mature; good crown density, growth increment and needle colour; lower crown thin due to combined influence (shading) of trees #18, 20, 21 and 22; to be preserved and protected

Picture 5. Trees #17-24 (left to right) located on and adjacent to 155 Iber Road

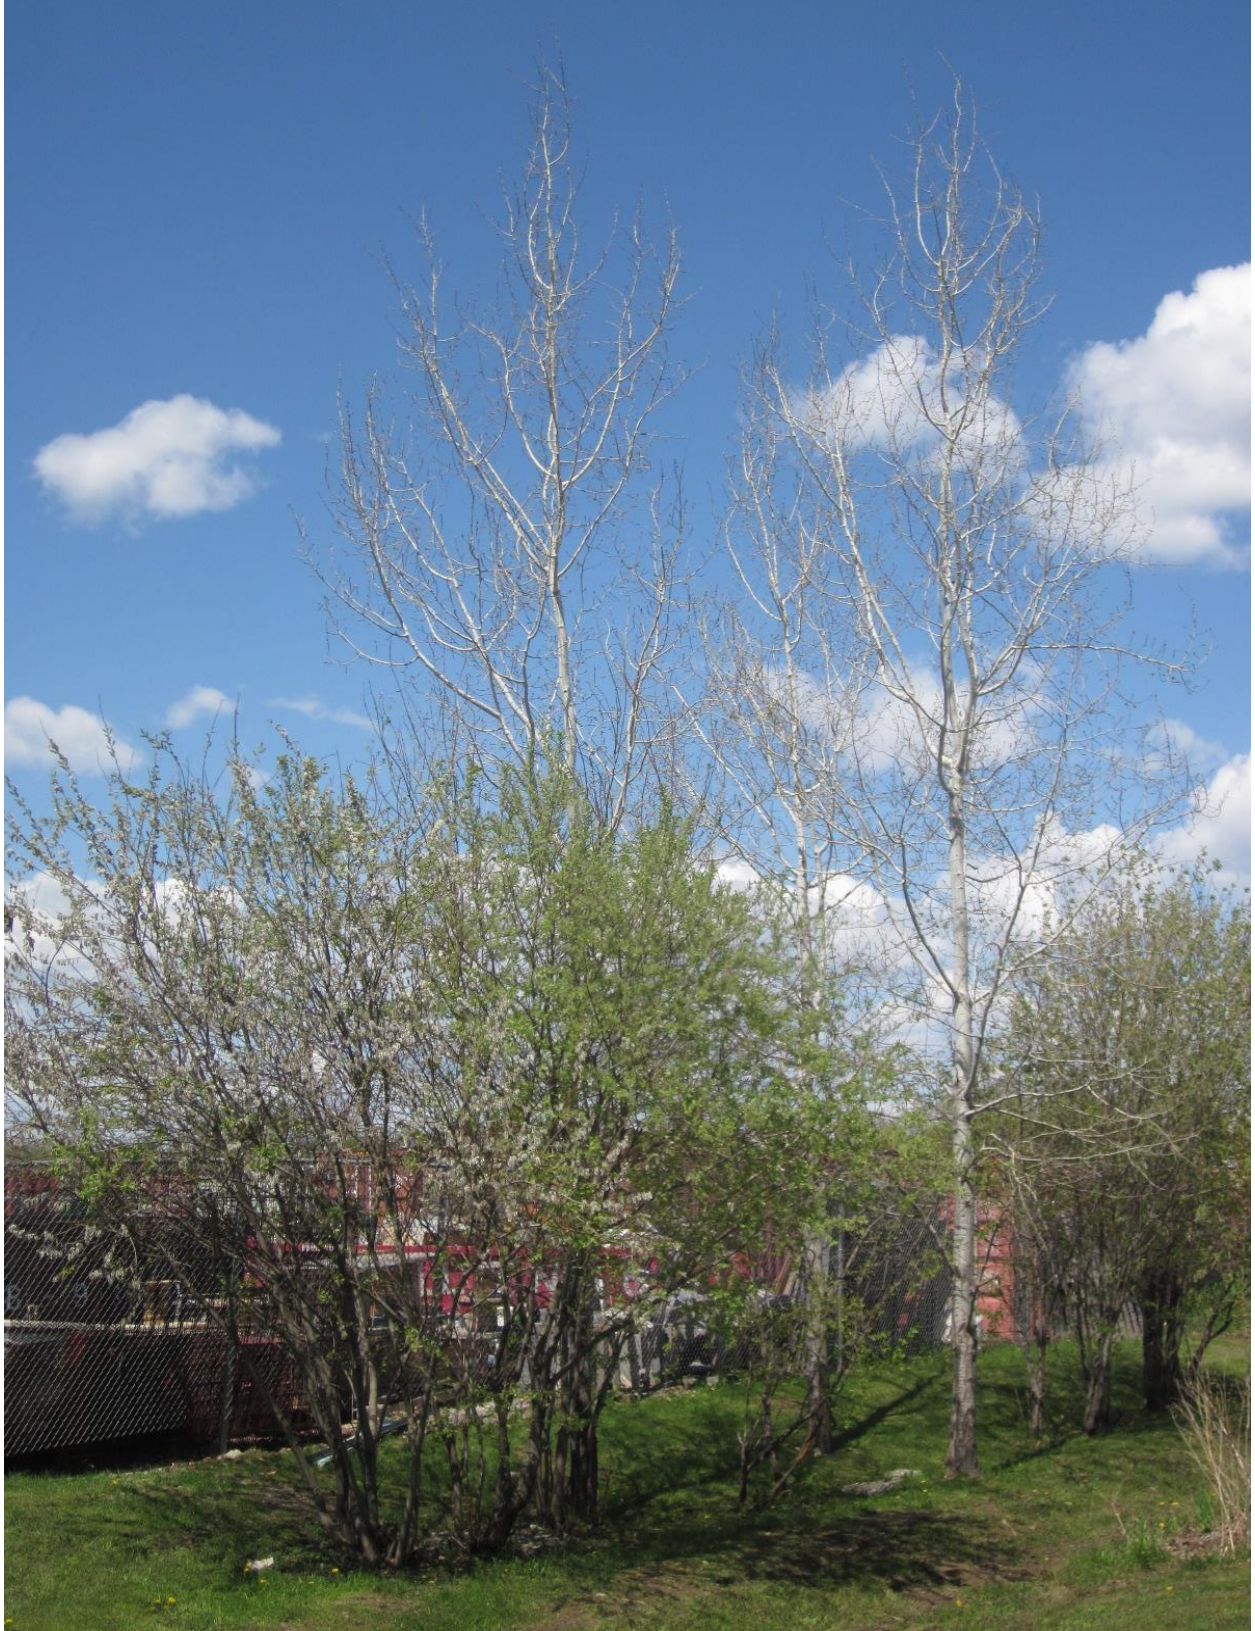
25	Trembling aspen (<i>Populus tremuloides</i>)	Fair	16.7, 21.1 & 21.2	Private	Maturing; group of three trees; 21.2cm stem with oozing wounds 2-4m from grade on north side; native species; to be preserved and protected
----	--	------	-------------------	---------	--

Picture 6. Tree grouping #25 located at 155 Iber Road
