TREE CONSERVATION REPORT

216 McArthur

Tree Conservation Report submitted as Partial
Requirements for a Site Plan Control Application,
September 13, 2022

Date of Report: September 13, 2022

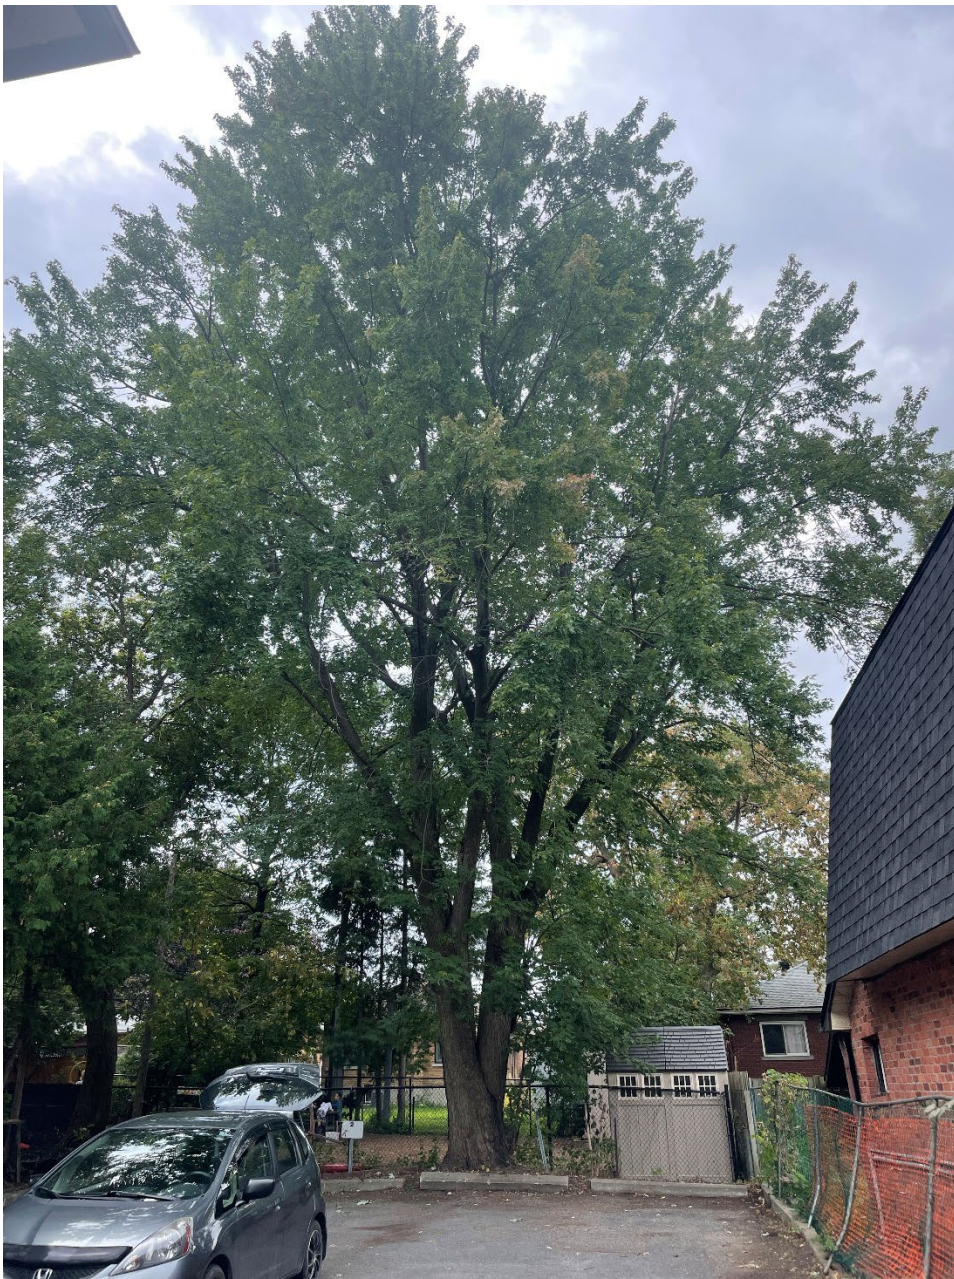
The large silver maple (tree 1) at the rear of the property could be retained if there is no significant site grading or infrastructure planned for the rear yard. The CRZ on the subject site is under pavement, under which there are likely some roots. If possible, this pavement should not be replaced until the final stages of construction as it is currently acting as a protective layer for the roots. It is possible that some roots will be lost during excavation for the new building. If any roots are severed during the excavation, the following mitigation measures should be applied:

Figure 1: Tree 1, large silver maple at the rear of the property

- Prune roots back with a clean hand tool to reduce the risk of pathogens from entering the tree through proper sealing
- Do not use wound dressings or pruning paint to cover root tips
- Avoid pruned exposure of roots. Keep all exposed roots moist and covered with soil, mulch, irrigation, or at least moistened burlap.

When the pavement is replaced with soft landscaping, care should be taken to avoid any root tearing. Keeping these roots covered with organic material as quickly as possible is key to avoid desiccation.

Although it is recognized that the entire CRZ of the silver maple cannot be retained, as much of it as possible should be kept out of the construction zone and protected as per the following **City of Ottawa Tree Protection Specifications (March 2021)**. Protective fencing should be installed around the tree as indicated in the attached Tree Information Map and maintained until all construction on site has been completed as per the Within the fenced area, the following tree protection guidelines should be applied:

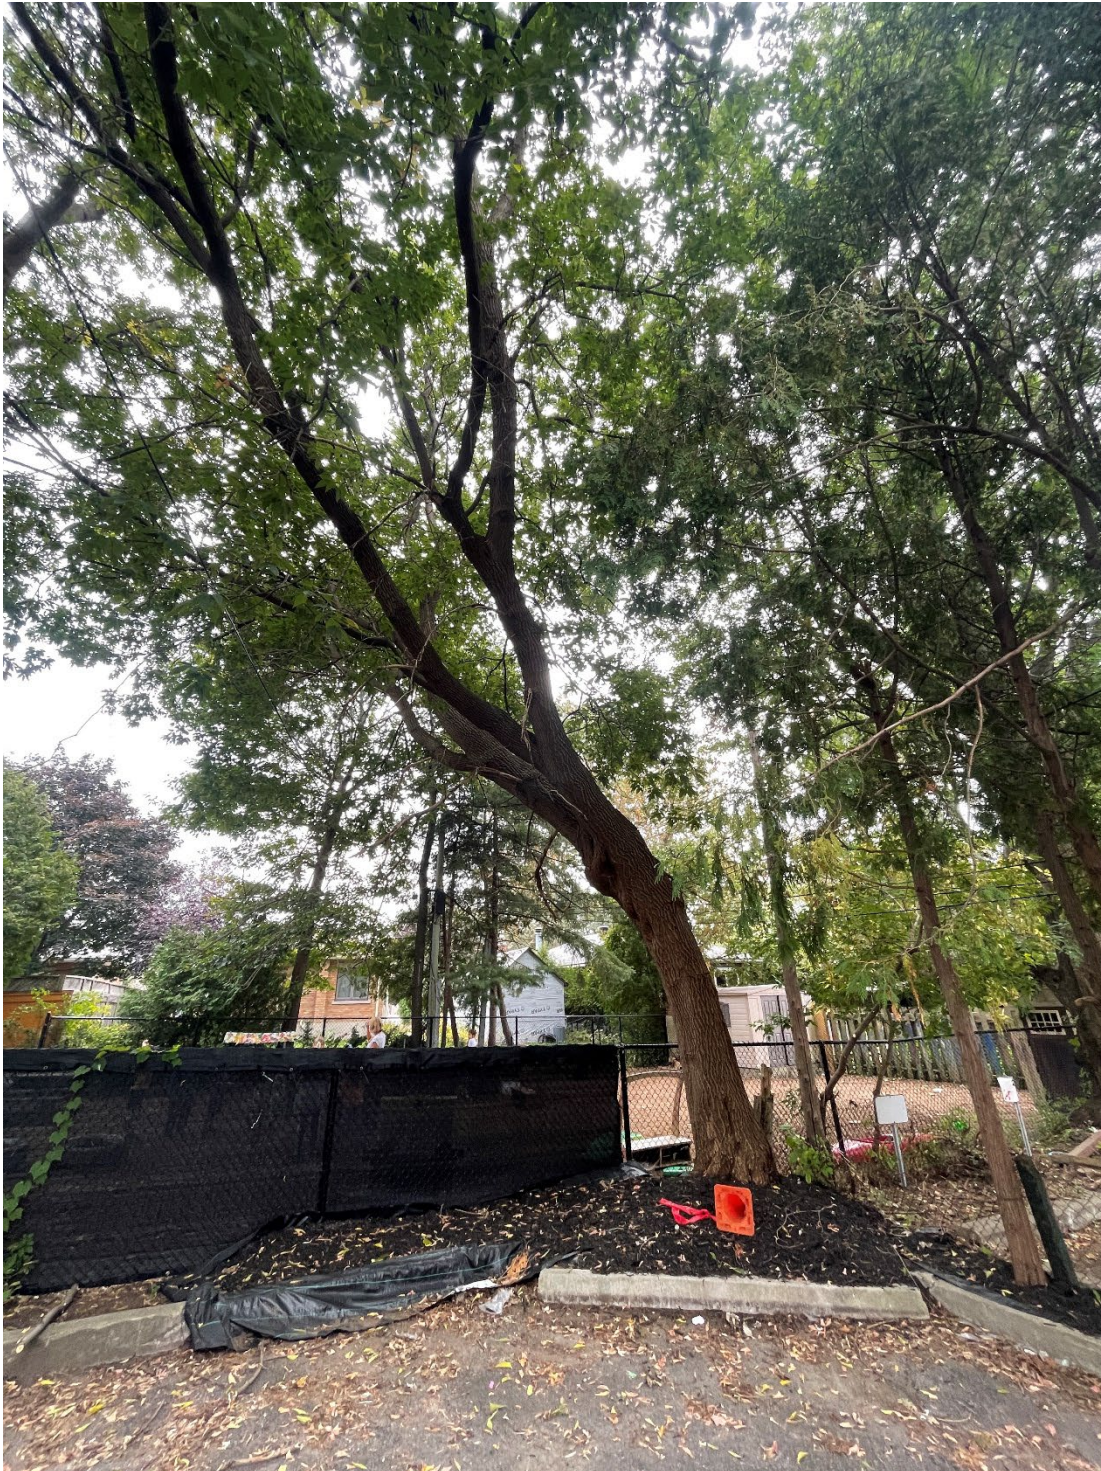
The large Manitoba maple on adjacent property has a large vertical crack in the bend of the trunk, and also has some horizontal stress fractures at this location. The majority of the crown is leaning over the playground on adjacent property, and it is advised to remove this tree as soon as possible.

Figure 2: Tree 2, jointly owned Manitoba maple tree leaning over playground behind the properties

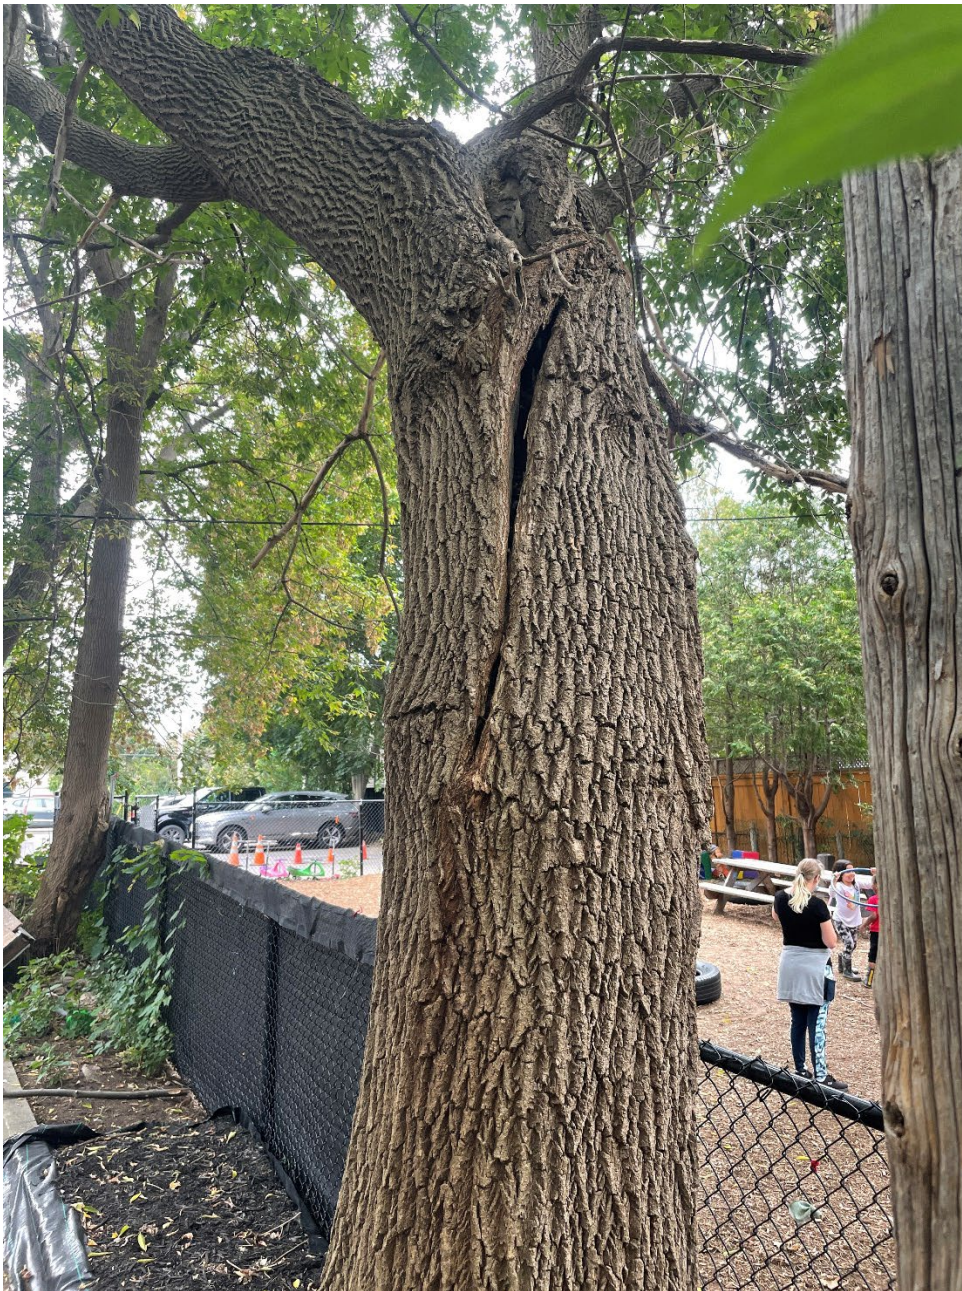
Figure 3: Vertical and horizontal stress fractures of tree 2 located on the upper side of the bend in the trunk

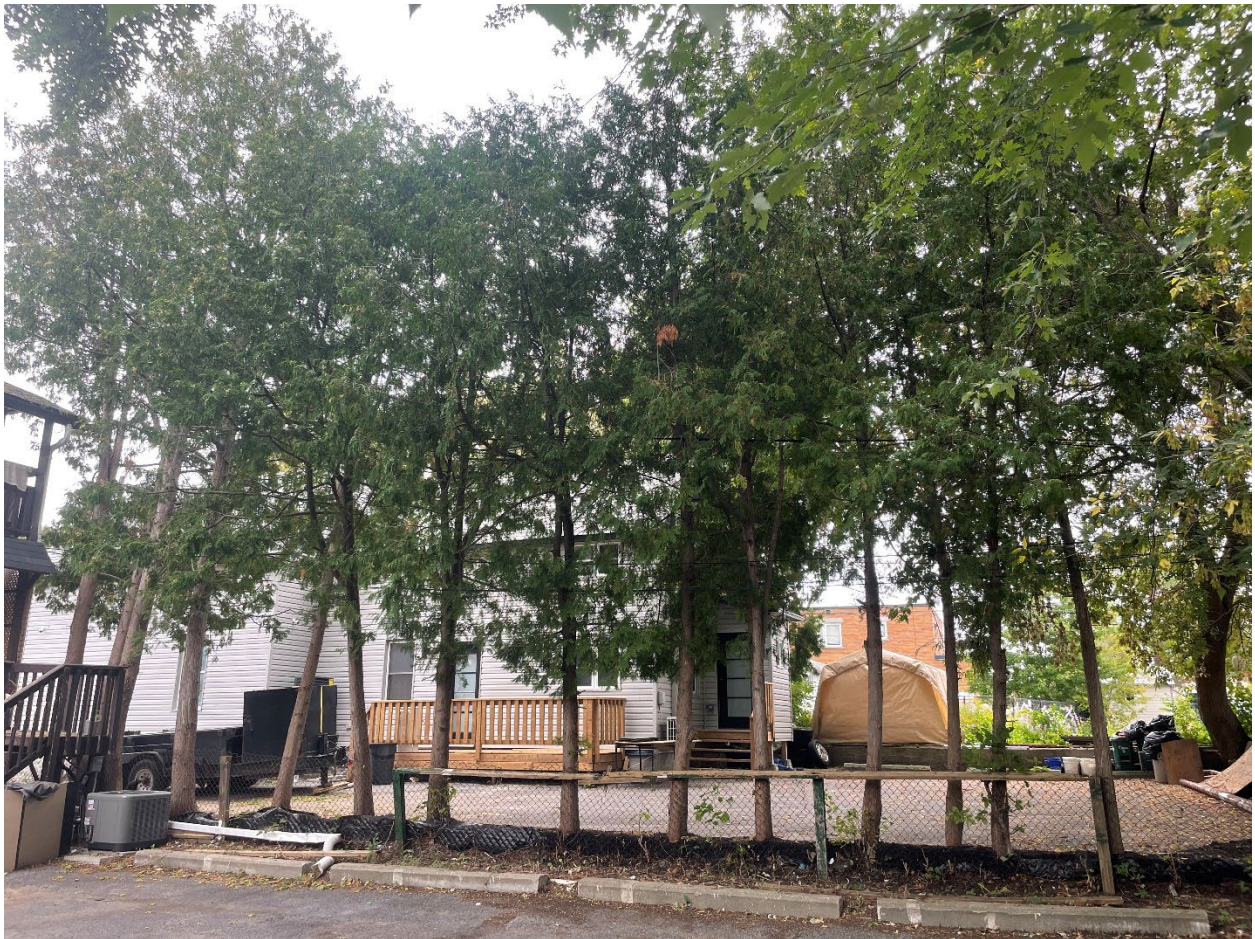
The cedar hedge runs along the east side of the fence on the eastern property line. Most of the trees are on the adjacent property, but some appear to be jointly owned according to the survey. The root system of these cedars is restricted by pavement on the adjacent property, and the majority likely lie under the soft surface of the subject property. Excavation for the new building will extend to the base of these trees, and removal would be the most practical option for this proposed development. Because these trees are on the adjacent property, permission from the adjacent property owner is required as part of the Tree Permitting process.

Figure 4: Line of eastern white cedars along the east property line

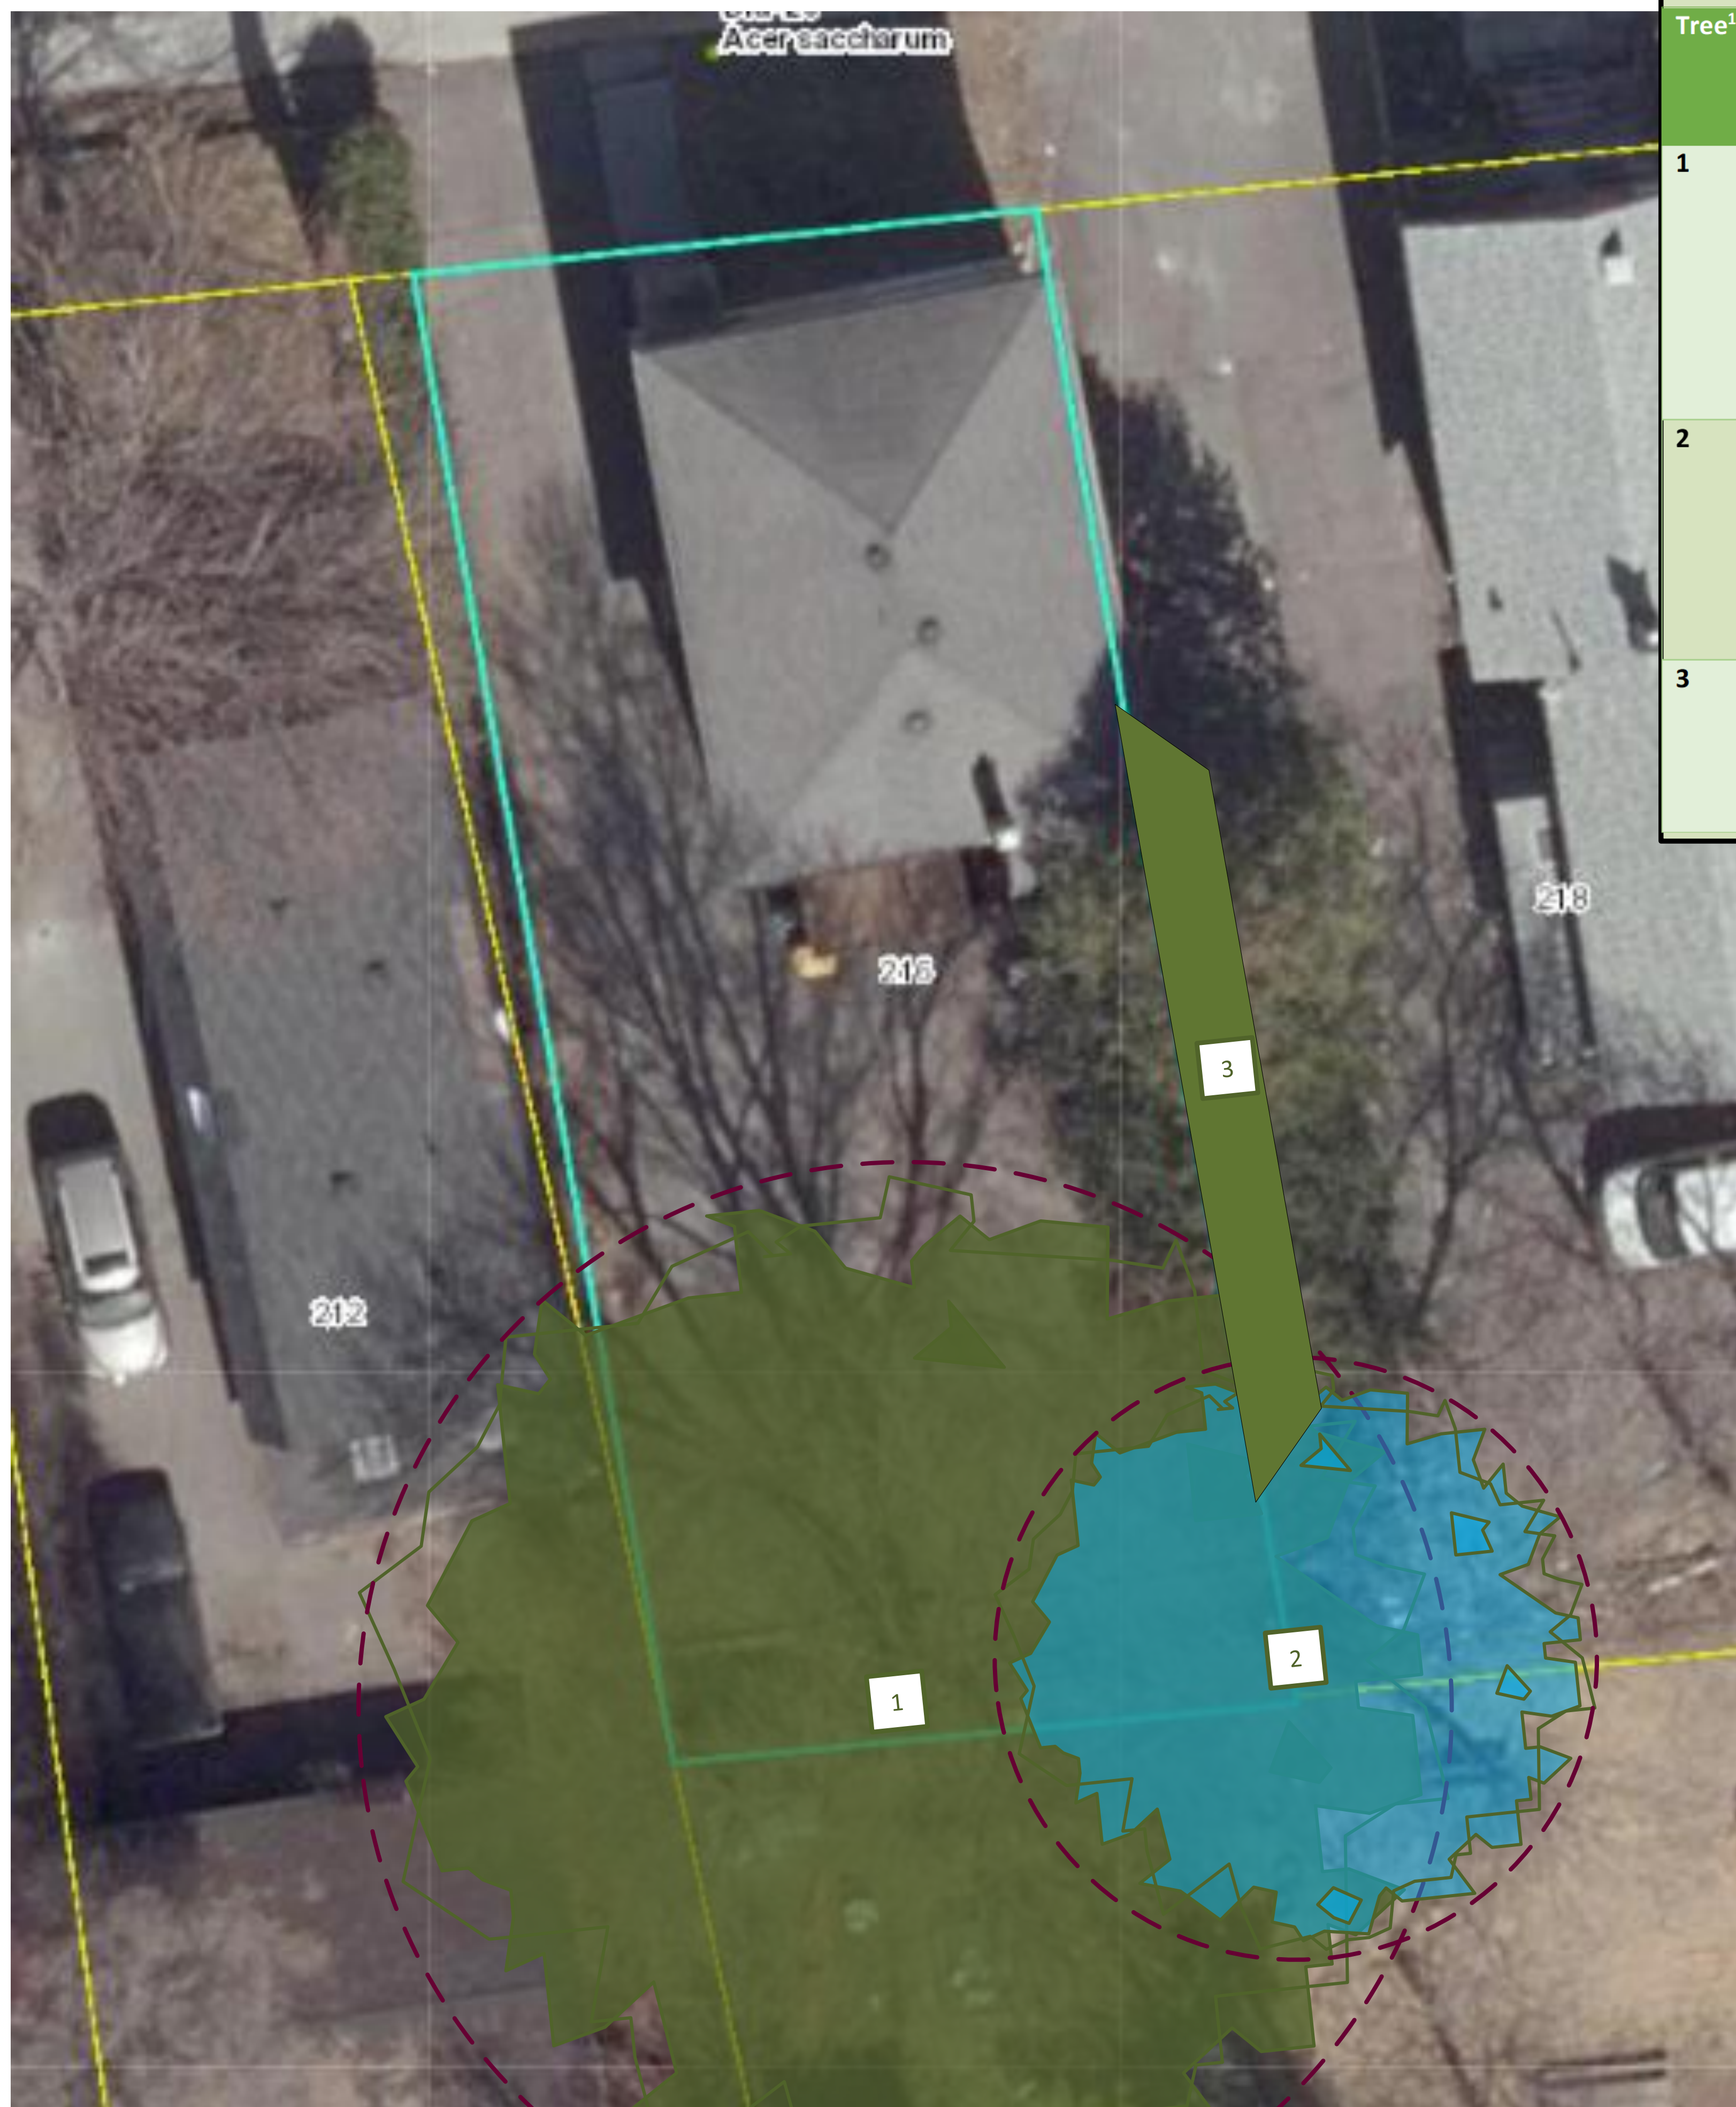
Tree Conservation Report – 216 McArthur
 Existing Conditions REport
 Tree layer prepared by Dendron Forestry Services
 Version 1.0, September 14, 2022
 For more information, please contact info@dendronforestry.ca

Tree ¹	Species	Diameter at breast height (dbh)	Ownership ^{2,3}	Condition
1	Silver maple (<i>Acer saccharinum</i>)	101 cm	Private – 216 McArthur	Fair/good; 2 codominant stems with included bark at the base, roots likely extend under pavement which compromises almost 50% of CRZ, low to medium amount of epicormic shoots with 5% crown dieback
2	Manitoba maple (<i>Acer negundo</i>)	56 cm	Jointly owned with 218 McArthur	Poor; heavy lean over playground area in the property to the rear, significant vertical splitting with decay at bend in trunk where there are also horizontal stress fractures
3	Eastern white cedar (<i>Thuja occidentalis</i>) hedge	13,12,13, 14,15,17 16,19,19 17,26,26 22,25	Some fully owned by 218 McArthur and some jointly owned	Fair/good; recent addition of 25 cm of mulch and landscape fabric at base

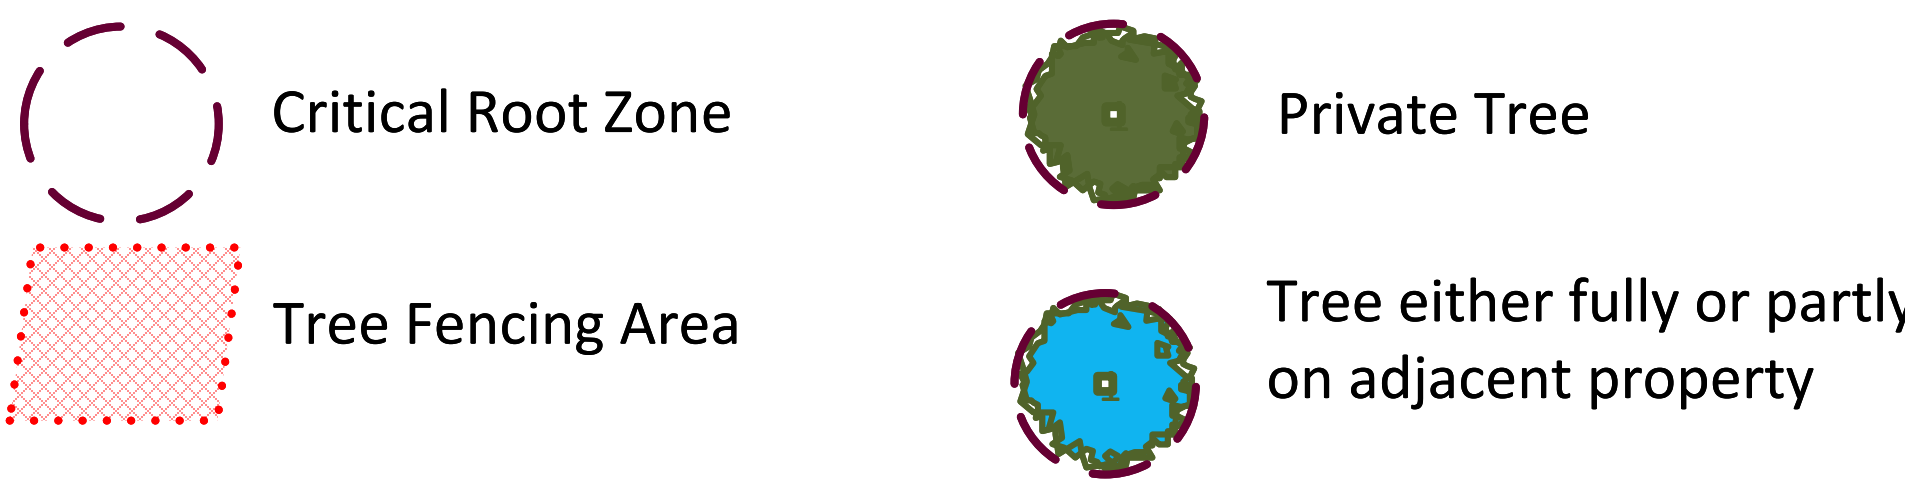
Tree Conservation Report – 216 McArthur
Proposed Development and Conserved Vegetation
Tree layer prepared by Dendron Forestry Services
Version 1.0, September 14, 2022
For more information, please contact info@dendronforestry.ca

Tree ¹	Species	Diameter at breast height (dbh)	Condition	Action
1	Silver maple (<i>Acer saccharinum</i>)	101 cm	Fair/good; 2 codominant stems with included bark at the base, roots likely extend under pavement which compromises almost 50% of CRZ, low to medium amount of epicormic shoots with 5% crown dieback	Retain and protect; remove pavement cautiously without severing roots, keep roots moist and covered at all times (see root mitigation measures)
2	Manitoba maple (<i>Acer negundo</i>)	56 cm	Poor; heavy lean over playground area in the property to the rear, significant vertical splitting with decay at bend in trunk where there are also horizontal stress fractures	Remove based on health and risk for failure over children in the playground; recommend to adjacent property owner to remove tree
3	Eastern white cedar (<i>Thuja occidentalis</i>) hedge	13,12,13, 14,15,17 16,19,19 17,26,26 22,25	Fair/good; recent addition of 25 cm of mulch and landscape fabric at base	Remove; excavation for new building will extend to base of trees; Tree Permit and permission from adjacent property owner required

Prior to any site works, protective fencing should be installed around the trees as indicated in Map and maintained until all construction on site has been completed as per the **City of Ottawa Tree Protection Specifications (March 2021)**. Within the fenced area, the following tree protection guidelines should be applied:

The tree protection fencing must be 1.2 m in height and constructed of a rigid or framed material (e.g. modulus – steel, plywood hoarding, or snow fence on a 2”X4” wood frame) with posts 2.4 m apart such that the fence location cannot be altered. All supports must be placed outside of the CRZ and installation must minimize damage to existing roots.

- Place a layer of 6-12 inches (15 to 30 cm) of woodchip mulch to the area
- Apply ¼ (2 cm) inch plywood, or road mats over a 4+ inch (10 cm) thick layer of the wood chip mulch
- Apply 4-6 inches (10 to 15 cm) of gravel over a taut, staked, geotextile fabric

- Prune roots back with a clean hand tool to reduce the risk of pathogens from entering the tree
- Do not use wound dressings or pruning paint to cover root tips
- Avoid pruned exposure of roots. Keep all exposed roots moist and covered with soil, mulch, irrigation, or at least moistened burlap.
