# TREE CONSERVATION REPORT

**1983 Carling Ave**

Tree Conservation Report submitted as Partial  
Requirements for a Site Plan Control Application

January 28, 2022

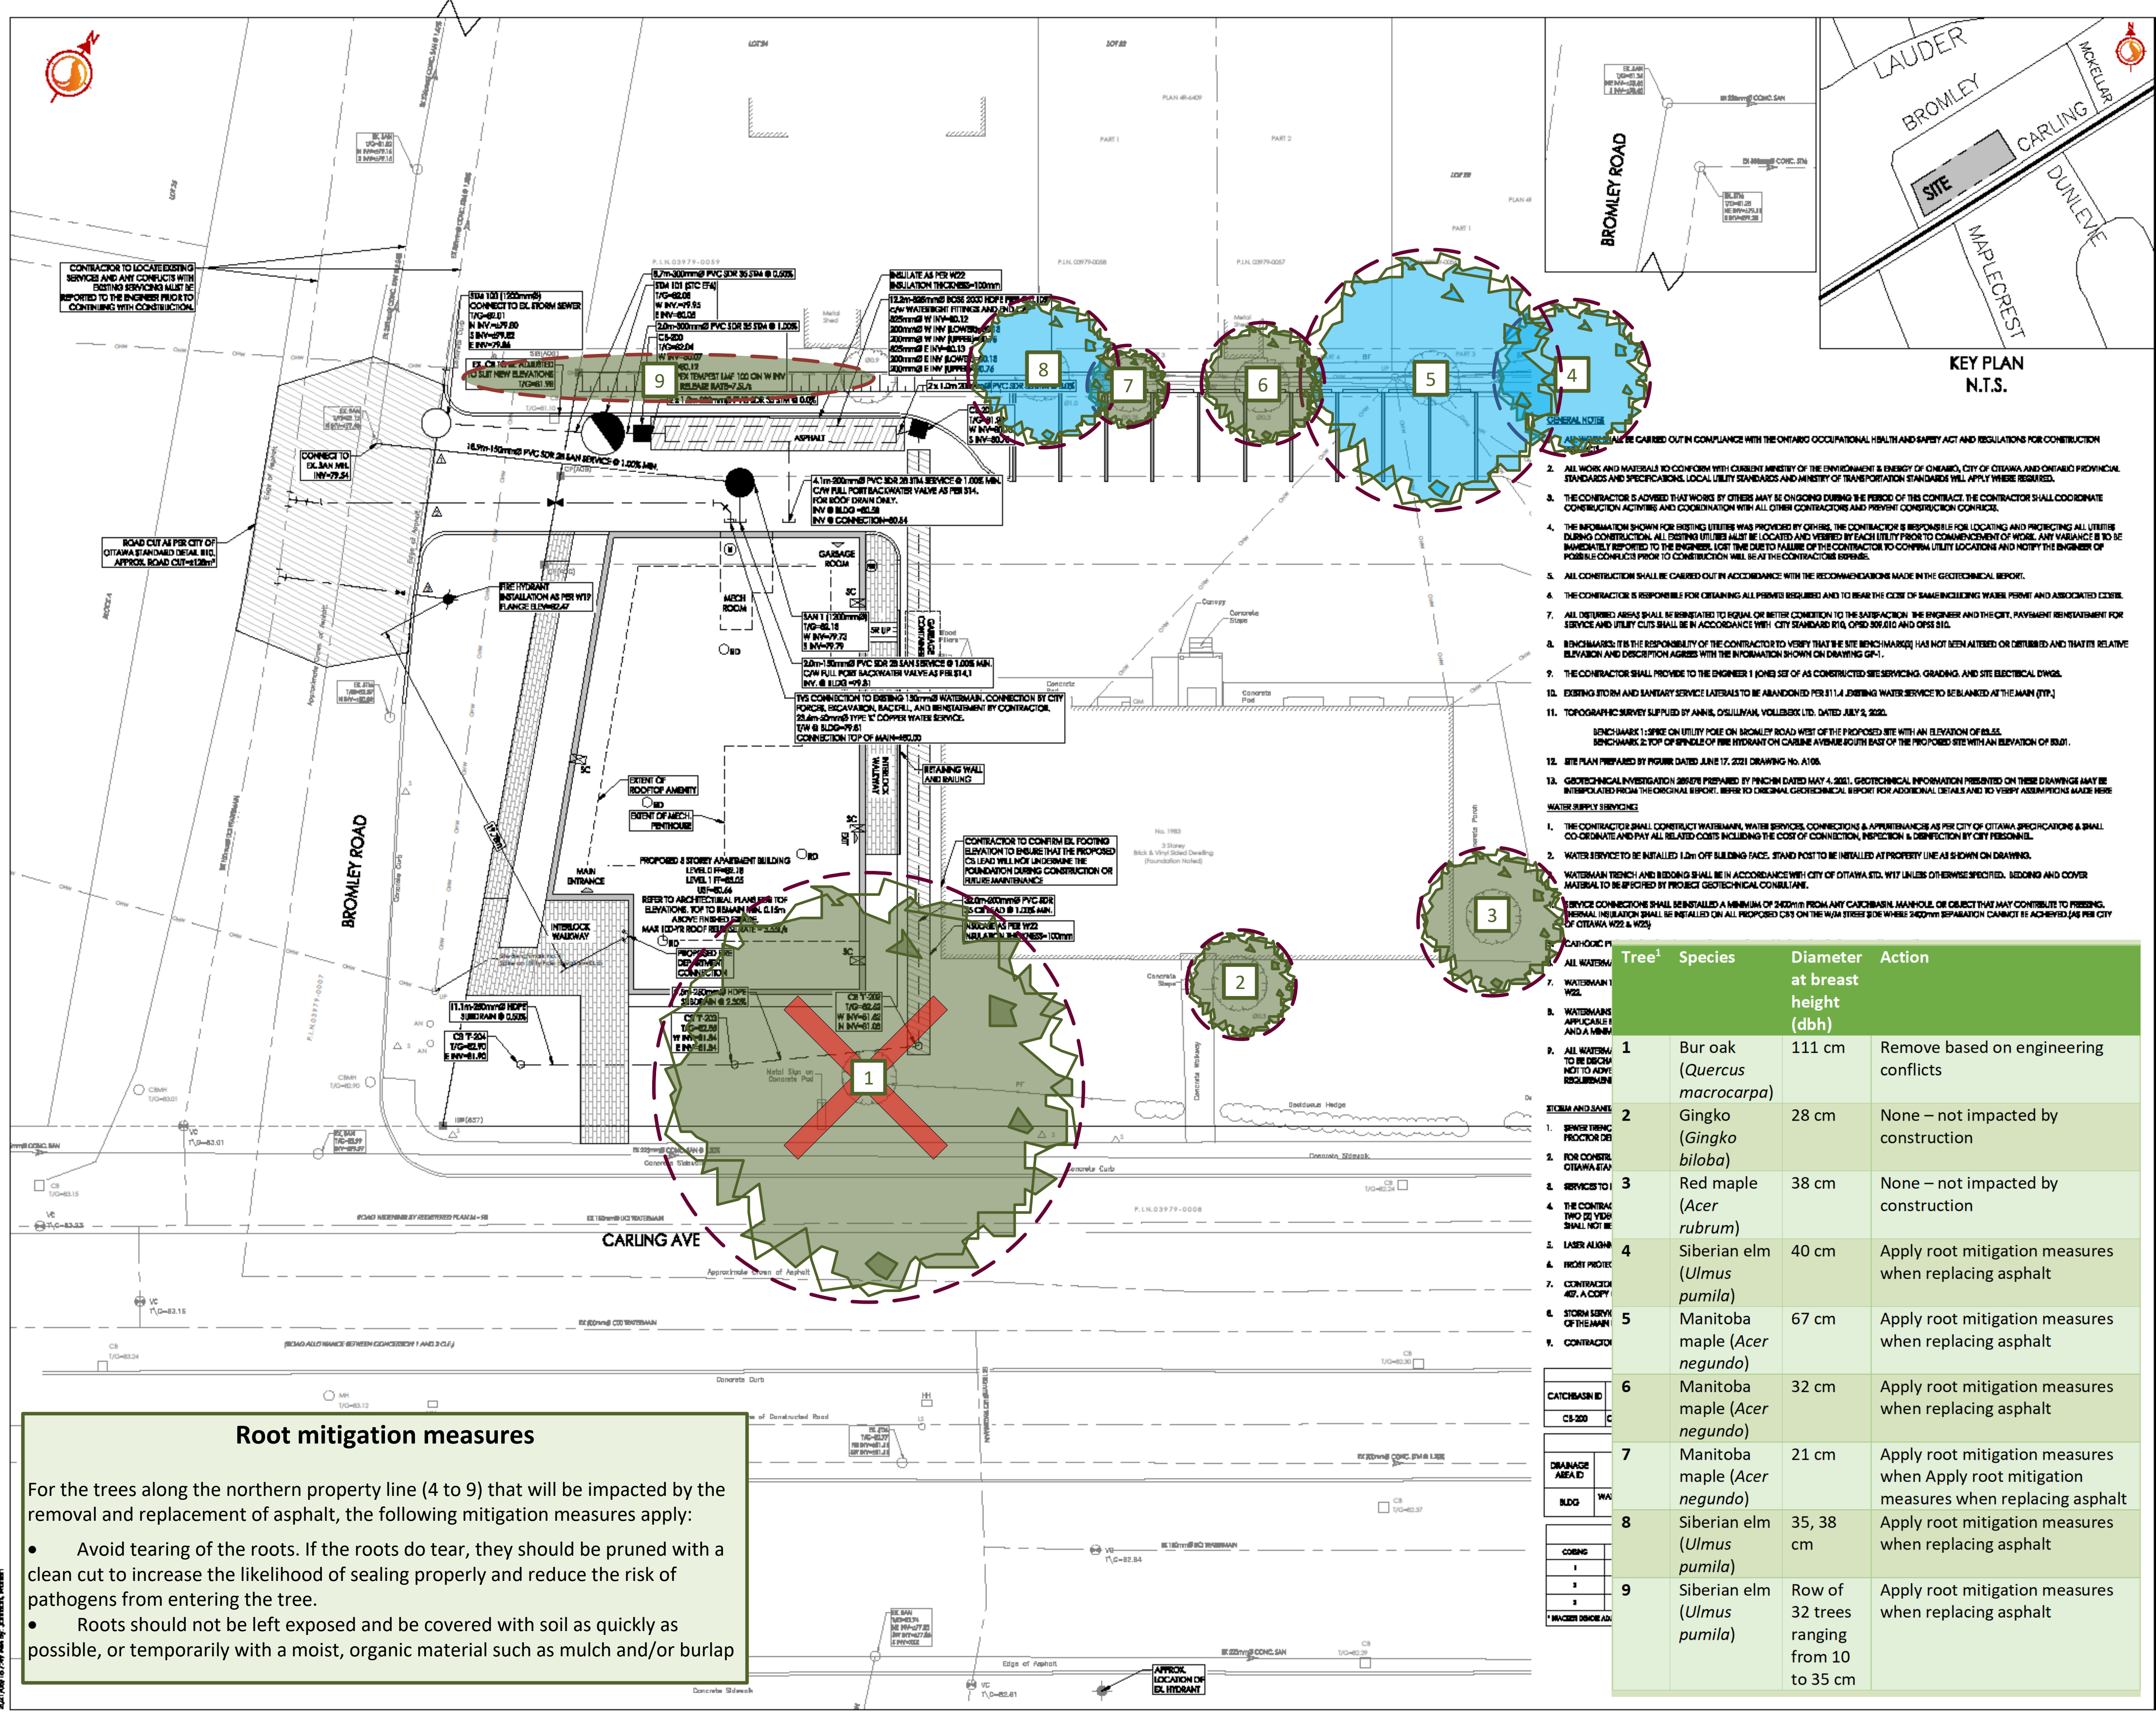
Tree Conservation Report – 1983 Carling Ave  
Proposed Development and Conserved Vegetation (site servicing)  
Tree layer prepared by Dendron Forestry Services  
Version 1.0, January 27, 2022  
For more information, please contact info@dendronforestry.ca

- 2) Site servicing (refer to Proposed Development and Conserved Vegetation (site servicing) map) as well as the Site Servicing plan prepared by Stantec): to properly manage the stormwater on the site, a 250 mm pipe between two catch basins will need to be installed approximately 1 m from the tree trunk. In discussions with engineering staff from Stantec, boring could be used to install the pipe, but there would be excavation required to install the catch basins. Boring can be an effective alternative to trenching for the installation of services when root preservation is a goal. However, this is only a feasible option when further away from the tree. For a tree this large with high consequences of failure (Carling Avenue), boring within the static root zone (approximately 3 m) is not recommended. Relocating the catch basins closer to the building was also discussed, but Stantec engineers indicated that this would create ponding up against the building.

For the trees along the northern property line (4 to 9) that will be impacted by the removal and replacement of asphalt, the following mitigation measures apply:

- Avoid tearing of the roots. If the roots do tear, they should be pruned with a clean cut to increase the likelihood of sealing properly and reduce the risk of pathogens from entering the tree.
- Roots should not be left exposed and be covered with soil as quickly as possible, or temporarily with a moist, organic material such as mulch and/or burlap

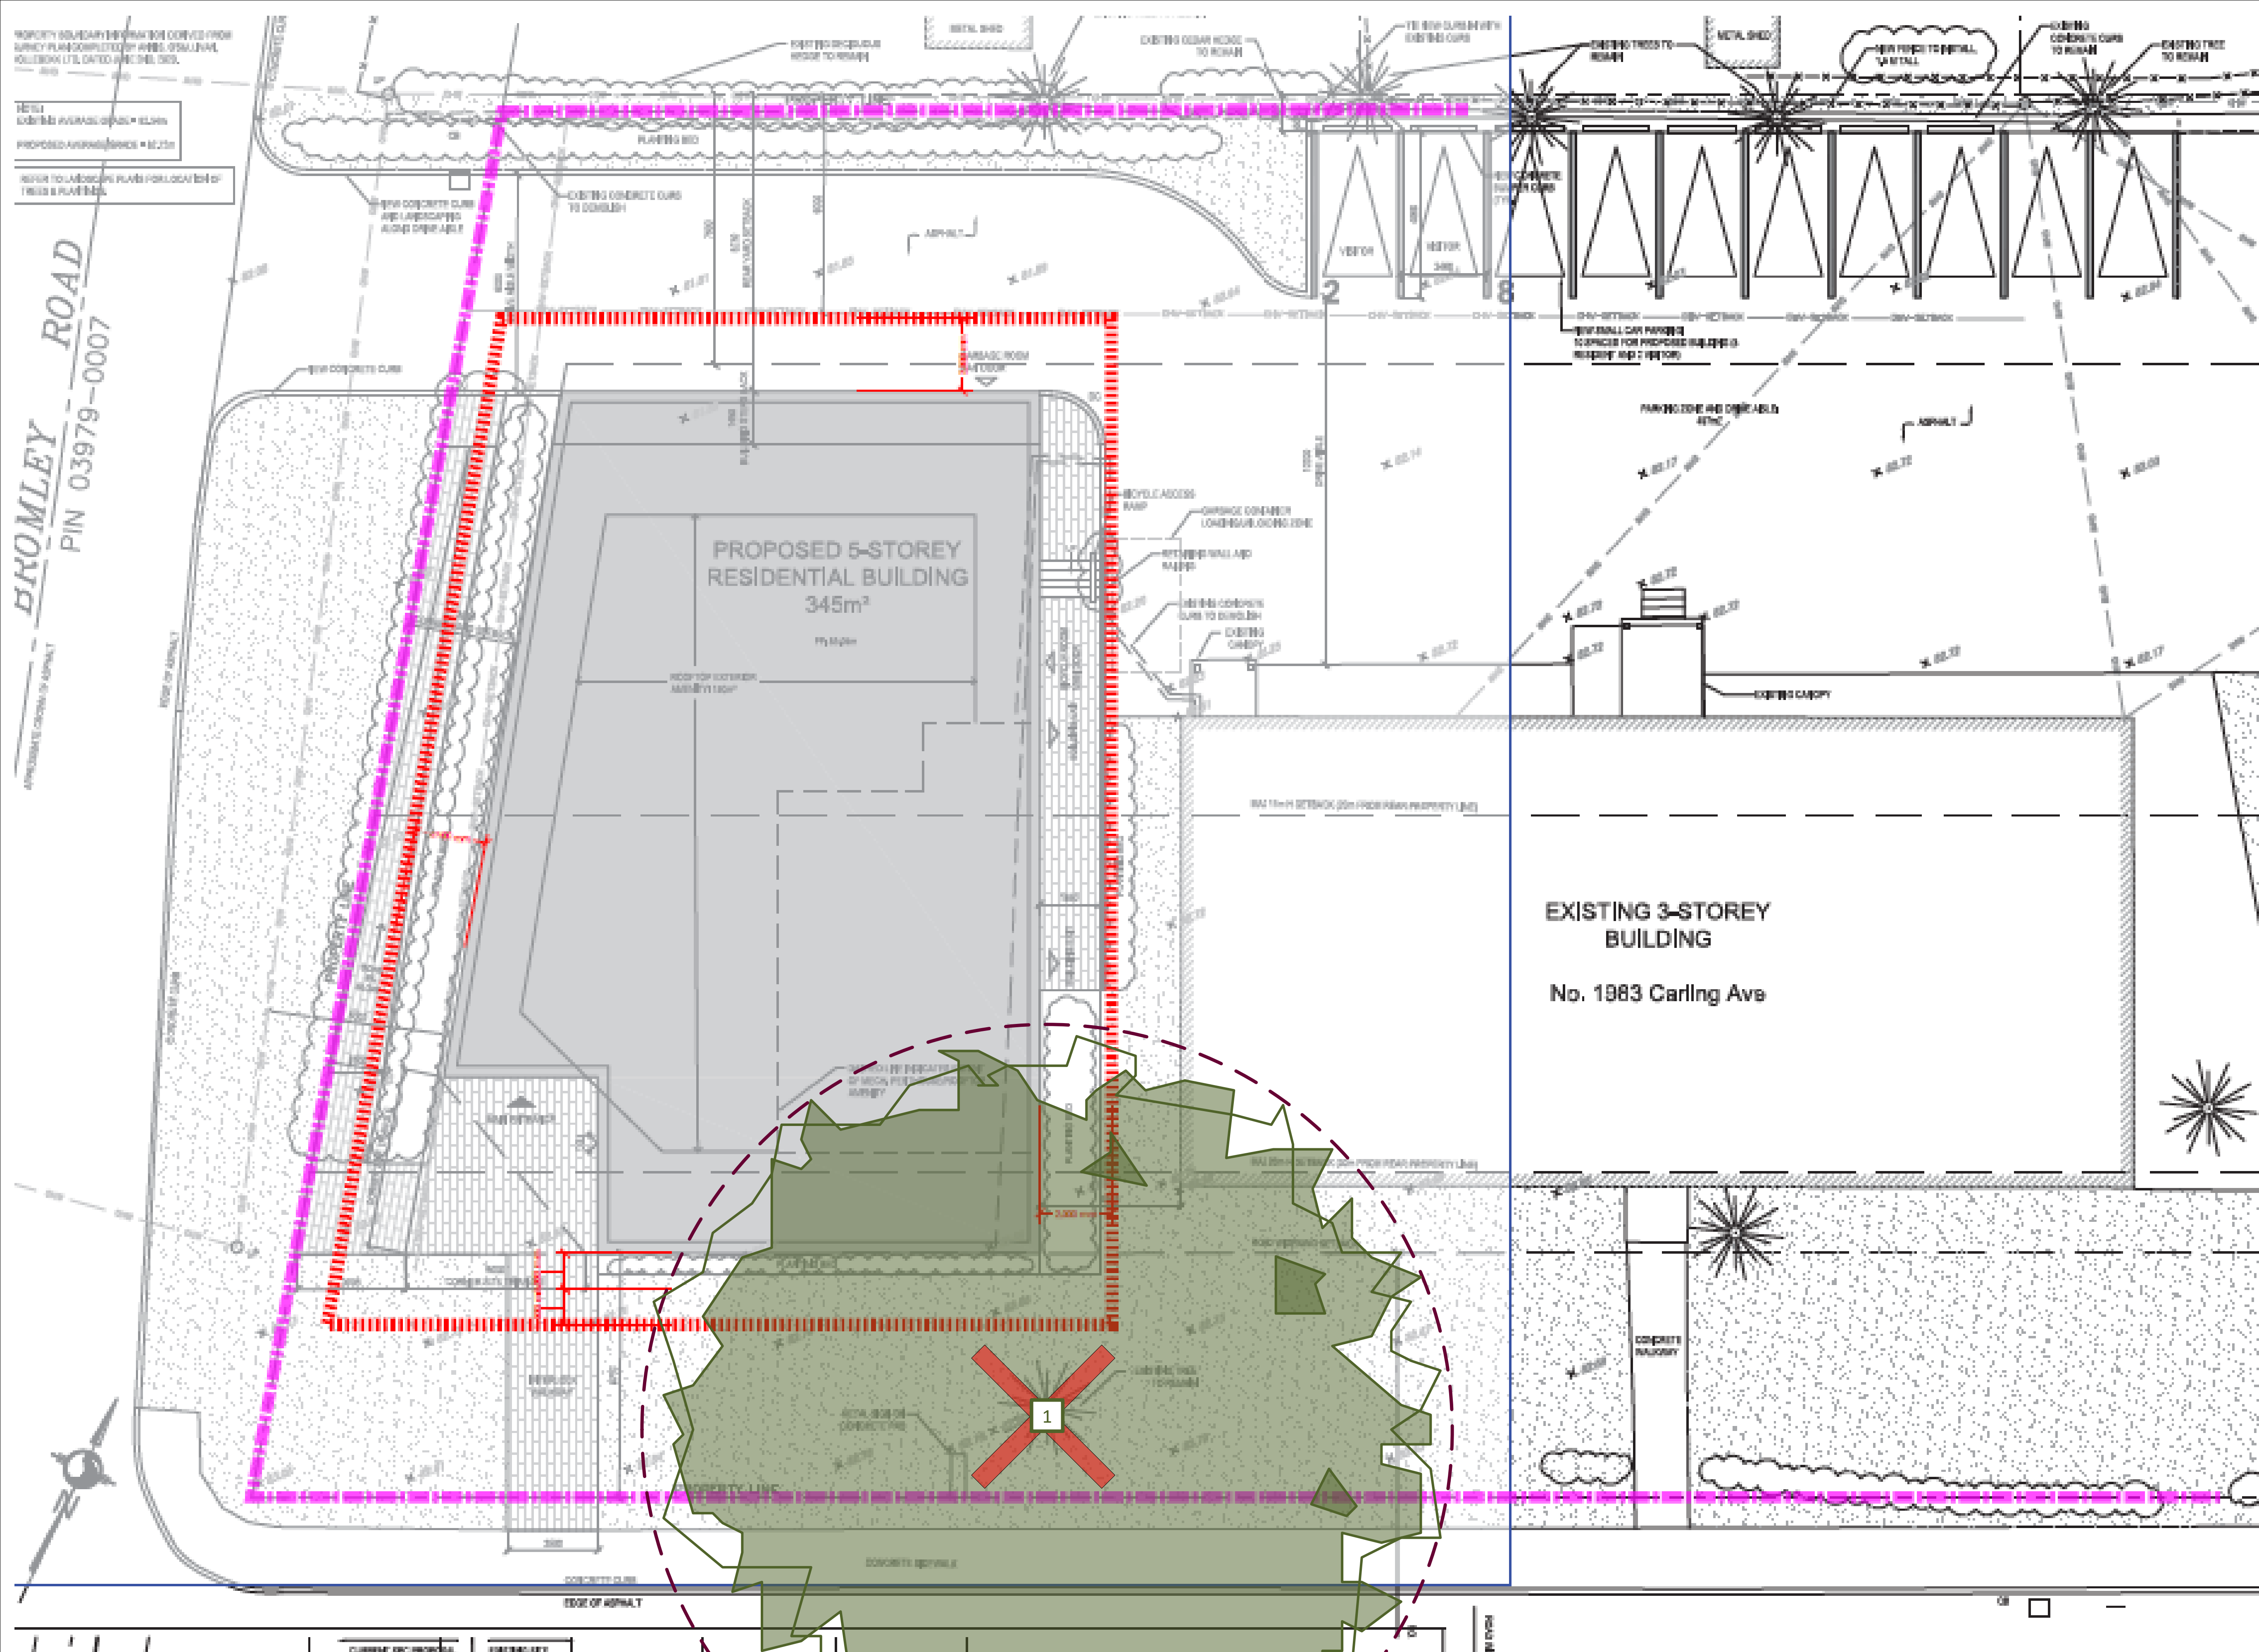
Tree Conservation Report – 1983 Carling Ave  
 Proposed Development and Conserved Vegetation (excavation zone)  
 Tree layer prepared by Dendron Forestry Services  
 Version 1.0, January 27, 2022  
 For more information, please contact [info@dendronforestry.ca](mailto:info@dendronforestry.ca)

- 1) Excavation zone (refer to Proposed Development and Conserved Vegetation (excavation zone) map): The excavation will extend well into the critical root zone as well as the static root zone to less than 2 m from the edge of the tree. A large portion of the critical root zone will be lost during the excavation which would impact both the long-term viability of the tree and possibly the structural integrity.

Based on the impacts to the tree as noted above, tree removal is the recommended option.
