FINAL Geotechnical Investigation – Slope Stability Analysis

150 Kanata Avenue & 1200 Canadian Shield Avenue, Kanata, Ontario

March 9, 2023

Pinchin File: 290435.003

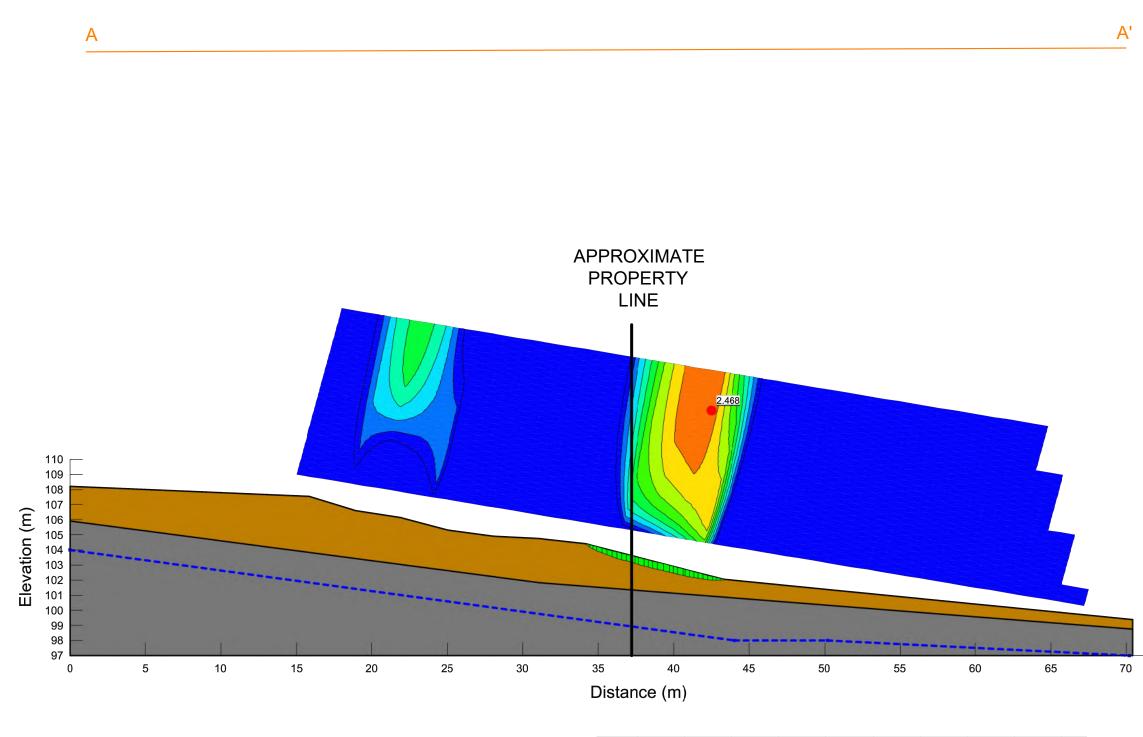
The results of the analysis indicate that the cross-section profiles have factors of safety against slope failure of 2.47 (existing) and 1.68 (proposed). The factors of safety are closely related to the shallowness of the slope, strength of the soil, and absence of groundwater. The results of the slope stability analysis are included on Figures 3 (existing) and 5 (proposed).

Color	Name	Model	Unit Weight (kN/m³)	Effective Cohesion (kPa)	Effective Friction Angle (°)	Piezometric Line
	Bedrock	Bedrock (Impenetrable)				1
Glacial Till - M Sand & Silt		Mohr-Coulomb	20	0	32

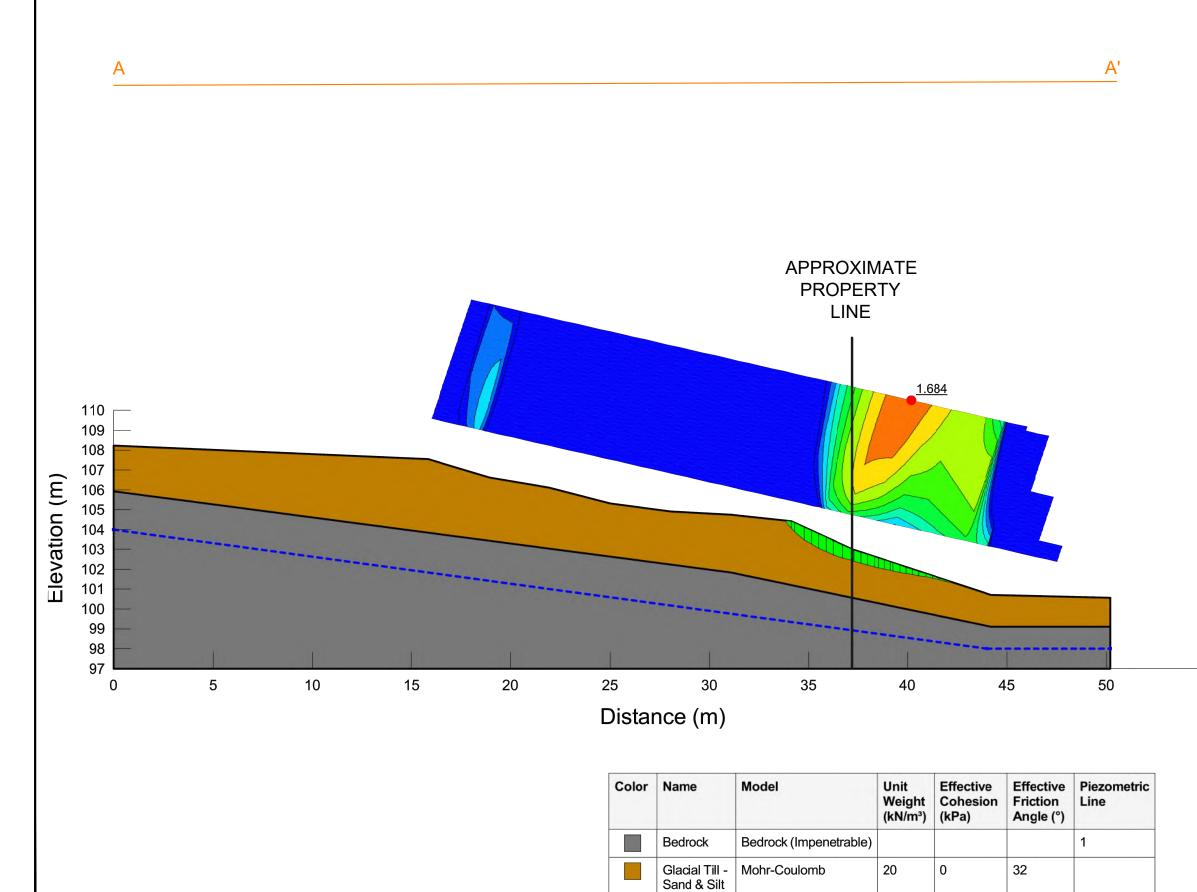
Based on our analysis, the proposed slope inclination will maintain a factor of safety of greater than 1.5 after completion of the development.
