Project:
50 THE DRIVEWAY
 50 THE DRIVEWAY
 OTTAWA, ONTARIO

Drawing:
TREE CONSERVATION REPORT

Scale: 1:200	Date: JULY, 2021
Design By: AC	Drawn By: SMc
Project Number: 2096-01	Sheet Number: TCR 01

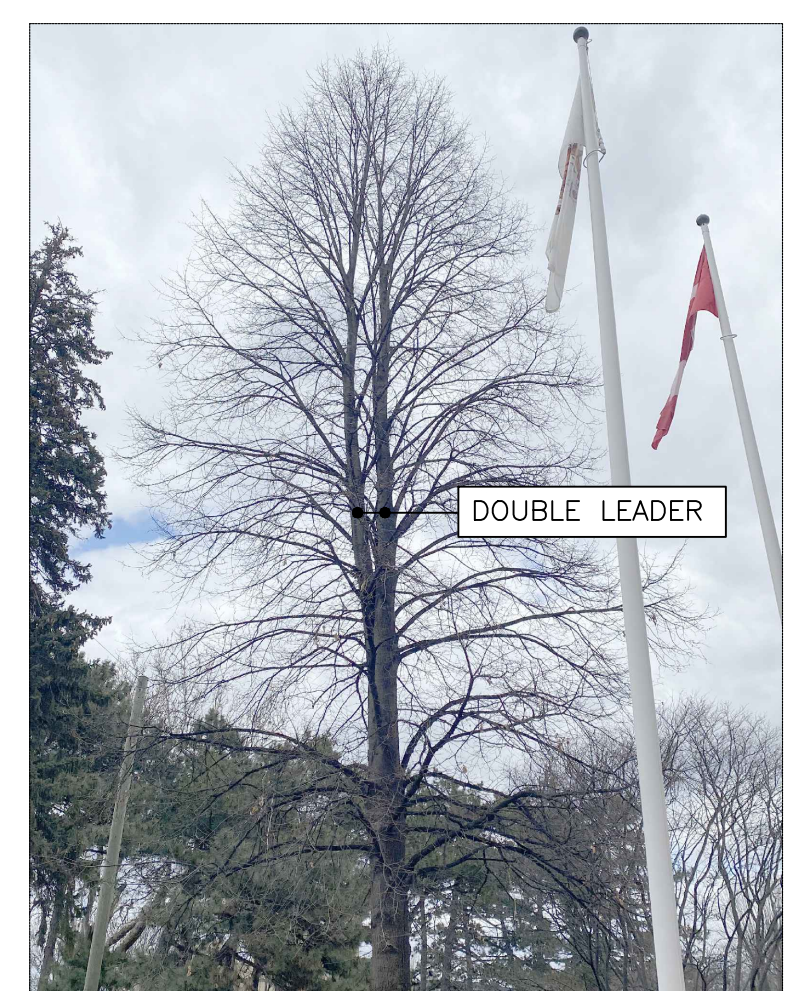
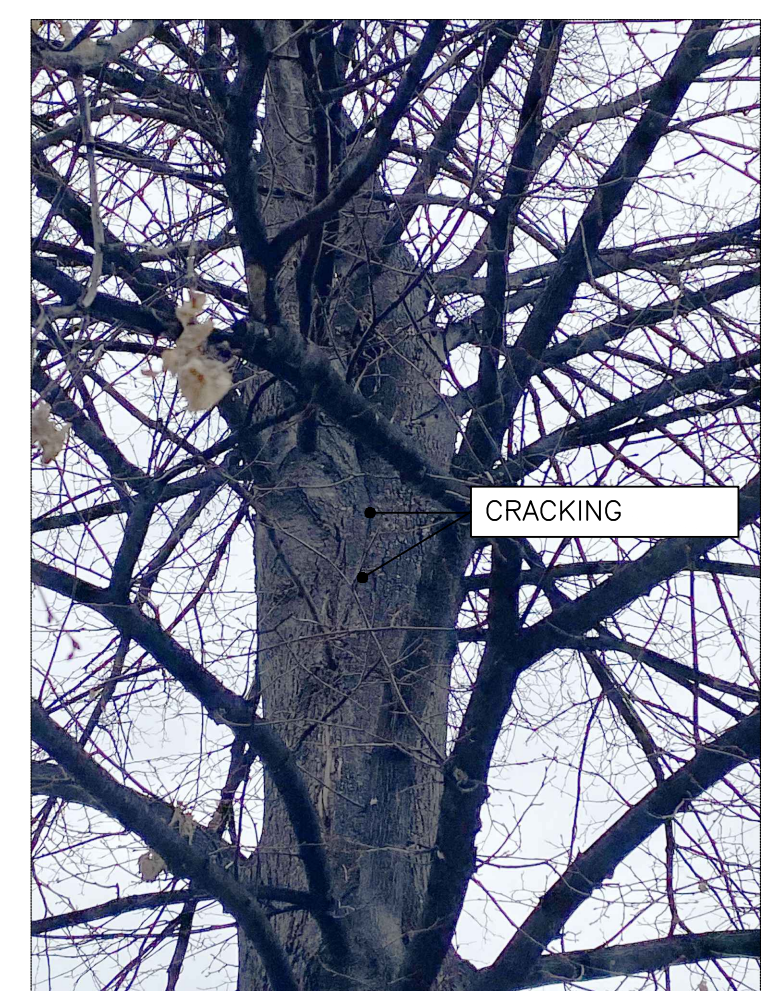
5 TREE #2 - PHOTOS

Condition Rating: 'Good'
No significant damage or disease, normal vigour, good form. Double leader with cracking constitutes a defect, though it may be mitigated.
Location Rating: Site Position and Contribution are good, however placement very close to property line is unfortunate.
Species Rating: Lower end of range of values was chosen due to invasive status of Tilia cordata in Ottawa region.

DOUBLE LEADER

CRACKING

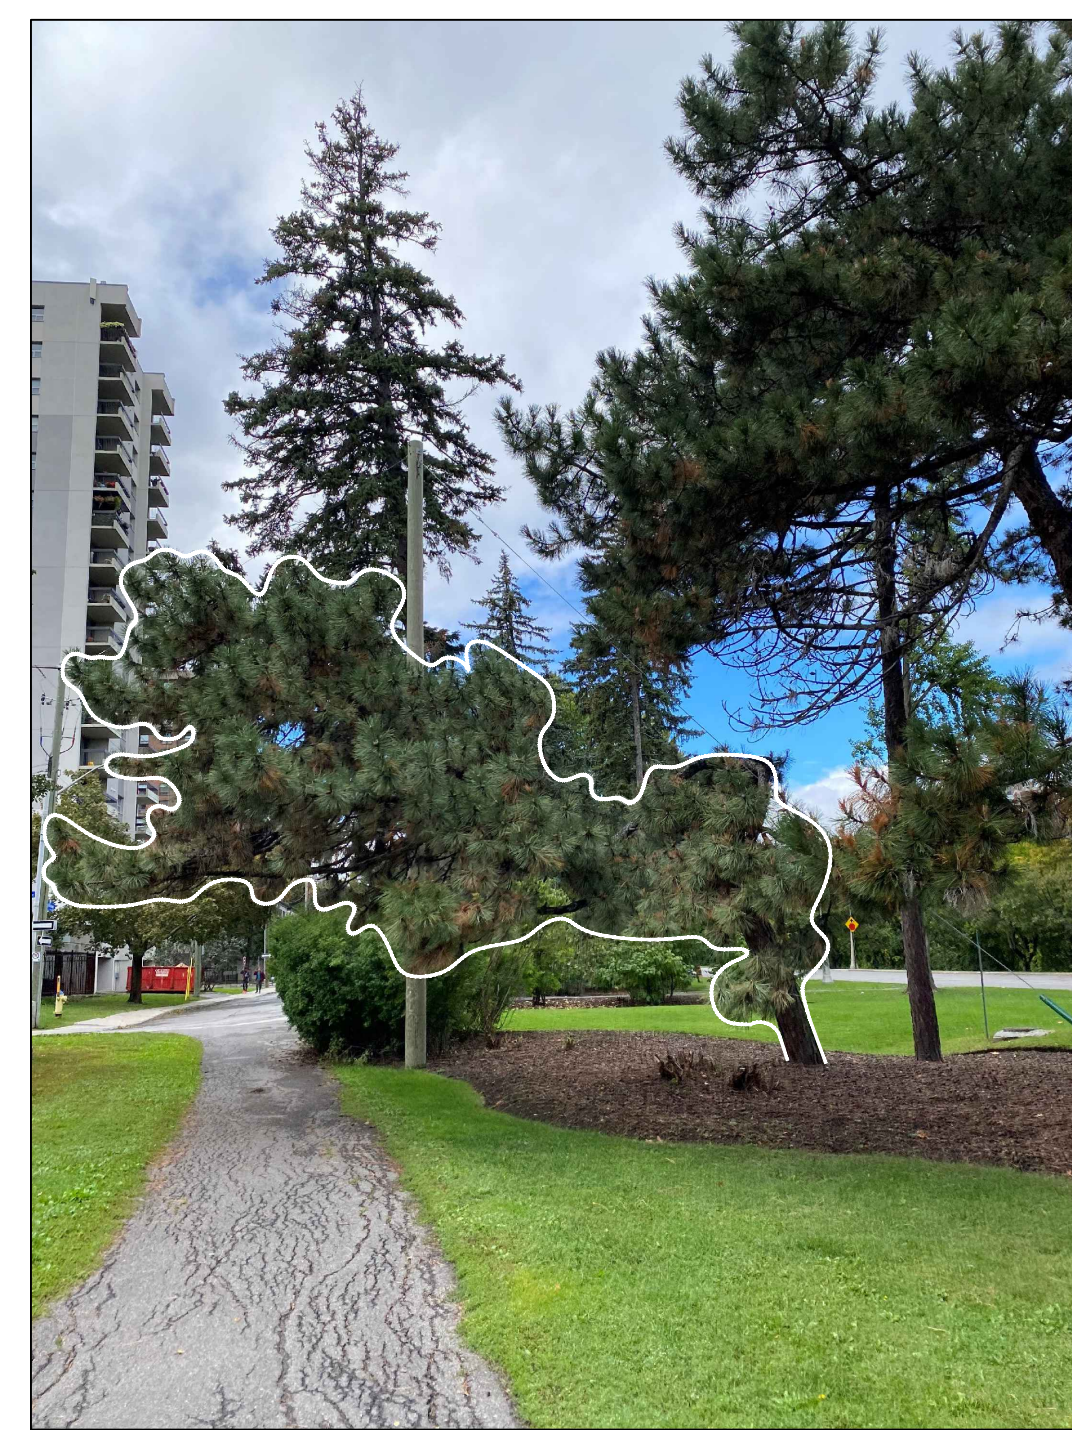
6 TREE #5 - PHOTO
CANOPY EXTENDS BEYOND CRITICAL ROOT ZONE -
STAGING BOUNDARIES ADJUSTED FOR PROTECTION

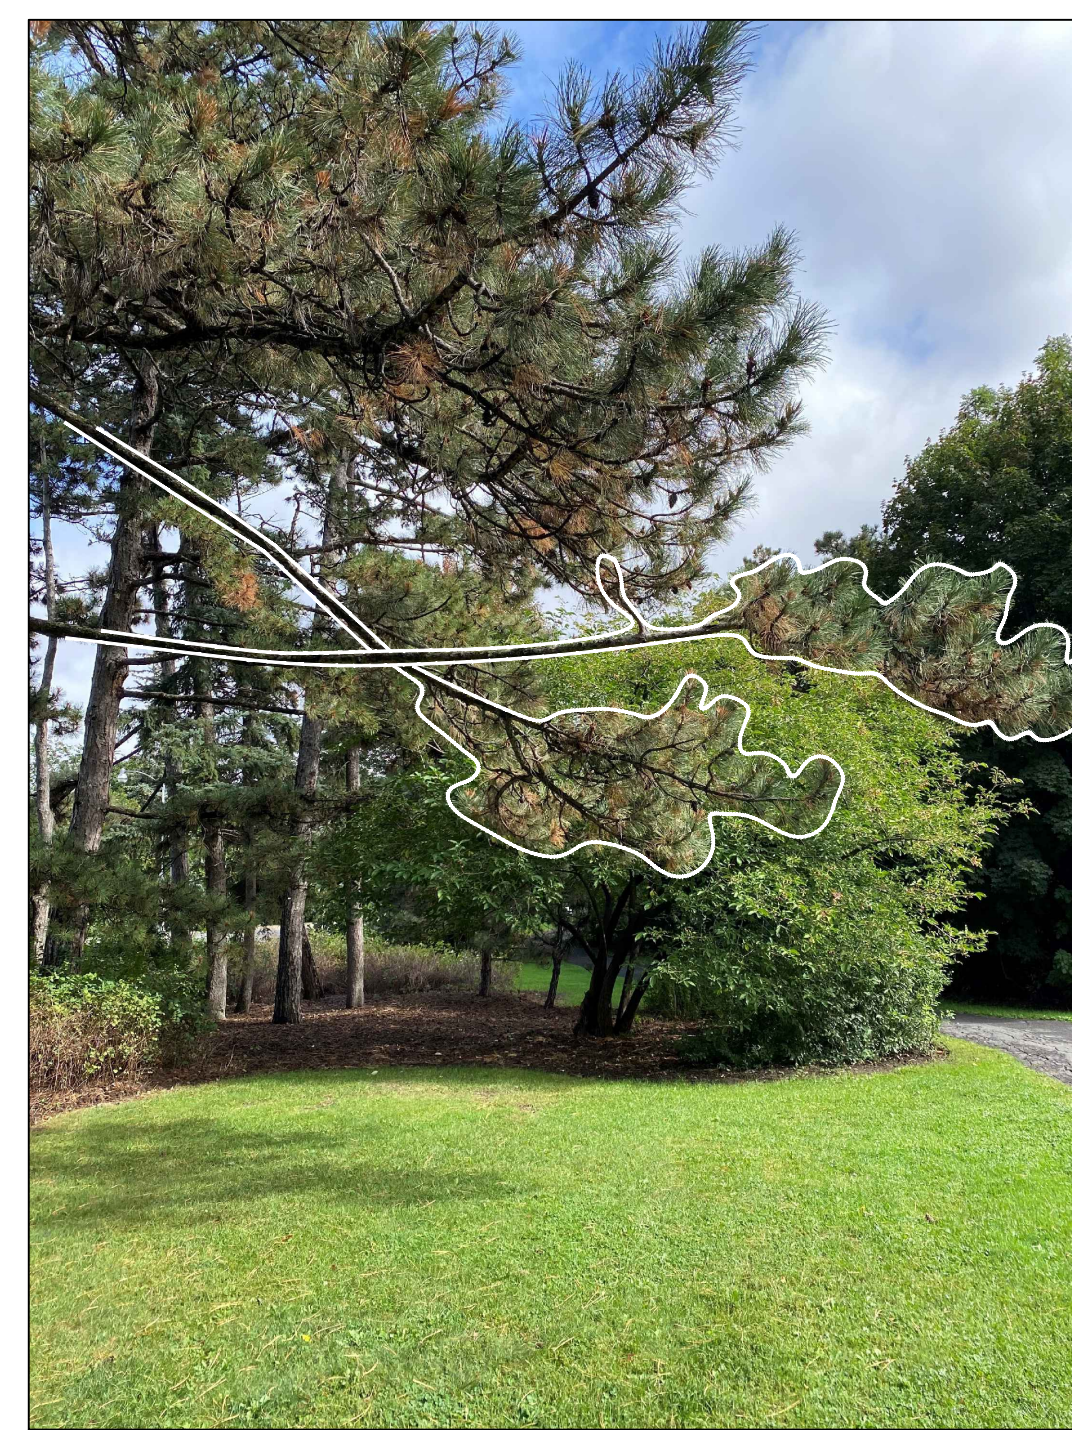
7 TREE #16 - PHOTO
LIMBS EXTEND BEYOND CRITICAL ROOT ZONE -
PRUNING IS PROPOSED FOR STAGING AREA
