June 6, 2019

Chmiel Architects Inc.
Attention Richard Chmiel
200-109 Bank Street
Ottawa, Ontario, K1P 5N5

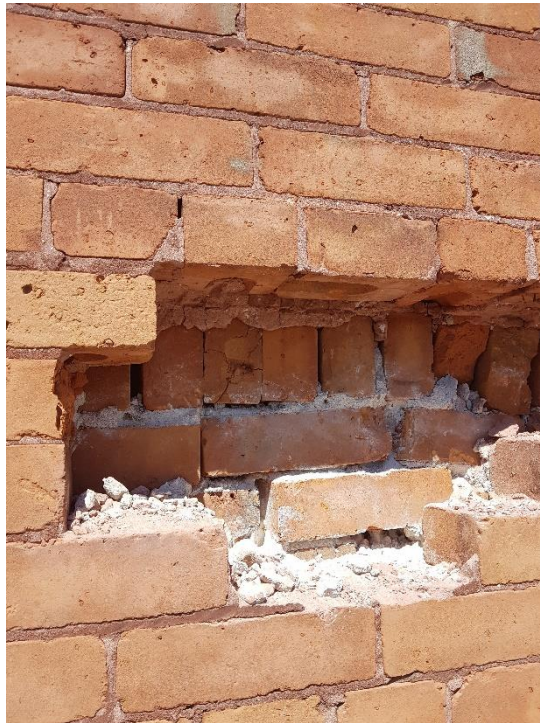
Photograph 11: View of the middle wythe condition. Mortar in poor condition and some cracked bricks.
Opening on south wall, third floor.

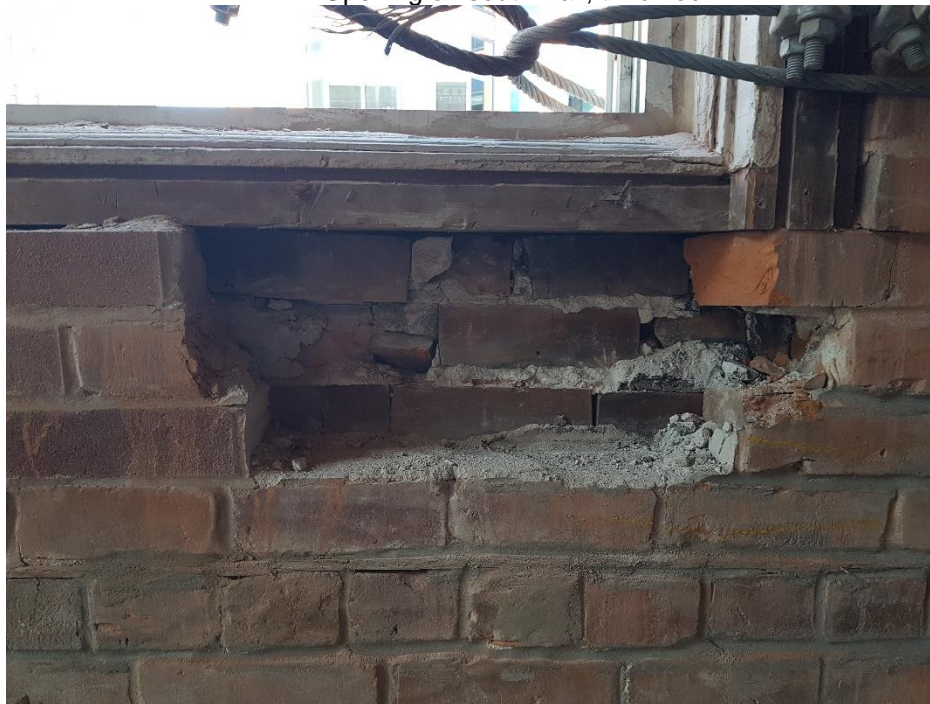
Photograph 12: View of the middle wythe condition. Mortar in poor condition and some cracked bricks.
Opening on north wall, second floor (below window to extract middle wythe).

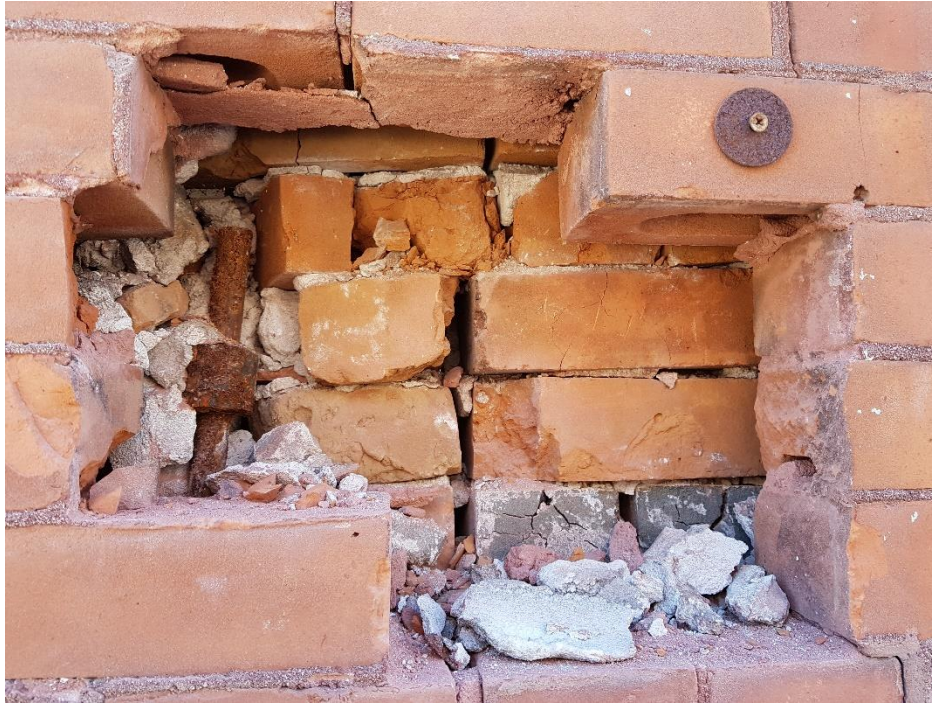
Photograph 13: View of the middle wythe condition. Mortar deteriorated, crack and crushed bricks. Opening on the exterior, ground floor of the north elevation.
