**PATERSON
GROUP**

July 19, 2022
File: PE4937-LET.04

Subject: **Phase I - Environmental Site Assessment Update
Navan at Renaud Road
Ottawa, Ontario**

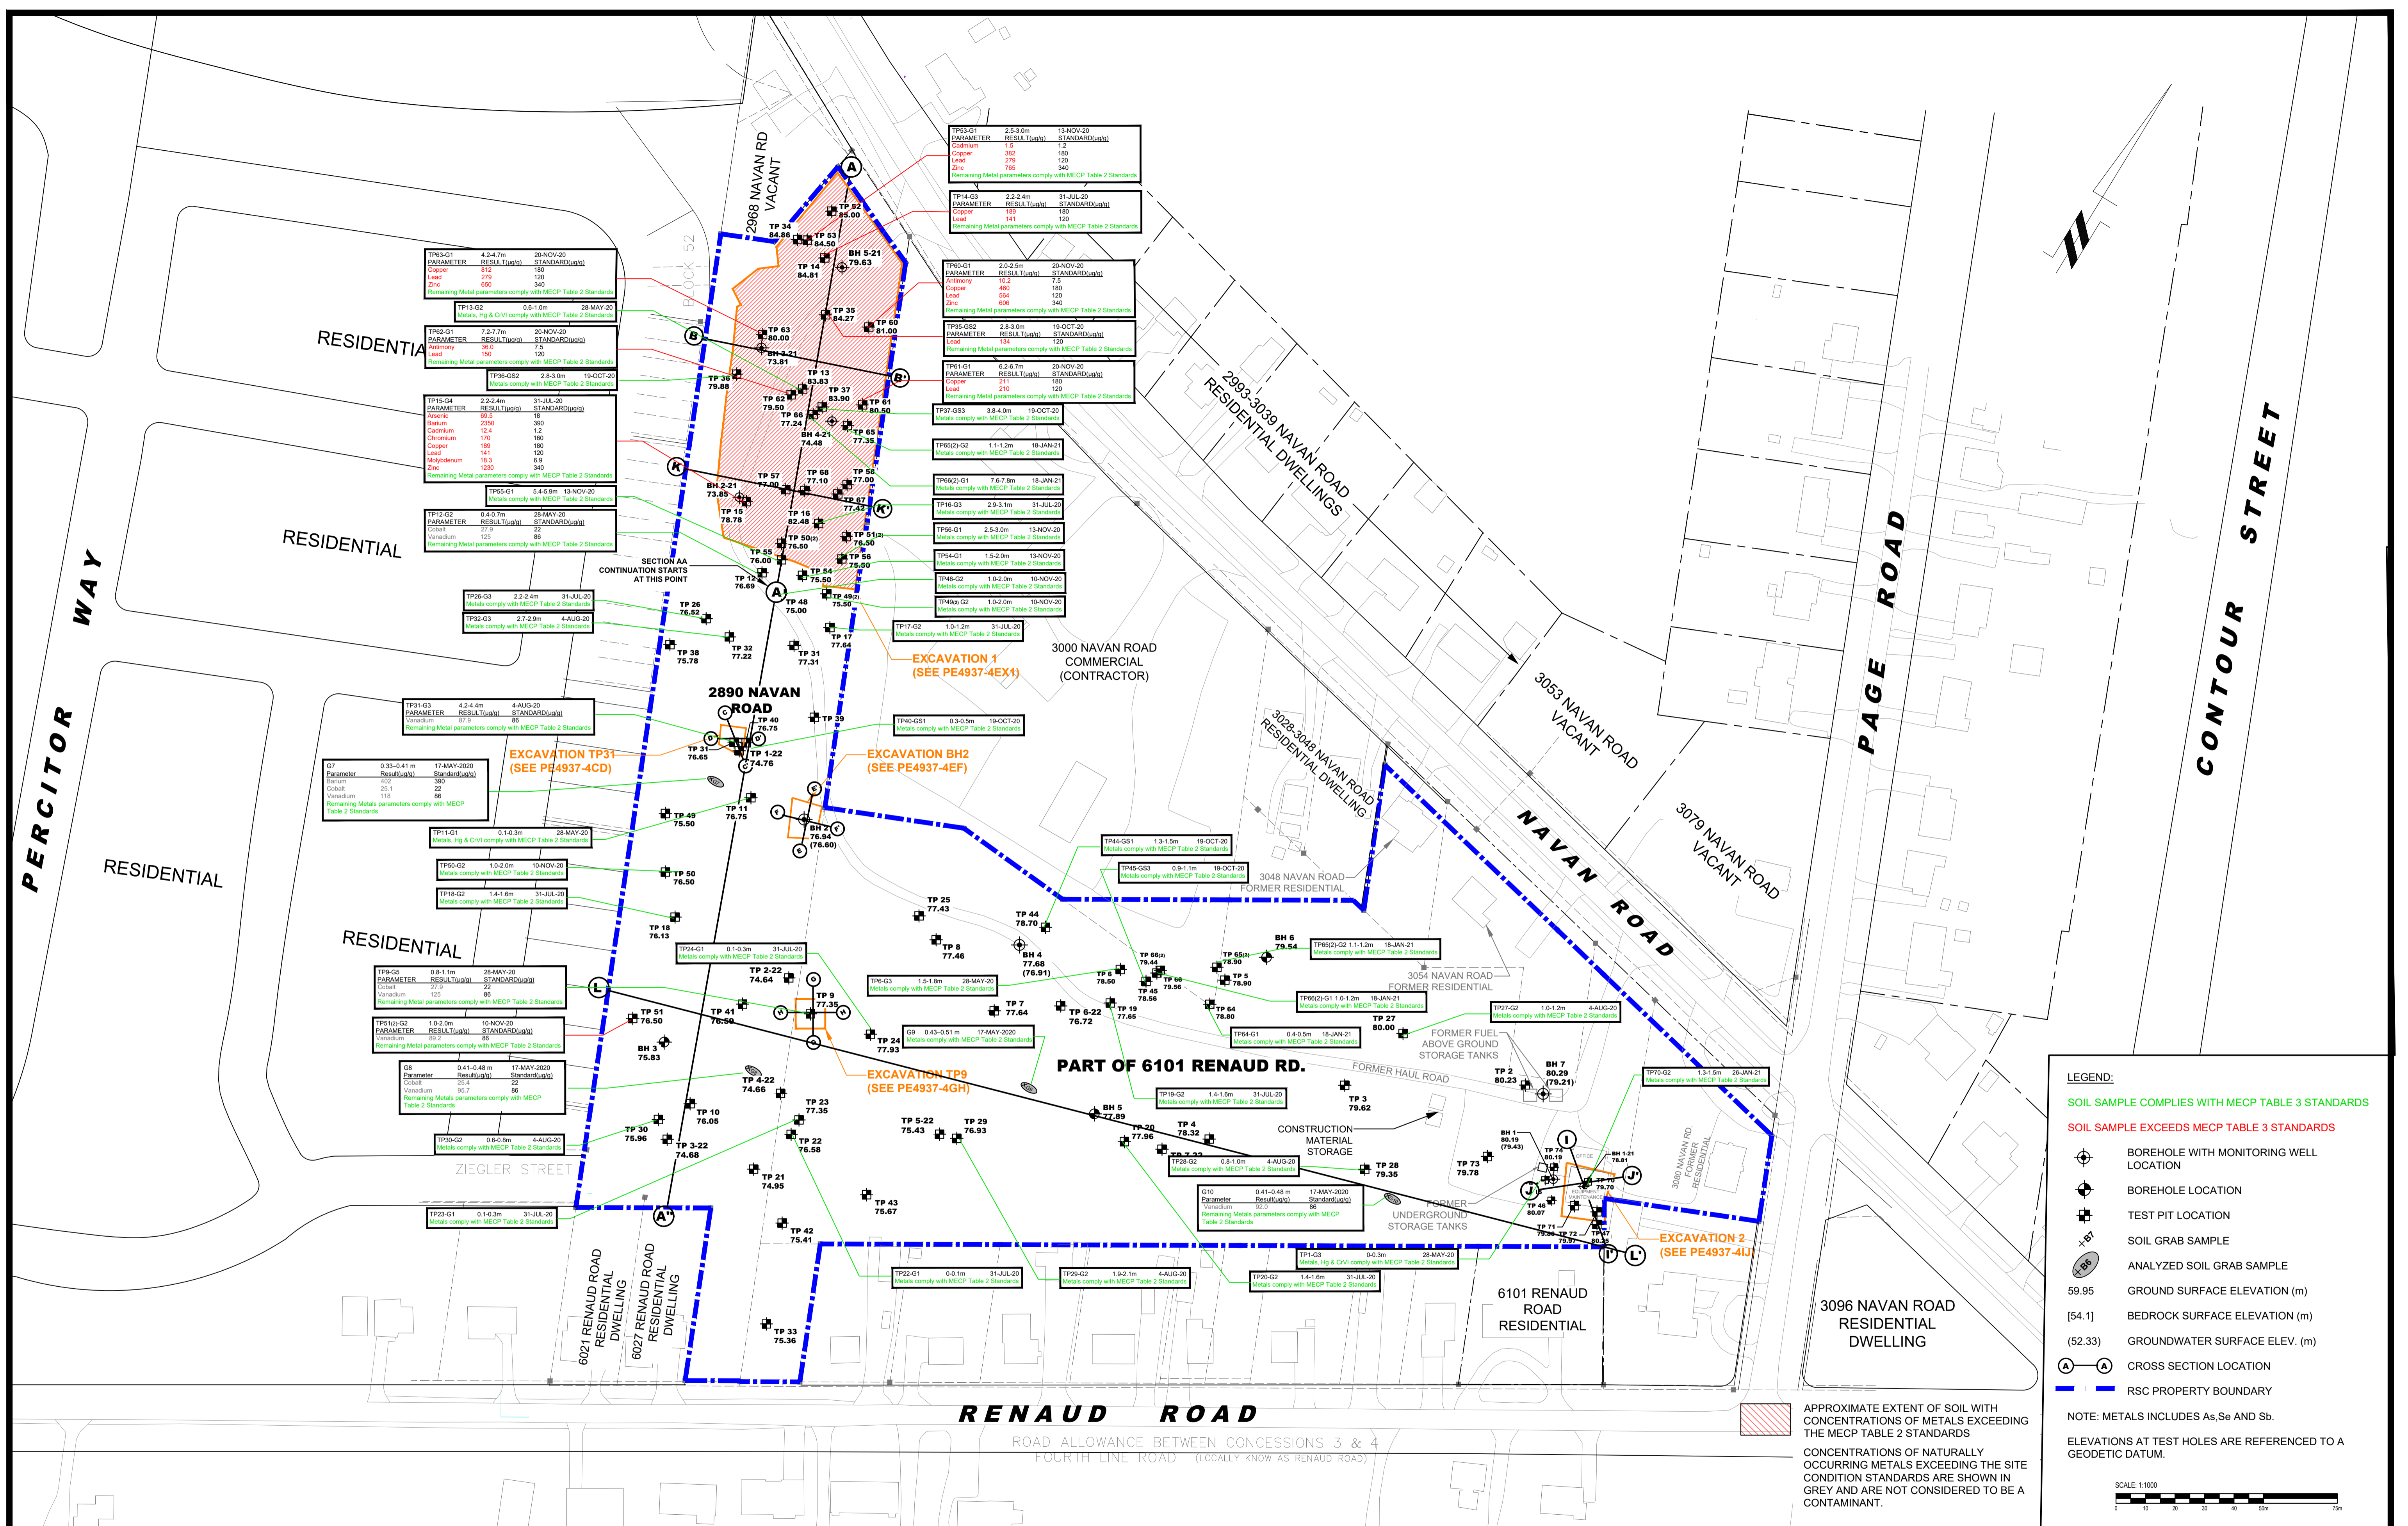
Scale: 1:1000	Report No.: PE4937
Drawn by: RG	Drawing No.:
Checked by: JC	PE4937-4
Approved by: MB	Revision No.: 0
Date: 03/2021

As shown on Drawing PE4937-4, samples from across the RSC property exceeded the Site Condition Standards (SCS) for Barium, Cobalt, and Vanadium, however the remaining metals parameters listed above only exceeded the site condition standards in the northwest corner of the RSC property.

CONCENTRATIONS OF NATURALLY OCCURRING METALS EXCEEDING THE SITE CONDITION STANDARDS ARE SHOWN IN GREY AND ARE NOT CONSIDERED TO BE A CONTAMINANT.

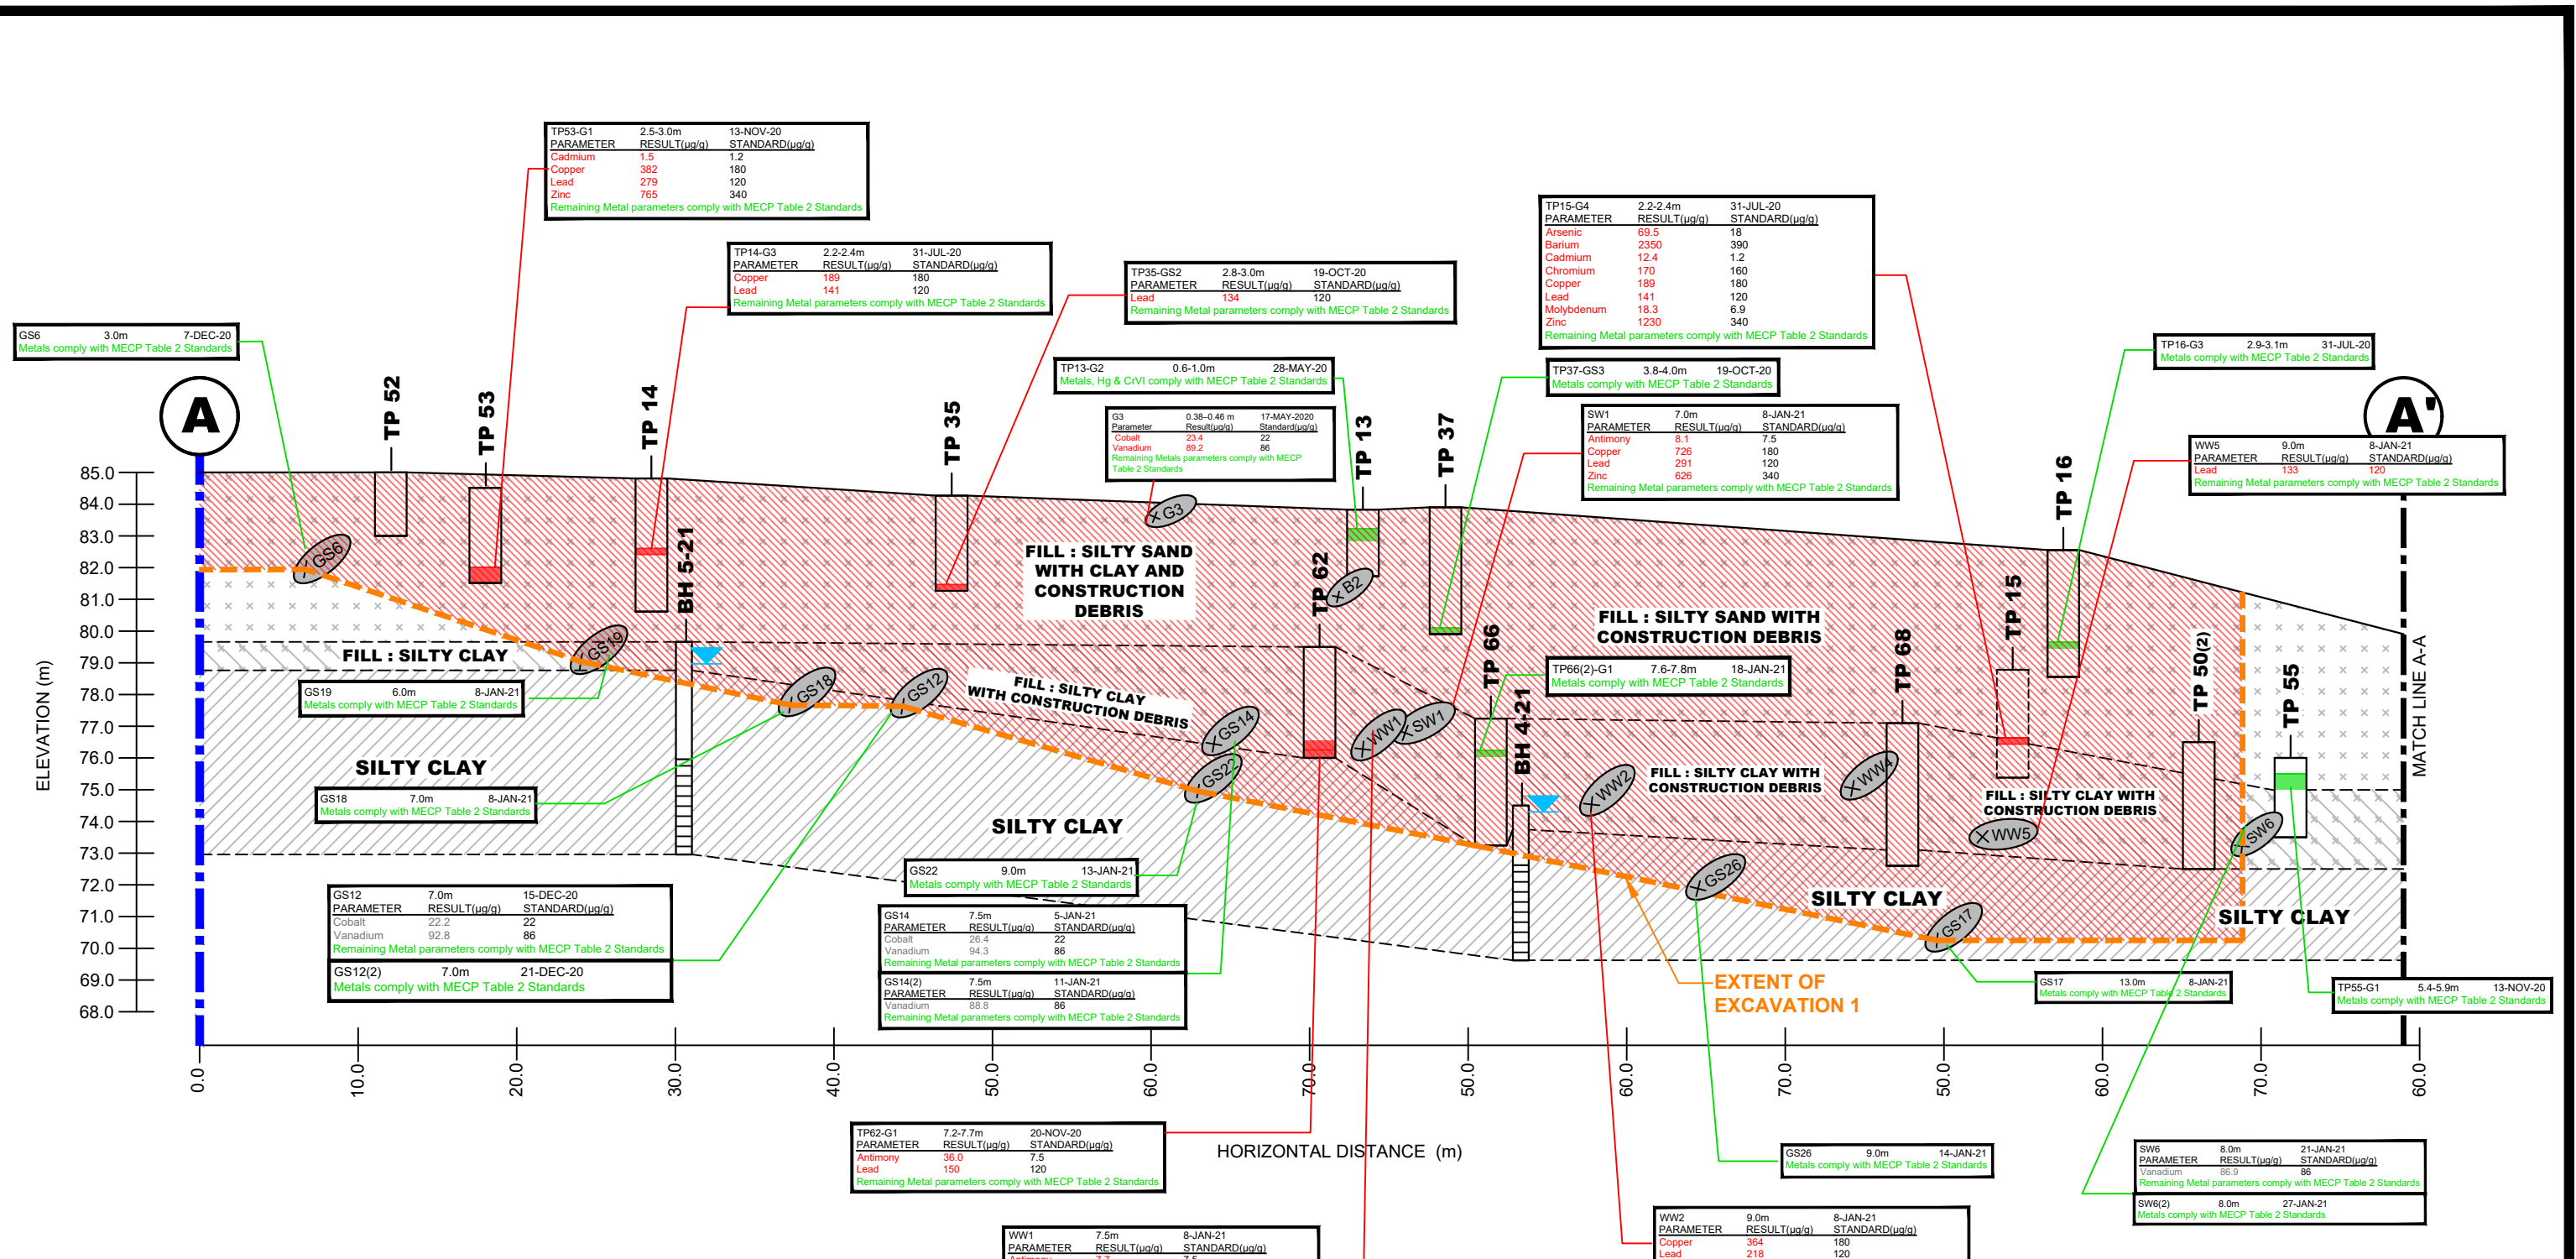
CAIVAN COMMUNITIES
PHASE II - ENVIRONMENTAL SITE ASSESSMENT
RENAUD ROAD AT NAVAN ROAD
 OTTAWA, ONTARIO
 Title: **CROSS SECTION A-A' - SOIL (METALS)**

APPROXIMATE EXTENT OF SOIL WITH CONCENTRATIONS OF METALS EXCEEDING THE MECP TABLE 2 STANDARDS
 CONCENTRATIONS OF NATURALLY OCCURRING METALS EXCEEDING THE SITE CONDITION STANDARDS ARE SHOWN IN GREY AND ARE NOT CONSIDERED TO BE A CONTAMINANT.
