# UPDATED CONSERVATION PLAN CHAMPLAIN OIL COMPANY SERVICE STATION 70 RICHMOND ROAD OTTAWA, ONTARIO

SUBMITTED TO: TRINITY DEVELOPMENT GROUP INC.

PREPARED BY: JOHN STEWART, COMMONWEALTH HISTORIC RESOURCE MANAGEMENT

Updated V5 April 2023

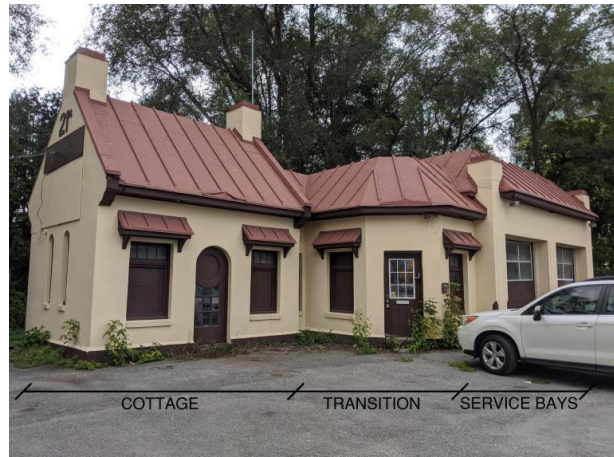
**The Champlain Oil Company Service Station** has been vacant for a number of years with no maintenance undertaken on the structure. Based on the assessment from both John G. Cooke Consulting Engineers and Cleland Jardine Engineering Limited, the building is in poor to fair condition.

The Service Station is a 100m<sup>2</sup>, one storey structure constructed in 1937 (Patterson Group EA 70 Richmond Road Title Search Deed NP45576 Registered Feb 16, 1937, Champlain Oil Company). The structure is made-up of three parts - a cottage retail, administration office (transition), and a two-bay service area. The foundation consists of cast in place perimeter concrete walls with a chamfered stepped base approximately 12". It is assumed that the foundation extends down approximately 5' below grade and is supported on perimeter footings.

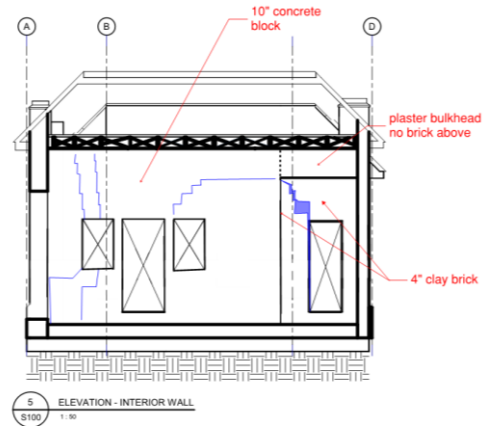
The elevation plan and pictures ( Figure 2) document the condition of the partition wall. The demolition drawing submitted as part of the application to move recommends its demolition. The three sections of the building – cottage, office, and garage (Figure1) are defined attributes in the designation, but it is not clear if the interpretation requires them to be separate spaces. The wall is in very poor shape. This wall is a load bearing wall and if it is removed support for the roof is required.

The wall between the cottage and the office was removed before designation, which suggests that there is some ambiguity. Given the poor condition and the client’s preference to have the wall removed, demolition is being recommended. This wall is a load bearing wall and with its removal there will be need to provide new roof support.

Figure 2: Interior dividing wall. Source: Cleland Jardine

Options such as distinguishing marks on the floor and a dropped header with columns will be introduced as a means of interpreting the original three-part interior.

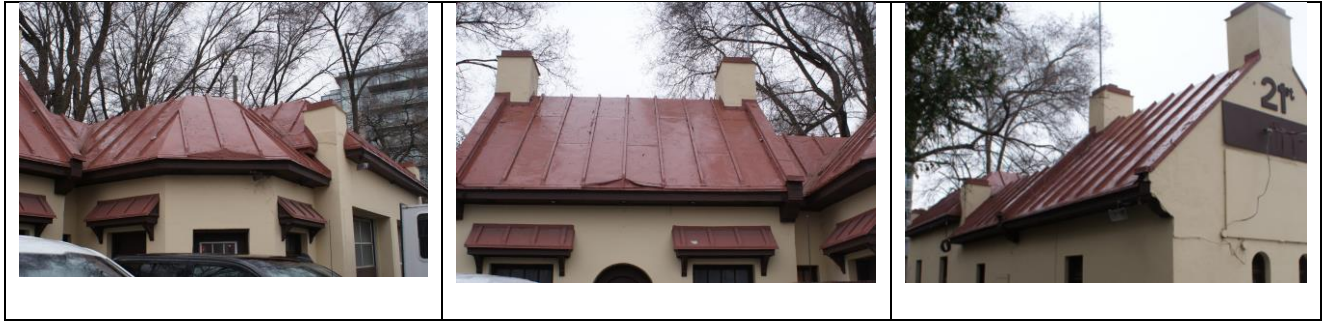
The standing seam metal roof membrane is an important character defining feature and will be reconstructed. The flashings in the valleys of the roof and around chimneys and at junctions between roof forms have failed as is evident by the stained wood sheathing as noted in John Cooke’s review. A new standing seam metal roof will replace the existing. The distinctive standing seam metal roofs on the awnings above windows and doors will be preserved depending on condition following detailed inspection. Remedial work prior to the move includes patching of the existing roof to prevent further damage.

The roof membrane and decking will have to be replaced due to the deteriorated condition of the roof deck. The roof structure, in addition to requiring repairs, will also be subjected to snow loads from being at the base of the new mid-rise structure and seismic requirements will also need to be addressed. Along the west elevation the heritage building will sit flush with the new concrete shear wall structure supporting the projecting bay above at the third floor. There will be a requirement for a hopper to direct water coming off of the garage roof away from the shear wall.

Figure 10: images of the standing seam roofs. Note the diverter flashing treatment above the doors.

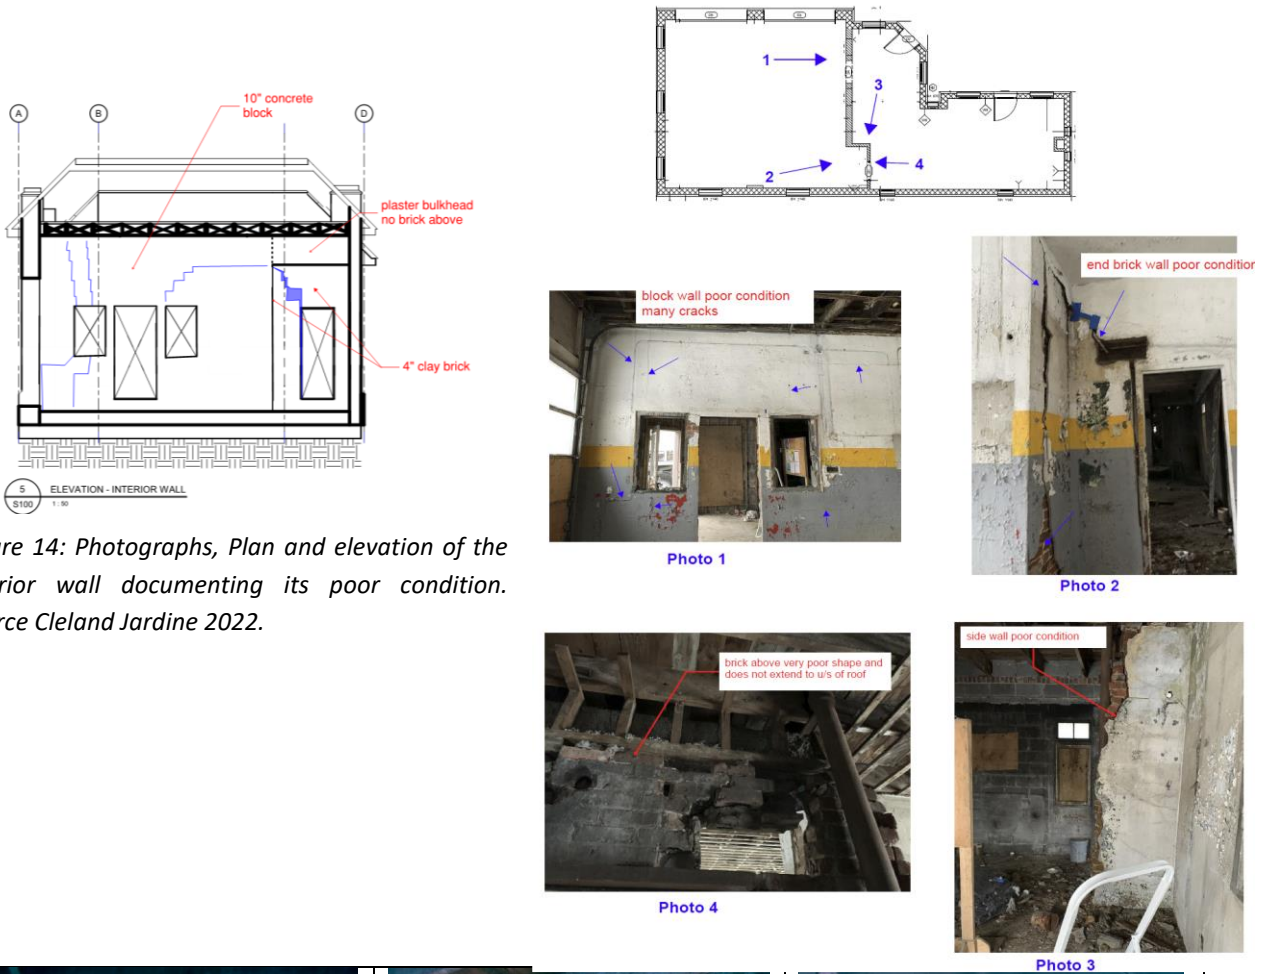
The elevation plan and pictures ( Figure 19) document the condition of the partition wall. The demolition drawing submitted as part of the application to move recommends its demolition. The three sections of the building – cottage, office, and garage (Figure1) are defined attributes in the designation, but it is not clear if the interpretation requires them to be separate spaces. The wall is in very poor shape.

The wall between the cottage and the office was removed before designation, which suggests that there is some ambiguity. Given the poor condition and the client's preference to have the wall removed, demolition is being recommended. This wall is a load bearing wall and with its removal there will be need to provide new roof support.

Figure 14: Photographs, Plan and elevation of the interior wall documenting its poor condition. Source Cleland Jardine 2022.

Options such as distinguishing marks on the floor and a dropped header with columns will be introduced as a means of interpreting the original three-part interior.

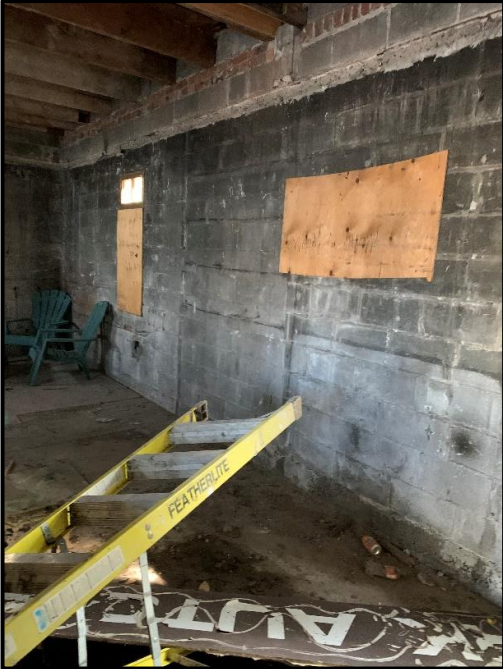
The masonry walls were in overall fair to poor condition with localized vertical cracking noted in several locations. Based on a few limited areas, where holes in the masonry were noted, the masonry does not appear to be grouted nor reinforced.

**Exposed Masonry Wall Administration Area**

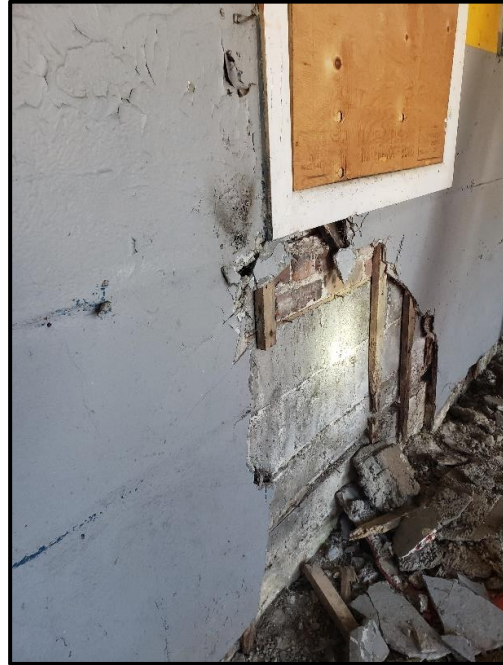
**Masonry Wall Behind Plaster Lath - Service Bay**

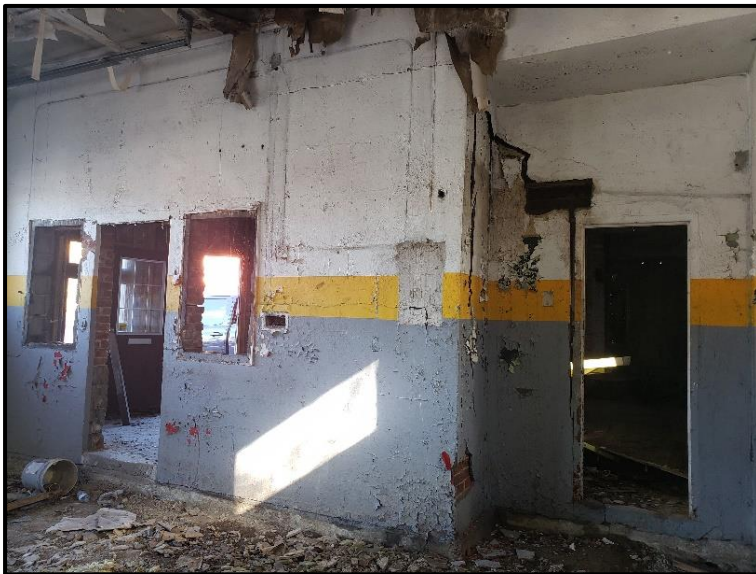
The load bearing masonry wall, between the service bay and administration area, is in poor condition with several cracks and major displacement (40mm) at the back portion.

**Interior wall with major crack/displacement at door openings**

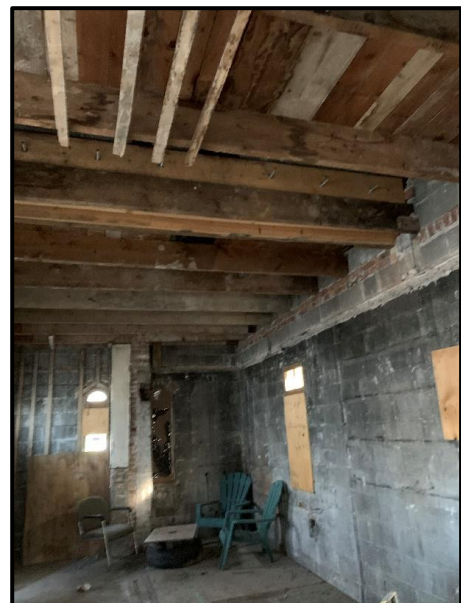
**Roof framing administration area**

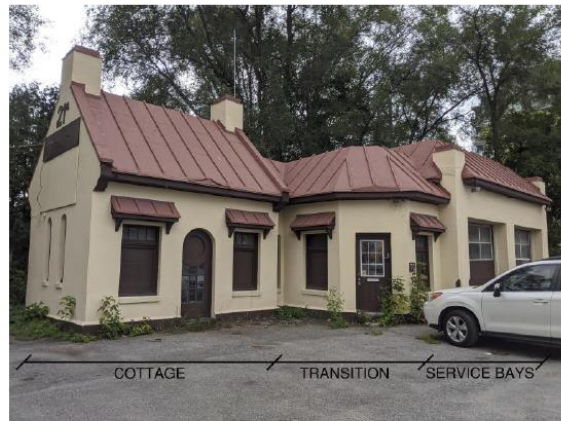
In general there are three main spaces; the cottage, the transitional area and the service bays, see Photo 1. The transitional area and garage are divided by an interior loadbearing brick wall. The separation of these spaces is visible by the differing roof structures from the exterior.

Photo 1: Overview of building [JCAL 2020]
