URBAN FORESTRY & FOREST MANAGEMENT CONSULTING

July 29, 2022

**RE: TREE PROTECTION AND PRESERVATION REPORT FOR CITY MAPLE AT 1364-1370
STITTSVILLE MAIN STREET**

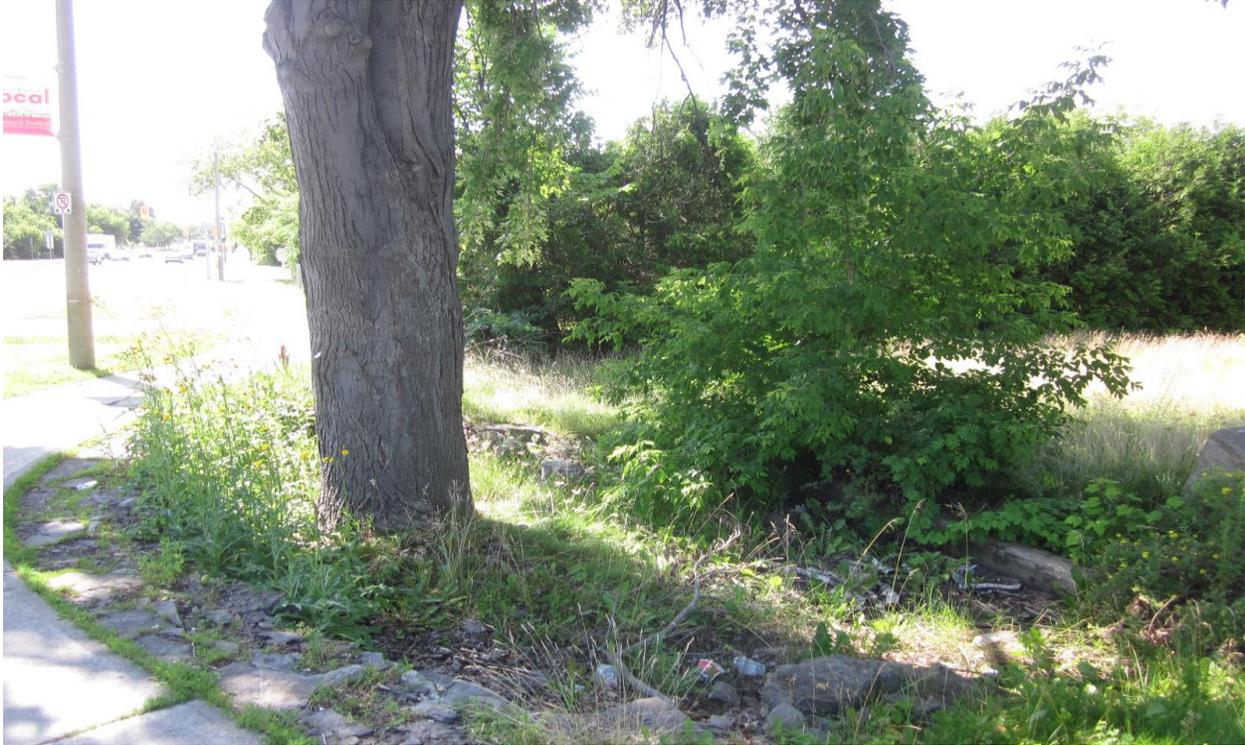
- 3) Rooting is restricted to the northeast by a concrete sidewalk less than 2m away. It is partially restricted to the northwest by the aforementioned compacted stone driveway and is completely unrestricted in all other directions (see Pictures 1 and 2 on page 4).

Picture 1. Looking southward - lower bole and existing growing environment of mature red maple located within City of Ottawa ROW adjacent to 1364-1370 Stittsville Main Street (proposed building will be located to the right)

- 1) Tree Protection Barrier: Following the City of Ottawa's tree protection barrier detail included on plan L.1, wooden hoarding supported by t-bars should be installed at a distance of at least 8.5m from the tree (where possible). This barrier should be a minimum of 1.2m in height and all of the supports and bracing should be installed in such a way as to minimize root damage. Since the desired effect is to prevent construction traffic and storage/stockpiling of materials within the CRZ, the barrier should be kept in place until all construction has been completed. Lastly, it should also have signage attached to it indicating its presence as a tree protection barrier.

- 2) Surface Treatment: Where construction traffic must pass outside the protection barrier a protective root buffer is required. This buffer will consist of woodchips spread to a thickness of 10 cm covered by a layer of granular 'A' gravel deep enough to stabilize 2 cm thick ($\frac{3}{4}$ inch) plywood or rubber ground mats. This will help prevent the compaction of soil surrounding the tree's fine feeding roots.

- 3) Excavation/Exposed Roots: Since some excavation within the CRZ is necessary a trench should first be dug carefully using hydro excavation (*i.e.* via a hydrovac truck). After the trench is established traditional equipment can be used to complete the work. If roots are encountered while trenching they should be preserved intact where possible. If they must be severed they should be cleanly cut and the cut ends sealed with a paste containing bees wax. The cuts should be made with either pruning shears or saw wiped with alcohol before each cut. This will ensure clean disease-free cuts of the roots, thus facilitating healing.

- 4) Covering/Watering/Fertilization: If any tree roots are exposed during construction they should be immediately reburied with soil or temporarily covered with burlap, filter cloth or woodchips and kept moist (*i.e.* watering with a soft-spray nozzle at least three times a week). A covering of plastic should be used in order to retain moisture during an extended period when watering may not be possible (*i.e.* over weekends). Fertilizing the tree with a liquid, deep-root, slow-release fertilizer is recommended only after the completion of all construction. Since the tree could suffer root-related stress, a fertilizer with a high-phosphorus formulation should be used. This should be repeated every other year.

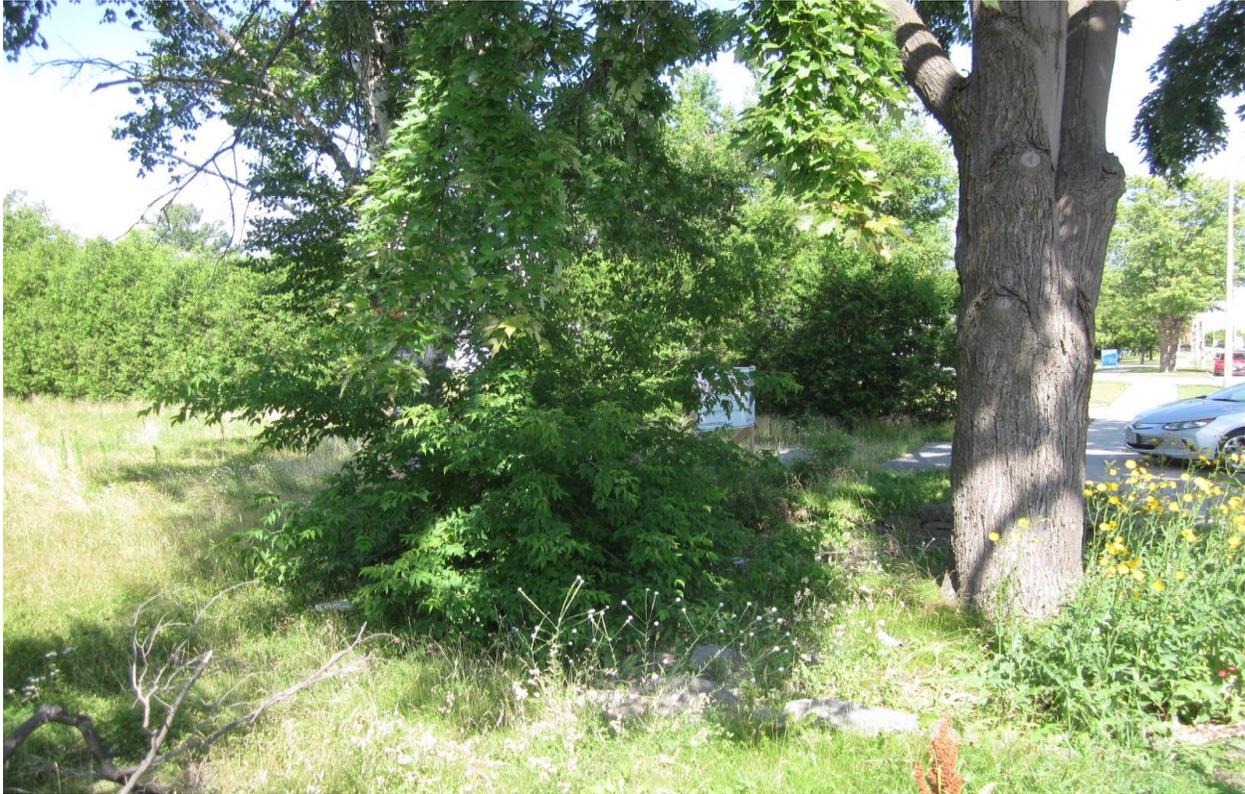
Picture 2. Looking towards northwest - lower bole and existing growing environment of mature red maple located within City of Ottawa ROW adjacent to 1364-1370 Stittsville Main Street (proposed building will be located to the left of tree)

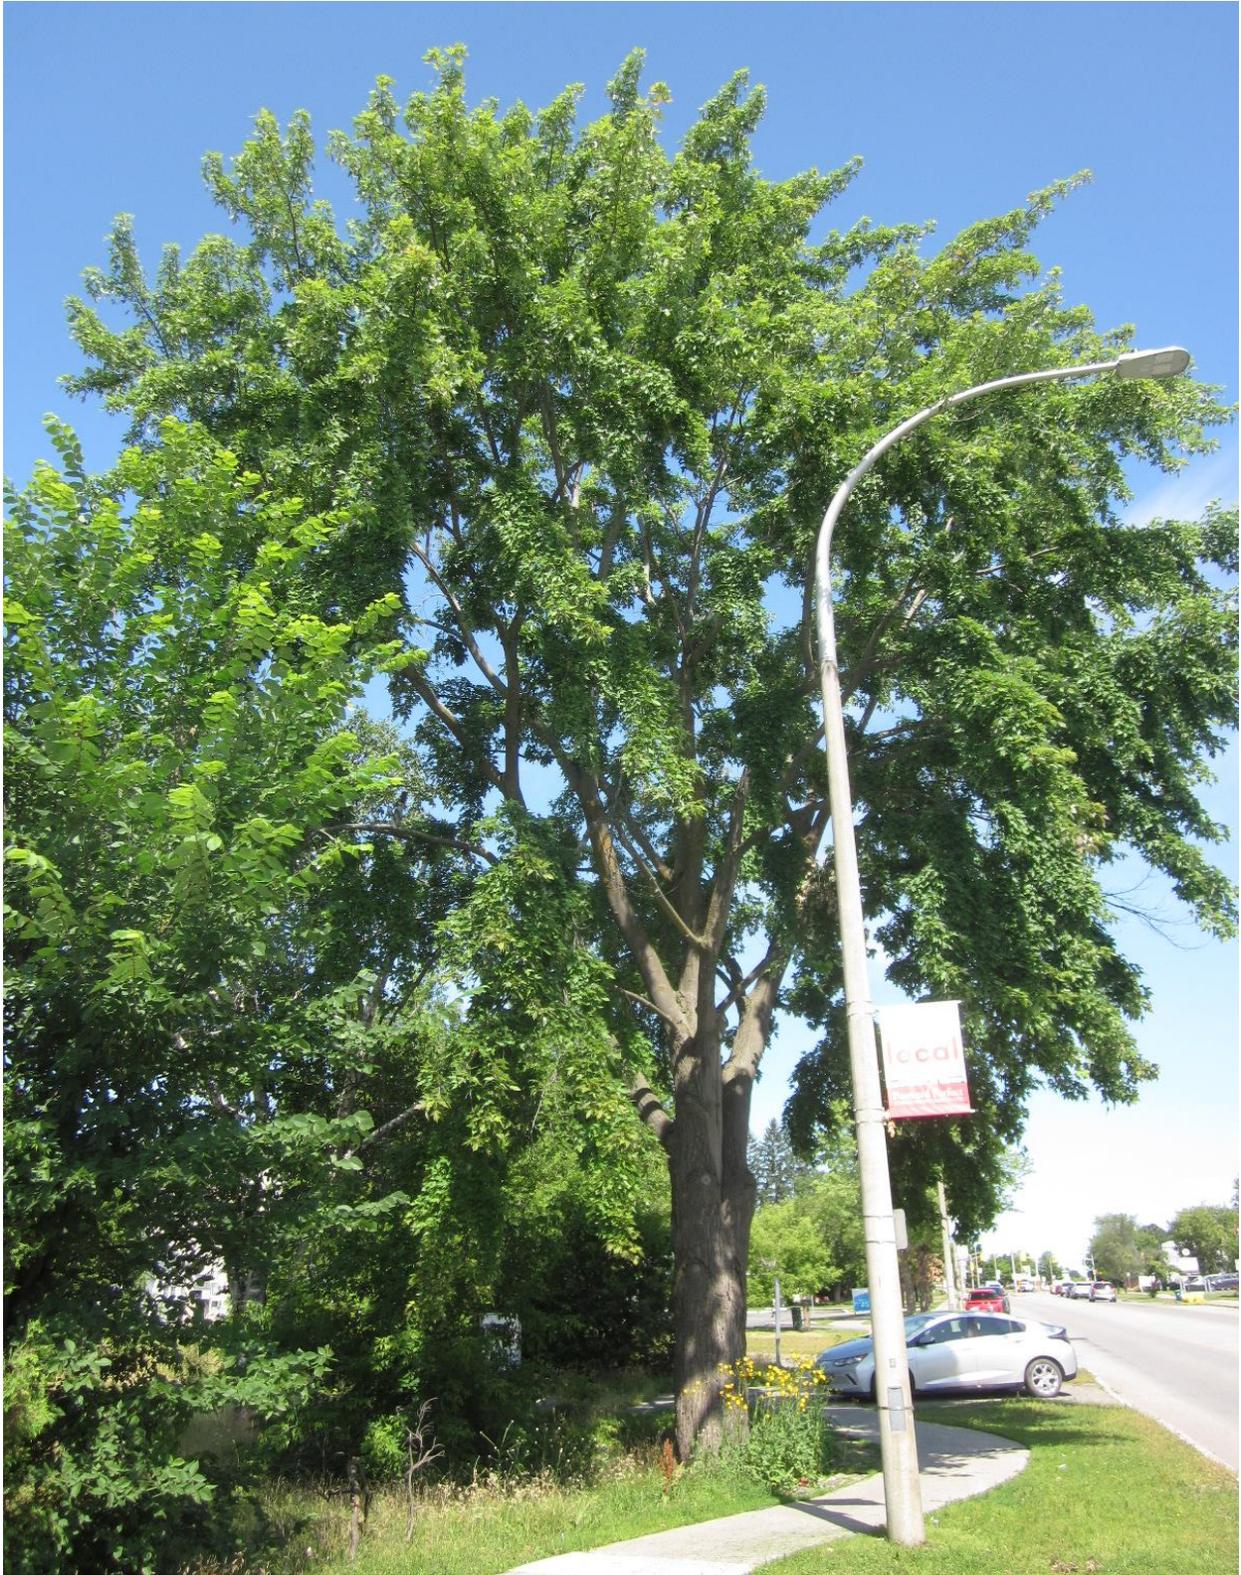
- 4) Root flares at the tree's root collar are not visible indicating the grade was likely raised around the tree in the past.
- 5) The tree's crown is comprised of a central stem with competing and suppressed laterals arising at 3.5m from grade. The crown is broad with a moderately good density of foliage. At the time of inspection the crown showed less than ten percent dieback.

Picture 3. Crown and existing growing environment of mature red maple located within City of Ottawa ROW adjacent to 1364-1370 Stittsville Main Street (all pictures taken July 2022).

Over the next several years the maple should be monitored and any dieback or dead branches be pruned from the crown.
