THOMSON WATSON CONSULTING ARBORISTS Inc

Re: Tree Conservation Report for Canadian Tire Centre at 2501 Greenbank Road, Nepean

TREE PHOTOGRAPHS – 2501 Greenbank Road, Nepean

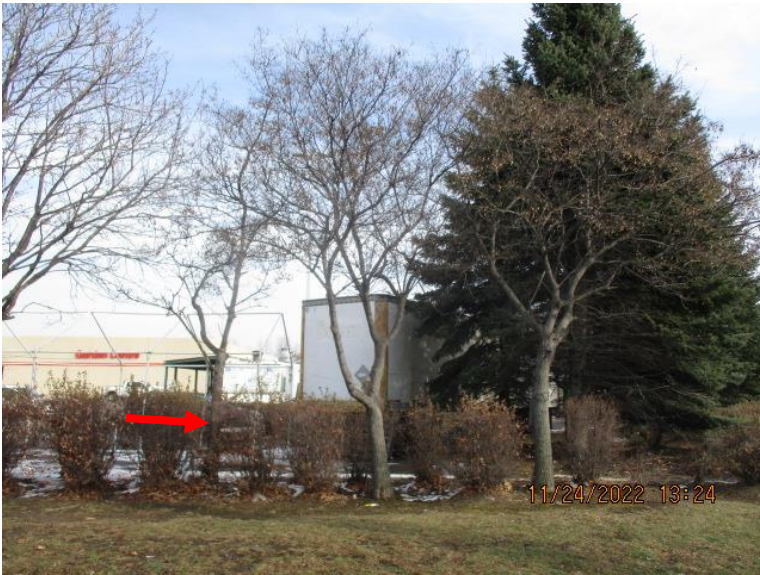
Tree 42 – Amur Maple

43	Amur Maple	<i>Acer ginnala</i>	14	3.0	fair	
44	Amur Maple	<i>Acer ginnala</i>	19	3.0	fair	canker on south side trunk at 2 m,
45	Colorado Spruce	<i>Picea pungens</i>	26	3.0	good	6 inch growth rate, lower deadwood
46	Colorado Spruce	<i>Picea pungens</i>	25	3.0	good	6 inch growth rate, lower deadwood
47	Colorado Spruce	<i>Picea pungens</i>	21	3.0	good	6 inch + growth rate lower deadwood due to lack of light
48	Colorado Spruce	<i>Picea pungens</i>	24	3.0	good	6 inch growth rate, slow growth
49	Amur Maple	<i>Acer ginnala</i>	18.5	3.0	fair	trunk splits into two stems at 1.5 m with included bark in union, slow growth
50	Spruce	<i>Picea pungens</i>	13	3.0	dead	no needles on tree
51	Colorado Spruce	<i>Picea pungens</i>	20	3.0	fair	1-4 inch growth rate, lower deadwood due to lack of light
52	Colorado Spruce	<i>Picea pungens</i>	22.5	3.0	fair-good	1 dead branch in mid canopy, 6 inch growth rate
53	Amur Maple	<i>Acer ginnala</i>	14	3.5	fair	sprouts at base

Trees 42, 50, 54, 62, 63, 66, 67 and 68 (8 trees). Tree 50 is dead and should not require a permit to allow its removal.

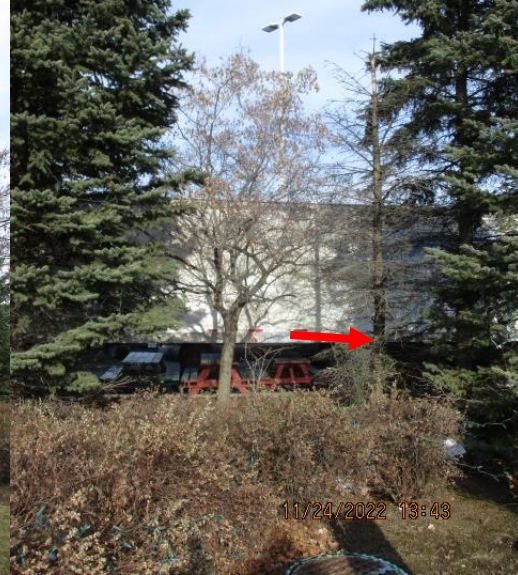
Tree 50 – dead Spruce

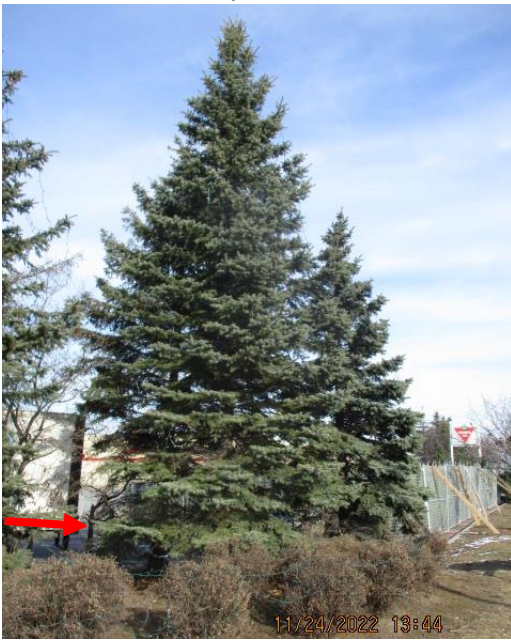
Tree 54 – Amur Maple

54	Amur Maple	<i>Acer ginnala</i>	9.5	2.5	poor	lost leader at 1.4 m, decay in stem
55	Colorado Spruce	<i>Picea pungens</i>	24	3.0	fair	lower deadwood
56	Colorado Spruce	<i>Picea pungens</i>	22	3.0	good	6 inch growth rate, lower deadwood
57	Colorado Spruce	<i>Picea pungens</i>	19	2.0	good	4 inch growth rate, lower deadwood
58	Norway Maple	<i>Acer platanoides</i>	14.5	3.0	fair	trunk guard, wounded surface roots
59	Norway Maple	<i>Acer platanoides</i>	13.5	2.0	poor-fair	trunk guard, extensive wounded surface roots, slow growth
60	Norway Maple	<i>Acer platanoides</i>	15	2.5	poor-fair	trunk guard, surface roots, slow growth
61	Norway Maple	<i>Acer platanoides</i>	16	2.5	fair	trunk guard, slow growth
62	Schubert Cherry	<i>Prunus virginiana</i>	13	4.0	poor	sprouts at base, Black Knot infection, canker in trunk at 1.5 to 2.5 m
63	Schubert Cherry	<i>Prunus virginiana</i>	14	3.0	fair	Black Knot infection, growing fine

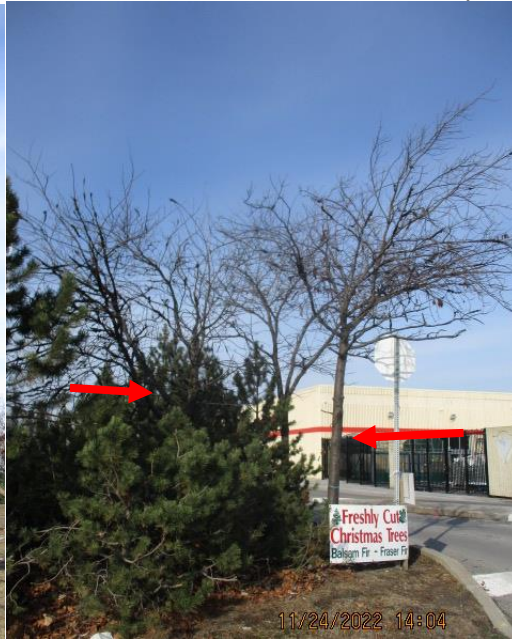
There are four Schubert Cherries (*Prunus virginiana* 'Schubert') growing on site. The trees are infected with Black Knot fungus (*Dibotryon morbosum* or *Apiosporina morbosa*) which affects branches and stems. The symptoms of the disease create a poor appearance and results in dead branches and stems. I have recommended the removal of all four trees.

Trees 62(left) and 63 (right) – Schubert Cherry

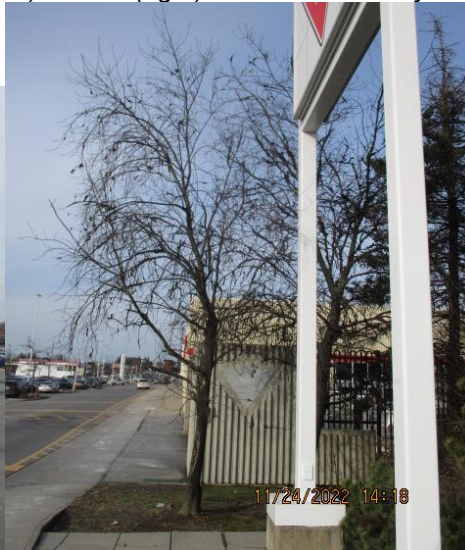
Along this side of the proposed building, it is proposed to remove Trees 66, 67 and 68 due to their health condition, Trees 70, 72, 74, 76, 77 and 78 for their location adjacent to the swale and Trees 82 to 90 due to excavation, construction access and proposed grade changes required to allow construction access. Trees 82 to 86 are growing on a sloped area. The grade will have to be dropped to the building side of the trees. Trees 87 to 90 will have excavation close to the base of the trees, removing 25 to 50% of their root systems. The canopies of these trees also extend up to and into the vertical footprint of the addition.

Trees 66 (left) to 68 (right)

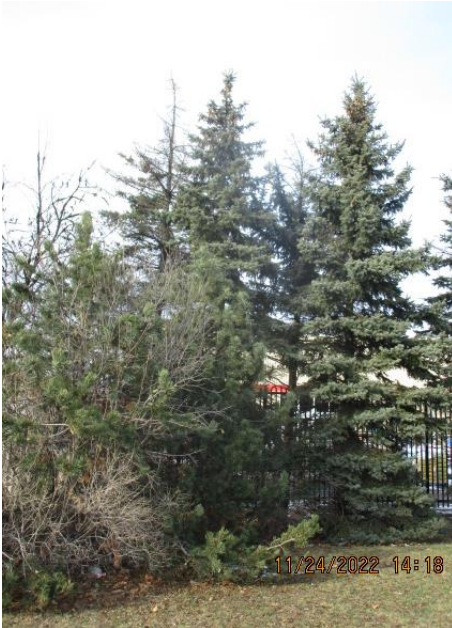
Trees 68 to 71 – Colorado Spruce

A Tree Protection Fence should be erected 3.0 metres from Trees 69, 71 and 73 and 4.0 metres from Trees 75, 79, and 81 to protect these trees during the construction of the building. When it is proposed to excavate the swale, the Fence will be moved to the road edge of the swale. It is assumed that the swale will be dug by machine. The machine used should be as small as possible to minimize soil compaction by the tracked vehicle. Soil excavated from the swale must be placed outside of the Tree Protection Fences and cannot be placed between trees. The excavation for the 3 to 1 swale slope adjacent to Tree 81 must be done by hand to allow significant roots (50 mm +) to be preserved above grade, if this is possible.

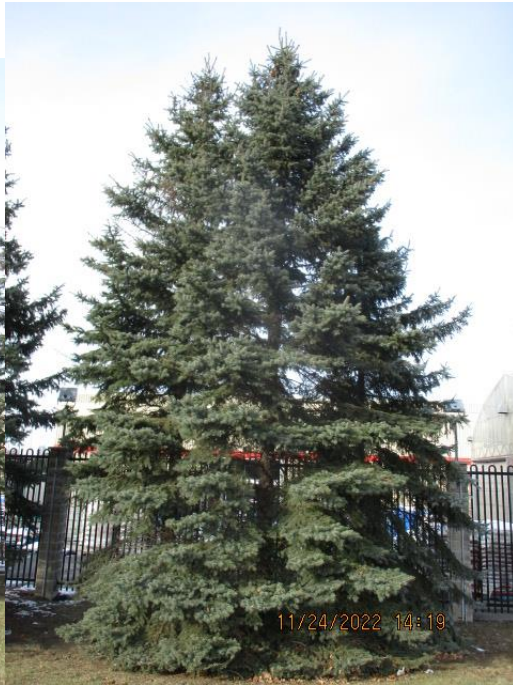
Trees 72 to 74 – Colorado Spruce

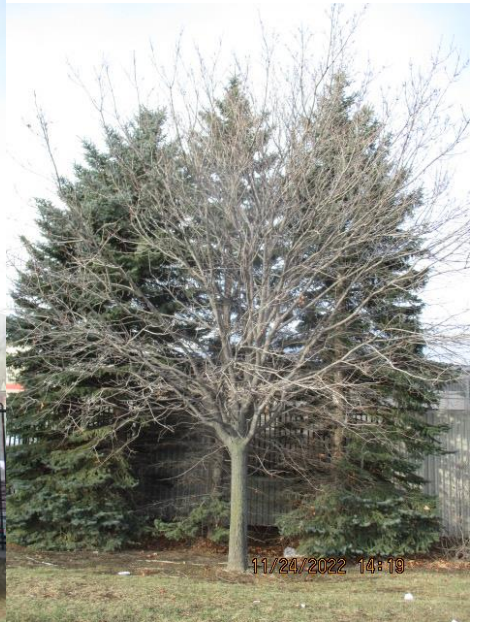
Trees 75 to 78 (Spruce) and 79 (Maple)

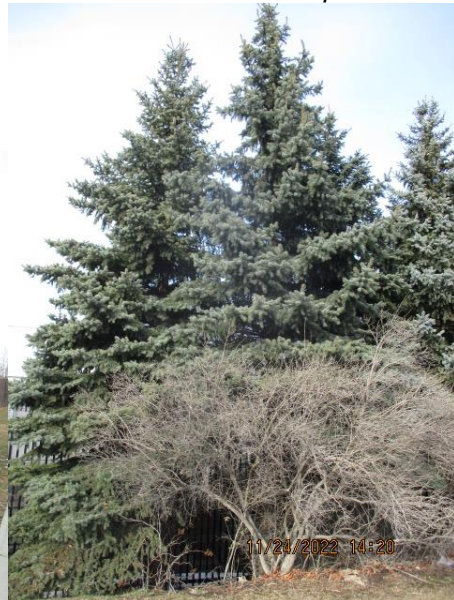
Trees 82 to 85 – Colorado Spruce

Trees 65, 70, 72, 74, 76, 77, 78, 82, 83, 84, 85, 86, 87, 88, 89 and 90 (16 trees).

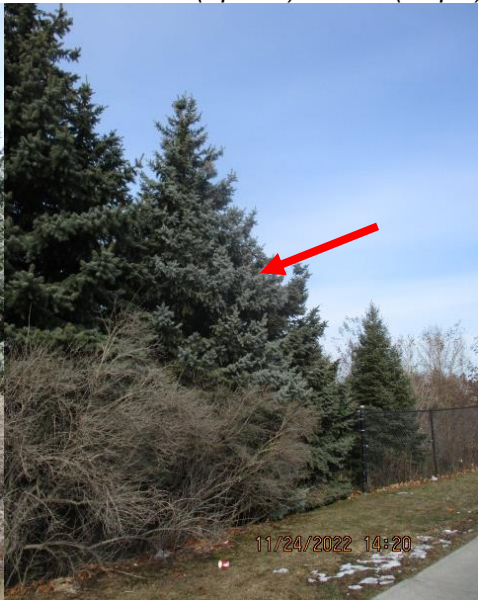
Tree 86 – Colorado Spruce

77	Colorado Spruce	<i>Picea pungens</i>	21	3.0	fair	deadwood in lower canopy due to Maple, 5 inch growth rate
78	Colorado Spruce	<i>Picea pungens</i>	28.5	3.0	fair	deadwood in lower canopy due to Maple, 6 inch growth rate
79	Norway Maple	<i>Acer platanoides</i>	23.5	4.0	fair	girdling roots, extensive wounded surface roots, slow growth
80	Norway Maple	<i>Acer platanoides</i>	25	3.5	fair	girdling root to west, slow growth
81	Norway Maple	<i>Acer platanoides</i>	28.5	4.0	fair	slow growth, multiple stems at 2 m with included bark in union
82	Colorado Spruce	<i>Picea pungens</i>	27.5	3.0	good	6 inch growth rate, on slope, lower deadwood
83	Colorado Spruce	<i>Picea pungens</i>	27	3.0	good	5 inch growth rate, lower deadwood
84	Colorado Spruce	<i>Picea pungens</i>	19	3.0	good	3-4 inch growth rate, lower deadwood
85	Colorado Spruce	<i>Picea pungens</i>	25	3.0	good	lower deadwood
86	Colorado Spruce	<i>Picea pungens</i>	26	3.0	fair	top dying, 3-4 inch growth rate, lower deadwood

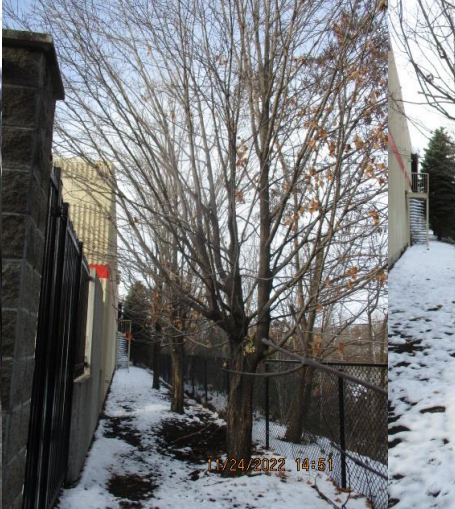
Trees 89, 90 and 91 – Sugar Maple

A Tree Protection Fence will need to be installed a minimum 2.5 metres east of Tree 91, from existing building to property line fence, to keep construction activities from the north side of the existing building.

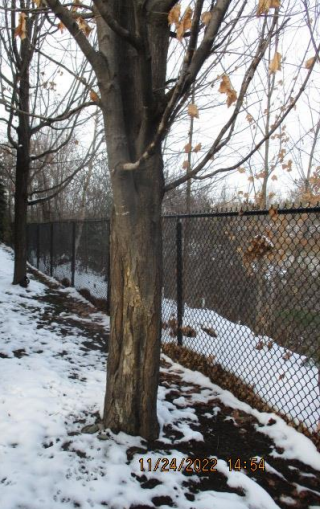
Tree 90 – trunk wound
