Project:
50 THE DRIVEWAY
 50 THE DRIVEWAY
 OTTAWA, ONTARIO

Drawing:
TREE CONSERVATION REPORT

Scale: 1:200	Date: JULY, 2021
Design By: AC/LM	Drawn By: SW
Project Number: 2096-01	Sheet Number: TCR 01

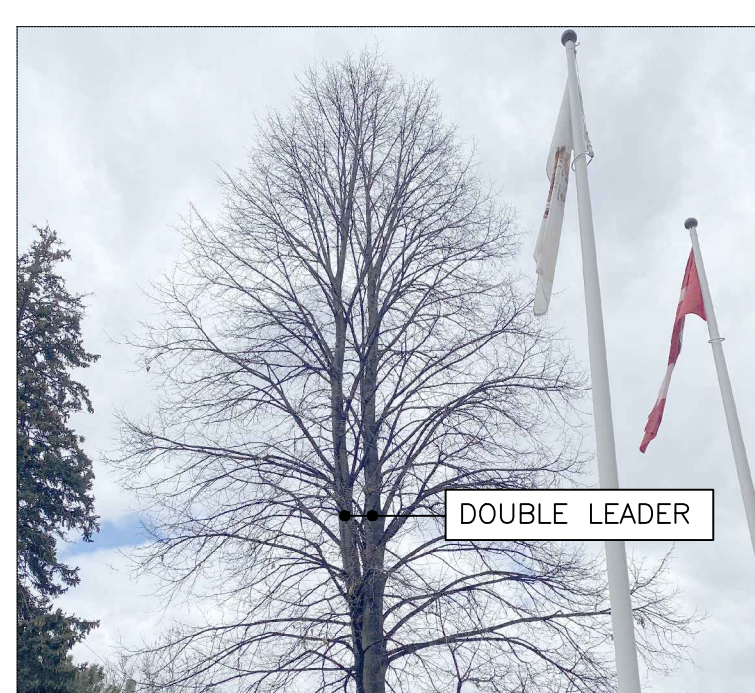
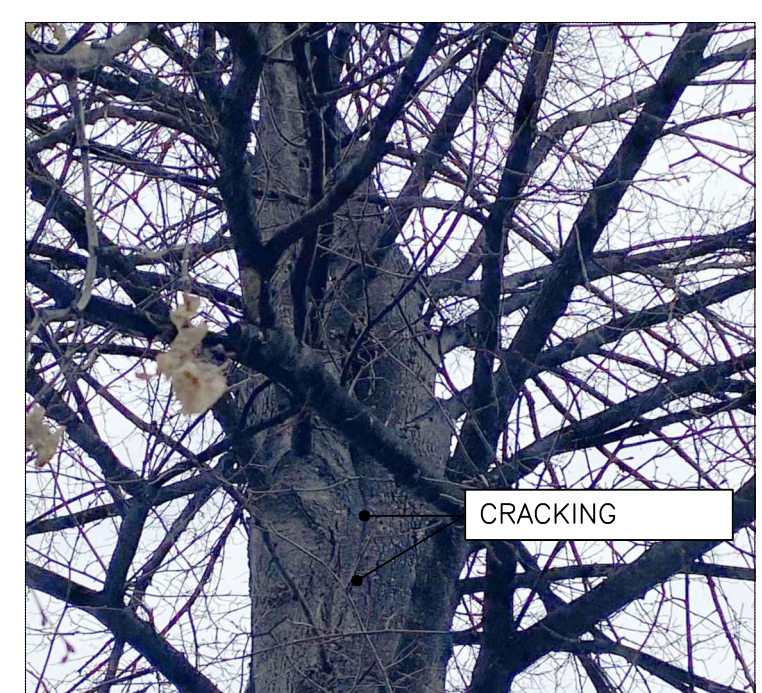
5 TREE #2 - PHOTOS

- Condition Rating: 'Good'
 No significant damage or disease, normal vigour, good form. Double leader with cracking constitutes a defect, though it may be mitigated.
 - Location Rating:
 Site Position and Contribution are good, however placement very close to property line is unfortunate.
 - Species Rating:
 Lower end of range of values was chosen due to invasive status of Tilia cordata in Ottawa region.

DOUBLE LEADER

CRACKING

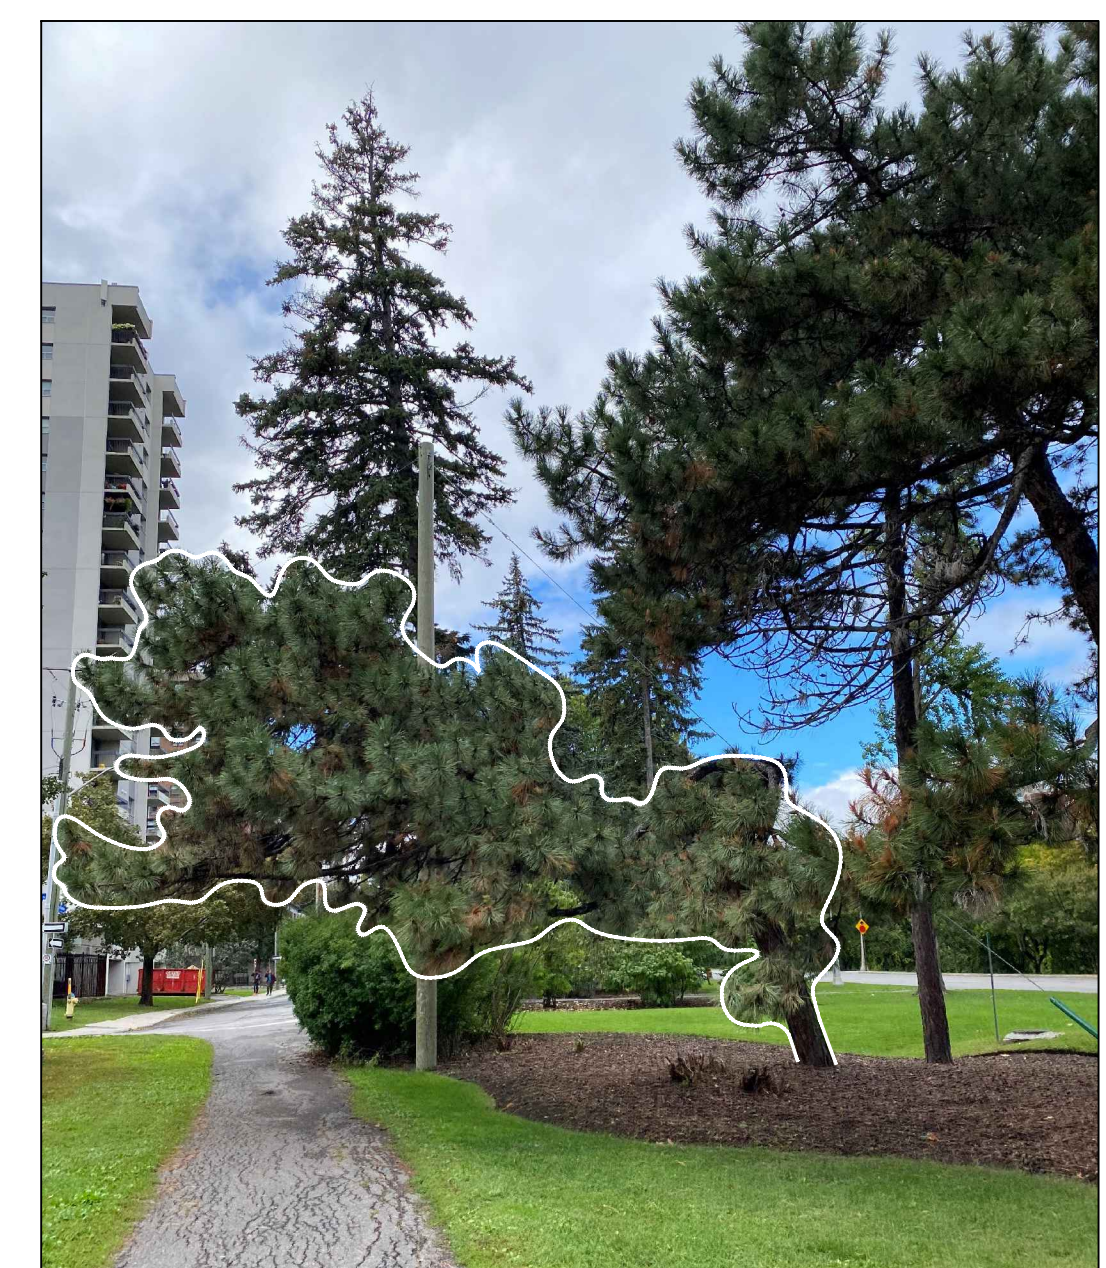
6 TREE #5 - PHOTO
 CANOPY EXTENDS BEYOND CRITICAL ROOT ZONE -
 STAGING BOUNDARIES ADJUSTED FOR PROTECTION

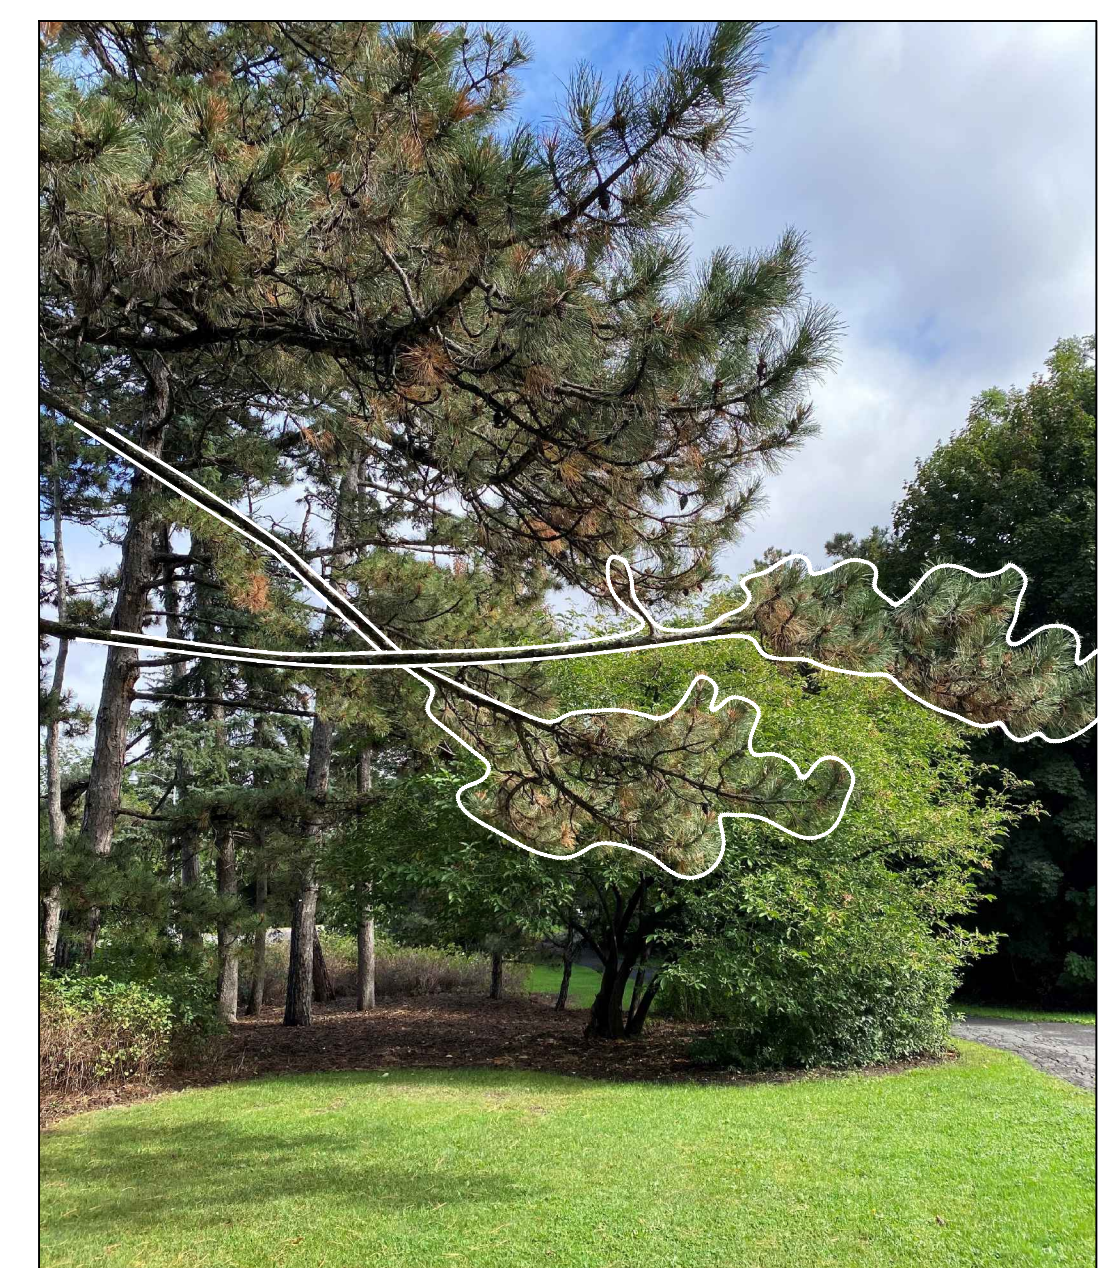
7 TREE #16 - PHOTO
 LIMBS EXTEND BEYOND CRITICAL ROOT ZONE -
 PRUNING IS PROPOSED FOR STAGING AREA
