**PATERSON
GROUP**

February 13, 2023
File: PE4934-LET.02R

Subject: **Phase II-Environmental Site Assessment Update
30, 38, 42 and 48 Chamberlain Avenue
Ottawa, Ontario**

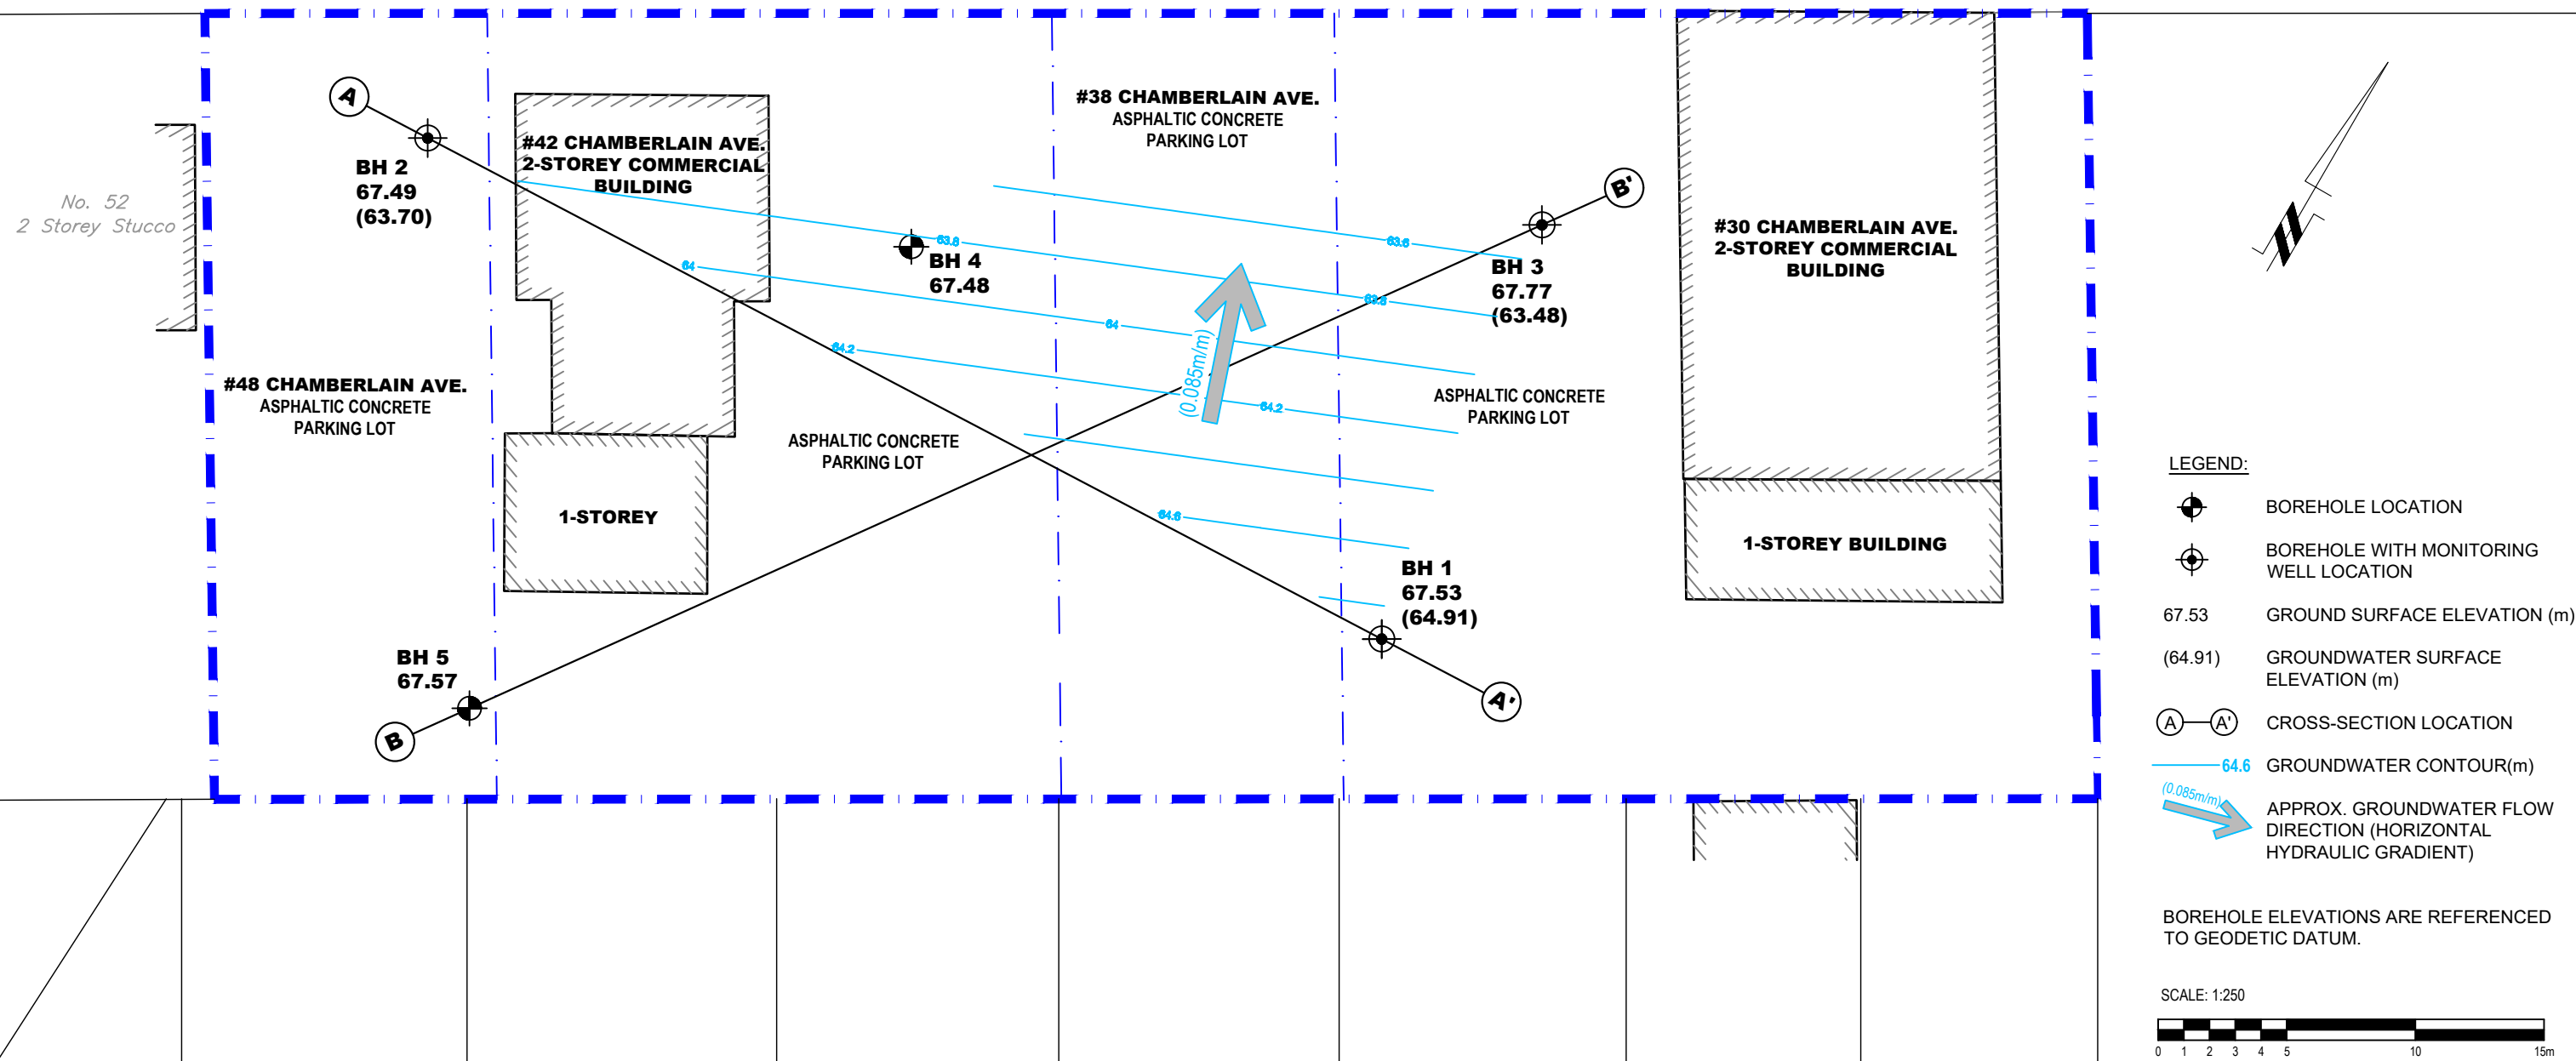
Date: 01/2023
 Report No.: PE4934-LET.02
 Dwg. No.: **PE4934-3R**
 Revision No.:

Groundwater flow was measured in a northerly direction with a hydraulic gradient of 0.085 m/m. Groundwater contours are shown on Drawing PE4934-3R–Test Hole Location Plan.
