Geotechnical Investigation and Slope Stability Assessment

Final (4th Revision)

Proposed Humanics Sanctuary and Sculpture Park
3400 Old Montreal Road
Part of Lot 7, Concession 1, Old Survey
Ottawa (Formerly Township of Cumberland), Ontario

OTT-00229886-A0

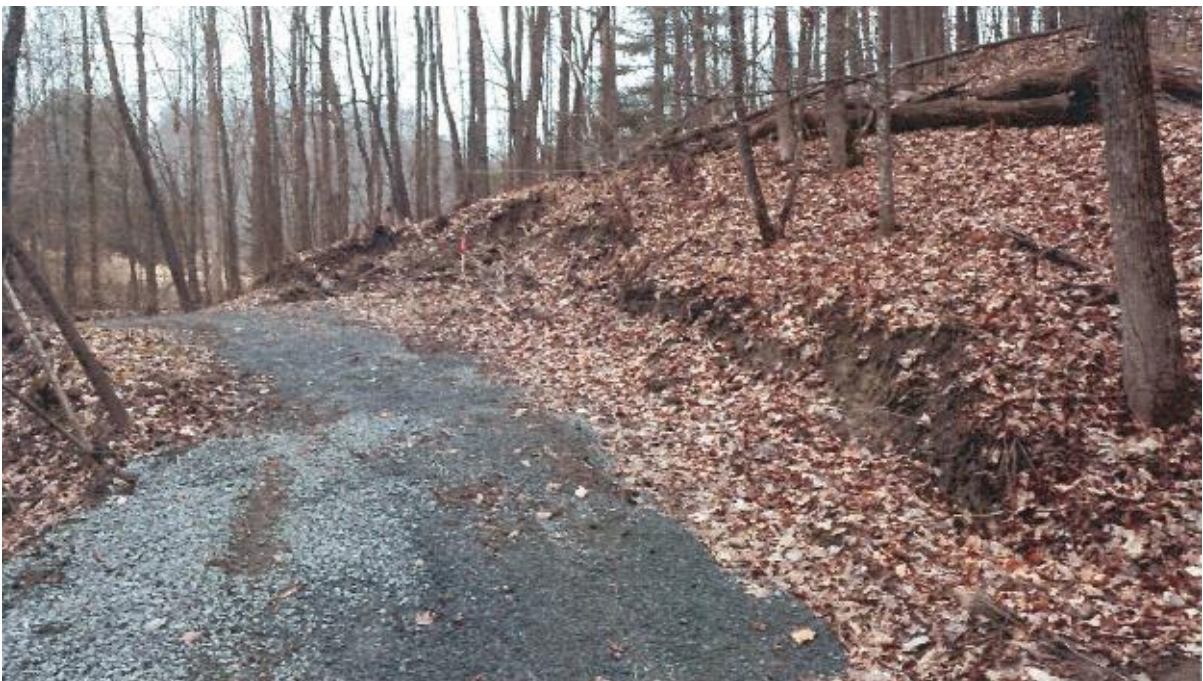
Photo No. 2 – Erosion of cut uphill of pathway. Cut approximately 9 m long x 0.4 m high.

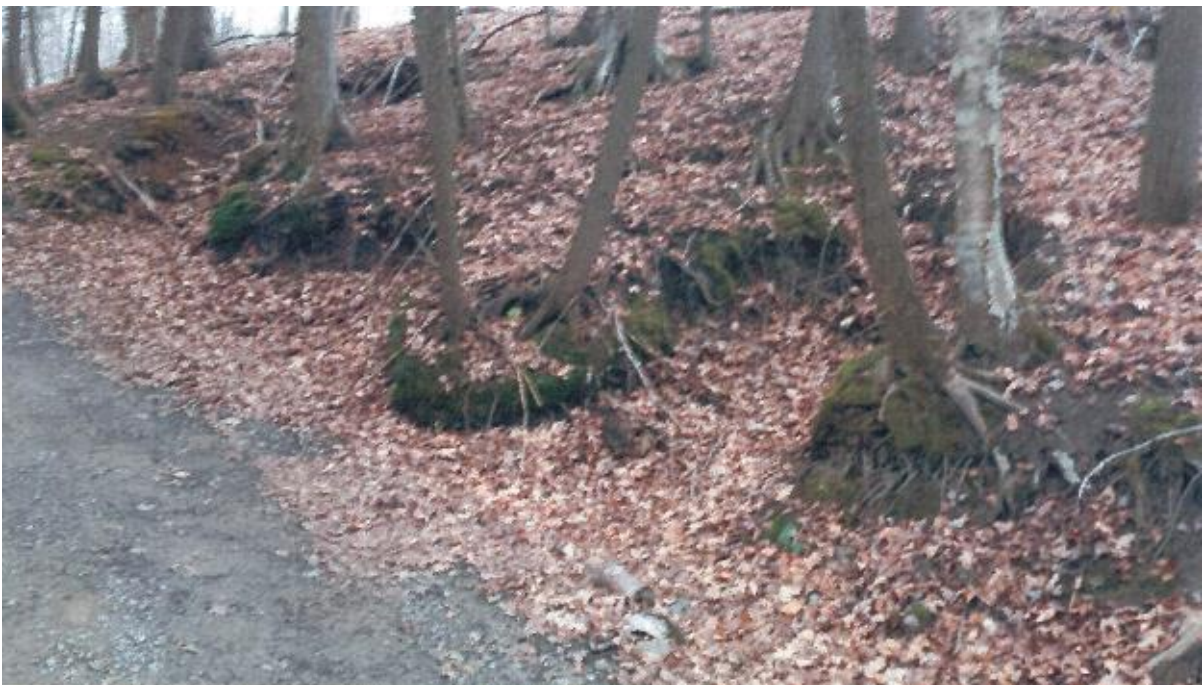
**Photo No. 10 – Erosion of cut uphill of pathway.
Cut approximately 20 m long x 0.4 m to 1.2 m high.**

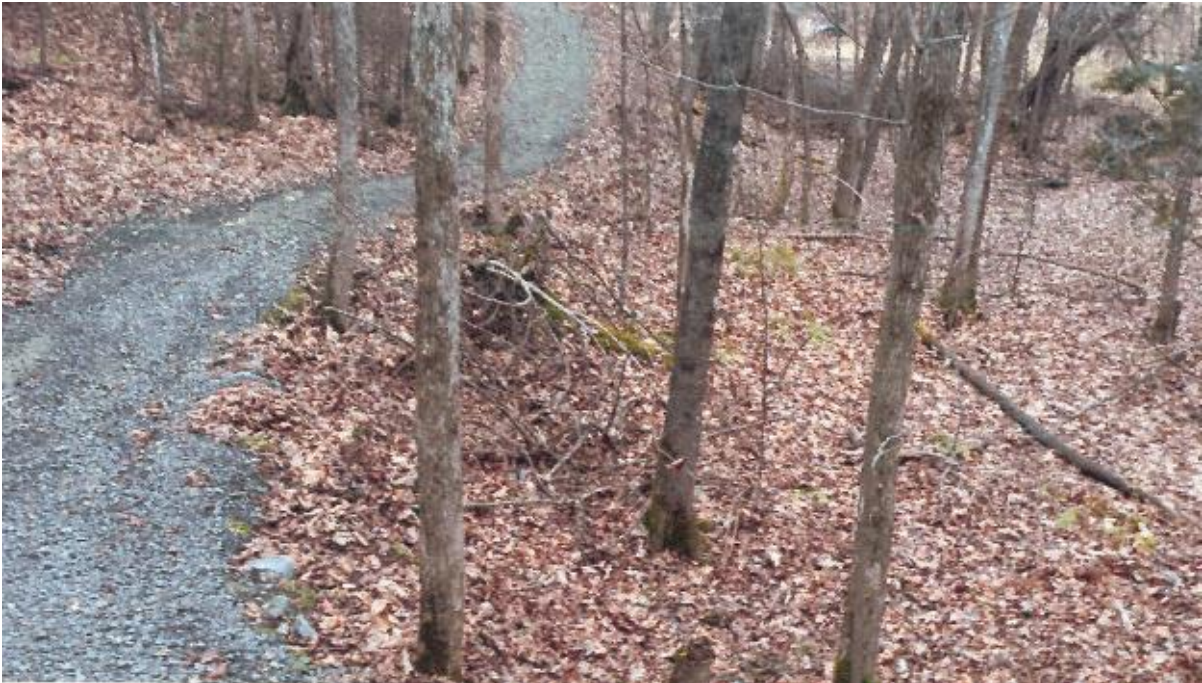
**Photo No. 20 – Deep cut downhill of pathway.
Cut approximately 12 m long x 0.5 m to 1 m high.**

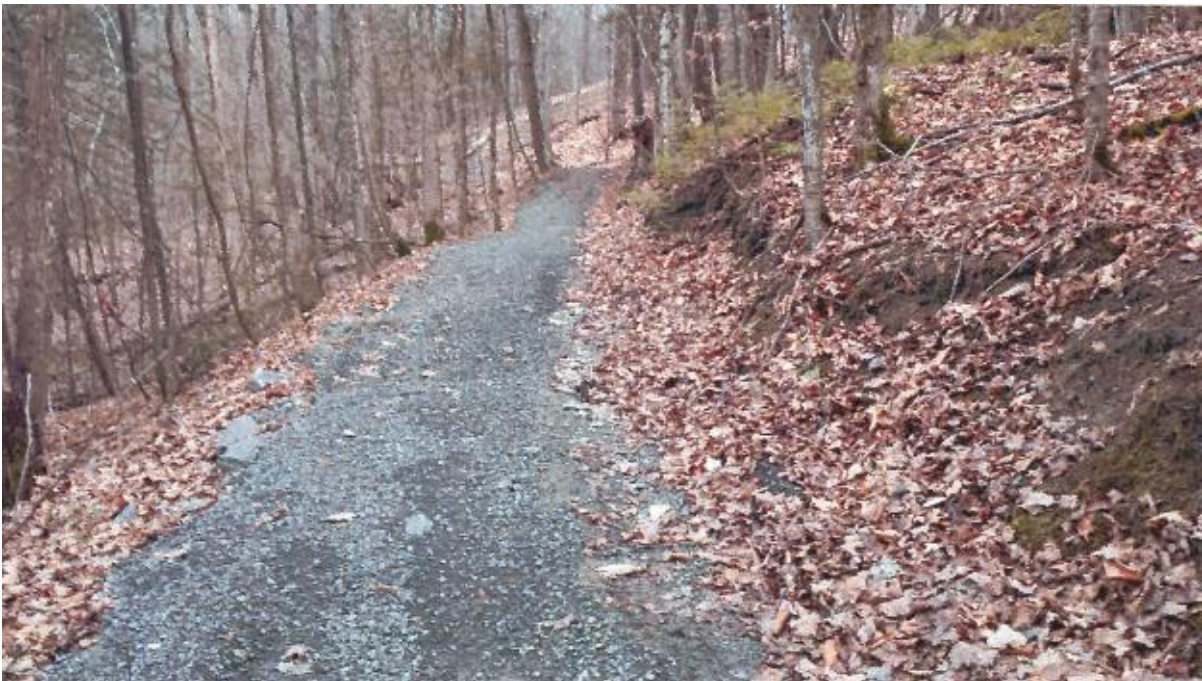
**Photo No. 21 – Erosion of cut above pathway.
Cut approximately 45 m long x 0.3 m to 0.8 m high.**

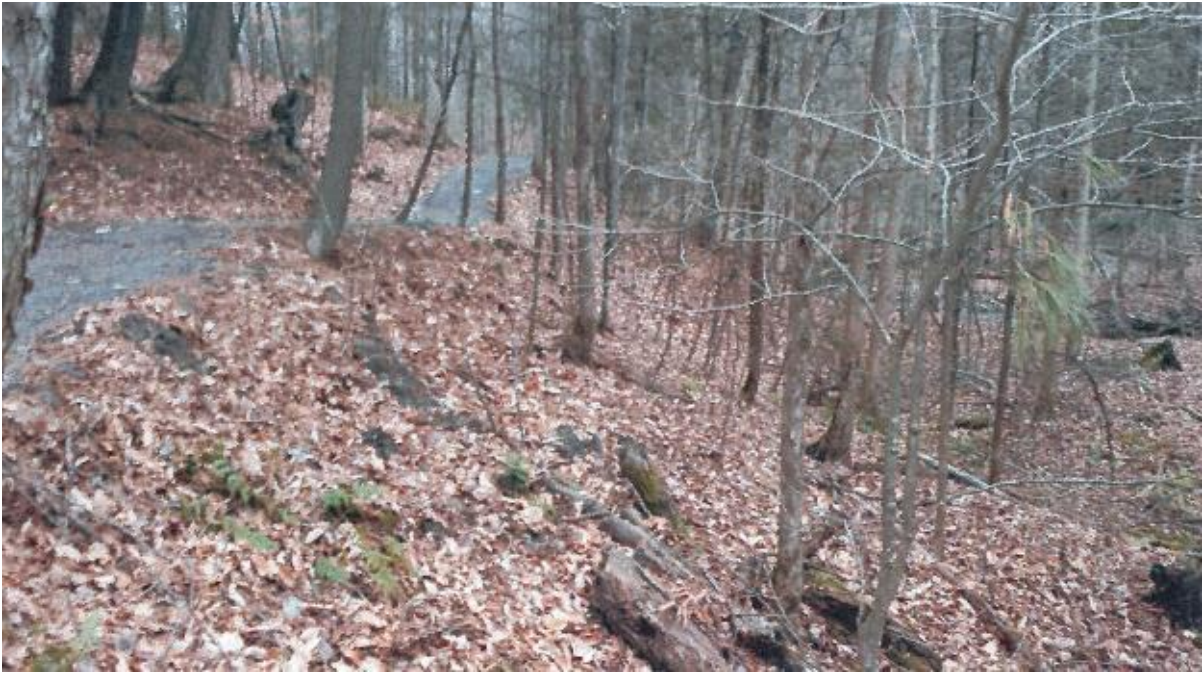
Photo No. 22 – Erosion below pathway. Cut approximately 30 m long x 0.5 to 2 m high.

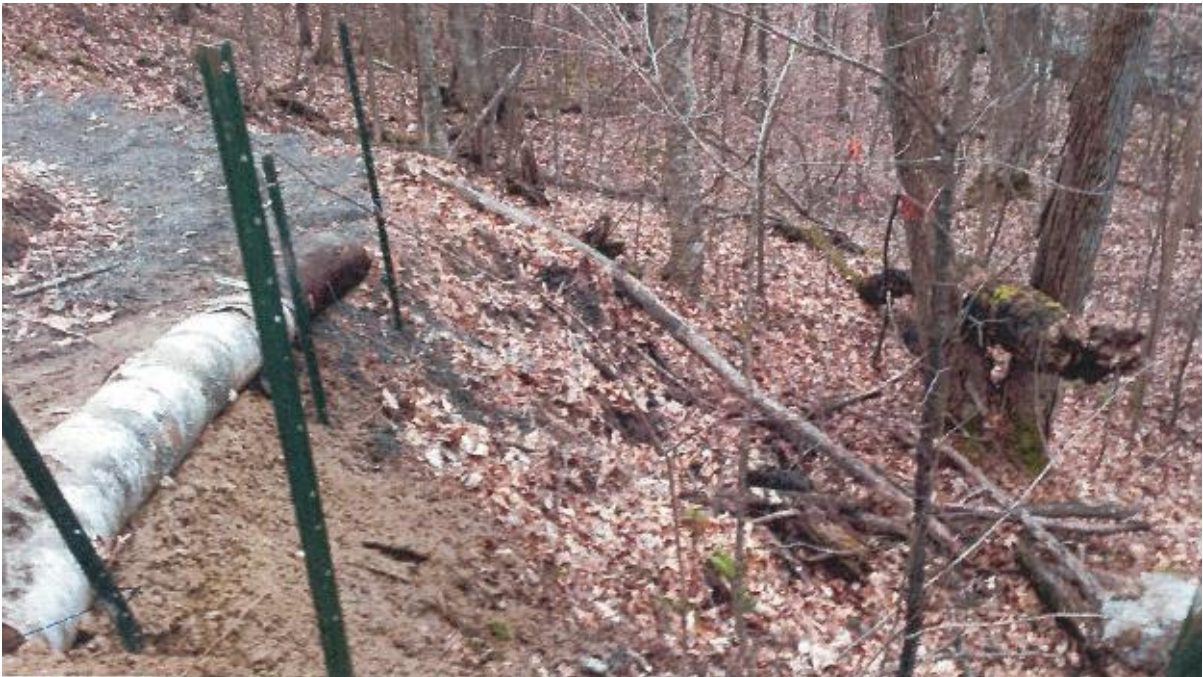
**Photo No. 23 – Erosion of slope downhill of pathway.
Area approximately 12 m long x 1.5 m to 2 m high.**
