December 16, 2022  
CO884.00

**Re: Designated Substances Survey  
5646 Manotick Main Street, Ottawa, Ontario**

Figure 1 Asbestos Sampling Location Plan

Figure 2 Paint Sampling Location Plan

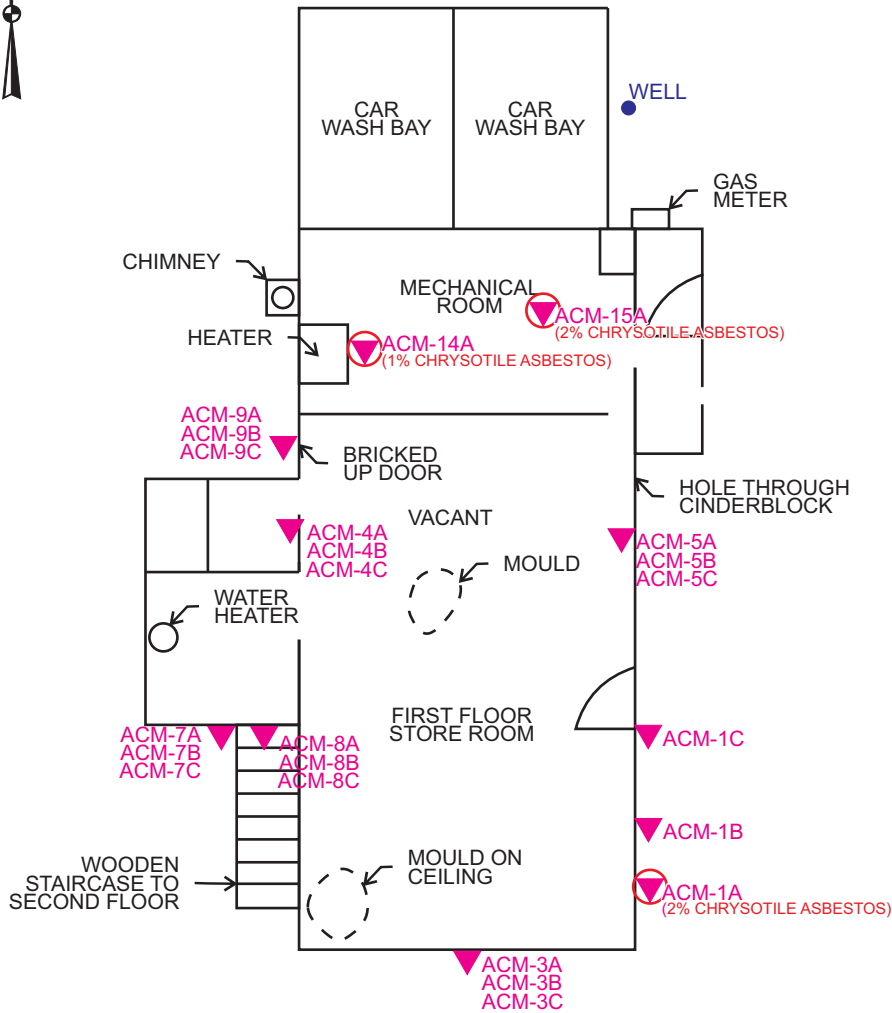
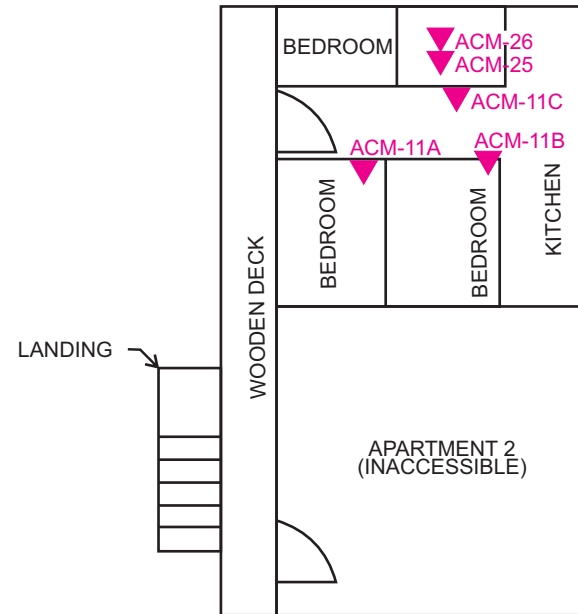
PROJECT #	CO884.00
SCALE	NOT TO SCALE
DATE	MARCH 2022
DRAWN	AB/SW
CHECKED	GS
DRAWING #	<b>FIGURE 1</b>

The locations of the potential ACM samples, material descriptions, approximate extent, and condition are summarized in Table 1 (attached). The locations of the samples are also shown on Figure 1 (attached). Laboratory Certificates of Analyses are attached.

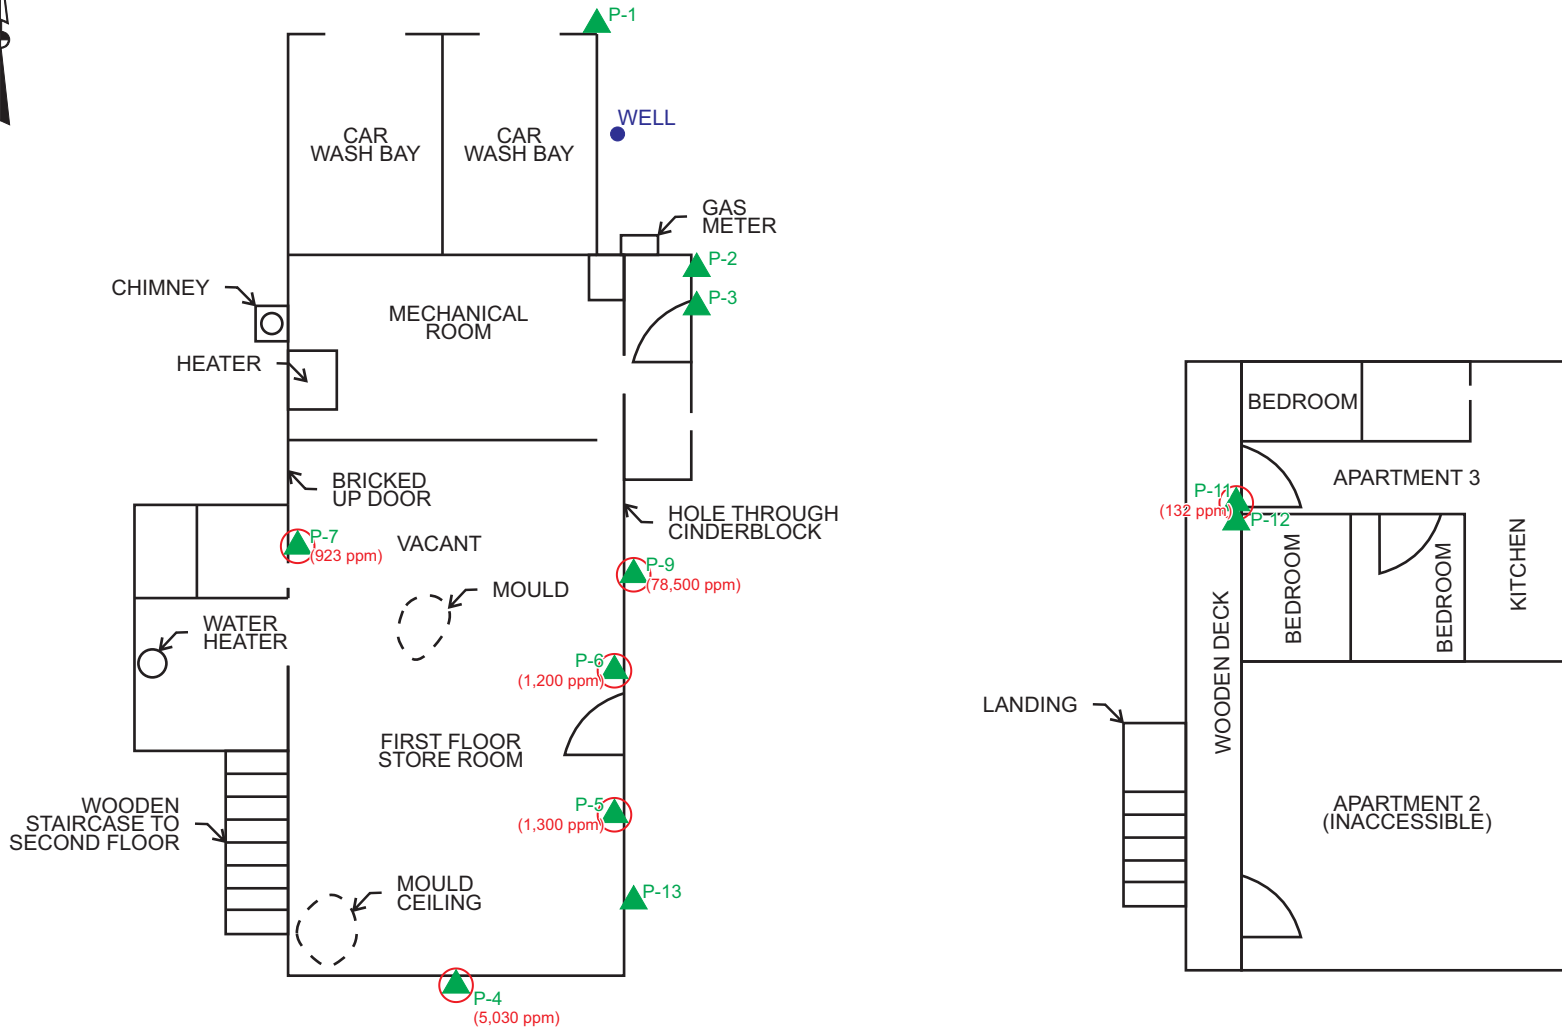
PROJECT #	CO884.00		
SCALE	NOT TO SCALE		
DATE	MARCH 2022		
DRAWN	AB/SW	CHECKED	GS
DRAWING #	FIGURE 2

Based upon the age of the building, lead may be present on painted surfaces and in piping. Twelve samples of paint (P-1 to P-7 and P-9 to P-13) from the building were collected and submitted for laboratory analysis of lead content. Lead in paint analysis was conducted using Inductively Coupled Plasma Mass Spectroscopy (ICP/MS) according to EPA method 6020. The sample locations, paint descriptions, approximate extent of the painted surfaces, and condition of the paint are summarized in Table 2 (attached). The locations of the paint samples are shown on Figure 2. Laboratory Certificates of Analyses are attached.

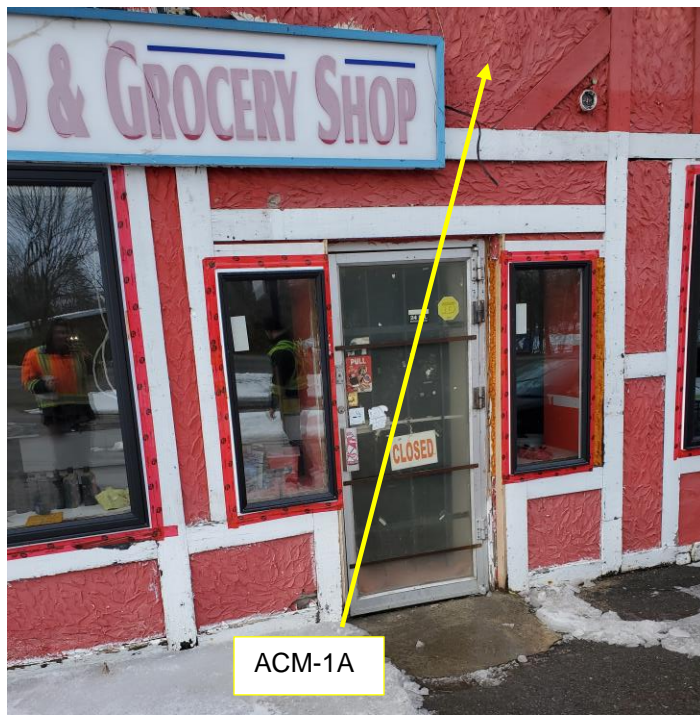
Photo No: 4

- ACM within the following building materials:
  - The red painted stucco present at the front exterior of the building (sample ACM-1A, non-friable, 2% Chrysotile asbestos, approximately 30 m<sup>2</sup> in area, fair to poor condition);

View of the stucco on the exterior of the building that was confirmed to be 2% chrysotile (AMCM-1A).

If any demolition, alteration or repair work that may result in disturbing ACM or potential ACM areas, a qualified asbestos abatement contractor should be retained for asbestos removal prior to undertaking the work. O. Reg. 278/05 defines three types of asbestos removal operations, which require different levels of protection, isolation and decontamination. Type 1 operations involve the lowest level of risk and include the removal of non-friable materials where the material is not damaged, or can be wetted and cut without power tools. Type 3 operations involve the highest level of risk, including removal of most types of friable materials, and require full enclosure of the area and construction of a decontamination area for workers and equipment, among other things.

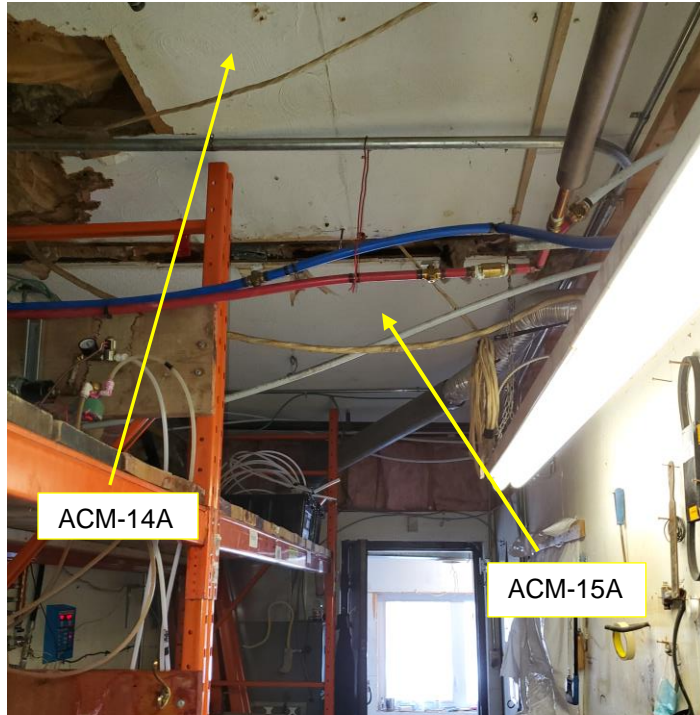
- Texture coating material on the ceiling of the carwash mechanical room the building, (sample ACM-14A, friable, 1% Chrysotile asbestos, approximately 4 m<sup>2</sup> in area, poor condition, and sample ACM-15A, friable, 2% Chrysotile asbestos, approximately 4 m<sup>2</sup> in area, poor condition); and,

A view of the texture coating of the ceiling in the mechanical room of the carwash (AMC-14A & ACM-15A).

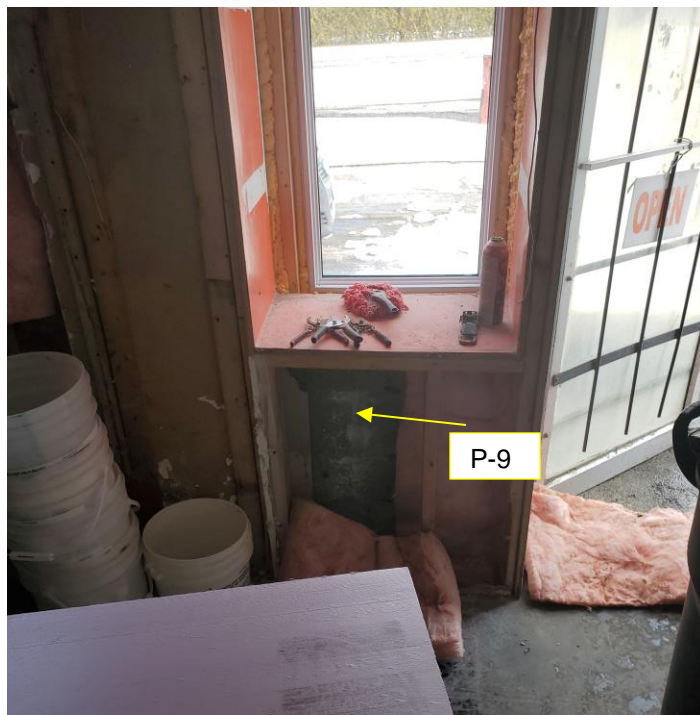
Photo No: 6

A view yellow-green paint (P-9) collected from the interior column of the first floor of the building.

Demolition and renovation contractors should ensure the use of appropriate personal protective equipment and proper dust control measures to protect themselves and the public from potential exposure by inhalation of silica dust or paint dust or chips.

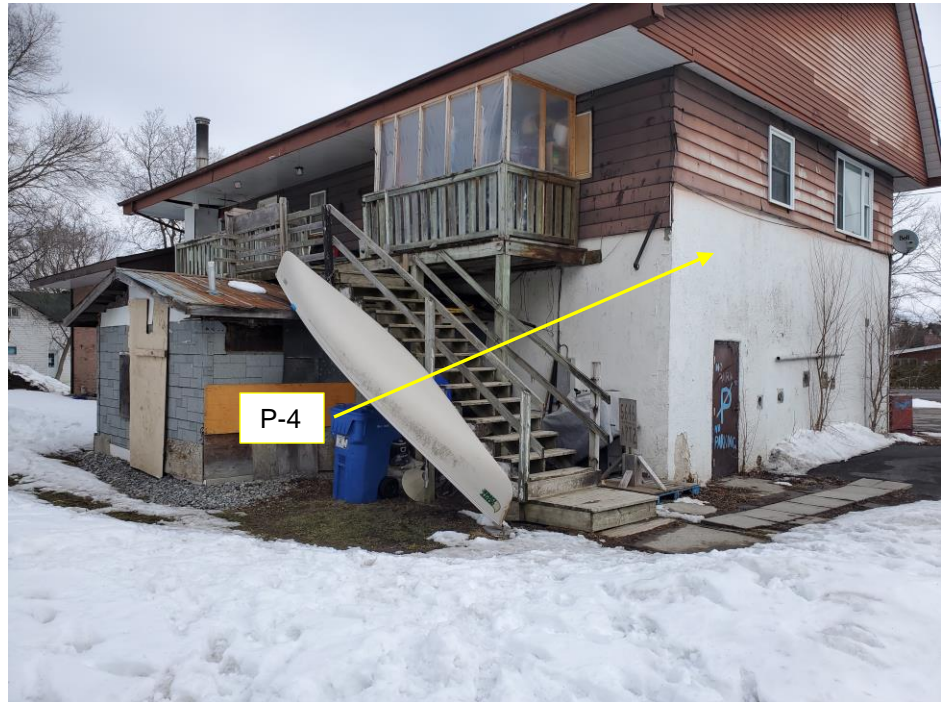
- the white paint (P-4) located on the exterior at the southern and western sides of the exterior;
- beige-brown paint (P-5) located on the first floor of the building;
- grey paint (P-6) located on first floor
- green paint (P-7) located on first floor
- yellow-green paint (P-9) located on first floor
- white paint (P-11) located on wood siding on exterior of building.

A view of exterior and side of the building. The white paint is where paint sample P-4 was collected.

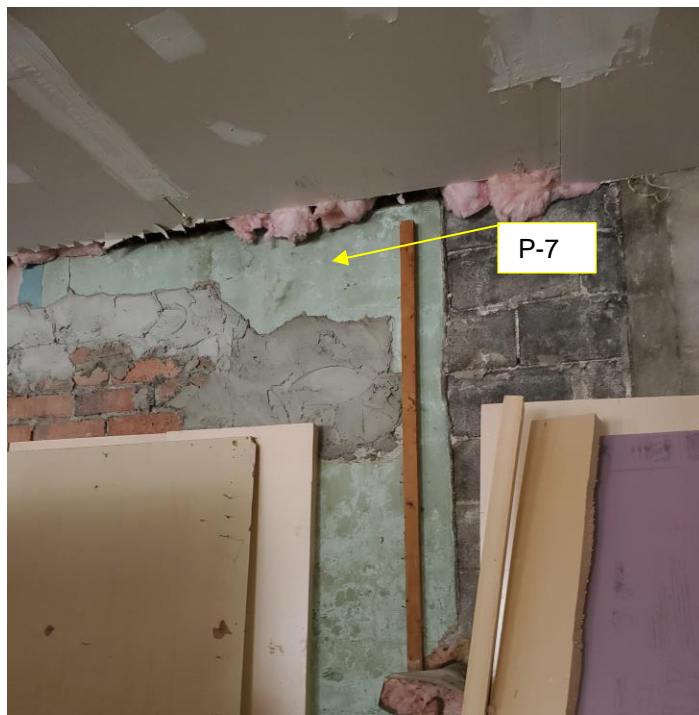
Photo No: 8

A view of the green paint (P-7) located in the first floor of the building.

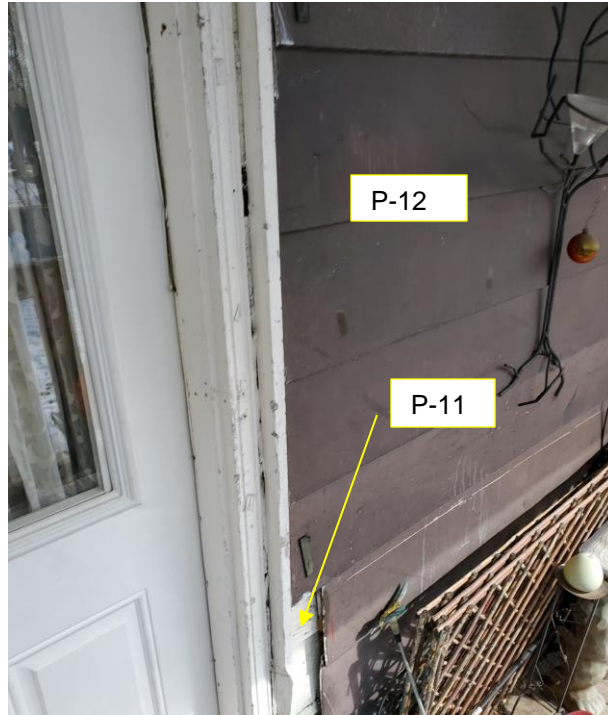
A view of white paint (P-11) and brown paint (P-12) collected from the exterior of the second story of the building.

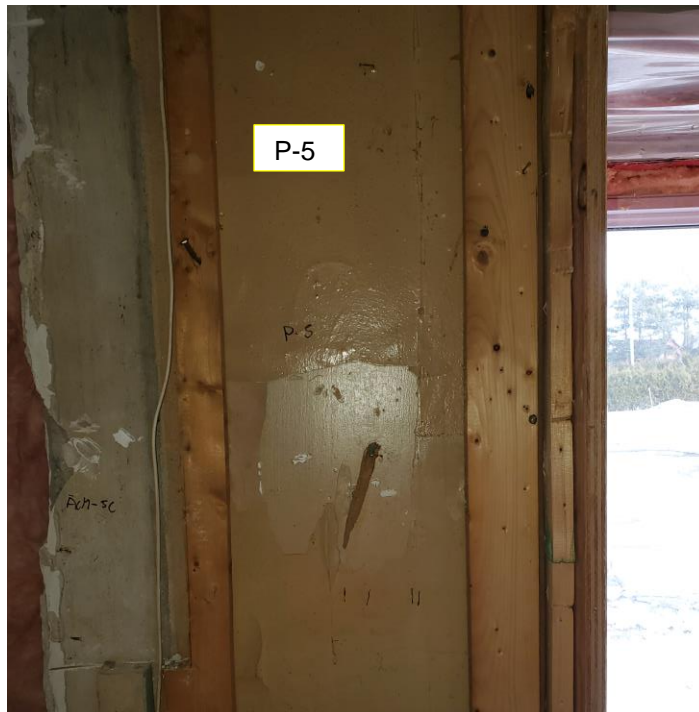
**Photo No:** 10

A view of beige-brown paint (P-5) collected from the interior of the building.

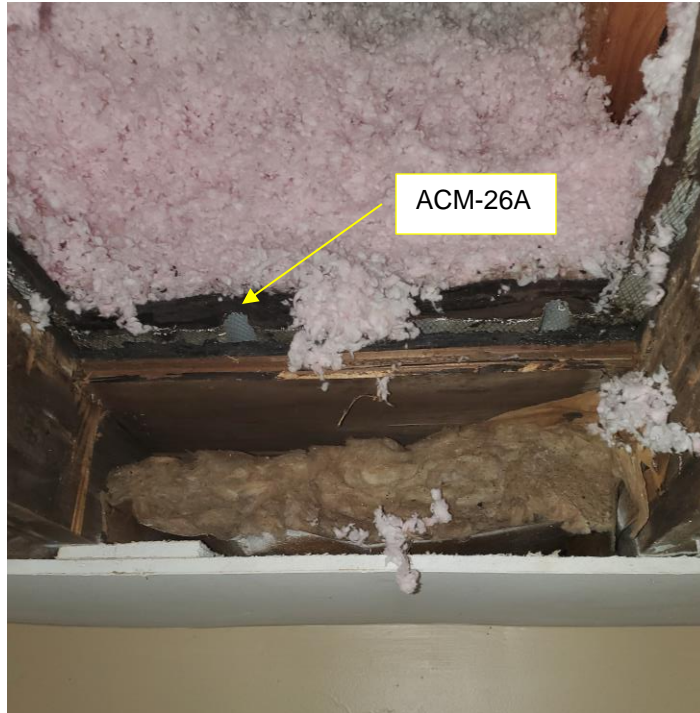
A view of insulation material in the attic of the main building.
