TREE CONSERVATION  
REPORT V2.0  
1983 Carling Ave

Tree Conservation Report submitted as Partial  
Requirements for a Site Plan Control Application

March 29, 2023

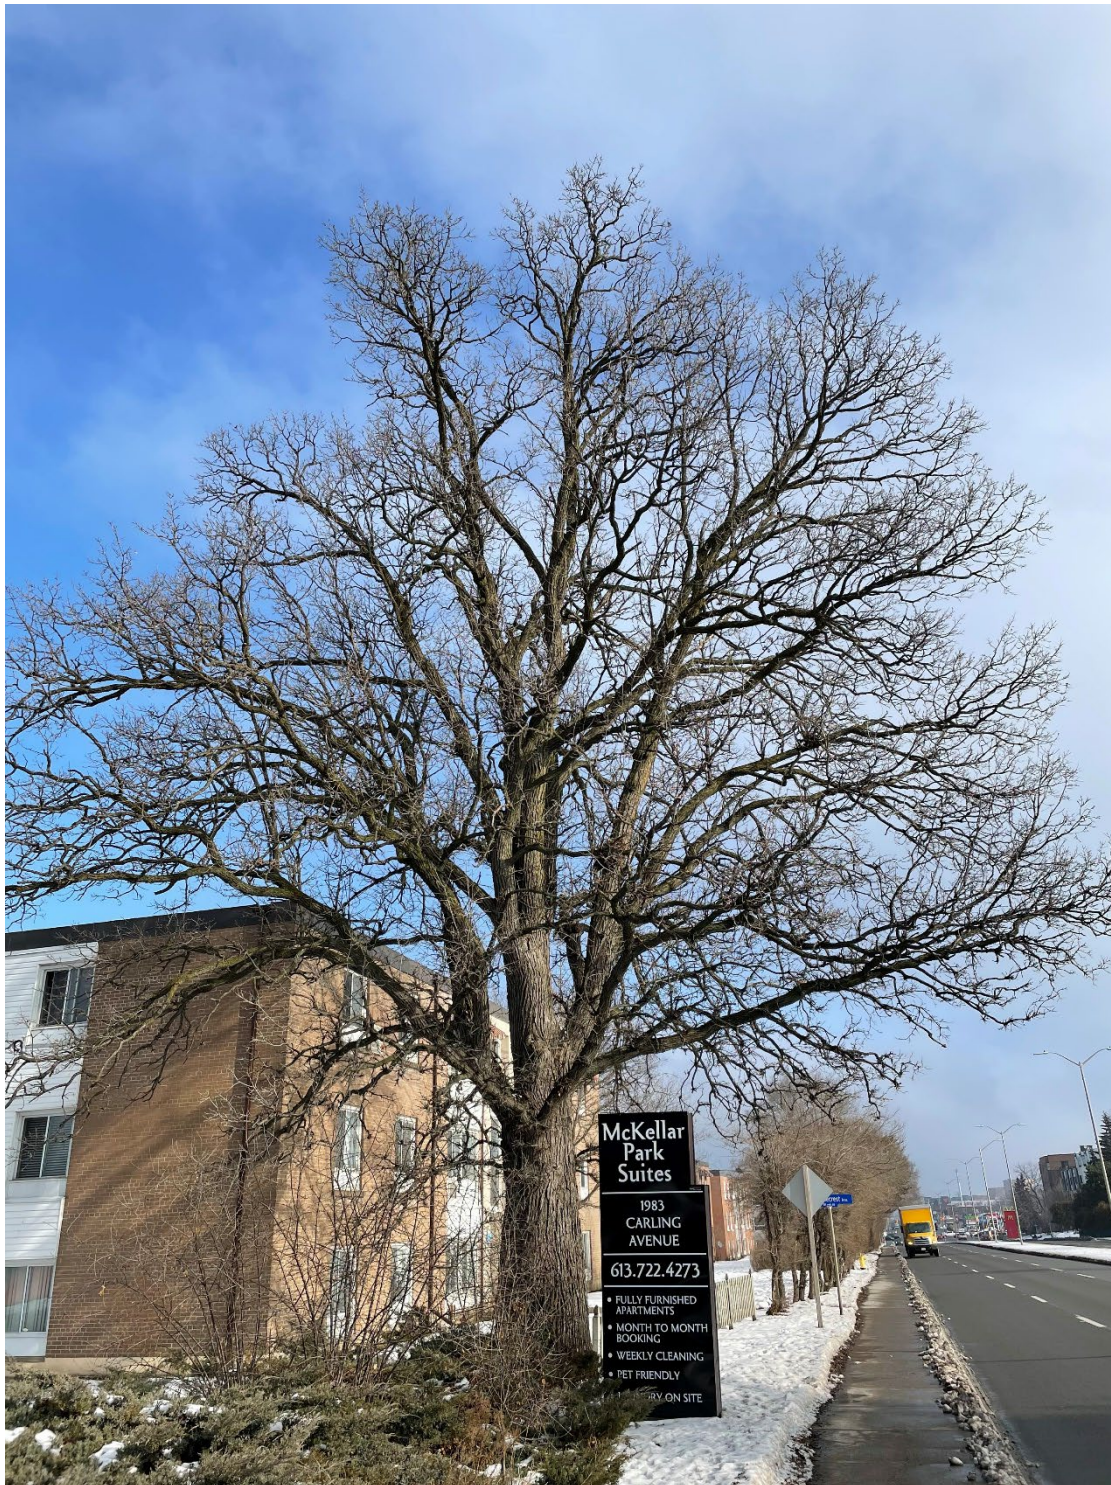
The large bur oak located close to the sidewalk and along Carling Avenue is the tree of concern that will be most impacted by the proposed development. This tree has a diameter of 111 cm, and its root system likely extends at least 11 m in all directions, except for where there is infrastructure such as the road and building. Although the tree appears in good health, it does have some health concerns to note. The crown is extensive, but since this tree is overhanging a major thoroughfare, it has been damaged by salt spray which is visible along the south side. Also, there is a large cavity at the base of the tree that measures 80 cm long; 15 cm wide; and 40 cm deep. A metal rod was inserted and extended past the cavity wall an additional 30 cm. Therefore, the decay and cavity extend 70 m into the trunk at the widest point. The extent of decay is over 1 m up the tree in the centre of the decay column – the 1 m rod did not reach the end. These observations on decay were made using tools for a basic assessment. To understand better the extent of internal decay in this tree, a Level 3 risk assessment would be required using an advanced technique such as sonic topography or resistance drilling. These tools can map out the decay in the stem at different heights up the trunk and are relatively non-invasive. Combining these results with a good understanding of the dynamics of how internal decay impacts large oak trees would help to assess the structural integrity of the tree. Although extensive decay can give the impression of structural weakness, this may not always be the case. Trees can learn to adapt to weaknesses by refocusing their growth on strengthening their stem and reducing the crown weight naturally.

Figure 1: Large bur oak along Carling, facing east

The intent of this development is to work around and retain the existing bur oak tree (tree#1). Excavation for the new building will extend well into the critical root zone and may impact the structural integrity of the tree. It is recommended that a certified arborist prune the roots ahead of excavation to ensure that a clean cut that offers the tree a better chance of sealing the wound properly. At the time of root cutting, the arborist should inspect the roots to ensure that no key stabilizing roots are being severed that would increase the risk of failure of this tree.

The walkway around the tree will be built above grade and will limit the requirement to sever any roots be severed. Furthermore, any grading within the critical should be limited to additions of no more than 10 cm, and no soil is to be placed against the tree trunk.

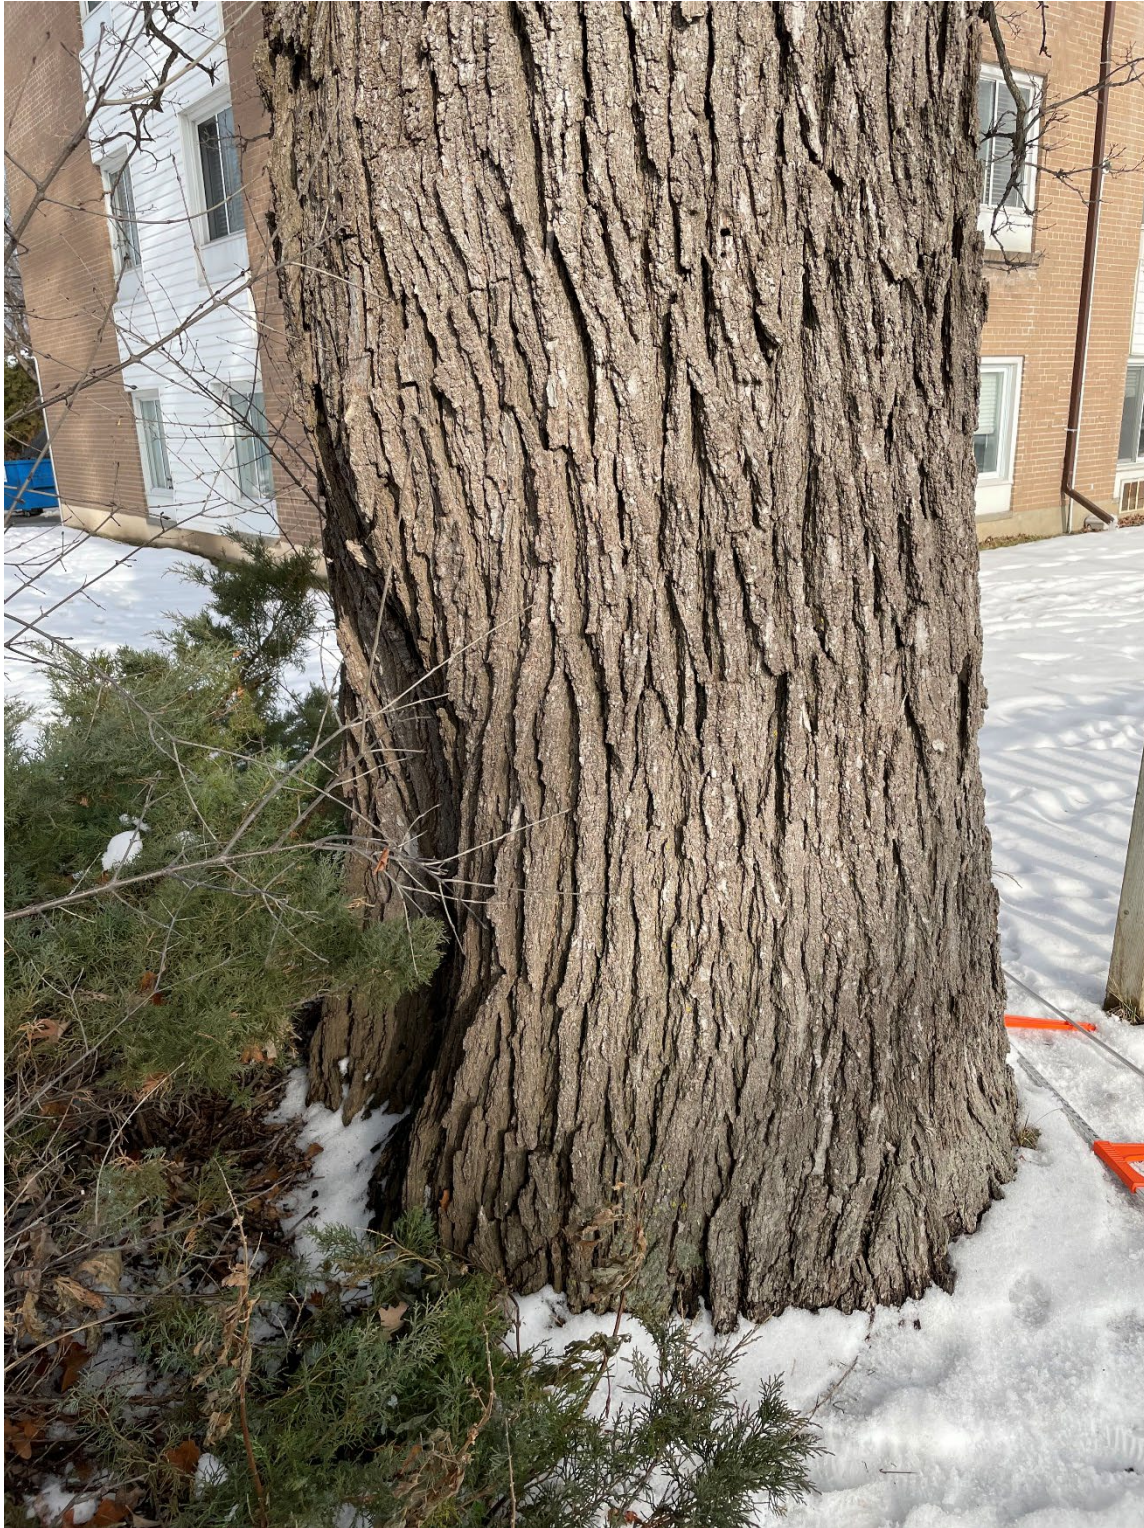
Figure 2: Wound at base of trunk along the west side

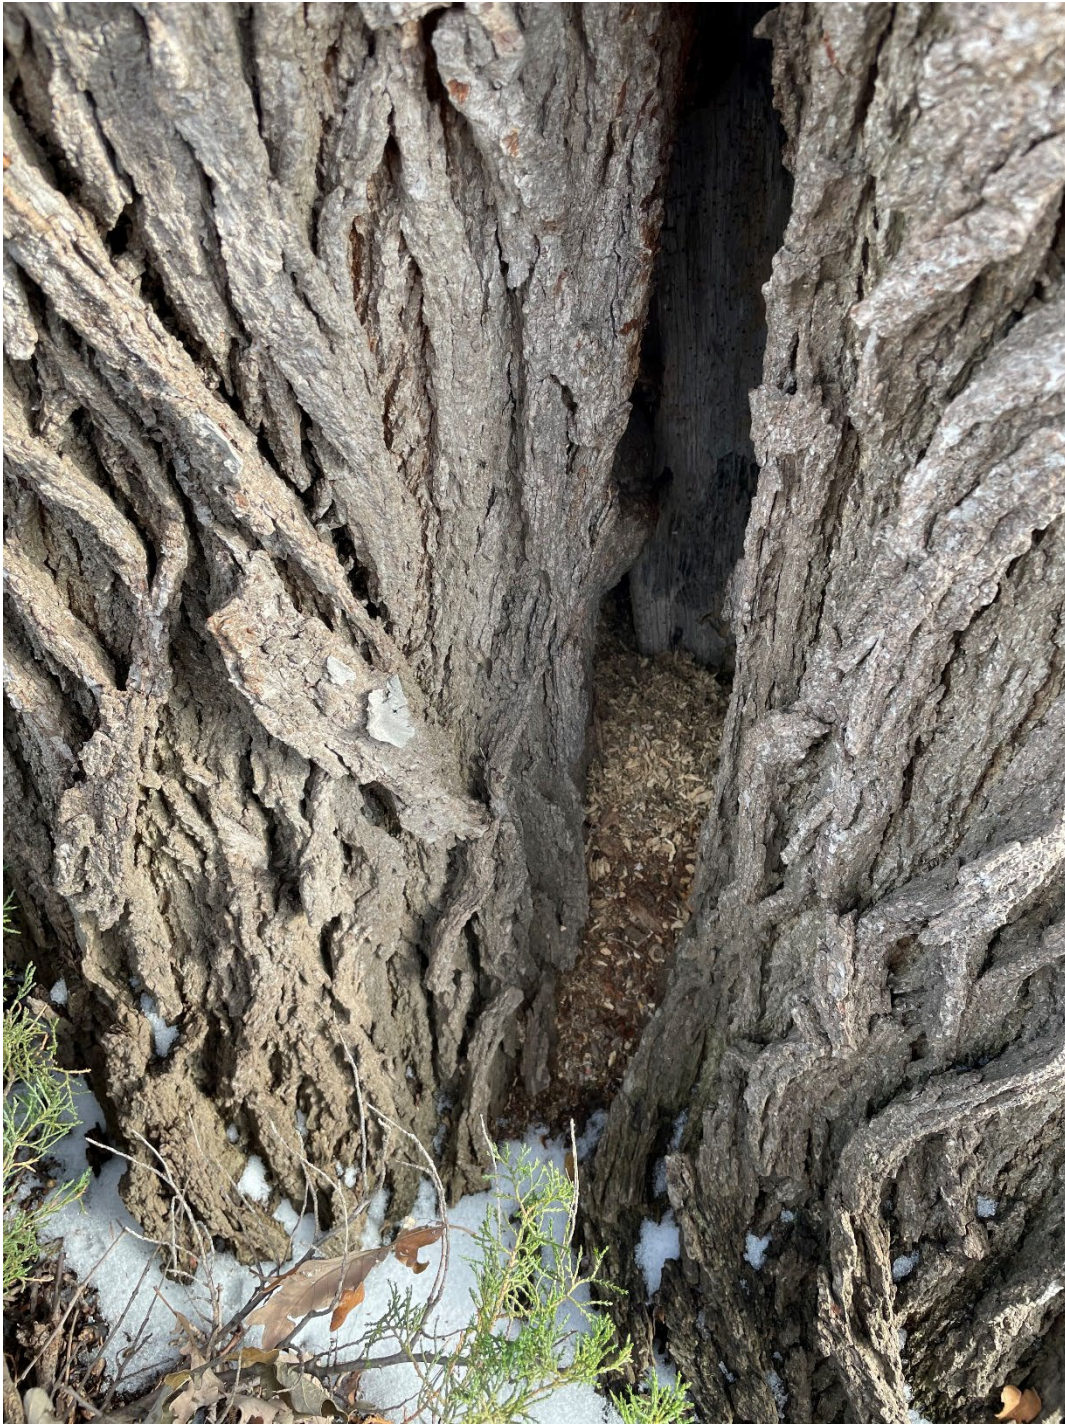
Figure 3: Picture showing cavity. Decay and cavity extend 70 cm into tree

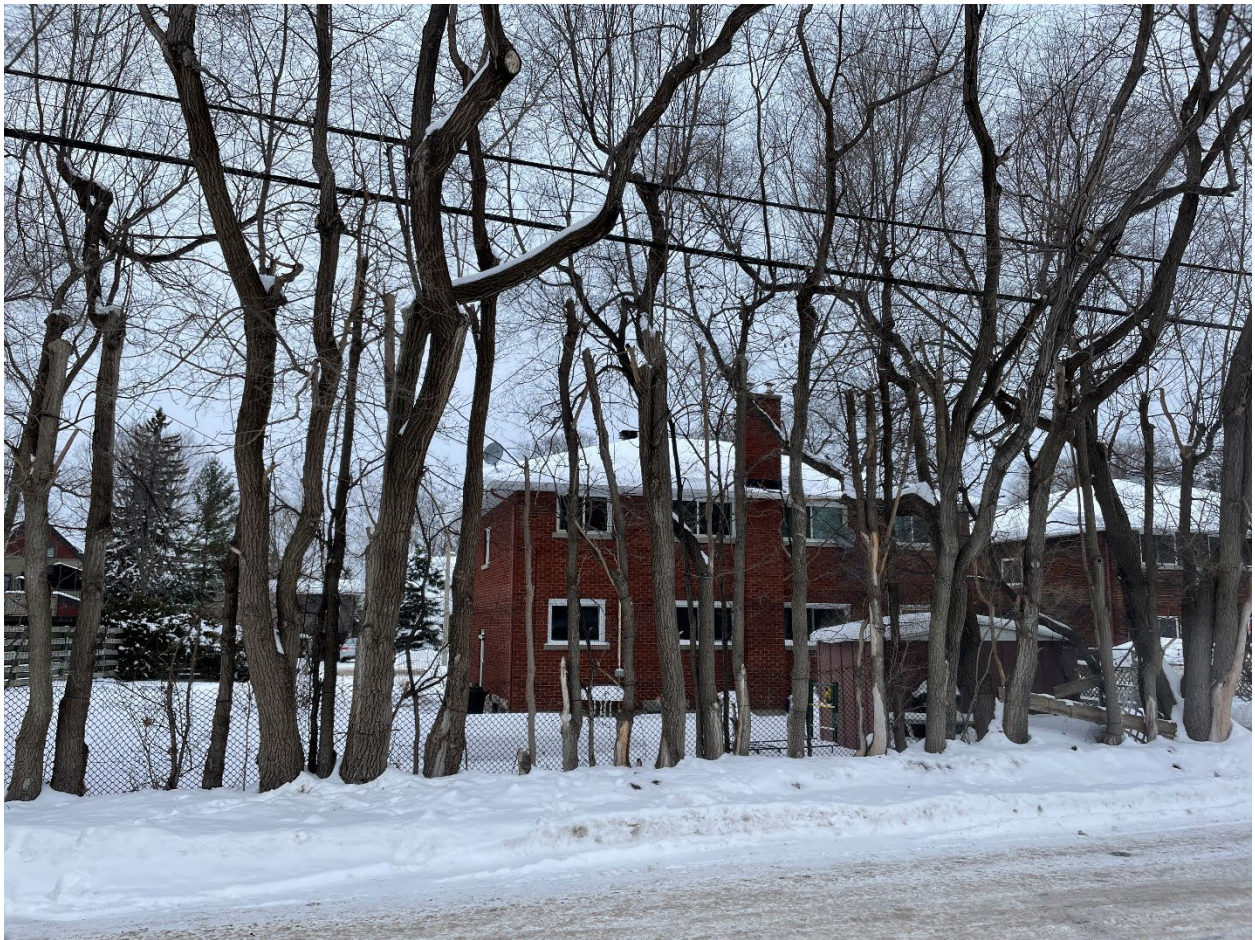
Figure 4: Trees grouping #9 - Siberian elm along northern property line under hydro – to be retained

Because the area is covered in asphalt, no tree protective fencing is required during site works. However, the following mitigation measures should be applied when replacing the asphalt and installing the subdrain:

- Avoid tearing of the roots. If the roots do tear, they should be pruned with a clean cut to increase the likelihood of sealing properly and reduce the risk of pathogens from entering the tree.
- Roots should not be left exposed and be covered with soil as quickly as possible, or temporarily with a moist, organic material such as mulch and/or burlap

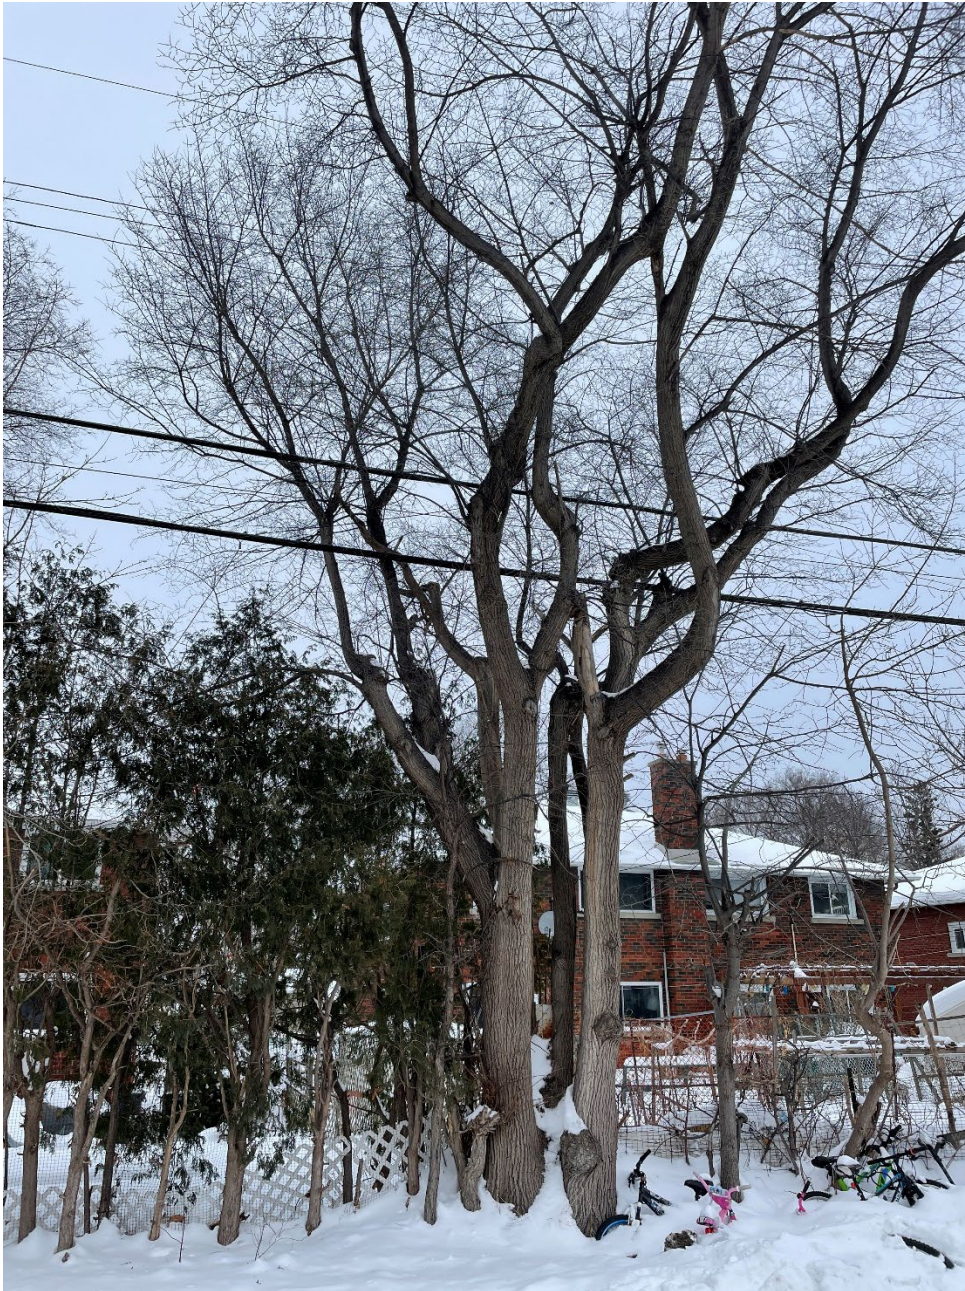
Figure 5: Tree 8, Siberian elm to be retained

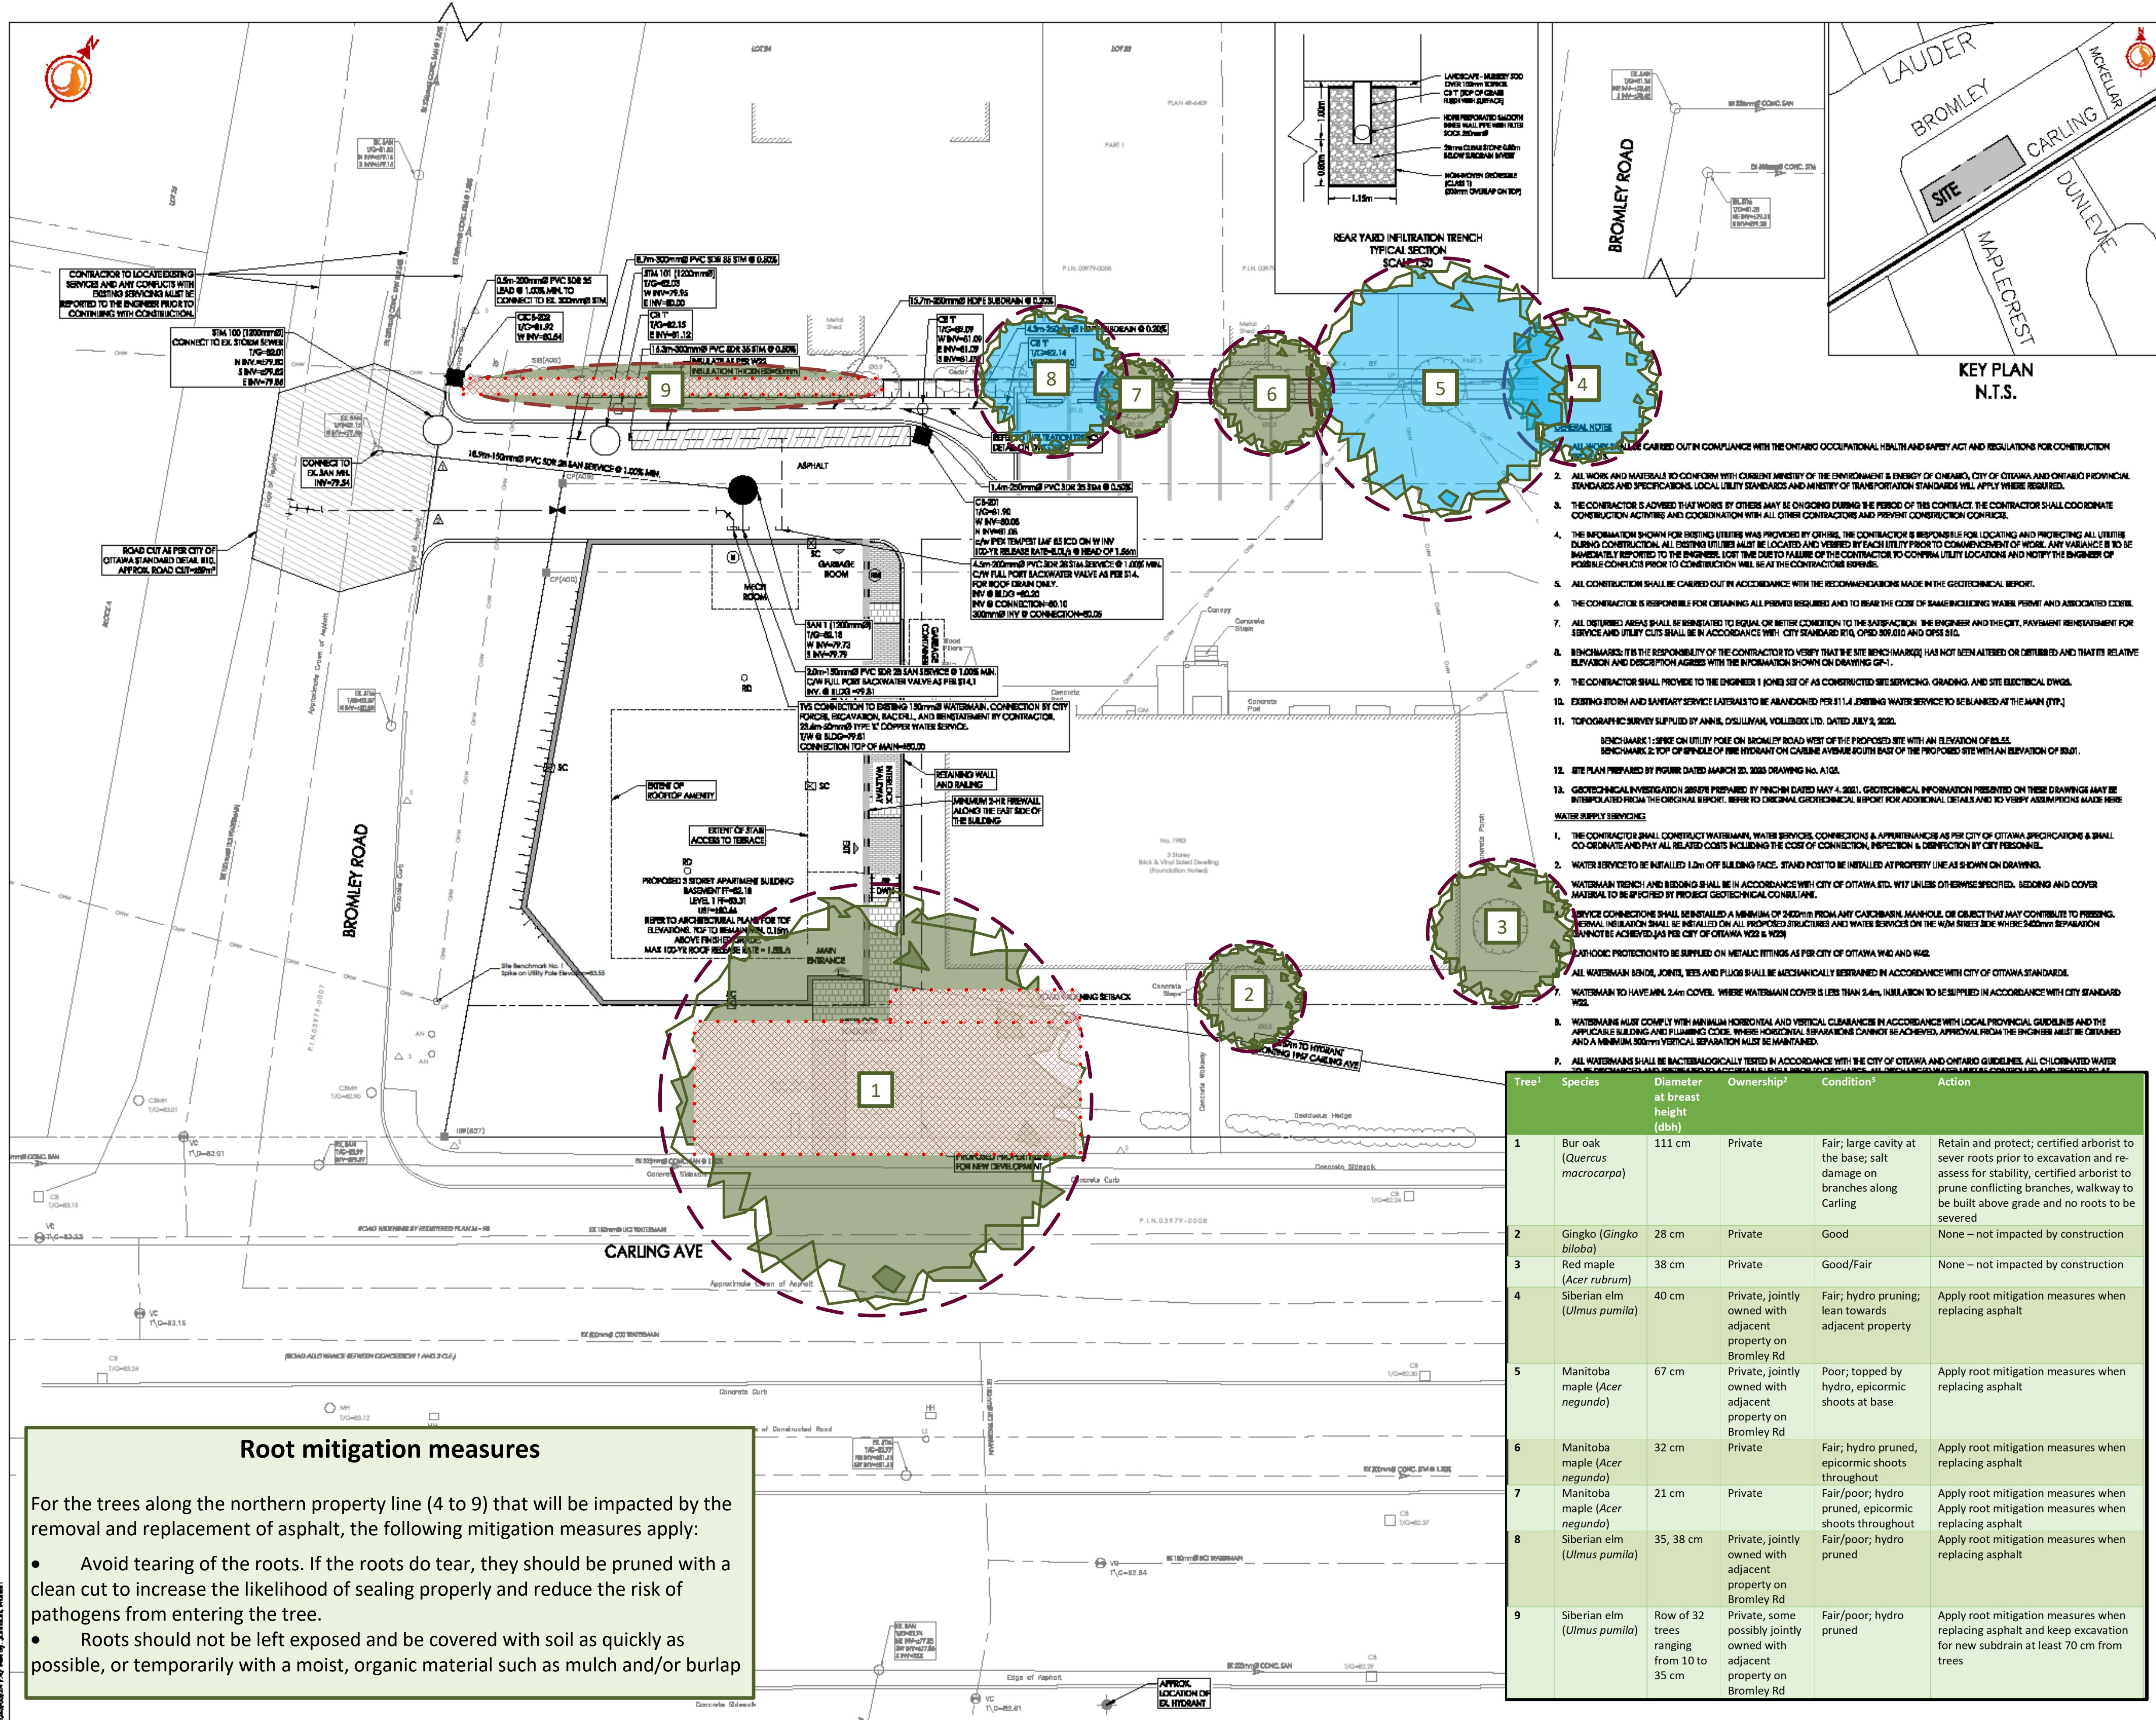
Tree Conservation Report – 1983 Carling Ave  
Proposed Development and Conserved Vegetation (site servicing)  
Tree layer prepared by Dendron Forestry Services  
Version 2.0, March 29, 2023  
For more information, please contact info@dendronforestry.ca

Tree #	Species	Diameter at breast height (dbh)	Ownership	Condition	Action
1	Bur oak ( <i>Quercus macrocarpa</i> )	111 cm	Private	Fair; large cavity at the base; salt damage on branches along Carling	Retain and protect; certified arborist to sever roots prior to excavation and reassess for stability, certified arborist to prune conflicting branches, walkway to be built above grade and no roots to be severed
2	Ginkgo ( <i>Ginkgo biloba</i> )	28 cm	Private	Good	None - not impacted by construction
3	Red maple ( <i>Acer rubrum</i> )	38 cm	Private	Good/Fair	None - not impacted by construction
4	Siberian elm ( <i>Ulmus pumila</i> )	40 cm	Private, jointly owned with adjacent property on Bromley Rd	Fair; hydro pruning; lean towards adjacent property	Apply root mitigation measures when replacing asphalt
5	Manitoba maple ( <i>Acer negundo</i> )	67 cm	Private, jointly owned with adjacent property on Bromley Rd	Poor; topped by hydro, epicormic shoots at base	Apply root mitigation measures when replacing asphalt

6	Manitoba maple ( <i>Acer negundo</i> )	32 cm	Private	Fair; hydro pruned, epicormic shoots throughout	Apply root mitigation measures when replacing asphalt
7	Manitoba maple ( <i>Acer negundo</i> )	21 cm	Private	Fair/poor; hydro pruned, epicormic shoots throughout	Apply root mitigation measures when replacing asphalt
8	Siberian elm ( <i>Ulmus pumila</i> )	35, 38 cm	Private, jointly owned with adjacent property on Bromley Rd	Fair/poor; hydro pruned	Apply root mitigation measures when replacing asphalt
9	Siberian elm ( <i>Ulmus pumila</i> )	Row of 32 trees ranging from 10 to 35 cm	Private, some possibly jointly owned with adjacent property on Bromley Rd	Fair/poor; hydro pruned	Apply root mitigation measures when replacing asphalt and keep excavation for new subdrain at least 70 cm from trees

For the trees along the northern property line (4 to 9) that will be impacted by the removal and replacement of asphalt, the following mitigation measures apply:

- Avoid tearing of the roots. If the roots do tear, they should be pruned with a clean cut to increase the likelihood of sealing properly and reduce the risk of pathogens from entering the tree.
- Roots should not be left exposed and be covered with soil as quickly as possible, or temporarily with a moist, organic material such as mulch and/or burlap
