URBAN FORESTRY & FOREST MANAGEMENT CONSULTING

June 21, 2023

RE: TREE CONSERVATION REPORT FOR 1919 RIVERSIDE DRIVE, OTTAWA

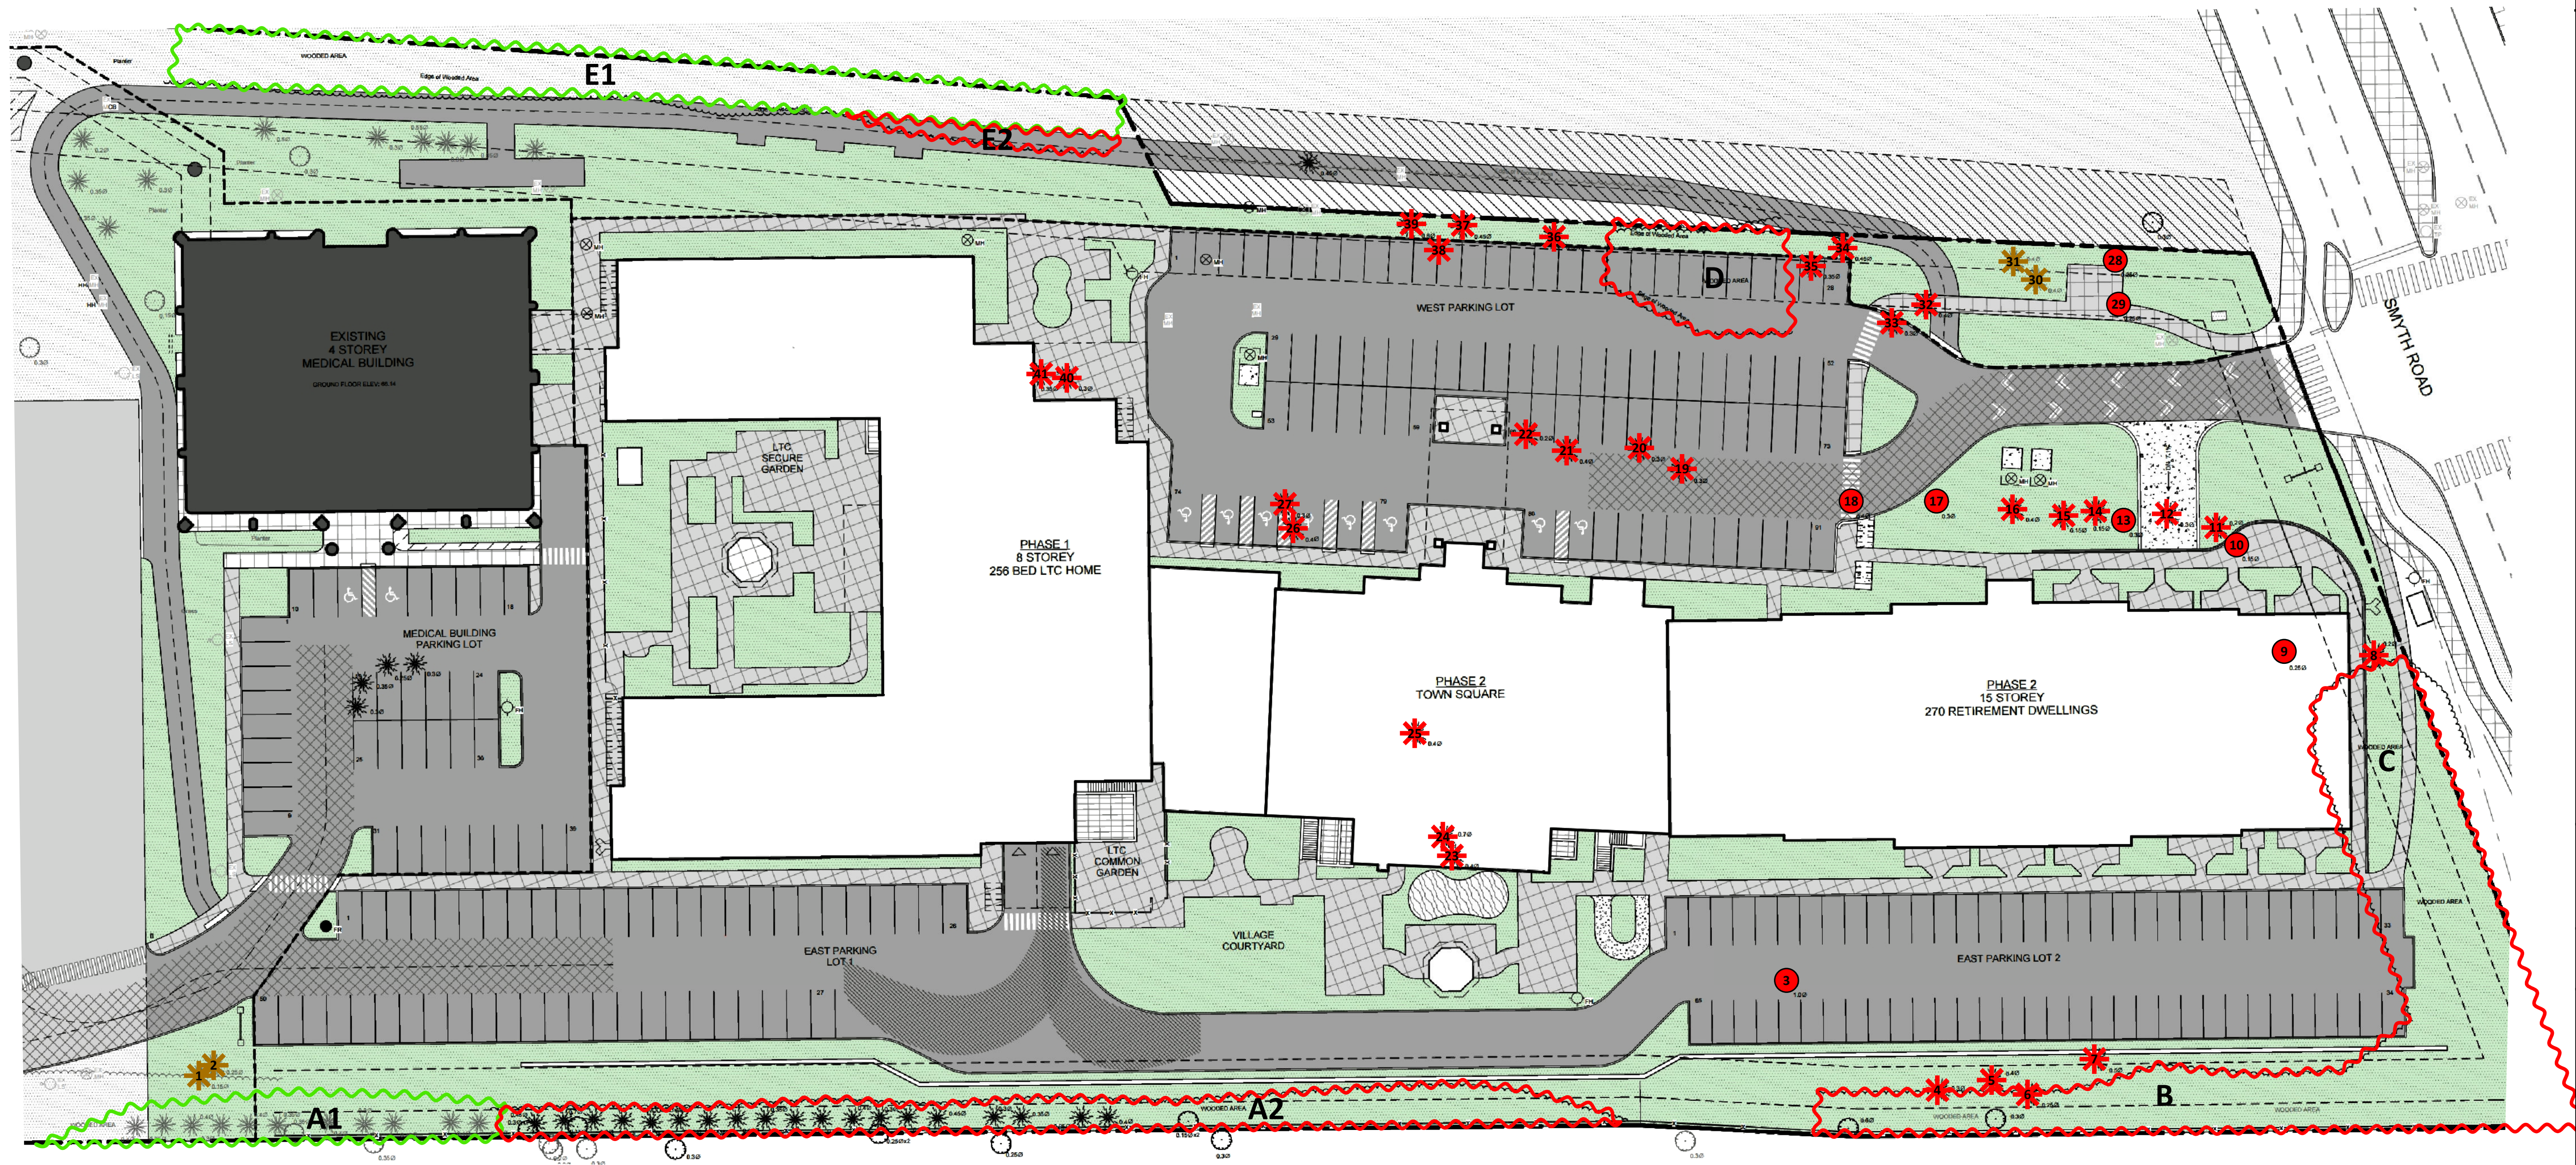
DRAWING: Tree Conservation Plan

Under the current site plan few existing trees can be retained as building layouts, excavation for the below grade parking and the necessary grade changes associated with this work will impact the entire property. A proposed crash wall along the eastern property line will result in the loss of most of the planted trees there as well. Field work for this report was completed in September 2020.

1. As per the City of Ottawa's tree protection barrier specification, erect a fence as close as possible to the CRZ of each tree (see City of Ottawa Tree Protection Barrier specifications on page 10).
2. Do not place any material or equipment within the CRZ of the tree;
3. Do not attach any signs, notices or posters to any tree;
4. Do not raise or lower the existing grade within the CRZ without approval;
5. Tunnel or bore when digging within the CRZ of a tree;
6. Do not damage the root system, trunk or branches of any tree;
7. Ensure that exhaust fumes from all equipment are NOT directed towards any tree's canopy.

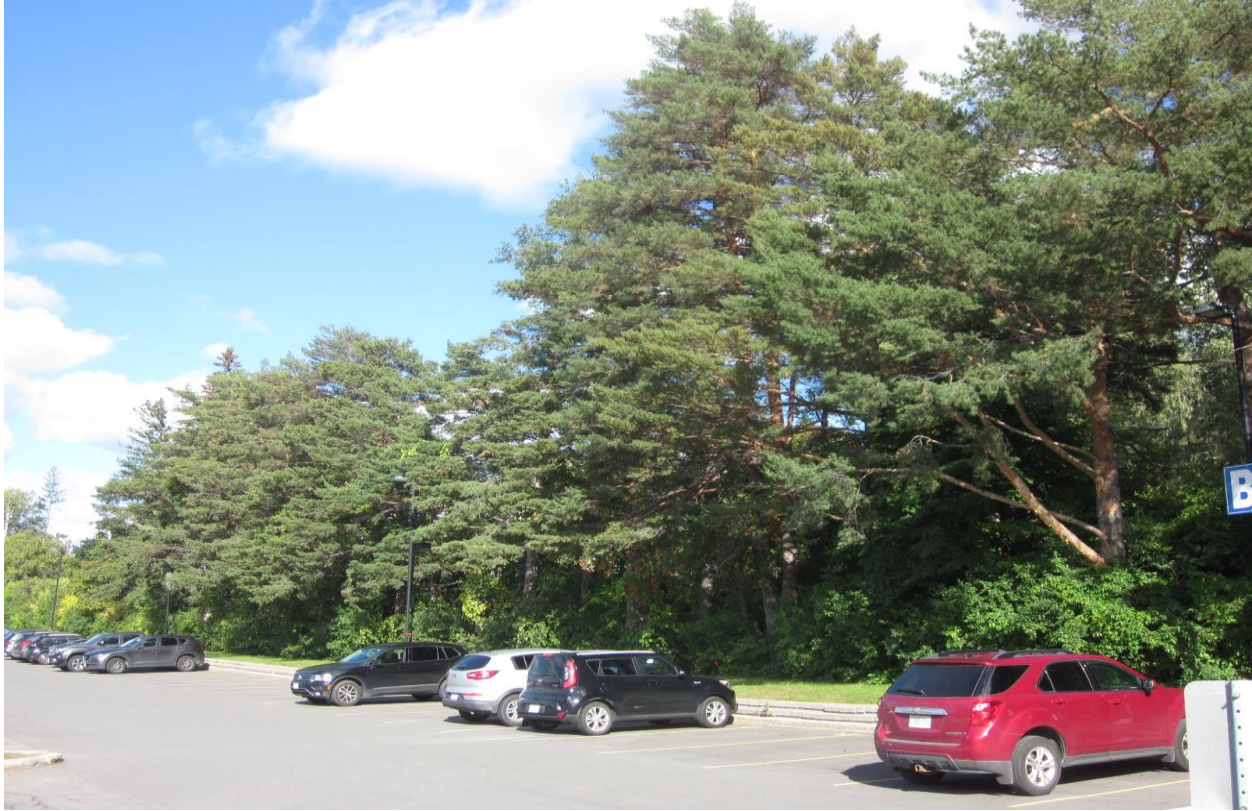
Tree grouping A2: A line of fourteen mature Scots pine and five mature white spruce **to be removed** due to conflicts with the proposed crash wall. All of these trees would have been planted. Generally they are in good condition – upright with good crown densities, growth increments and needle colour. Their crowns are held high above the understory and are often asymmetric towards the northwest due to intercompetition between trees. The understory is primarily introduced invasive buckthorn (*Rhamnus* spp.) and Norway maple (*Acer platanoides*) with scattered mountain-ash (*Sorbus* spp.), hawthorn (*Crataegus* spp.), bur oak and ash (*Fraxinus* spp.) – all of which are native species. All ash remaining on the property are either now dead or heavily infested with emerald ash borer (*Agrilus planipennis*).

Picture 1. Portion of tree grouping A2 at 1919 Riverside Drive

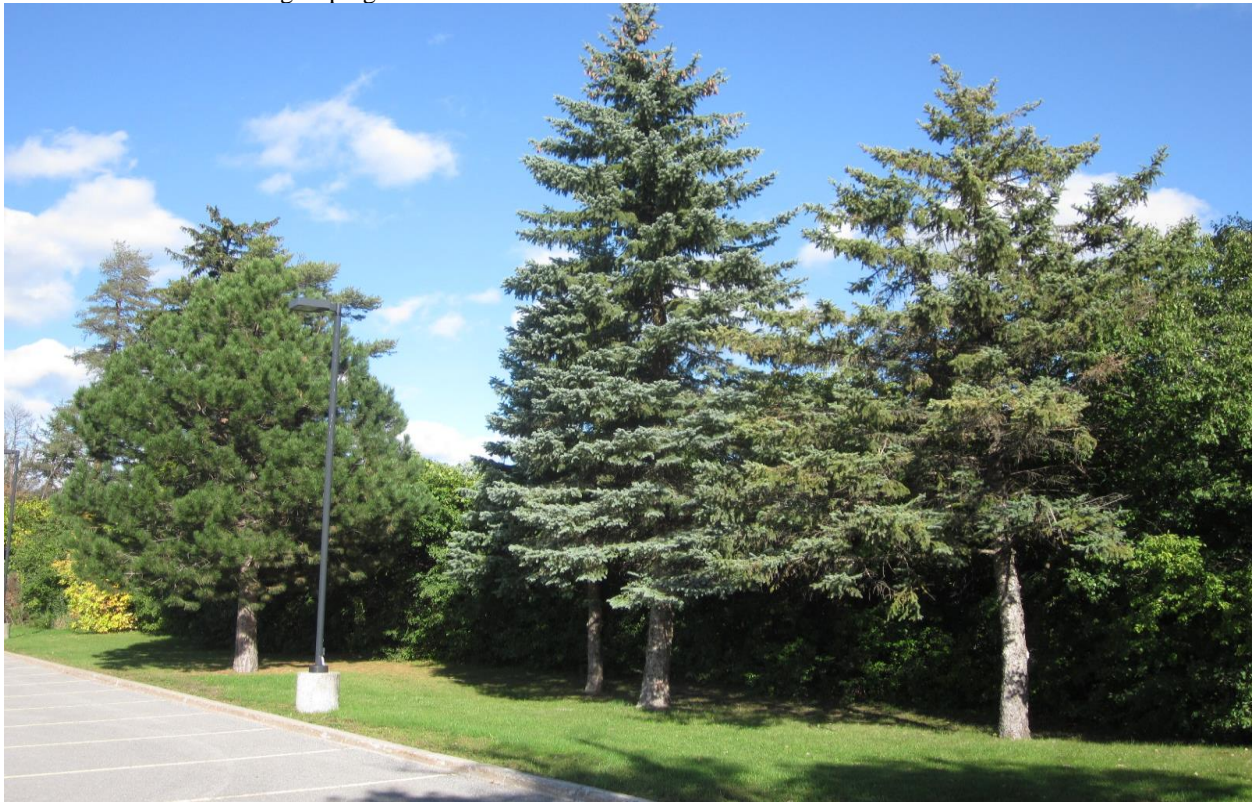
5	Colorado spruce	Very good	36.4	Mature; lower crown asymmetric; very good density, increment and colour; introduced species; to be removed
6	Colorado spruce	Good	24.7	Mature; lower crown asymmetric; good density, increment and colour; introduced species; to be removed
7	Austrian pine	Very good	40.9	Mature; very good density, increment and colour; introduced species; to be removed
8	European larch (<i>Larix decidua</i>)	Fair	19.1	Maturing; salt spray damage to west side of crown – extensive dieback; fair density, increment and colour; introduced species; to be removed
9	Honey-locust (<i>Gleditsia triacanthos</i>)	Good	22.6	Maturing; central stem with competing lateral at 1.5m on south side; good crown density, leaf size and colour; introduced species; to be removed

Picture 2. Trees #4-7 (right to left) at 1919 Riverside Drive

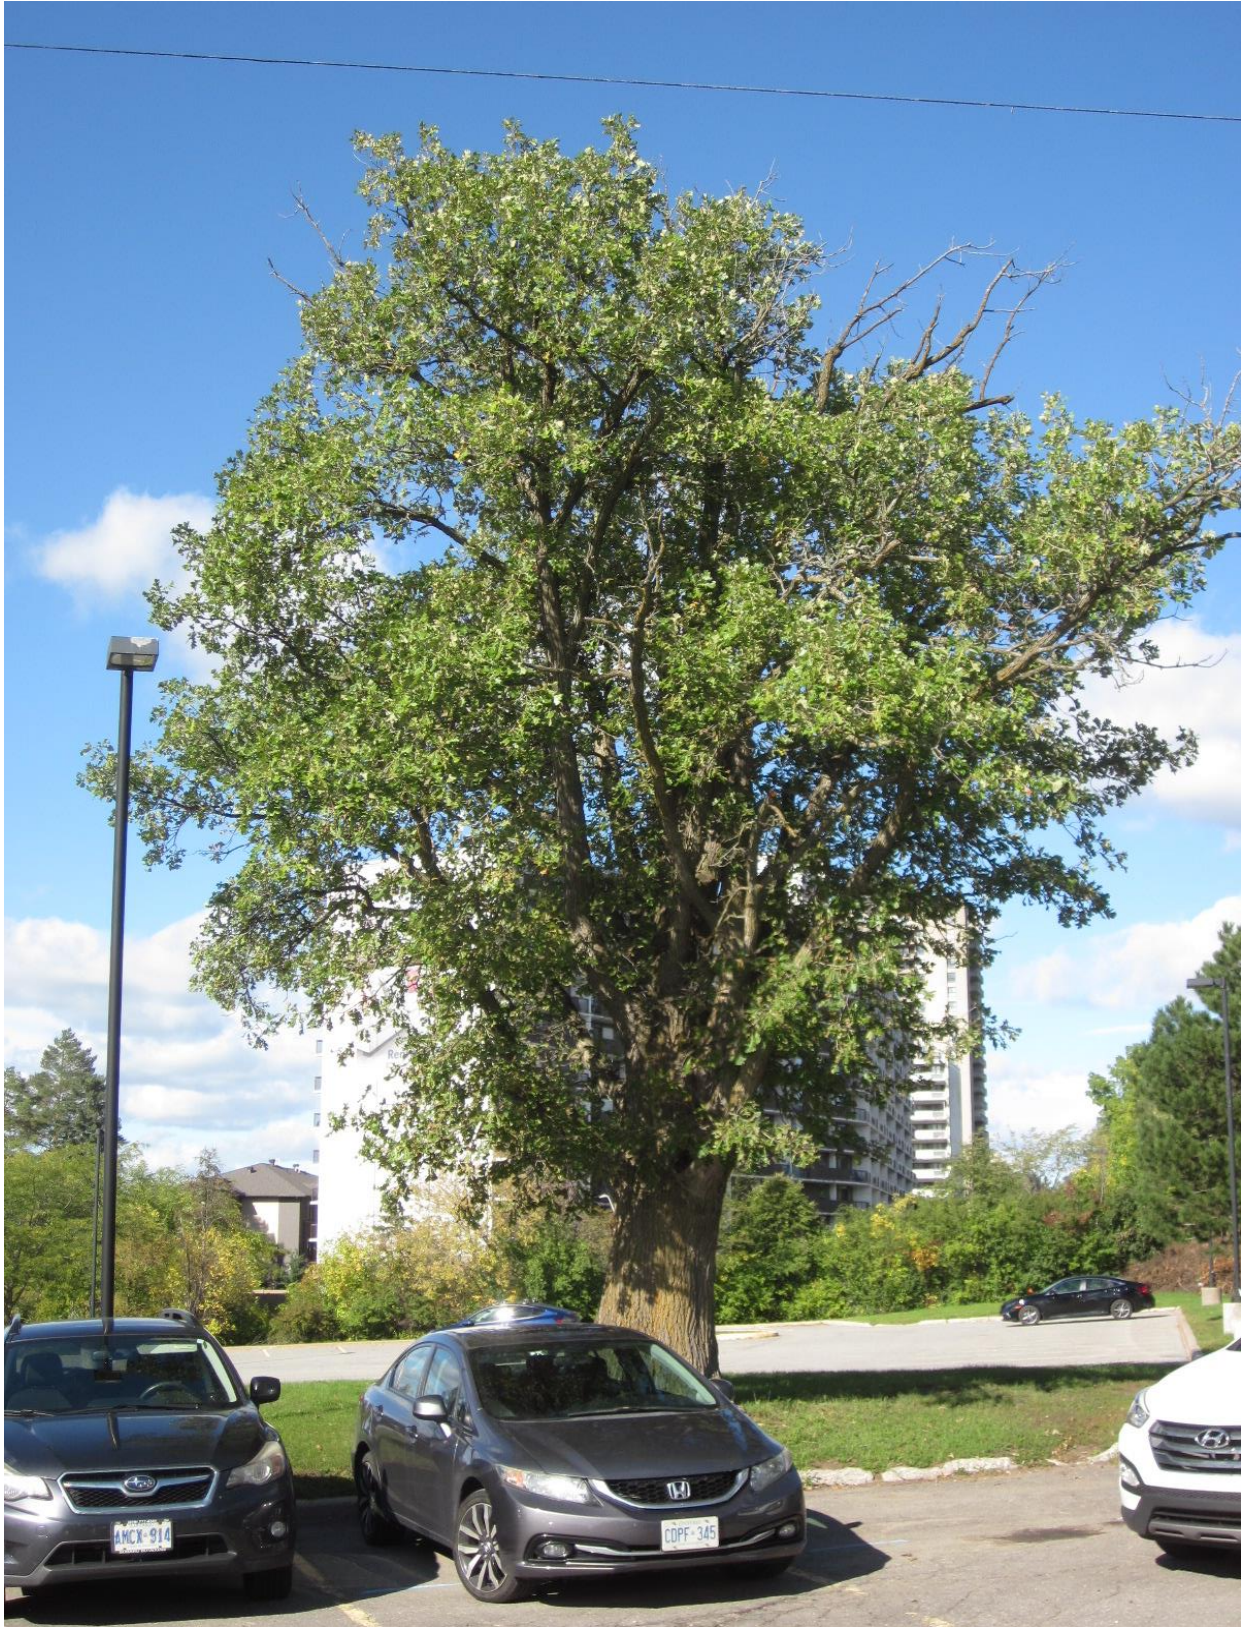
Tree No.	Tree species	Condition (VP→E)	DBH ¹ (cm)	Age class, tree condition notes & preservation status (to be removed or preserved and protected)
1	Austrian pine (<i>Pinus nigra</i>)	Fair	18.2	Mature; crown very asymmetric towards west; fair crown density, growth increment and needle colour; introduced species; to be preserved and protected
2	Austrian pine	Fair	29.2	Mature; crown asymmetric towards north; fair density, growth increment and needle colour; introduced species; to be preserved and protected
3	Bur oak (<i>Quercus macrocarpa</i>)	Poor	90.3	Overmature; continuously topped for clearance from overhead Hydro lines; located within a restricted rooting zone – parking median; significant dieback; tree is in advanced decline; native species; to be removed
4	Colorado spruce (<i>Picea pungens</i>)	Poor	28.8	Mature; lower crown asymmetric; poor crown density, growth increment and needle colour – tree is in advanced decline; introduced species; to be removed

Picture 3. Tree #3 at 1919 Riverside Drive

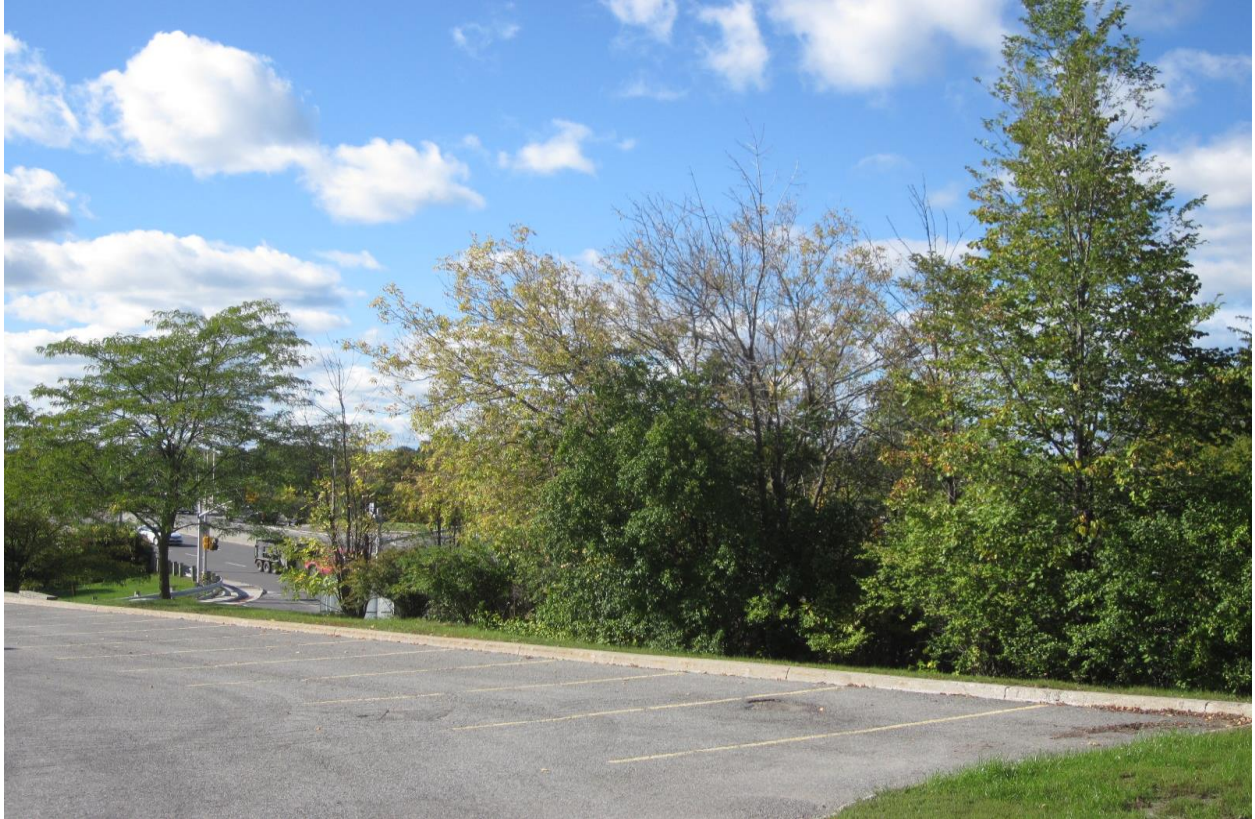
Tree grouping D: Three planted Scots pine and two American elms (*Ulmus americana*) **to be removed** due to conflicts with the proposed west parking lot. The pines are mature, upright in form and hold their living crowns high above the buckthorn in the understory. They are in good

condition, with good crown densities, growth increments and needle colour. The elms show no outward signs of Dutch elm disease (*Ophiostoma novo-ulmi*).

Picture 4. Tree grouping D (right) and trees #8 and 9 (left) at 1919 Riverside Drive

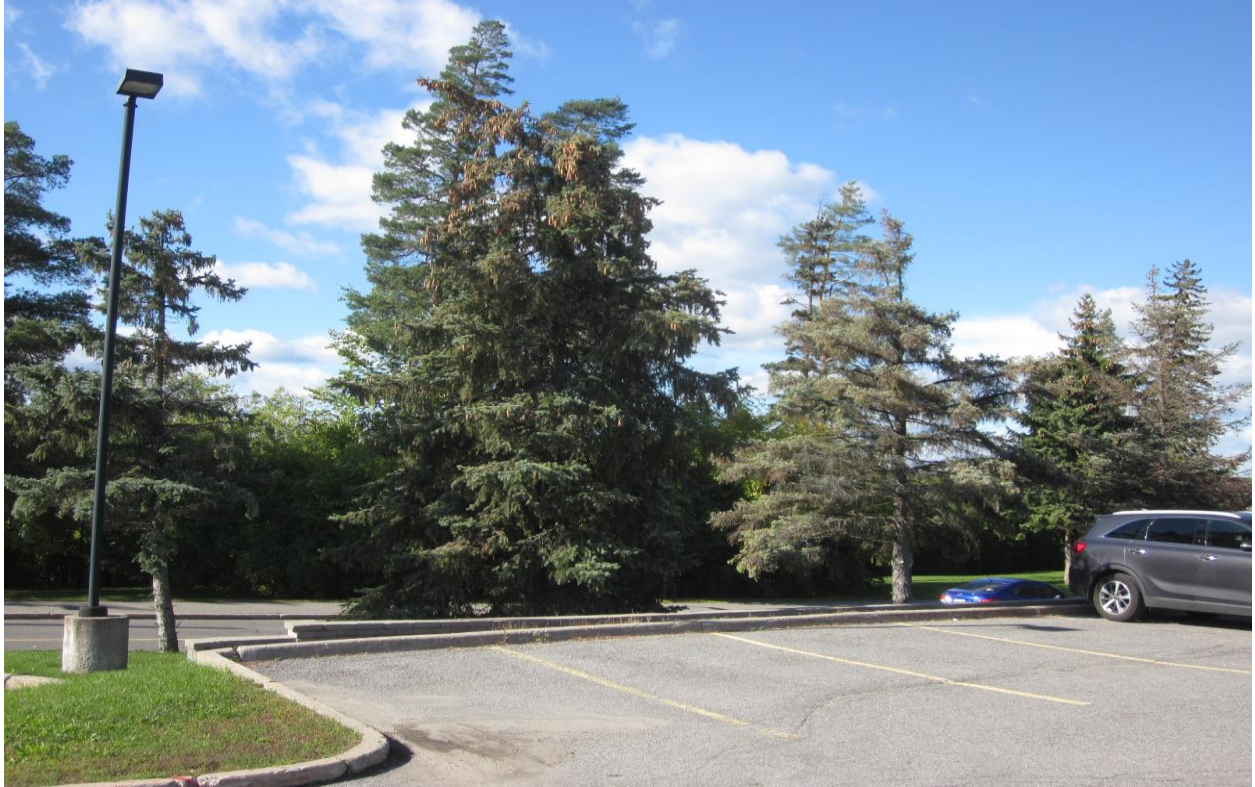
15	White spruce	Very poor	14.7	Maturing; divergent towards southeast; leader is dead; tree is in decline; poor density, increment and colour; native species; to be removed
16	Colorado spruce	Very good	24.1	Mature; good growth form; very good density, increment and colour; introduced species; to be removed
17	Little-leaf linden (<i>Tilia cordata</i>)	Good	23.9	Maturing; co-dominant stems at 3m – moderately divergent; good crown density, leaf size and colour; introduced species; to be removed
18	Little-leaf linden	Good	27.1 (at 1m)	Maturing; multiple stems at 2-2.5m – broad crown; good crown density, leaf size and colour; embedded guy wire at 1.3m; introduced species; to be removed
19	Colorado spruce	Very poor	25.3	Maturing; holding less than 10% living foliage; tree is in advanced decline; embedded guy wire at 0.6m; introduced species; to be removed
20	Colorado spruce	Poor	23.6	Maturing; holding less than 50% living foliage; tree is in decline; heavy basal damage; introduced species; to be removed

Tree No.	Tree species	Condition (VP→E)	DBH ¹ (cm)	Age class, tree condition notes & preservation status (to be removed or preserved and protected)
21	Colorado spruce	Fair	24.9	Maturing; fair density, increment and colour; leader strongly divergent towards southeast; introduced species; to be removed
22	Colorado spruce	Fair	17.9	Maturing; fair density, increment and colour; scattered dead branches; introduced species; to be removed
23	Scots pine (<i>Pinus sylvestris</i>)	Very poor	35.1	Mature; holding less than 10% living foliage; tree is in advanced decline – only 4 lowest branches alive; located within a restricted rooting zone – parking median; introduced invasive species; to be removed
24	Scots pine	Poor	58.4	Mature; very poor density, poor increment and colour; tree is in advanced decline; located within a restricted rooting zone – parking median; introduced invasive species; to be removed

Picture 5. Trees #19-22 (right to left) at 1919 Riverside Drive

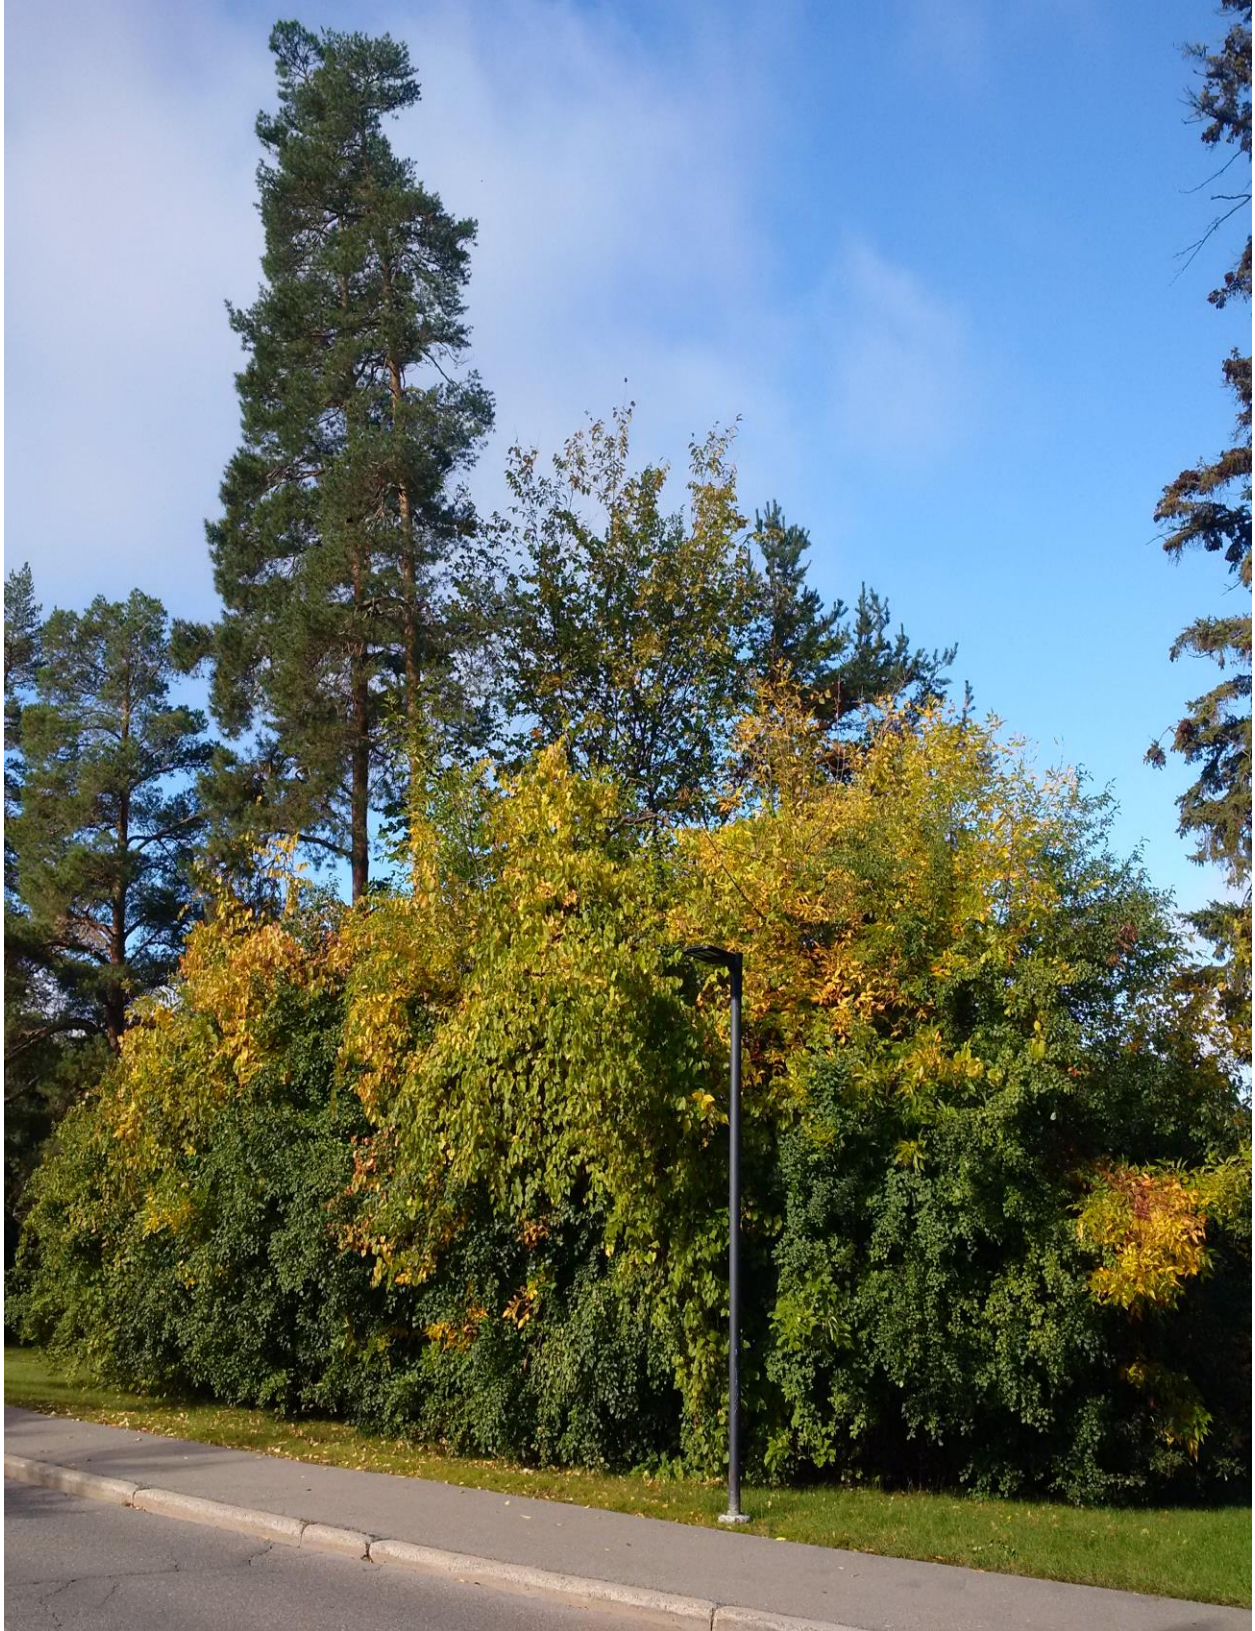
Picture 6. Tree grouping D at 1919 Riverside Drive

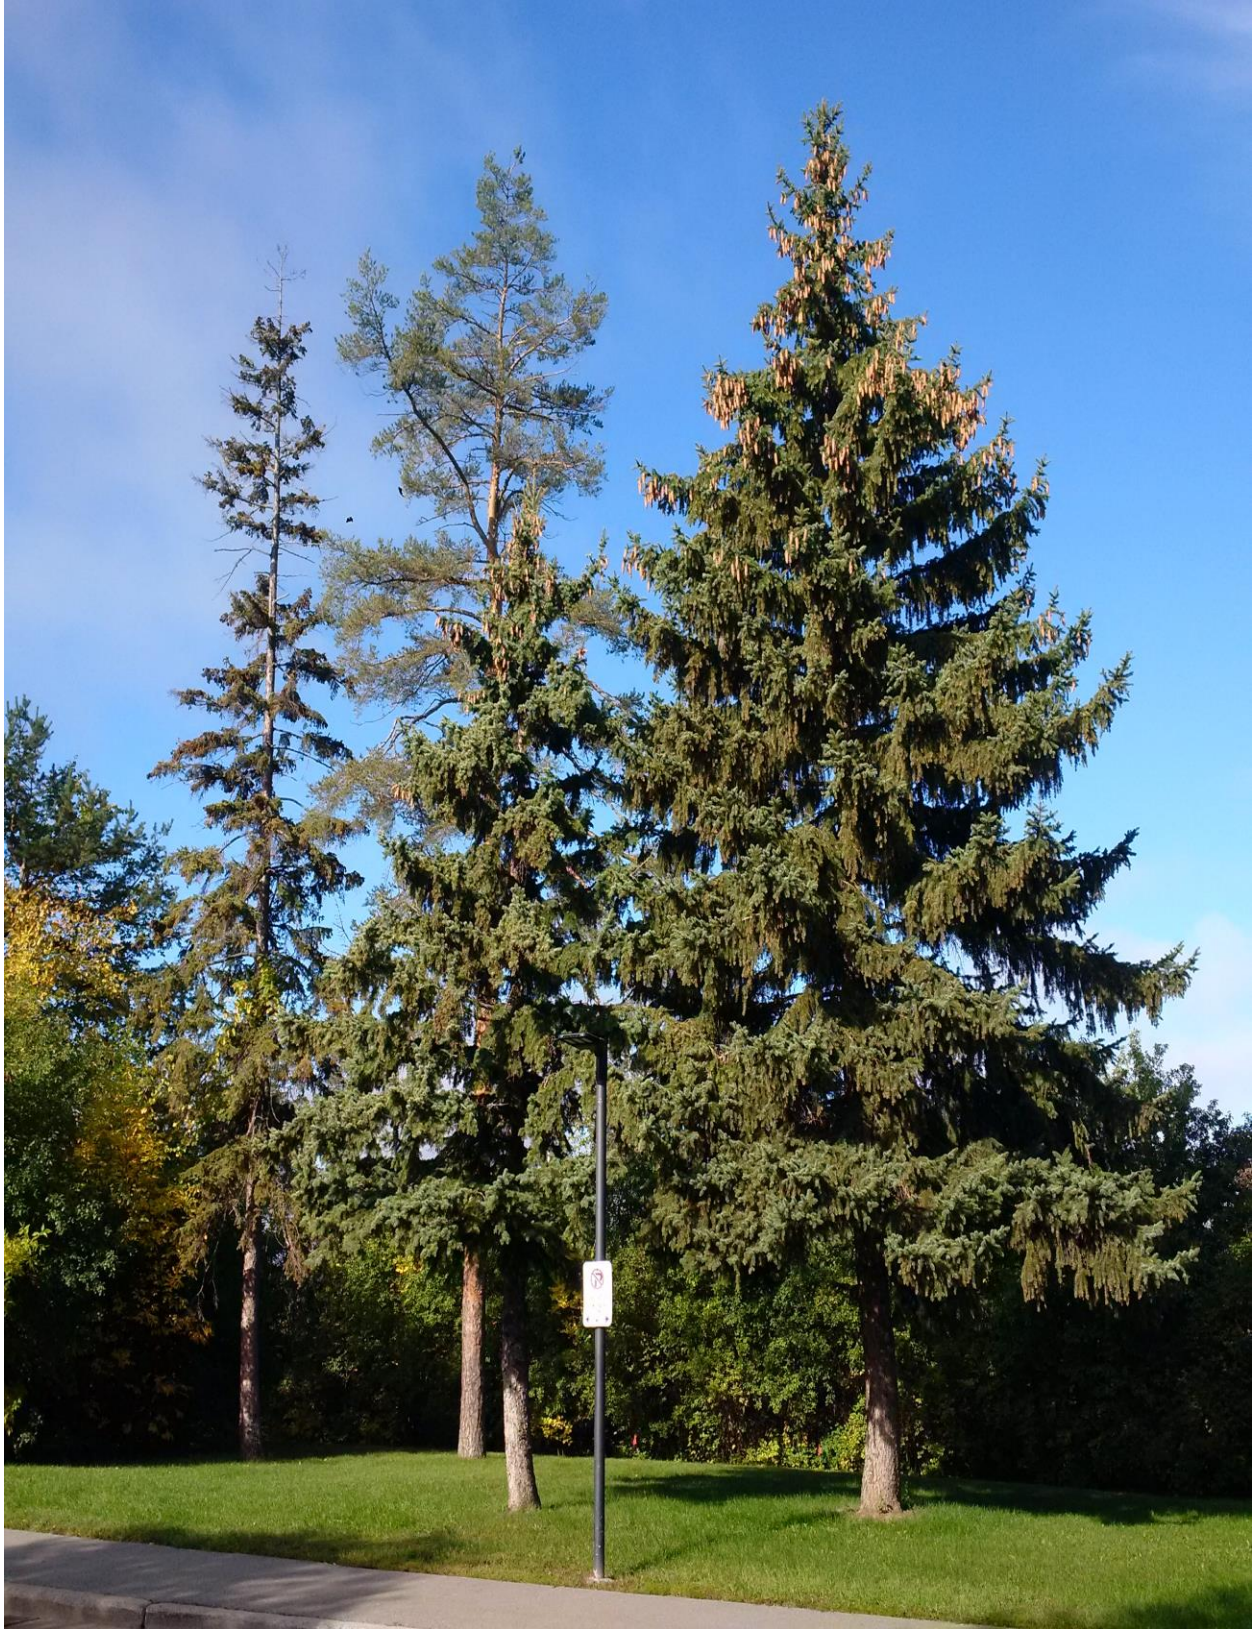
Tree No.	Tree species	Condition (VP→E)	DBH ¹ (cm)	Age class, tree condition notes & preservation status (to be removed or preserved and protected)
31	Scots pine	Good	39.8	Mature; crown asymmetric towards southeast; good density, increment and colour; introduced invasive species; to be preserved and protected
32	Colorado spruce	Very good	37.8	Mature; very good density, increment and colour; introduced species; to be removed
33	Colorado spruce	Good	28.2	Mature; good density, increment and colour; scattered dead branches; introduced species; to be removed
34	Scots pine	Good	41.4	Mature; upright stem, crown asymmetric towards southwest; good density, increment and colour; introduced invasive species; to be removed
35	White spruce	Fair	28.2	Mature; leader dead; scattered dead and dieback, especially near crown apex; fair density, increment and colour; native species; to be removed
36	Scots pine	Good	53.3	Mature; upright stem, crown asymmetric towards west; good density, increment and colour; introduced invasive species; to be removed

Picture 7. Trees #32-35 (right to left) at 1919 Riverside Drive

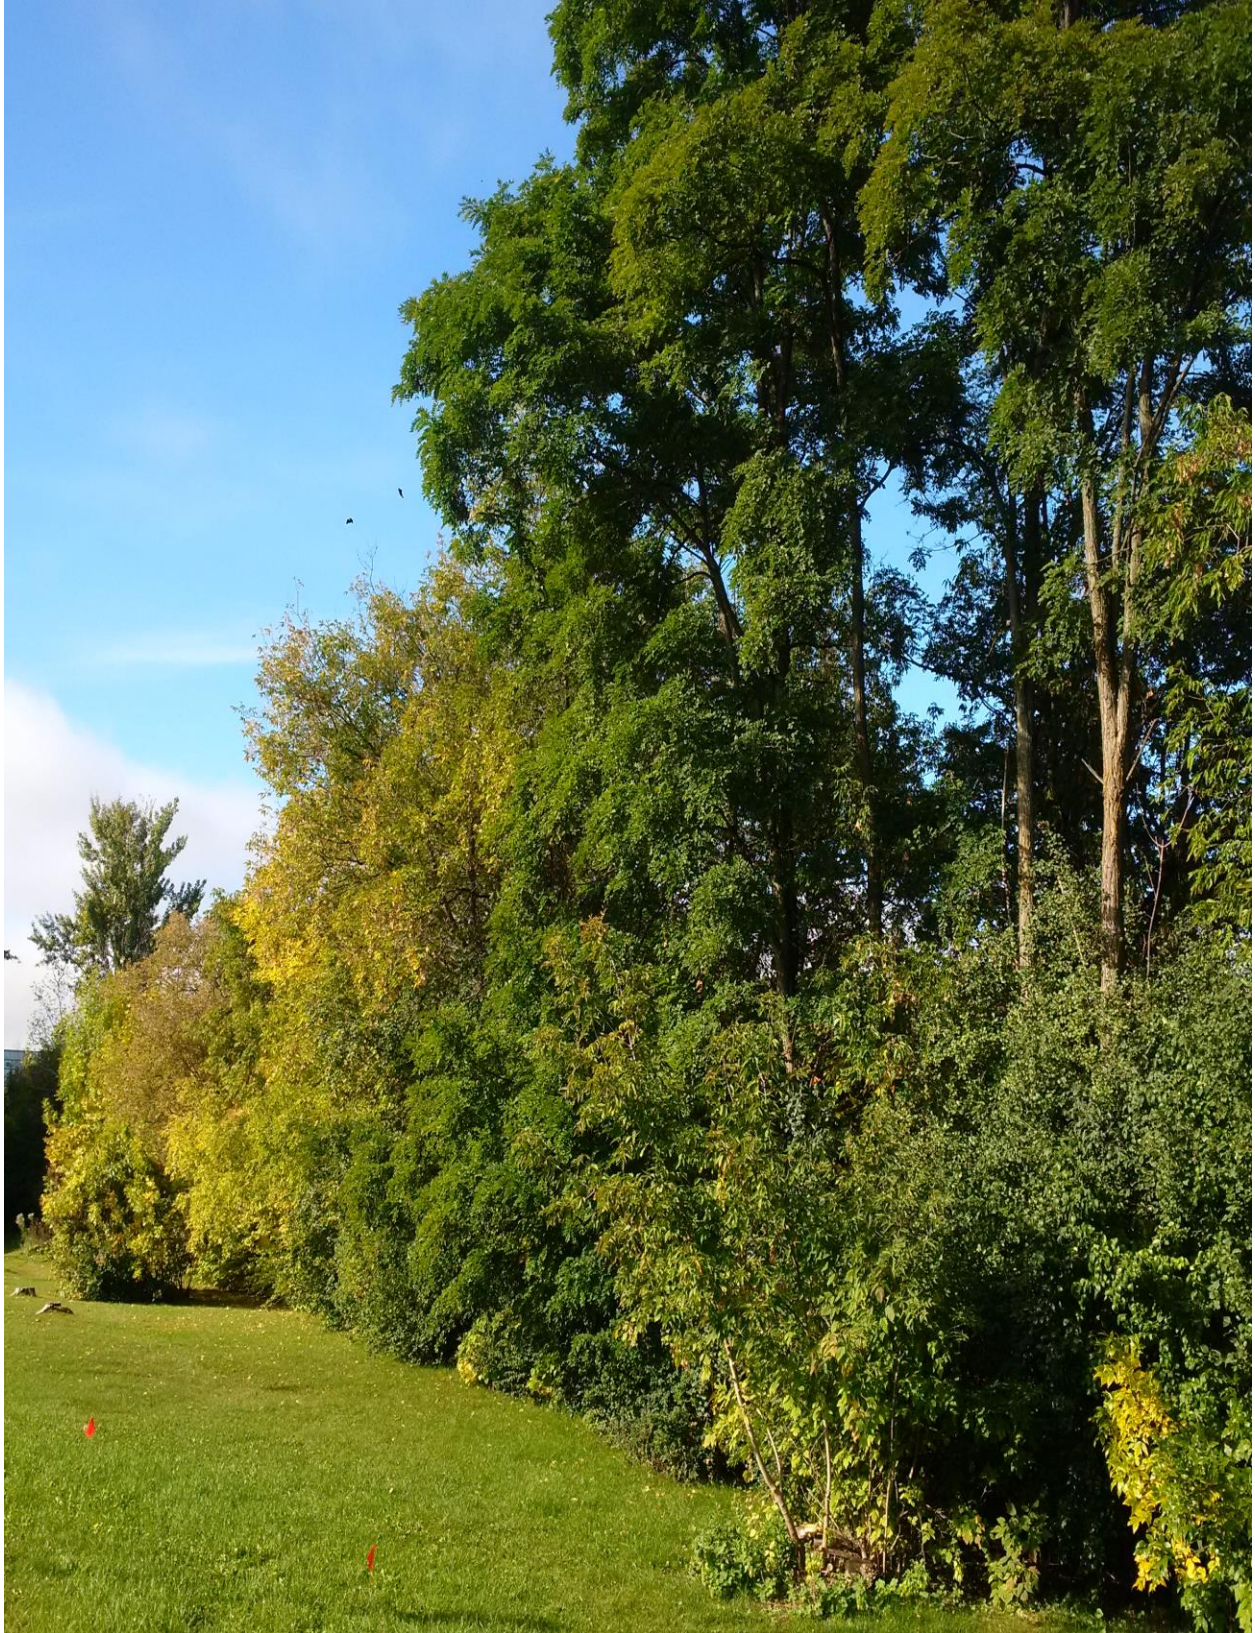
Tree grouping E1: In the overstory are naturalized Manitoba maple from seed, naturally occurring trembling aspen (*Populus tremuloides*) spreading via root sprouts from the adjacent forest, naturalized black locust (*Robinia pseudoacacia*) spreading similarly and dead ash. Buckthorn once again dominates the understory. **To be preserved and protected** except for a small linear area which conflicts with a proposed walkway (E2).

Picture 8. Tree grouping E at 1919 Riverside Drive
