Re: Remedial Action Plan and Cost Estimate

Proposed Residential Development

84 and 100 Gloucester Street - Ottawa, Ontario

Date: August 11, 2022 **File:** PE5571-RAP.01

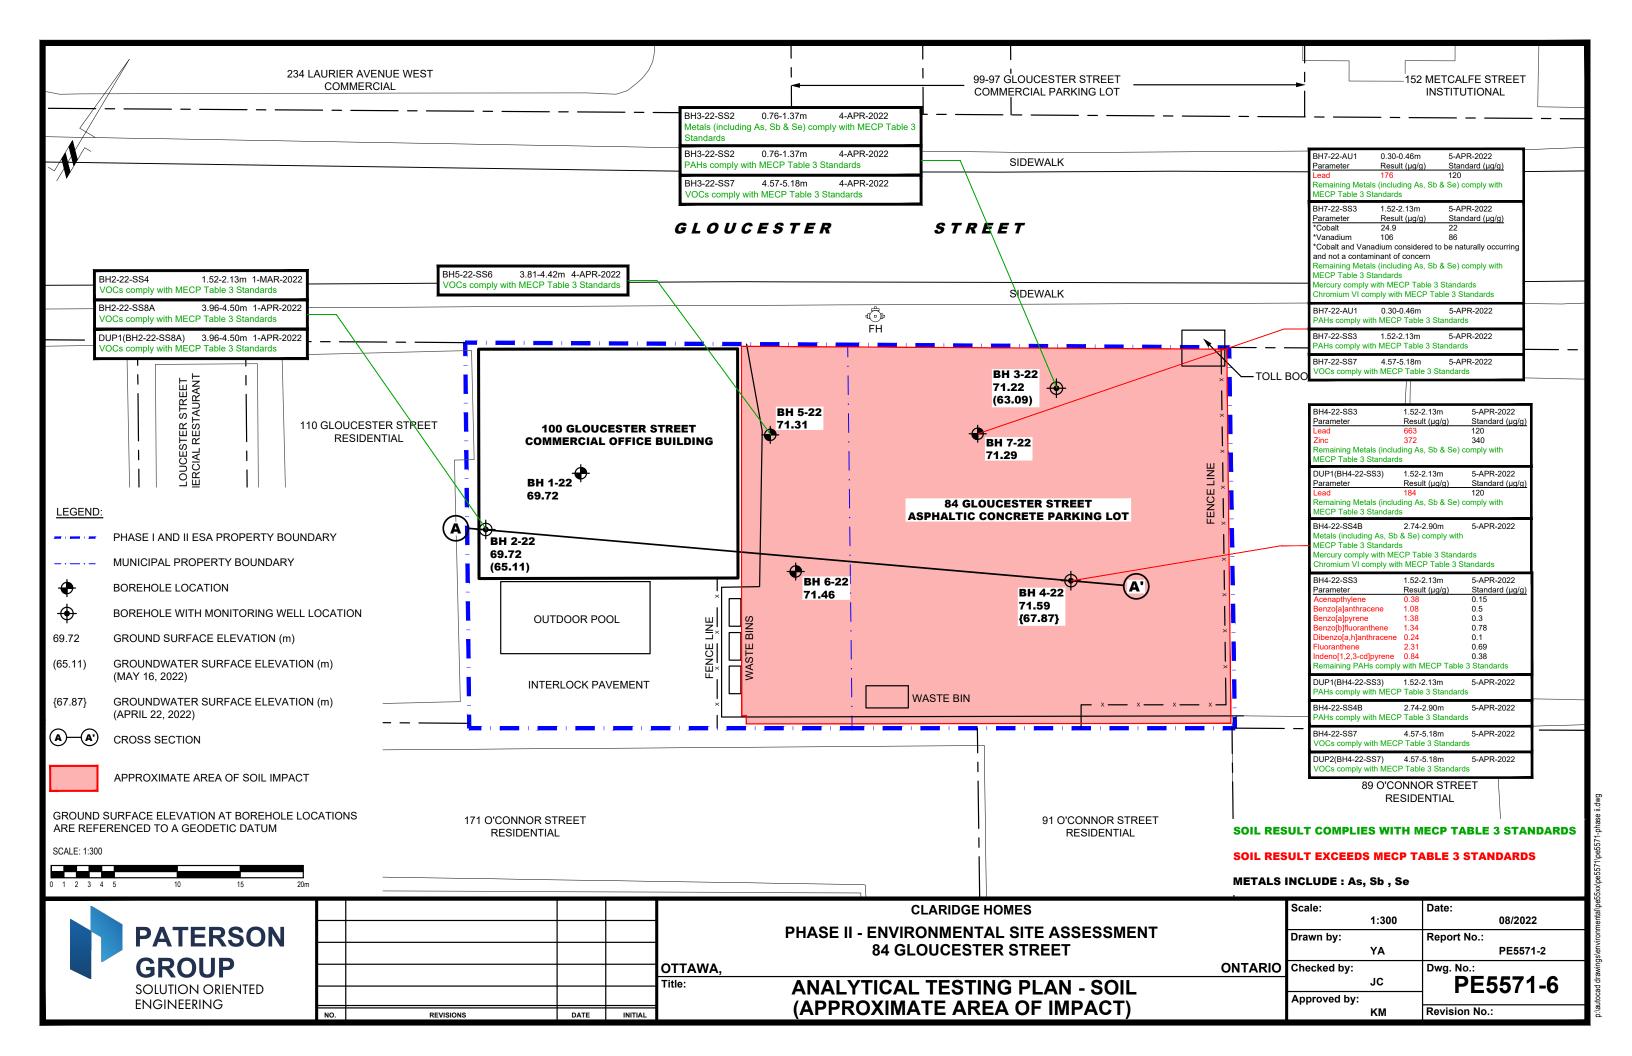
☐ Drawing PE5571-6 – Analytical Testing Plan – Soil (Approximate Area of Impacted Soil)

Based on the analytical results, some metal and/or PAH parameter concentrations were identified in soil samples BH4-2-SS3 and BH7-22-AU1 in excess of the selected MECP Table 3 Residential Soil Standards. Given the non-homogenous nature of the fill material, pockets of impacted fill are expected to be encountered across the subject site.

sumptions were used to determine a realistic cost estimate:
	The areas marked out on the enclosed Drawing PE5571-4 – Analytical Testing Plan – Soil, have or are expected to have soil impacted with metals to depths of approximately 2.0 m below ground surface.
the pro Bro	e proposed development will require a Record of Site Condition (RSC) to be filed with Ontario Ministry of the Environment, Conservation and Parks (MECP) due to the oposed change in land use and to comply with the requirements of the City of Ottawa's ownfields Property Tax and/or Rehabilitation Grant Programs. To meet the conditions an RSC, the suggested remedial action plan is as follows:
	The existing building at 100 Gloucester Street will be demolished as part of site redevelopment.
	Existing groundwater monitoring wells are required to be decommissioned by a licenced well driller in accordance with O. Reg. 903. It is recommended that the monitoring wells be retested, prior to their decommissioning, to confirm the groundwater quality.

A remediation program using a full-depth generic approach will be implemented. This will involve the excavation and removal of all impacted soil from the subject site. Prior to its off-site disposal, a leachate analysis of a representative sample of contaminated soil must be completed in accordance with O. Reg. 347/55.
	It is our understanding that the majority of the on-site soils will be removed during site redevelopment activities, and that the excavation will extend to the bedrock. As part of redevelopment, soil to be removed from the subject site will be assessed for

- ☐ Any impacted soil identified in excess of the selected MECP Table 3 Residential Coarse-Grained Soil Standards for Non-Potable Groundwater Conditions will be placed into trucks and hauled to an approved waste disposal facility.
