**PATERSON
GROUP**

July 19, 2022
File: PE4937-LET.04

Subject: **Phase II - Environmental Site Assessment Update
Navan at Renaud Road
Ottawa, Ontario**

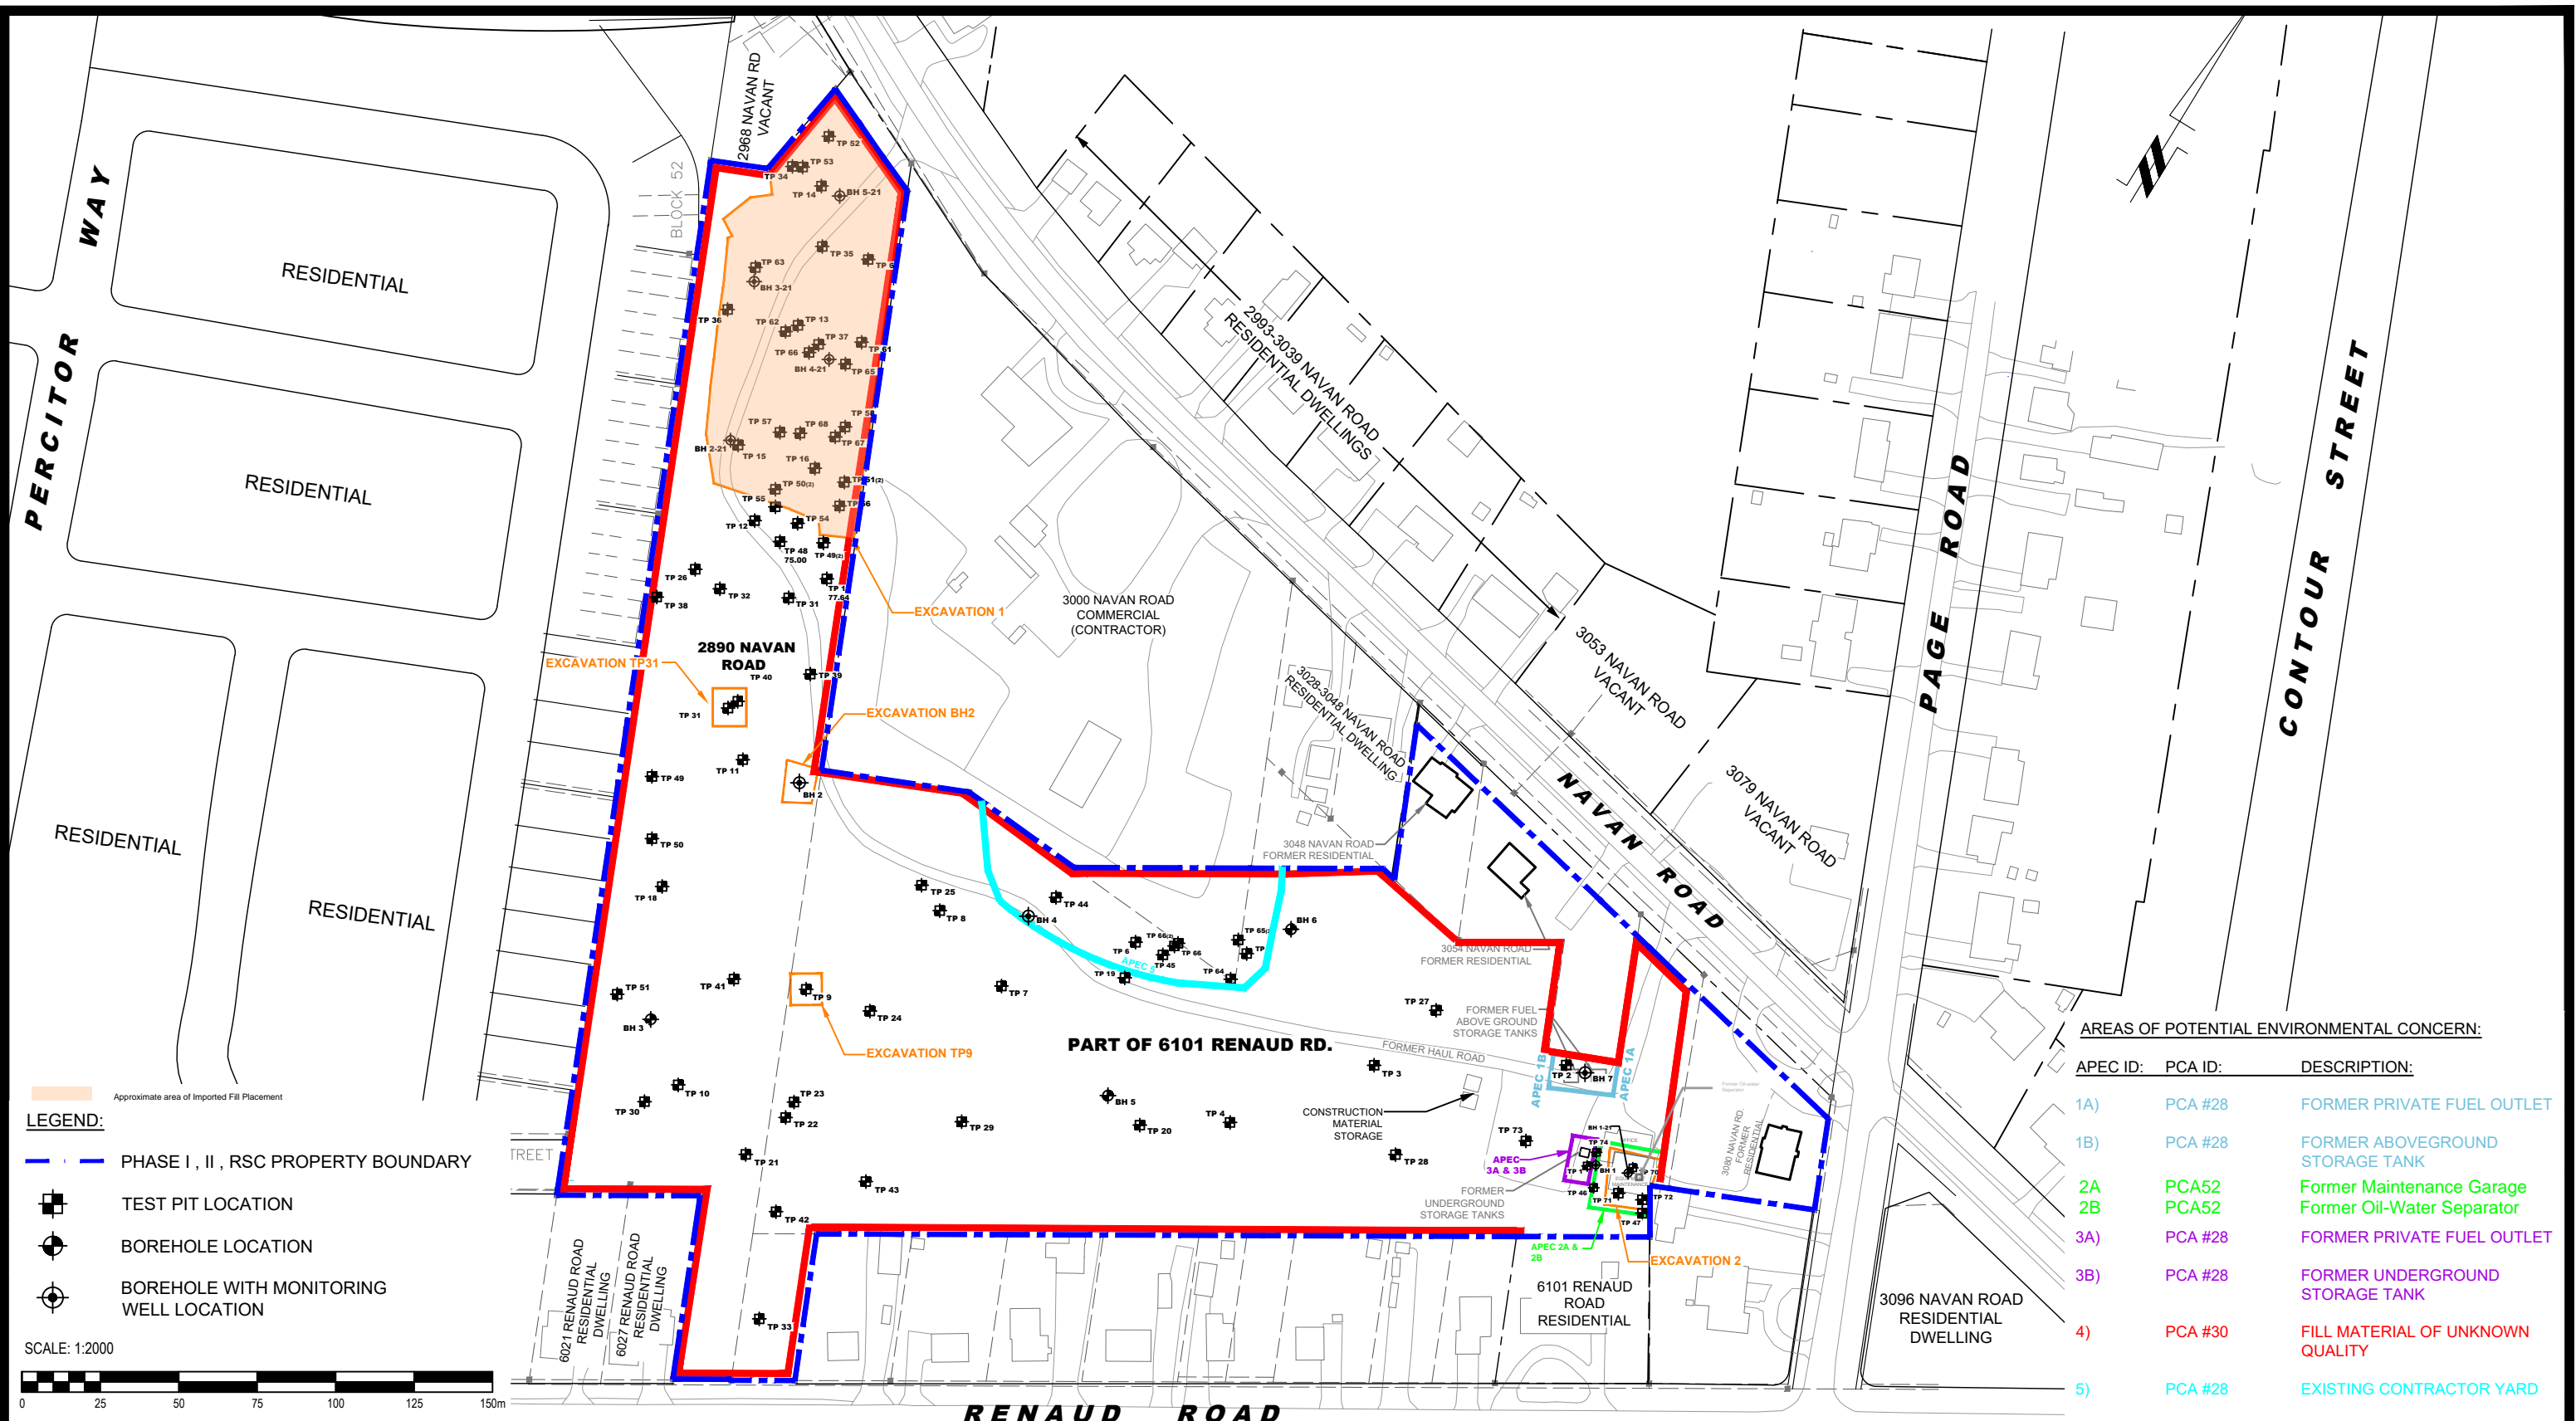
Scale:	1:2000	Date:	04/2022
Drawn by:	YA	Report No.:	PE4937-1
Checked by:	JC	Dwg. No.:	PE4937-1
Approved by:	MB	Revision No.:

APEC ID:	PCA ID:	DESCRIPTION:
1A)	PCA #28	FORMER PRIVATE FUEL OUTLET
1B)	PCA #28	FORMER ABOVEGROUND STORAGE TANK
2A)	PCA52	Former Maintenance Garage
2B)	PCA52	Former Oil-Water Separator
3A)	PCA #28	FORMER PRIVATE FUEL OUTLET
3B)	PCA #28	FORMER UNDERGROUND STORAGE TANK
4)	PCA #30	FILL MATERIAL OF UNKNOWN QUALITY
5)	PCA #28	EXISTING CONTRACTOR YARD

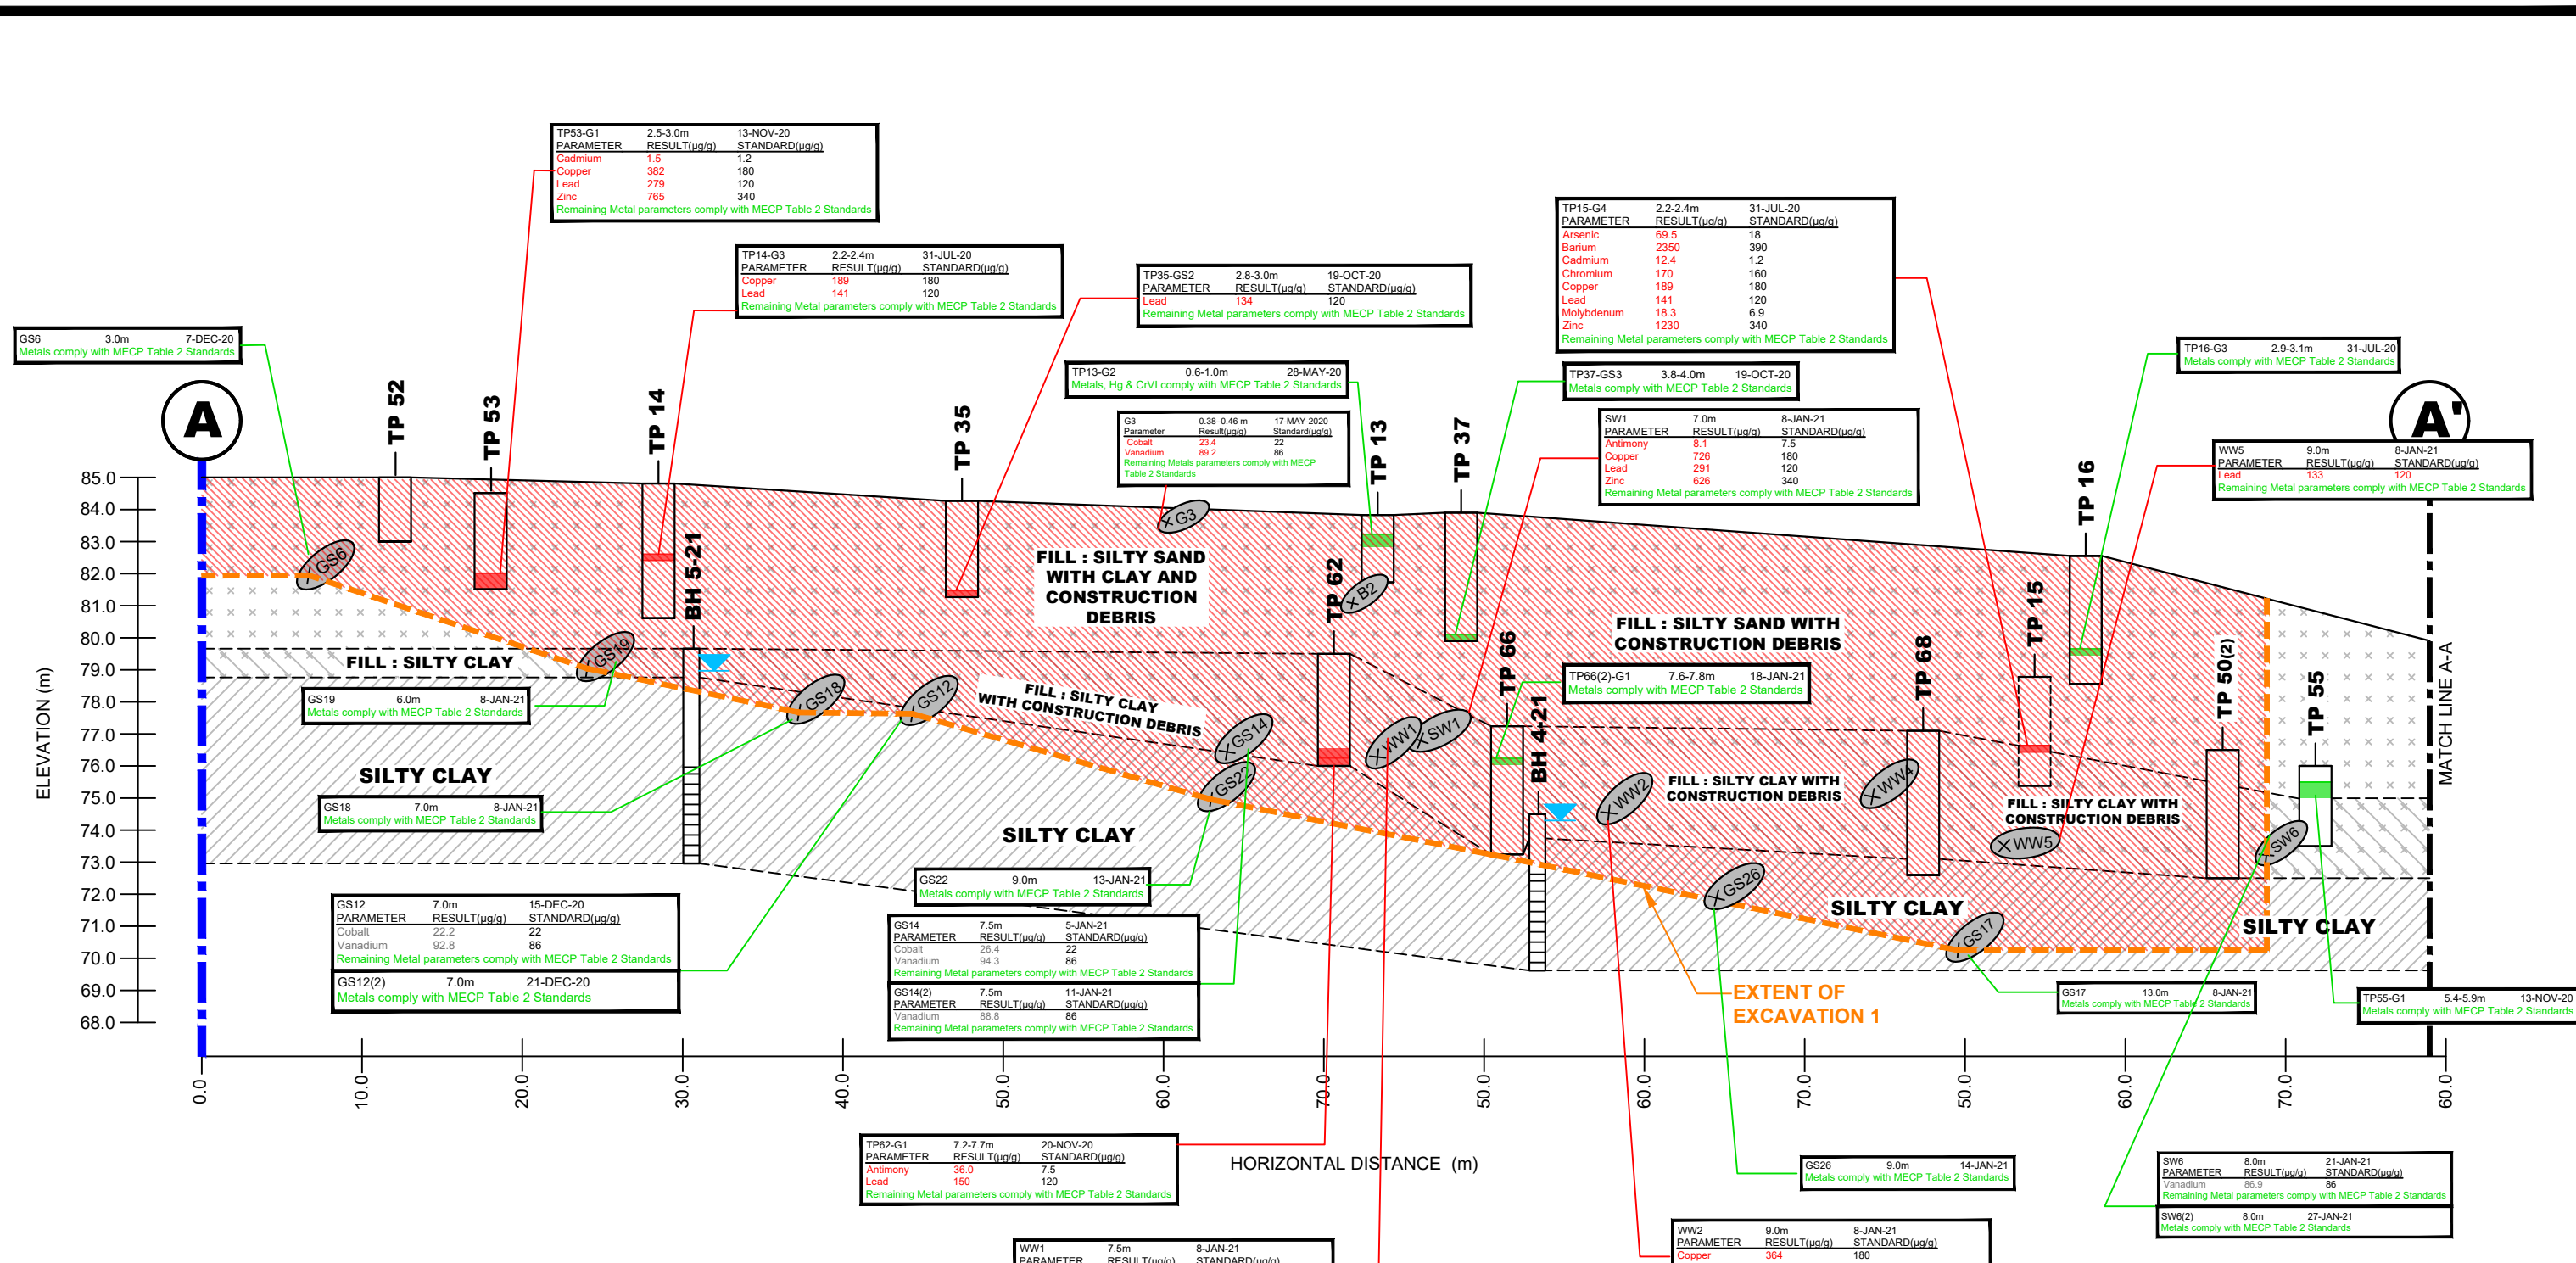
Scale:	AS SHOWN	Date:	03/2022
Drawn by:	RCG	Report No.:	PE4937-2
Checked by:	MB	Dwg. No.:	PE4937-4A
Approved by:	MB	Revision No.:

APPROXIMATE EXTENT OF SOIL WITH CONCENTRATIONS OF METALS EXCEEDING THE MECP TABLE 2 STANDARDS
 CONCENTRATIONS OF NATURALLY OCCURRING METALS EXCEEDING THE SITE CONDITION STANDARDS ARE SHOWN IN GREY AND ARE NOT CONSIDERED TO BE A CONTAMINANT.

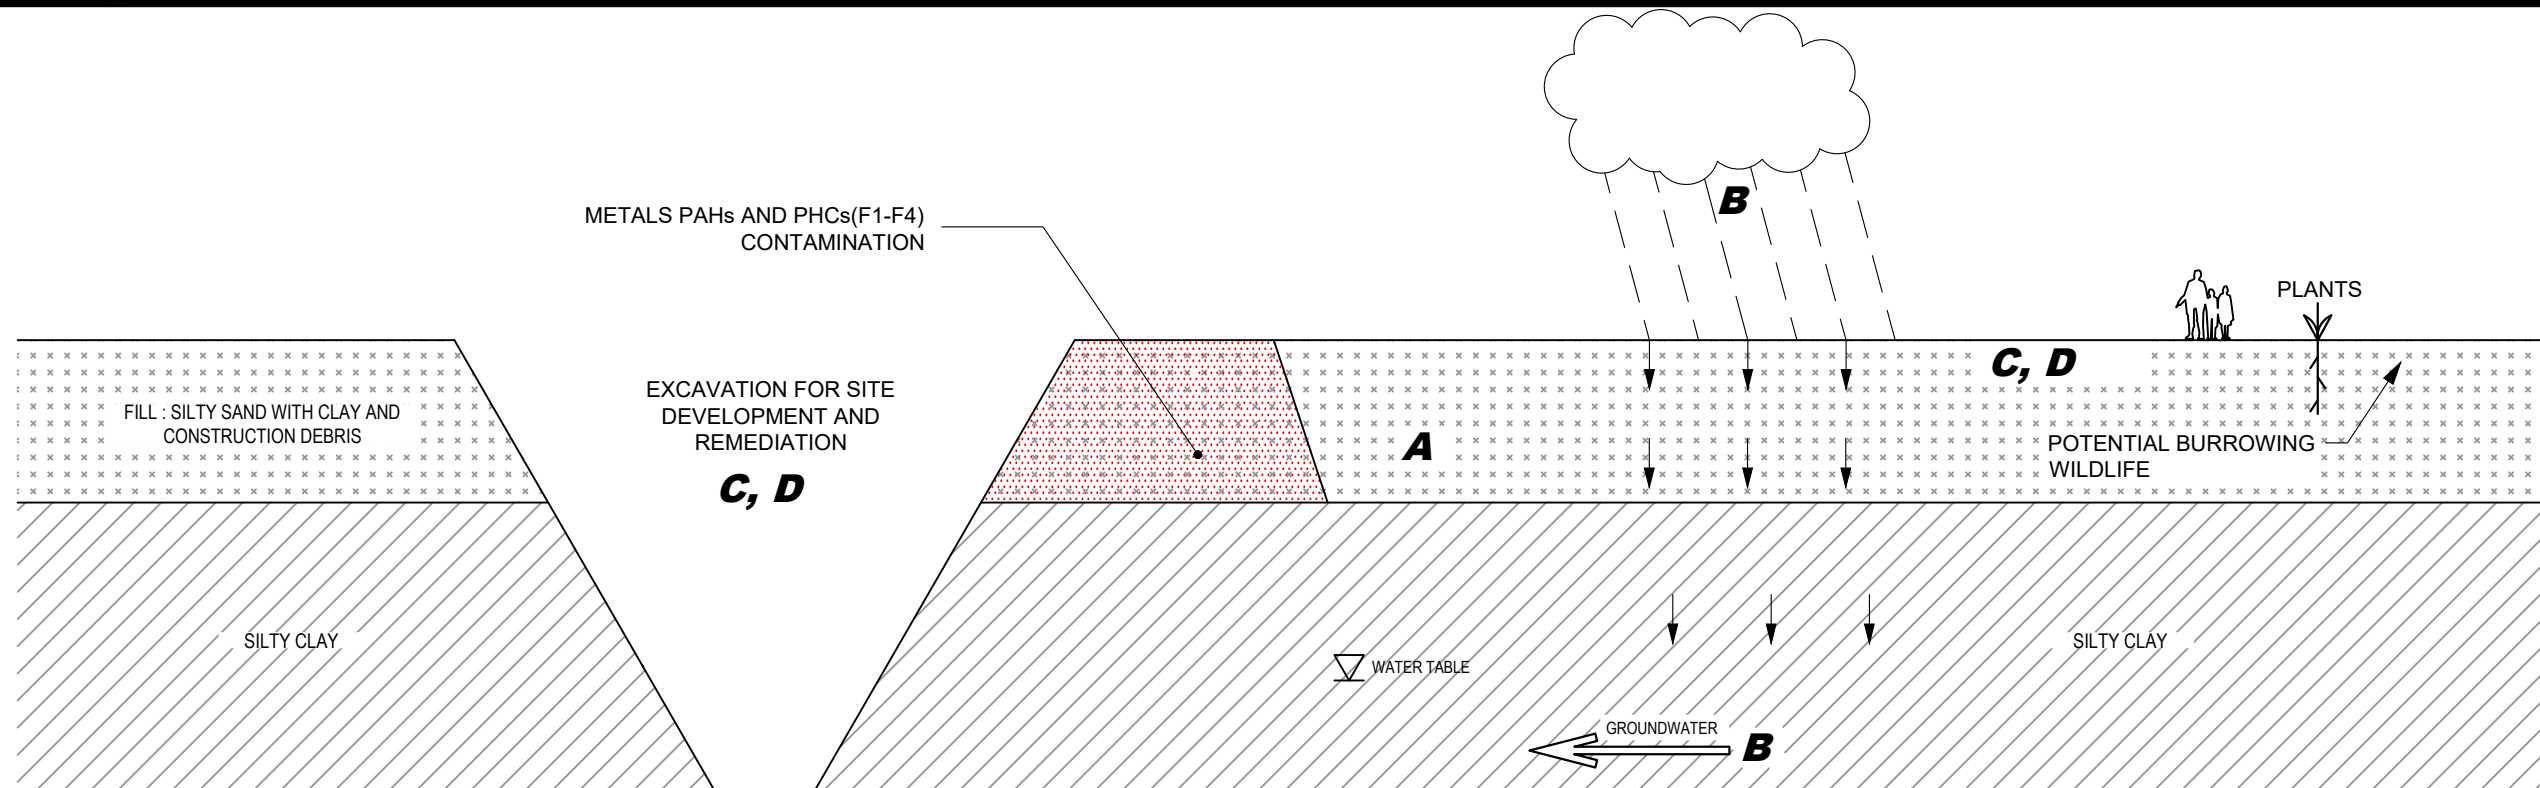
A Contaminant Transport Pathways

Physical transport – one potential contaminant transport pathway is the physical transport from one location to another of impacted soil, either intentionally or unintentionally, by earth moving equipment, vehicle traffic, or pedestrian traffic. The potential for physical transport of contaminants to have occurred on the RSC Property is considered to be low.
 Precipitation/Infiltration/Leaching – As precipitation falls on the ground surface and subsequently infiltrates through the soil to the groundwater table, there is the potential for contaminants in the soil phase to enter the groundwater, depending on the solubility of the contaminants. Impacts to the groundwater were not identified as such, precipitation, infiltration or leaching are not considered to have played a significant role in contaminant transport.
