October 24, 2023
CO884.00

**Re: Designated Substances Survey
5646 Manotick Main Street, Ottawa, Ontario**

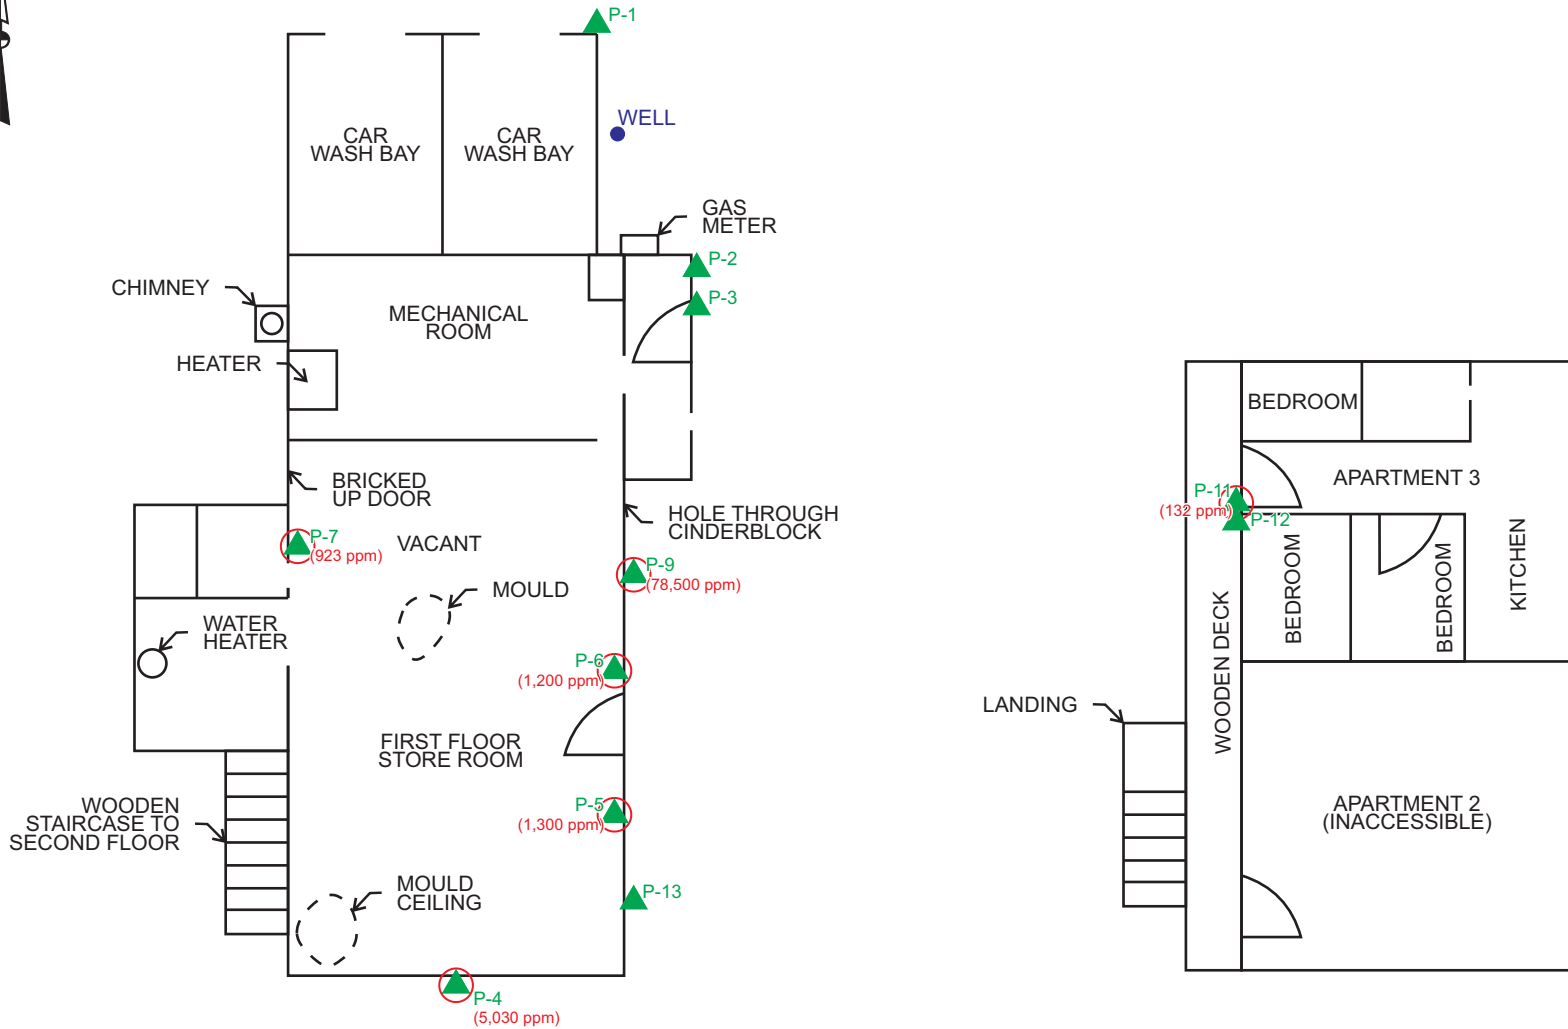
Based upon the age of the building, lead may be present on painted surfaces and in piping. Twelve samples of paint (P-1 to P-7 and P-9 to P-13) from the building were collected and submitted for laboratory analysis of lead content. Lead in paint analysis was conducted using Inductively Coupled Plasma Mass Spectroscopy (ICP/MS) according to EPA method 6020. The sample locations, paint descriptions, approximate extent of the painted surfaces, and condition of the paint are summarized in Table 2 (attached). The locations of the paint samples are shown on Figure 2. Laboratory Certificates of Analyses are attached.

The results of the analyses indicated that the following paint containing elevated levels of lead is present in the building:

- the white paint (P-4) located on the exterior at the southern and western sides of the exterior;
- beige-brown paint (P-5) located on the first floor of the building;
- grey paint (P-6) located on first floor
- green paint (P-7) located on first floor
- yellow-green paint (P-9) located on first floor
- white paint (P-11) located on wood siding on exterior of building.

Demolition and renovation contractors should ensure the use of appropriate personal protective equipment and proper dust control measures to protect themselves and the public from potential exposure by inhalation of silica dust or paint dust or chips.

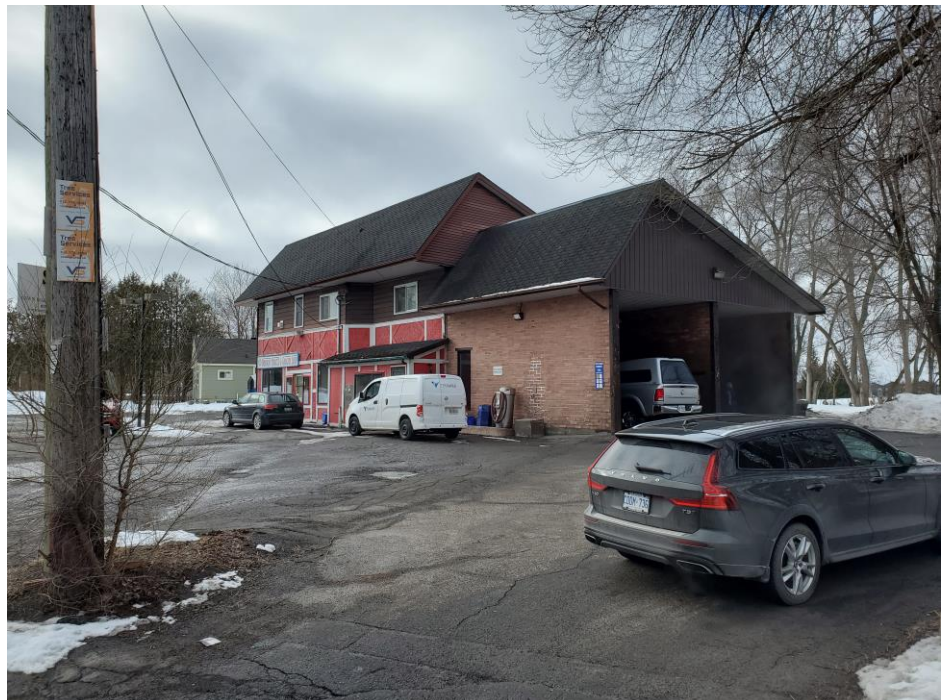
Photo No: 2

View of the Site from the northeastern portion of the Site. The two-bay car wash is visible in the foreground.

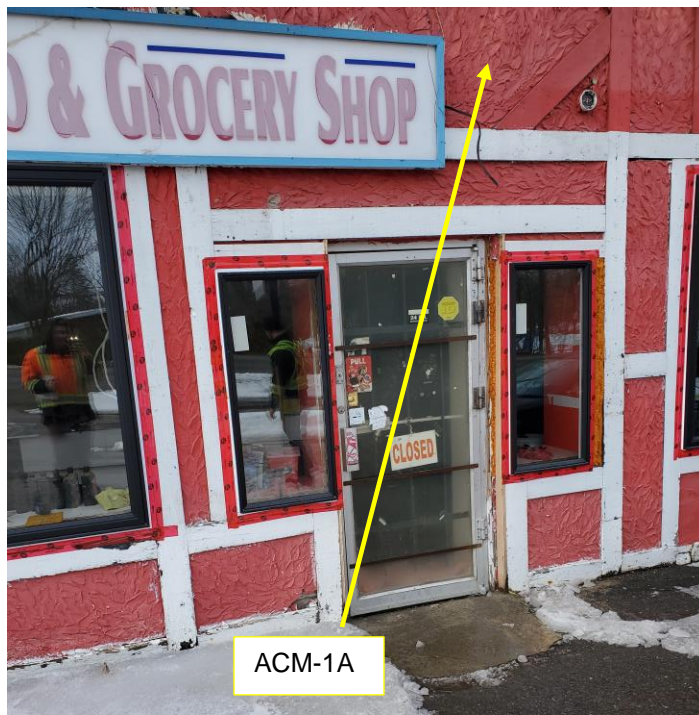
Photo No: 4

- ACM within the following building materials:
 - The red painted stucco present at the front exterior of the building (sample ACM-1A, non-friable, 2% Chrysotile asbestos, approximately 30 m² in area, fair to poor condition);

View of the stucco on the exterior of the building that was confirmed to be 2% chrysotile (AMCM-1A).

If any demolition, alteration or repair work that may result in disturbing ACM or potential ACM areas, a qualified asbestos abatement contractor should be retained for asbestos removal prior to undertaking the work. O. Reg. 278/05 defines three types of asbestos removal operations, which require different levels of protection, isolation and decontamination. Type 1 operations involve the lowest level of risk and include the removal of non-friable materials where the material is not damaged, or can be wetted and cut without power tools. Type 3 operations involve the highest level of risk, including removal of most types of friable materials, and require full enclosure of the area and construction of a decontamination area for workers and equipment, among other things.

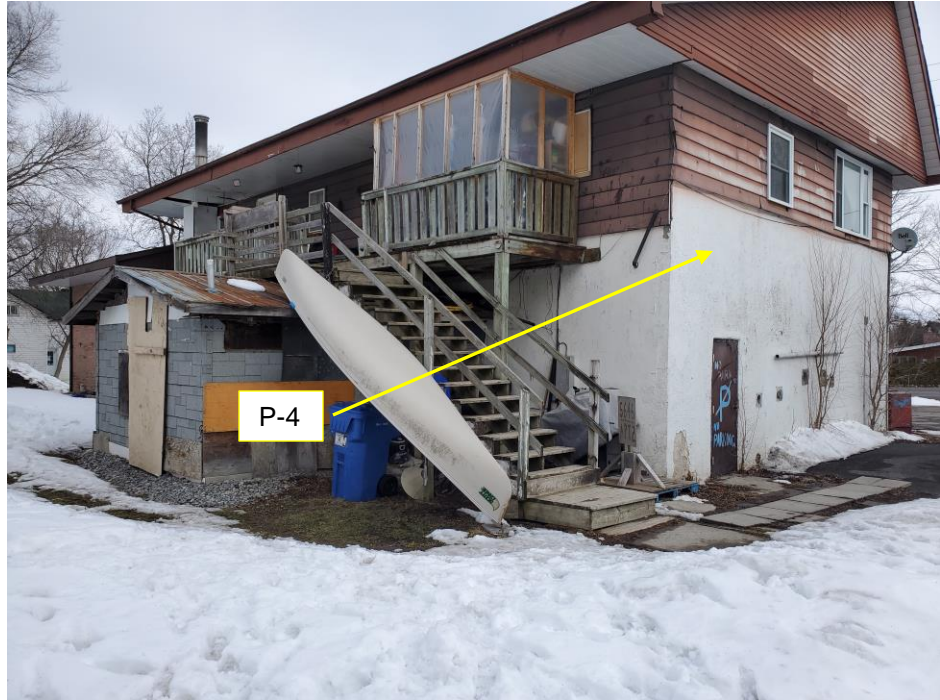
A view of exterior and side of the building. The white paint is where paint sample P-4 was collected.

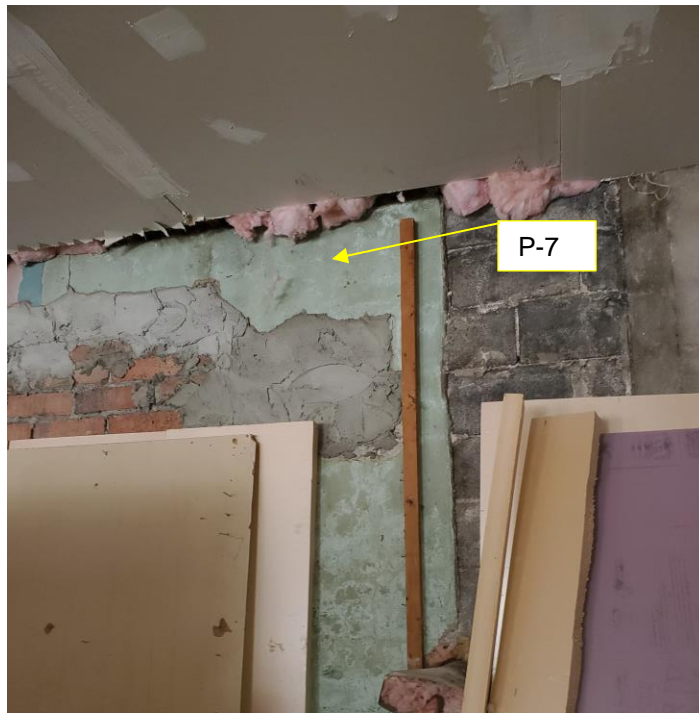
Photo No: 8

A view of the green paint (P-7) located in the first floor of the building.

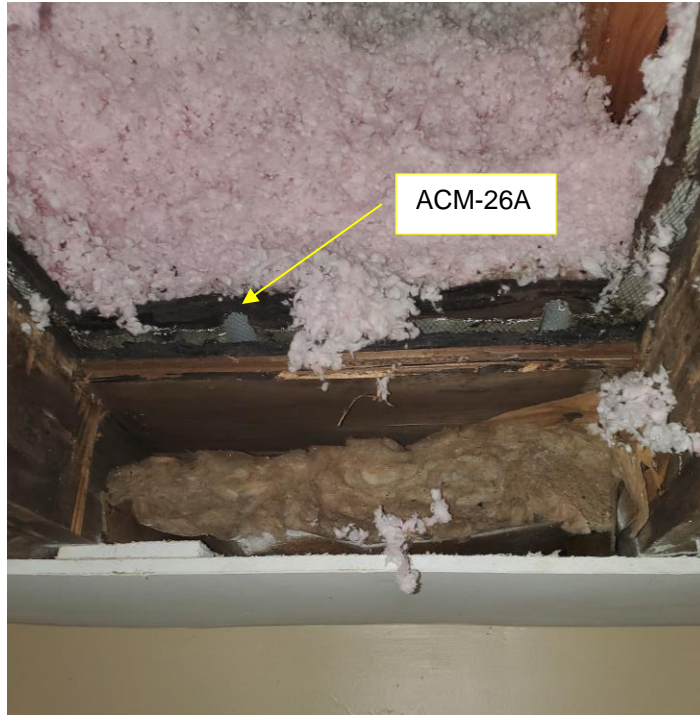
A view of insulation material in the attic of the main building.
