Project Name: Proposed Development, 1158 Old Second Line Road, Ottawa, ON
Project Number: OTT-00245054-A0
Subject: Site Condition Assessment, 1158 Old Second Line Road, Ottawa, Ontario

*Theberge Homes
Site Condition Assessment
1158 Old Second Line Road, Ottawa, Ontario
EXP Project Number: OTT-00245054-A0
April 21, 2023*

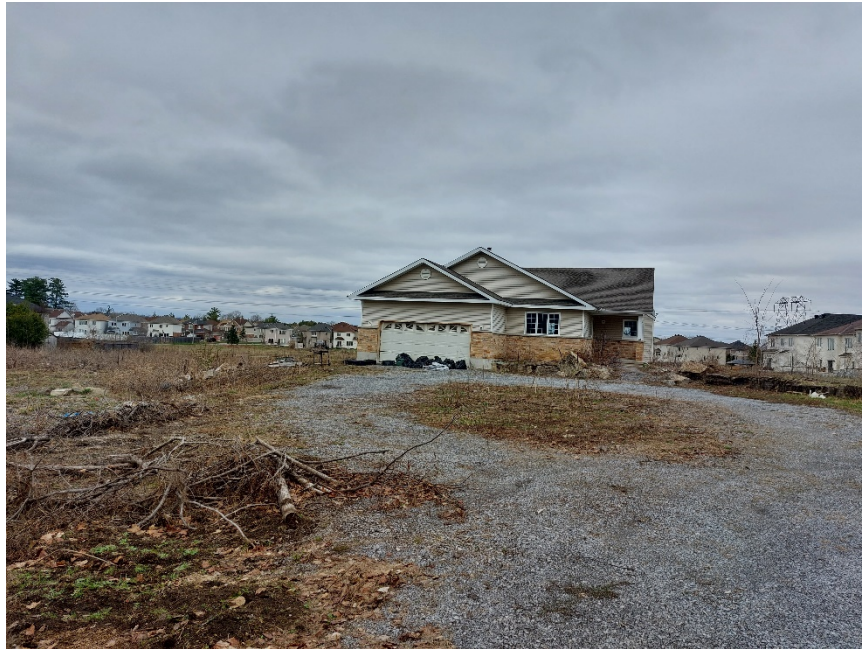
Photograph No. 1

View of the Site looking east.

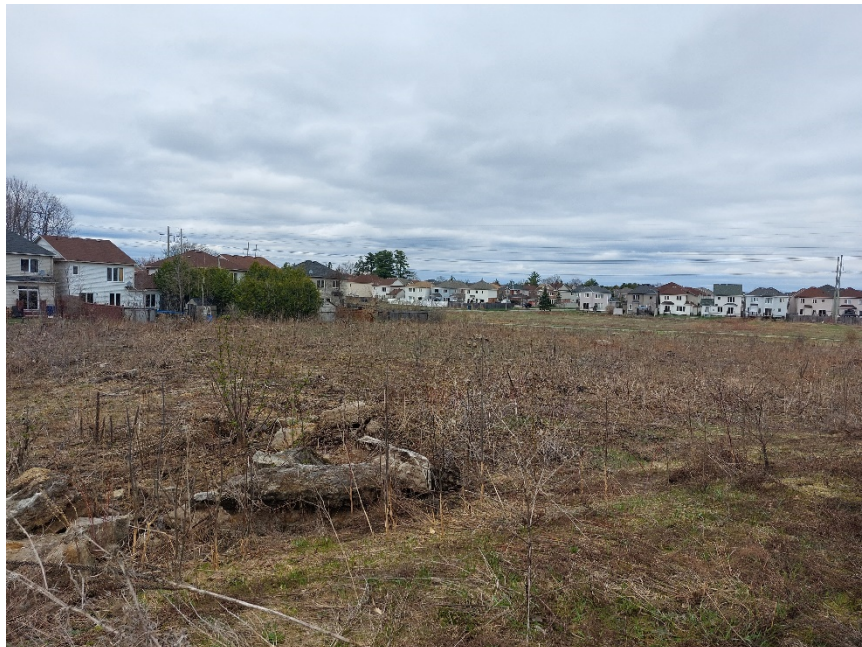
Photograph No. 2

View of the north half of the site looking northeast.

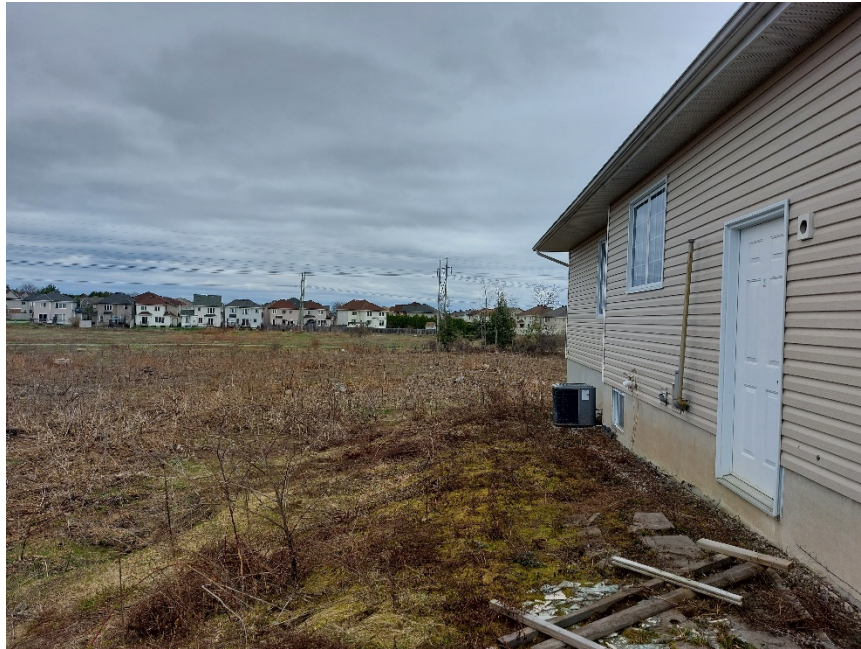
Photograph No. 3

View of the north side of the building and the northeast part of the site looking east.

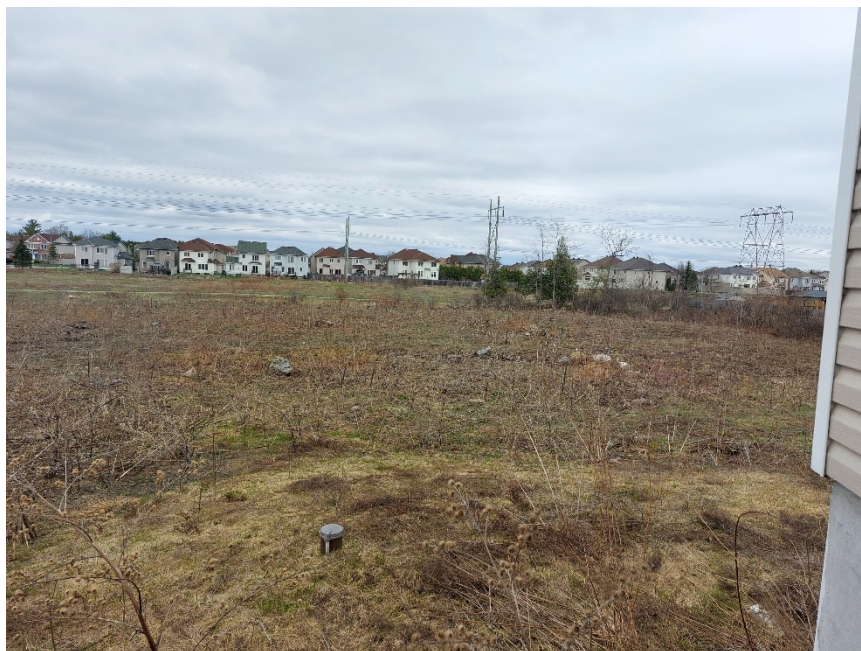
Photograph No. 4

View of the southeast part of the site looking east.

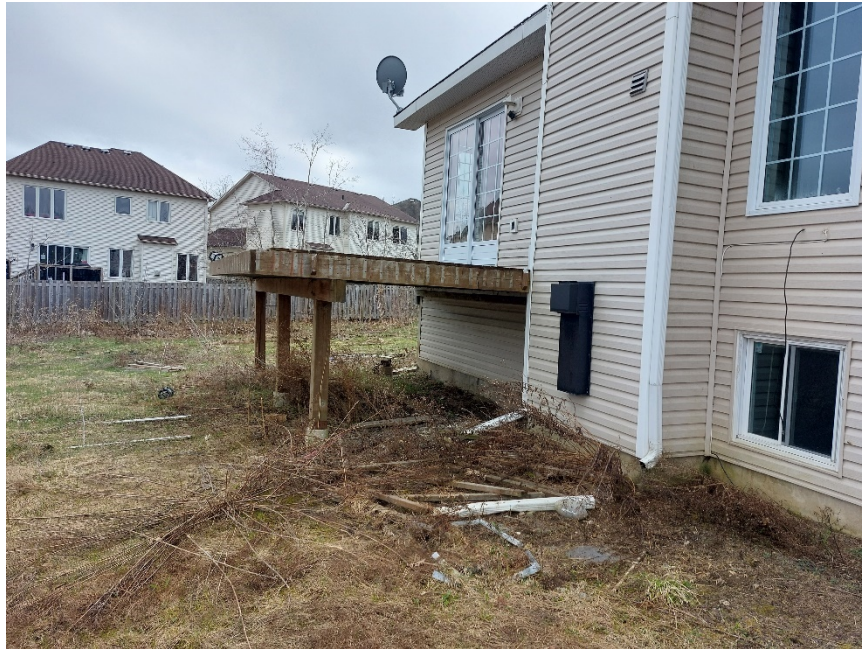
Photograph No. 5

View of the east side of the building.

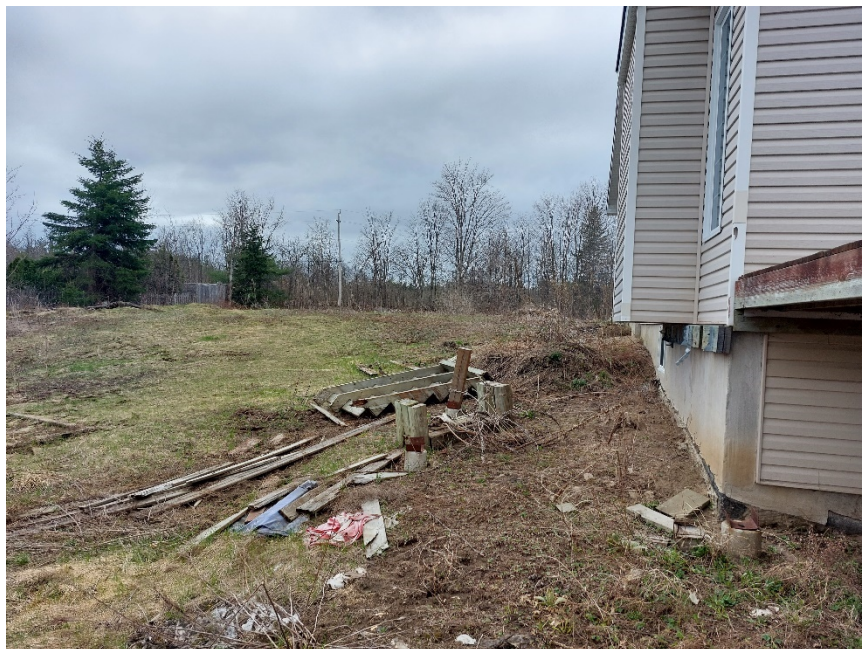
Photograph No. 6

View of the south side of the building and property

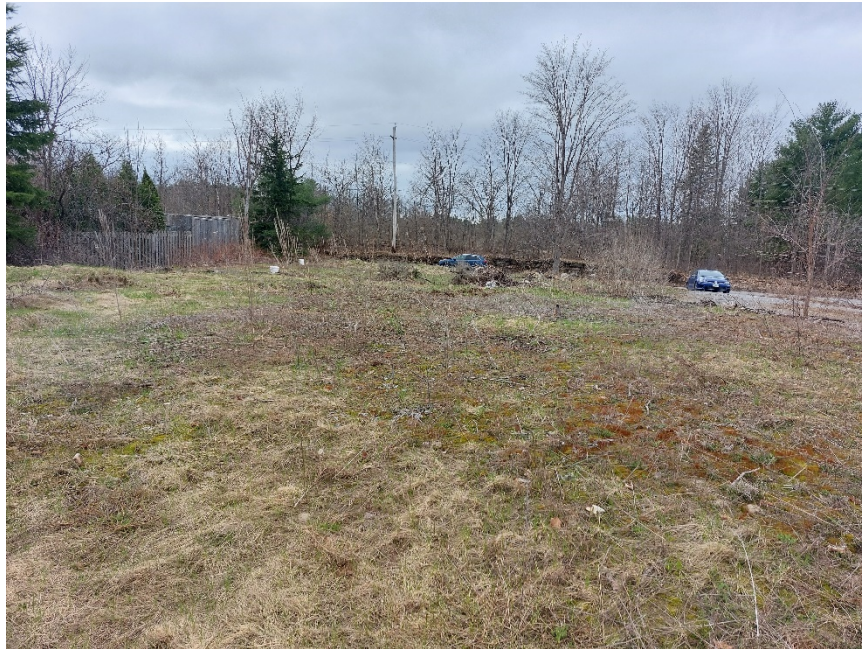
Photograph No. 7

View of the southwest part of the property.

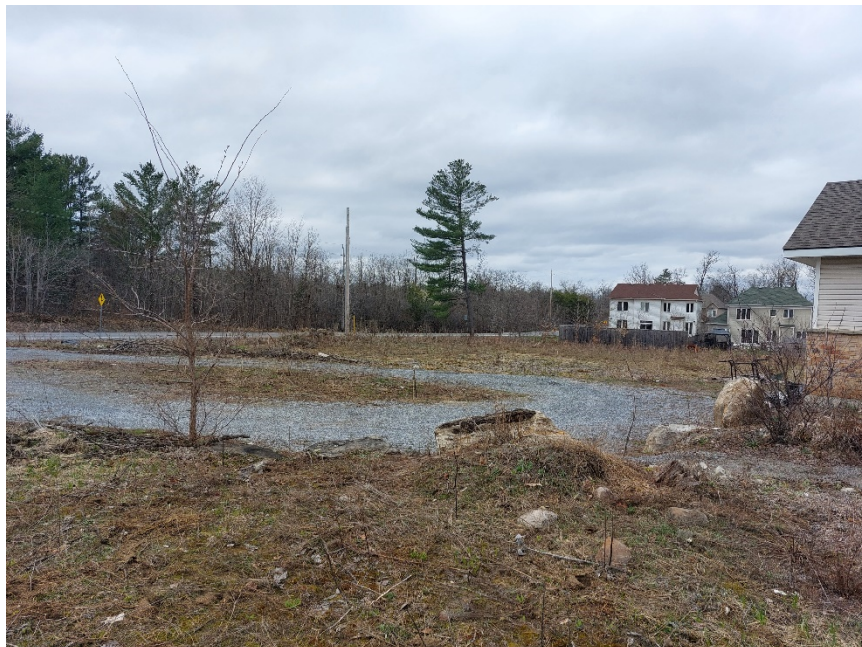
Photograph No. 8

View of the northwest part of the property.
