Landslide Hazard Assessment

Proposed Multi-Storey Building

3030 Saint Joseph Boulevard
Ottawa, Ontario

Report PG6609 - 2 dated February 12, 2024

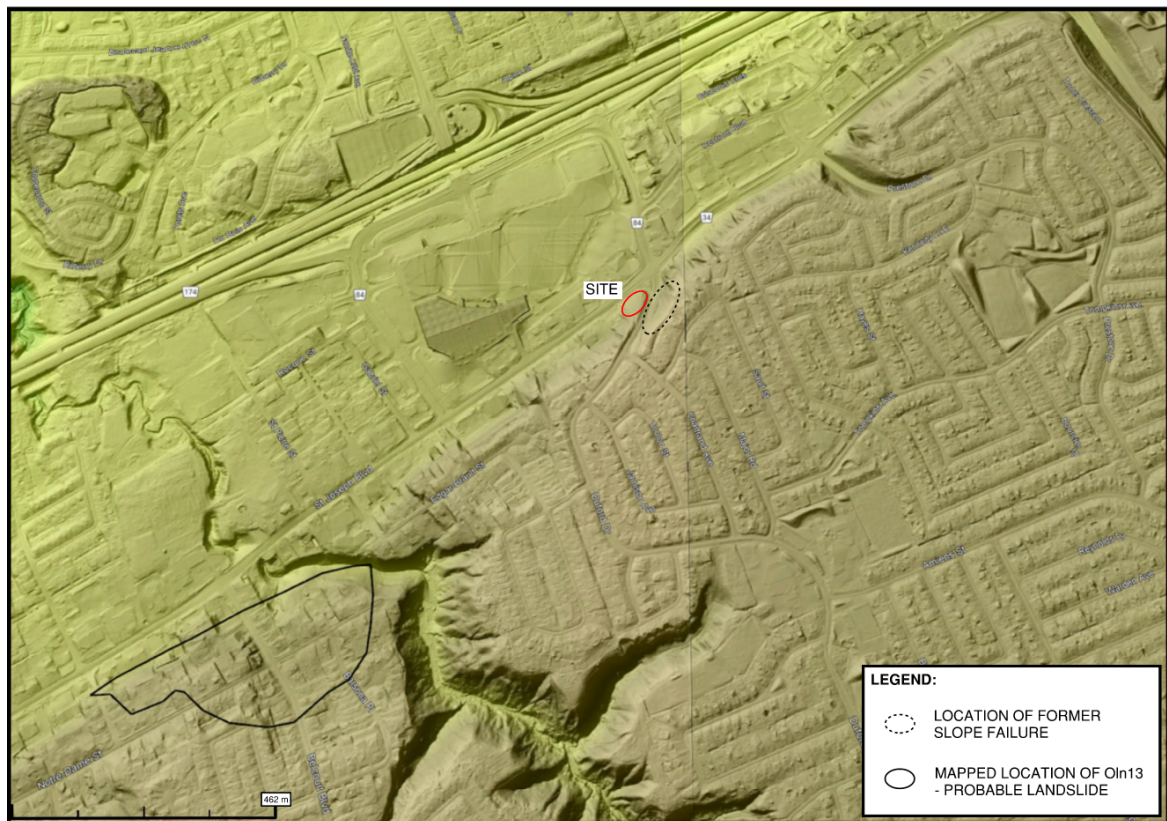
Figure 1 – LiDAR Image of Subject Site and closest landslide and slope failure.

Landslides Oln10, Oln11, Oln12 and Oln13 are located approximately between 0.7 and 2.2 km to the southwest of the subject site. Landslide Oln13, characterized as probable, is the one located closer to the subject site and has been depicted in Figure 1, included below for reference. The totality of the group has been reported by GSC to have retrogressed into the scarp slope above a terrace surface of the proto-Ottawa River (GSC OF8600, 2019).

The totality of the group is heavily altered by urban development which results in challenges to complete a thorough characterization of the landslide scar. However, it can be estimated that the aforementioned landslides experienced a topographic relief of approximately 20 m.

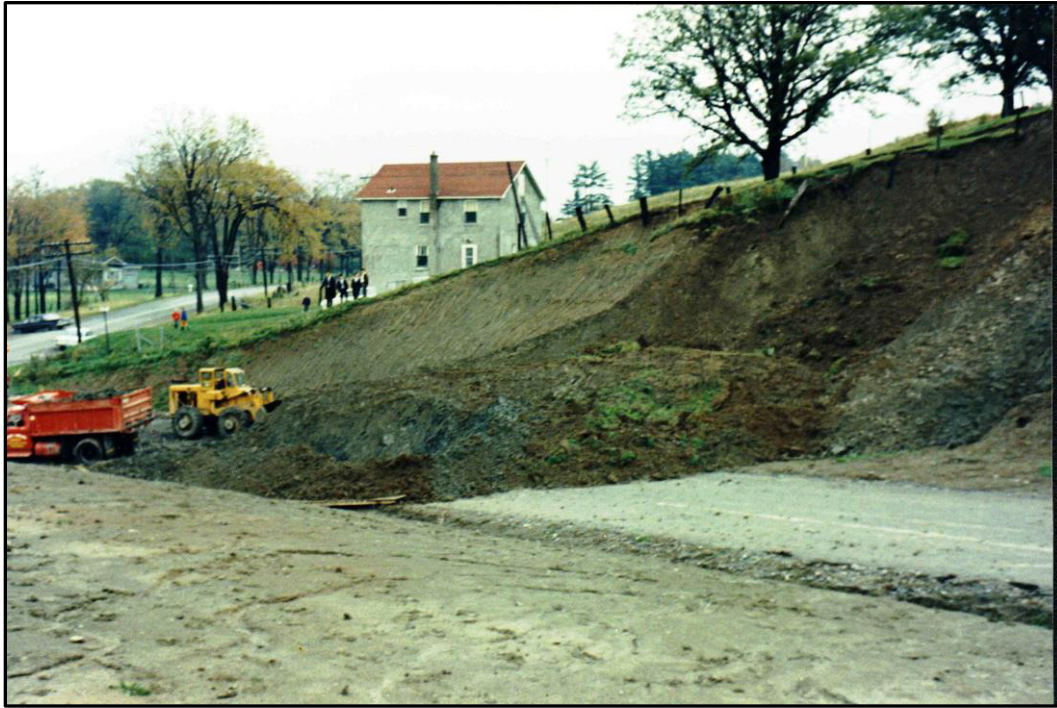
Section C was located within a former slope failure area. It is understood that a slope failure occurred along the east side of Duford Drive in the 1960s. Photographs of the slope failure were provided to Paterson for this response. Photographs 1 and 2 presented in Appendix 2 show a shallow slope failure across a limited section of overall slope face. Based on slope features noted in the photographs, such as lack of vegetation across the slope face and the soil surface in the area of Duford Drive, it appears that the slope failure occurred across a section of the slope, which had been recently re-shaped as part of the construction of Duford Drive.

The natural grade of the slope face was drastically changed during the construction of Duford Drive. It is expected that the slope failure can be directly contributed to the steepness of excavated slope face along with exposure to precipitation events before a vegetative layer could establish. It should be further noted that a vegetative layer across a slope face promotes surficial run-off during precipitation events and limits infiltration of rainwater into the slope soil. Infiltration of water from precipitation events into a slope reduces overall slope stability.

Photo 1: Localized slope failure occurring in the mid 1960s adjacent to Duford Drive. Subject site is located within the foreground of the photograph. St. Joseph Boulevard is in the background. Ground surface adjacent to Duford Drive is noted to be free of vegetation, which is indicative that construction of the subject roadway section and cutting of the subject slope was recently completed. It is suspected that the exposed slope was re-shaped to an unstable slope angle as part of the construction work at that time.

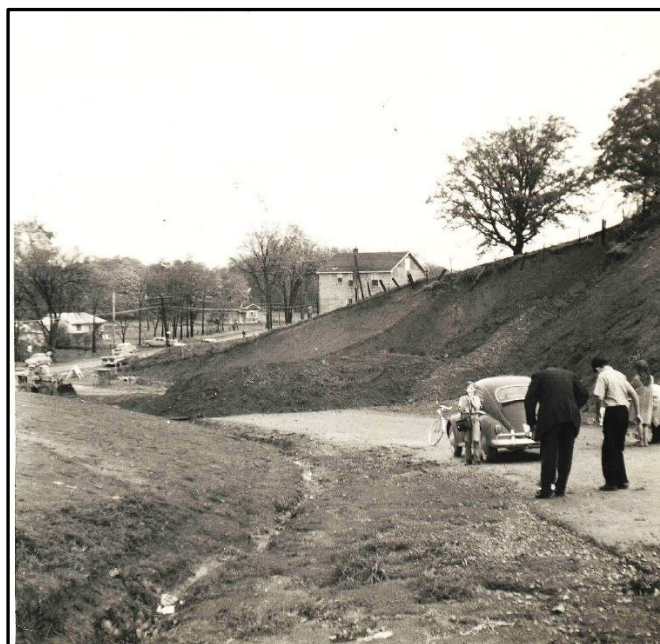
Photo 2: Same localized slope failure, which occurred in mid 1960s.

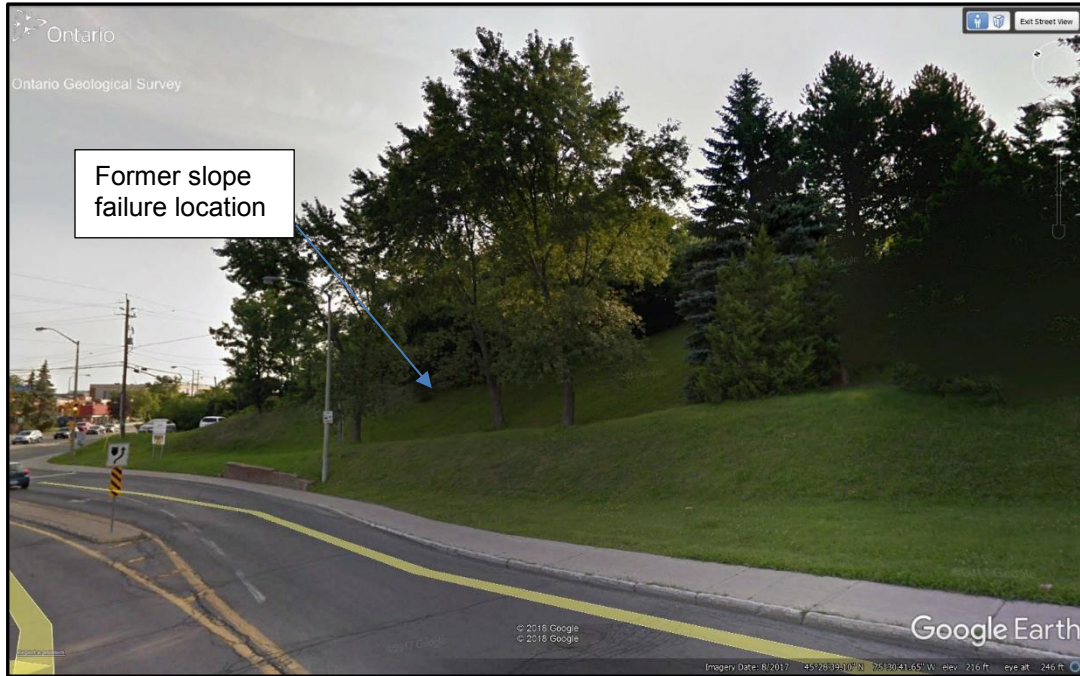
The current slope face was noted to include a terraced area along the base of the slope face in the area of the former slope failure (see Photos 3, 4 and 5 in Appendix 2). It is suspected that the terraced area was introduced after the initial slope failure to stabilize the reinstated slope. Currently, the slope face was noted to be grass covered with mature trees. No signs of slope instability were noted.

Photo 3: Street view image from Google Earth of former slope failure area (presented in Photos 1 and 2) adjacent to Duford Drive. Ground noted to be re-shaped with a terraced slope in front of reinstated slope.

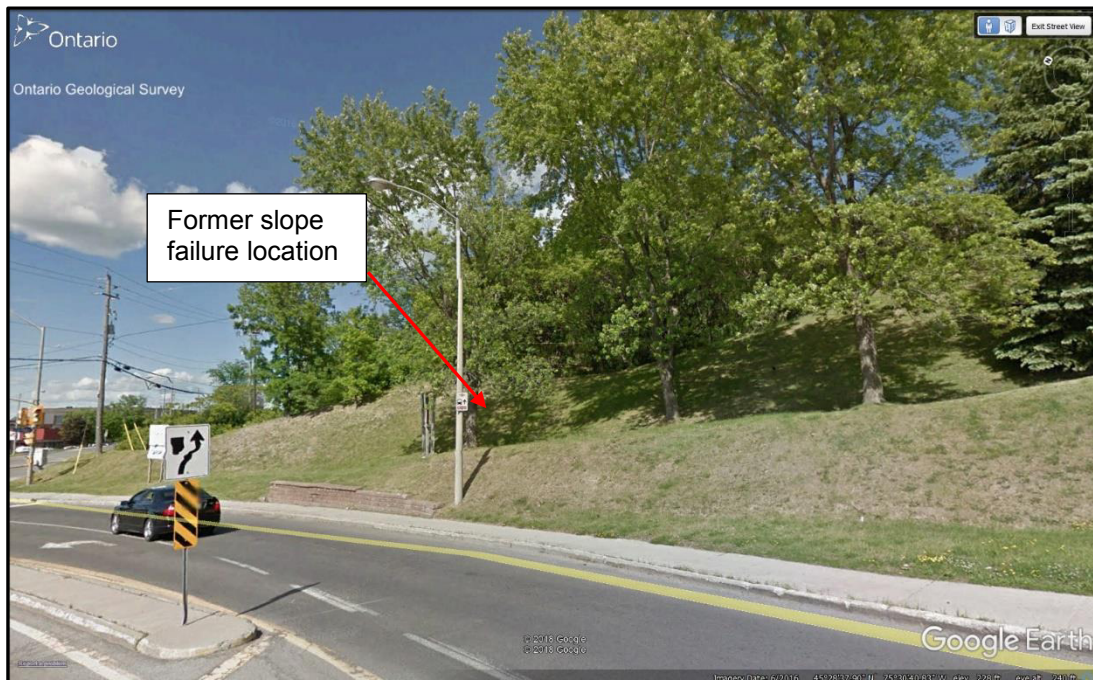
Photo 4: Street view image from Google Earth of the same former slope failure area presented in Photos 1 and 2. The ground surface is noted to be stable with no signs of slope instability.

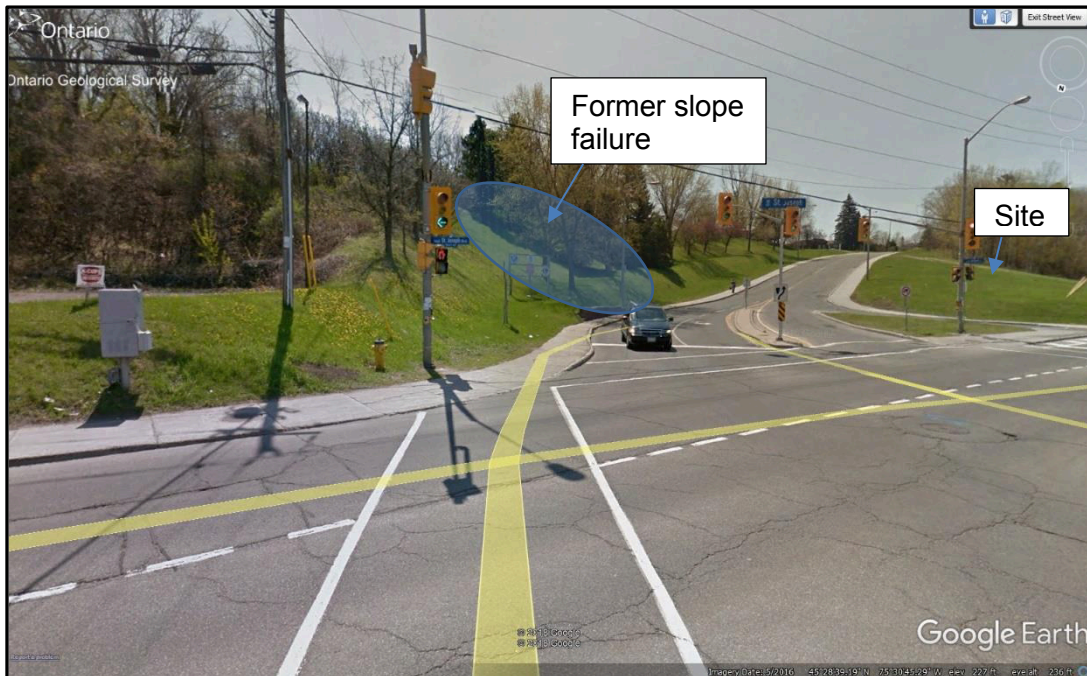
Photo 5: Area of former slope failure noted in Photos 1 and 2. Subject site is property along the right side of the photograph.
