June 5, 2023

Ref. No.: 23-215-1

Attn: Mohamed El-Koury, ing.**RE: Phase I Environmental Site Assessment Update – 788 March Road, Ottawa, Ontario**

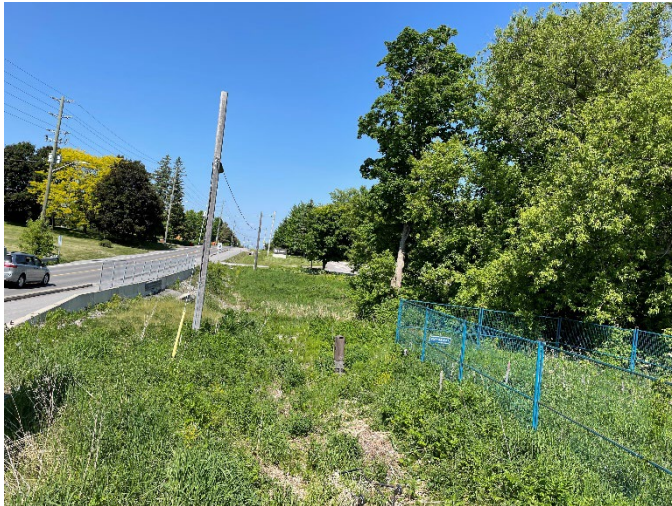
Wooded areas along Shirley's Brook had not been touched by construction activities and remained unchanged.

Looking east towards Shirley's Creek along the northern boundary

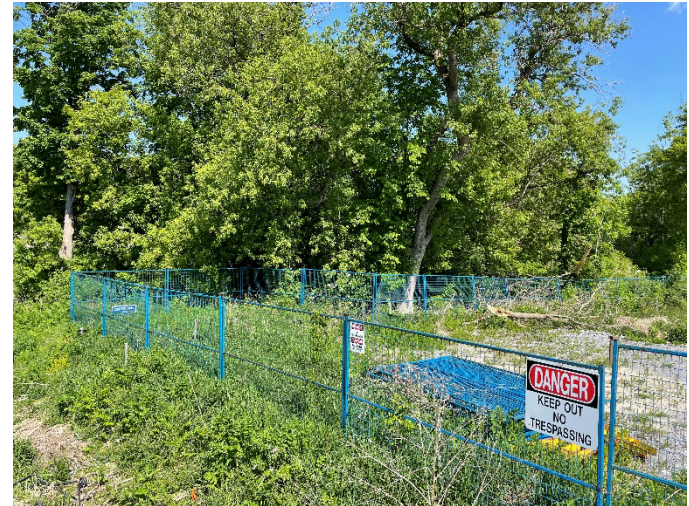
Looking at the northeast corner of the site from the access road along Klondike Road

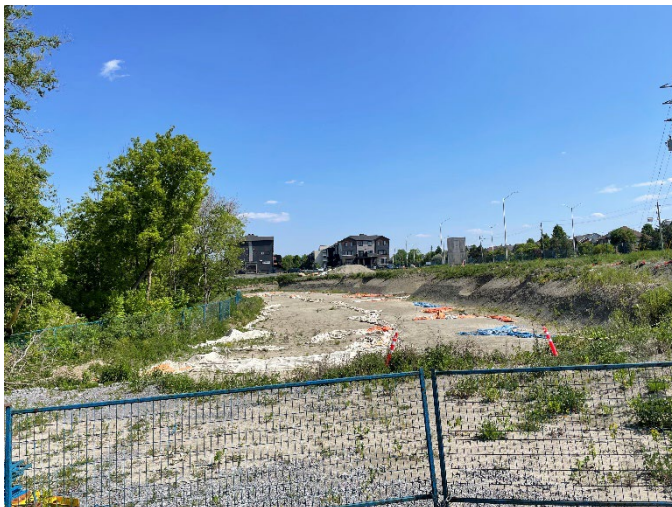
A large excavation was observed on the site in the area of the proposed building footprint. Two access roads were visible onto the property, one from March Road and one from Klondike Road. Both access roads appeared to contain imported gravel. The excavated construction area was surrounded with temporary metal construction fencing, limiting access to that area of the site. The excavation was generally flush with the landscape along the eastern edge of the building and Shirley's Brook. The western edge of the excavation was cut deep into the natural landscape as March Road is at a higher elevation than Shirley's Brook. Remnants of tarps were visible in the bottom of the excavation. Potential wooden survey markers were also visible in the bottom of the excavation and the bottom appeared smoothed and tamped flat in preparation of the building.

Looking south across the site from the access road along Klondike Road at the excavation area

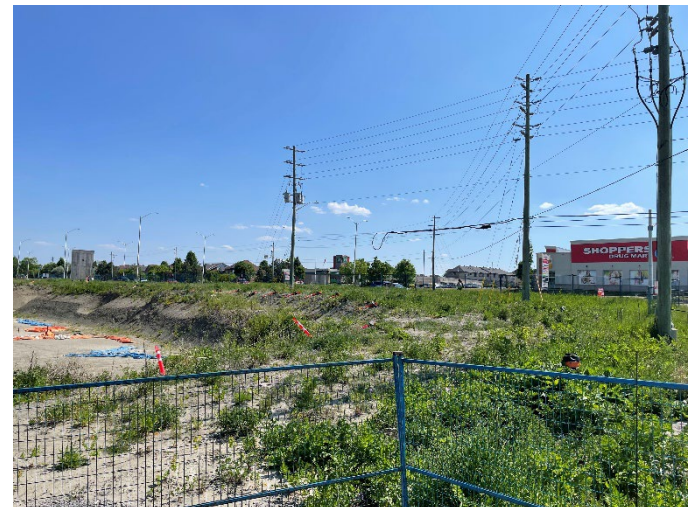
Looking west towards March Road, and the western boundary

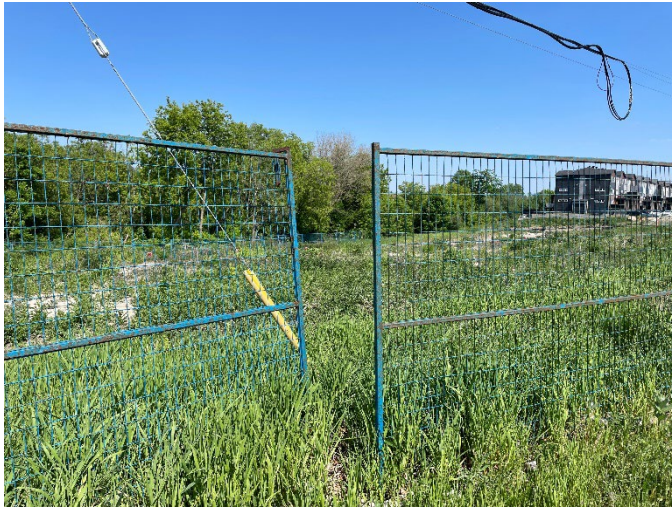
Looking southeast across the site at a break in the fence along March Road

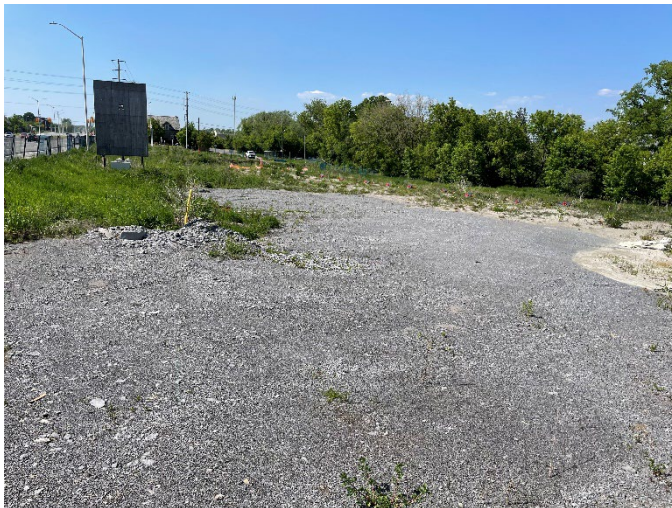
Looking north along the western boundary of the site and gravelled access area

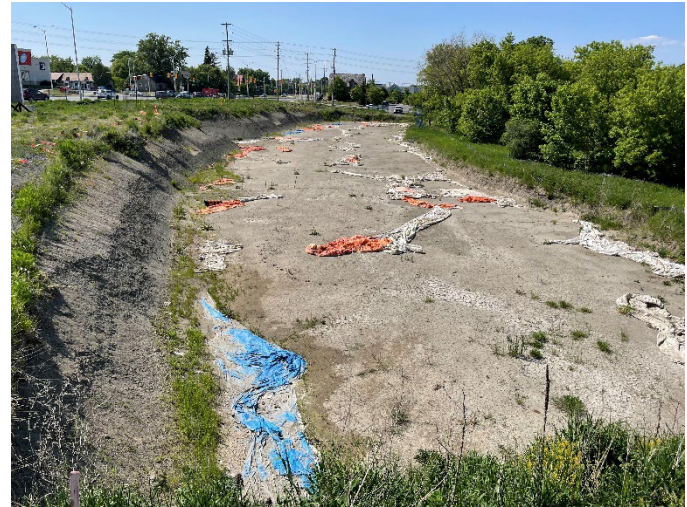
Looking north across the site from the southern boundary at the excavation area

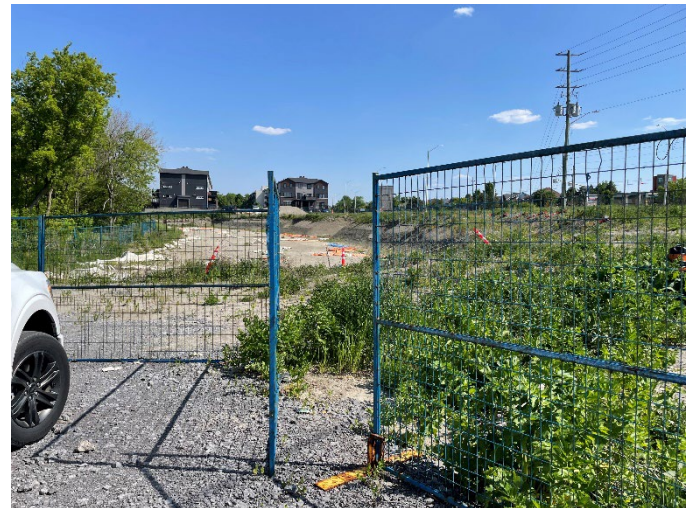
Looking south at the break in the fencing at the access road along Klondike Road
