September 20, 2022  
Project No.: 1954004.06

**Re: Landslide hazards affecting 3459 and 3479 St. Joseph Boulevard**

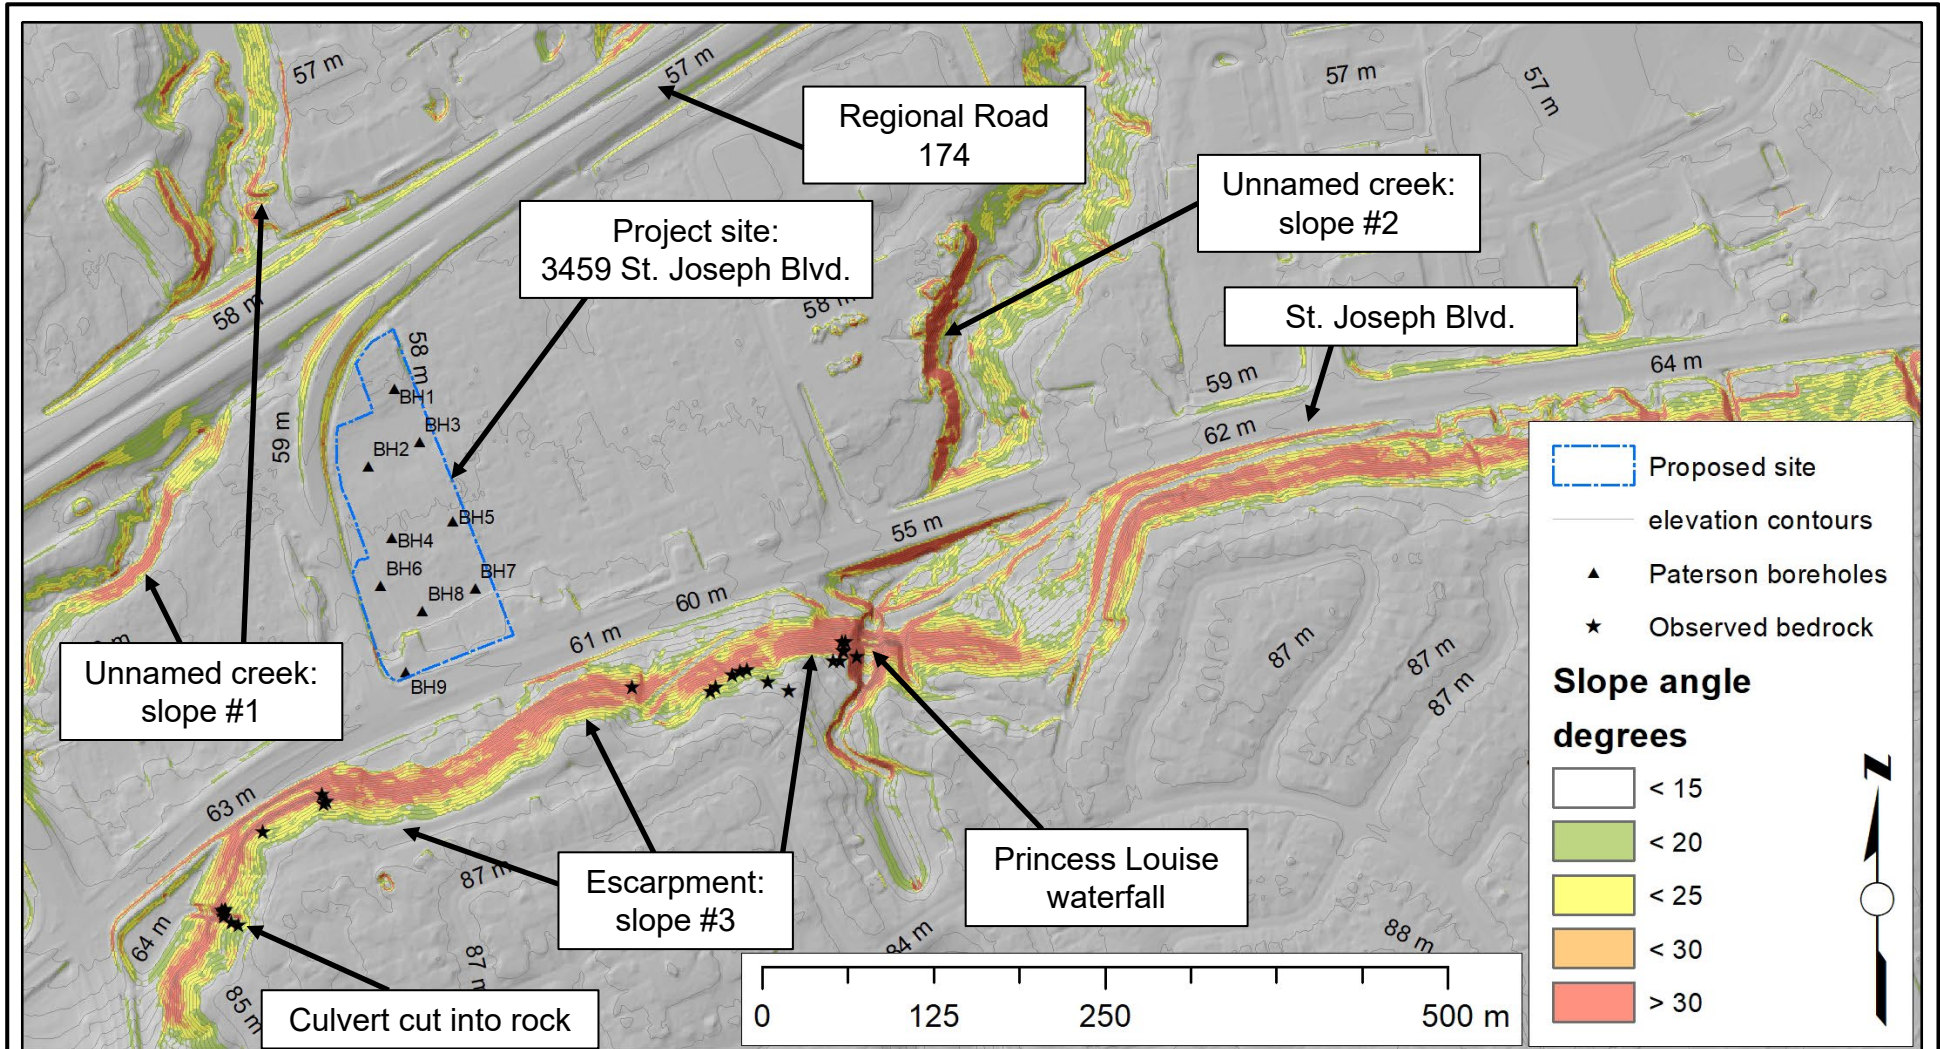
The proposed development site is located in the Orleans area of eastern Ottawa, Ontario, and is located south of Regional Road 174, north of St. Joseph Boulevard and immediately east of a ramp between those two roads. Figure 01 shows the approximate extents of the proposed development and the borehole locations as interpreted from Paterson (November 6, 2019).

1. An unnamed creek approximately 100 m west of the site flows east-northeast toward Ottawa River (see Figure 01). Creek valley slopes are typically 10 to 12 m high. Fill is present west of the creek valley, north of Regional Road 174, with anthropogenically modified slope heights on that side of the valley up to approximately 15 m. Maximum slope height is approximately 12 m on the east valley slopes closest to the project site.

2. A second unnamed creek approximately 350 m east of the site, with maximum slope height < 15 m, also shown in Figure 01. The natural slopes along this creek valley are typically < 10 m high. The nearest slope along the west side of the creek valley immediately north of St. Joseph Boulevard appears to have been modified through fill placement, resulting in locally steeper slopes up to approximately 15 m.

3. An escarpment immediately south of St. Joseph Boulevard, > 50 m from the southern perimeter of the site with slope height > 25 m, also shown in Figure 01.

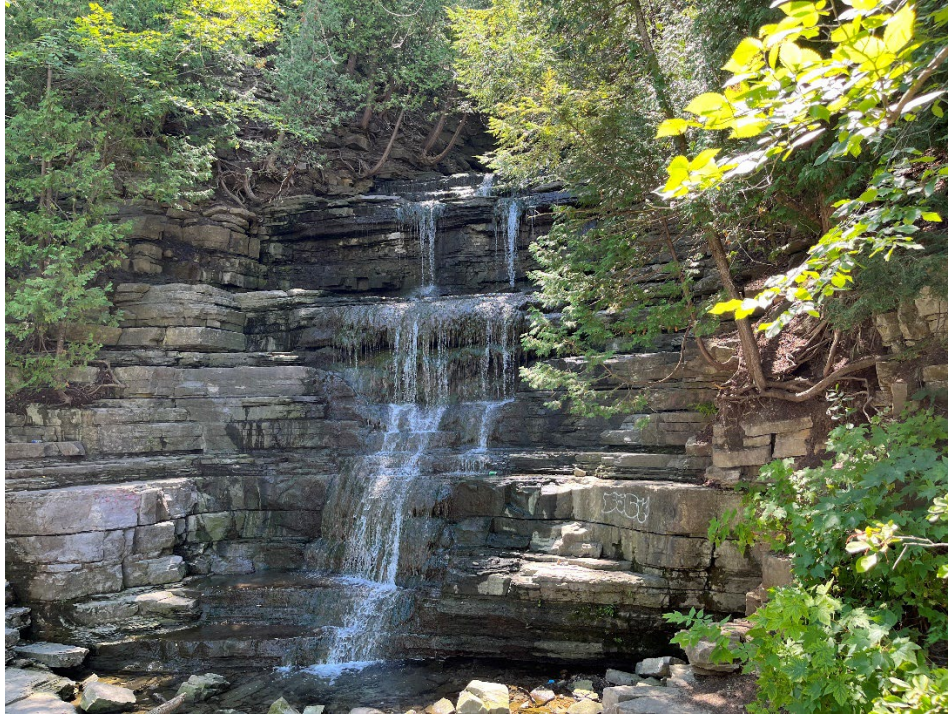
BGC conducted a ground traverse along the escarpment slope south of St. Joseph Boulevard, starting at the location of Princess Louise waterfall (see Figure 02 and Photo 1), and progressing west beyond the point where the escarpment curves to the southwest. BGC observed horizontally bedded limestone bedrock in several locations along the crest of the slope; these observation locations are shown on Figure 02. BGC observed the top of bedrock at approximately 83 m elevation near Princess Louise waterfall (Photo 2) and 80 m near the western end of the traverse at a culvert outlet discharging onto rock (Photo 3). Observations made along the traverse suggest that top of bedrock is at or above elevations with slope angle > 30 degrees, suggesting a minimum elevation of top of bedrock of 80 m along the length of the traverse. Ground elevations along the upland south of the escarpment slope crest range from 85 to 87 m, suggesting a maximum thickness of 7 m of overburden above bedrock, ranging from 0 m at the east end near the waterfall.

**Photo 1. Princess Louise waterfall (see Figure 02). Photo taken by BGC 2022-08-15.**

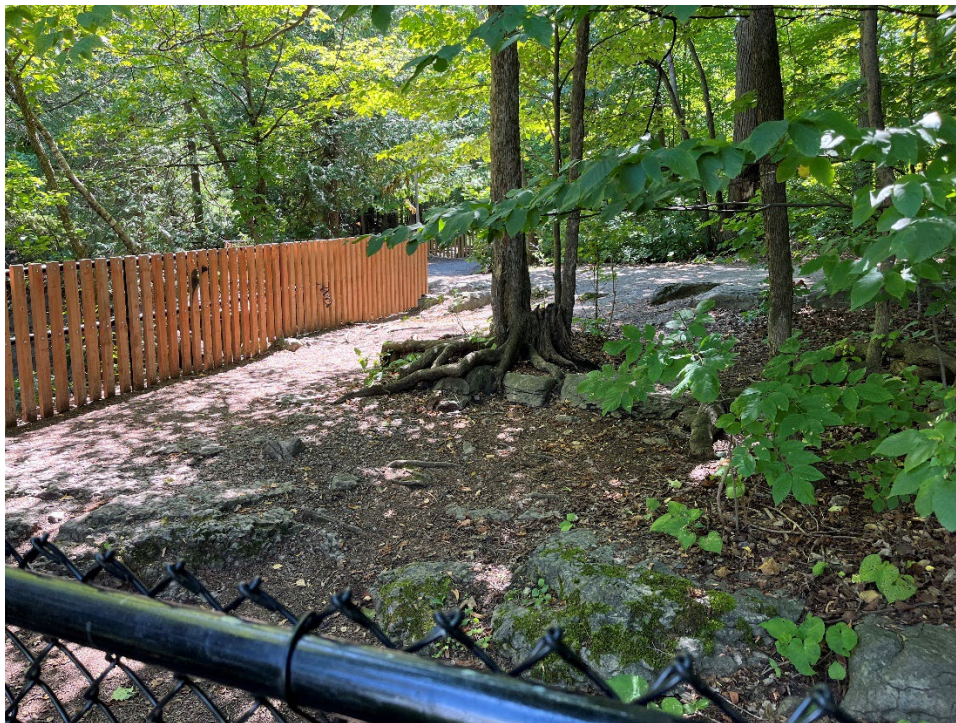
**Photo 2. Bedrock at the ground surface above the slope crest west of Princess Louise waterfall at an approximate elevation of 83 m (see Figure 02). Photo taken by BGC 2022-08-15.**

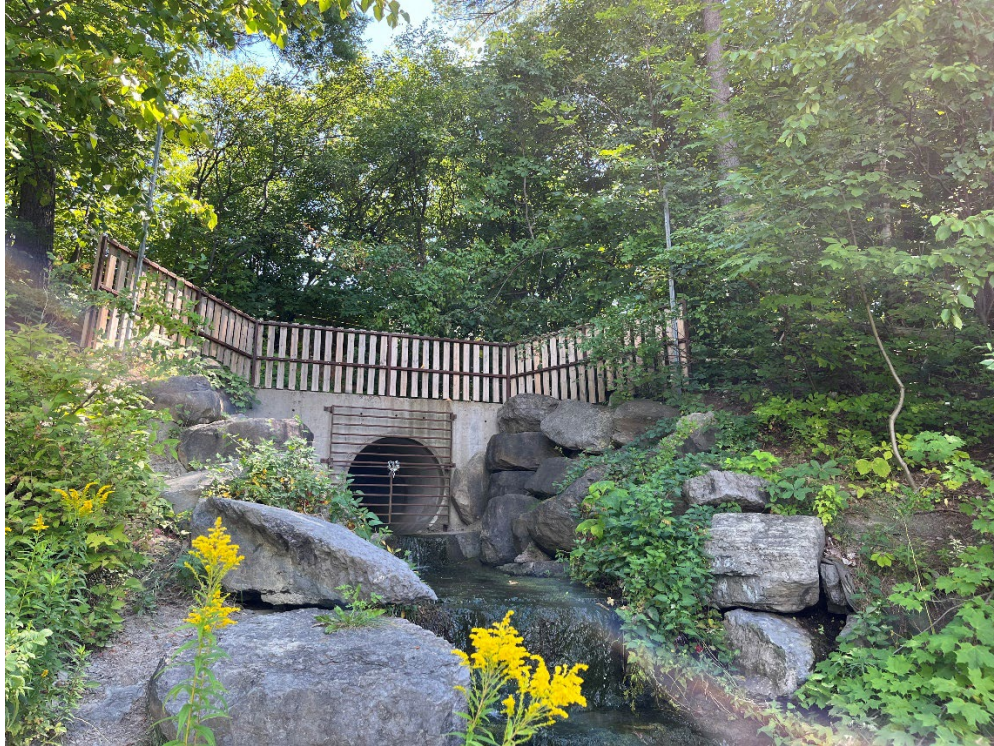
**Photo 3. Culvert outlet with discharge onto bedrock at an approximate elevation of 80 m (see Figure 02). Photo taken by BGC 2022-08-15.**
