July 23, 2019

File: 64153.85 – R01

**Re: Slope Stability Assessment and Meander Belt Setback  
Proposed Residential Subdivision  
1055 Klondike Road  
Ottawa, Ontario**

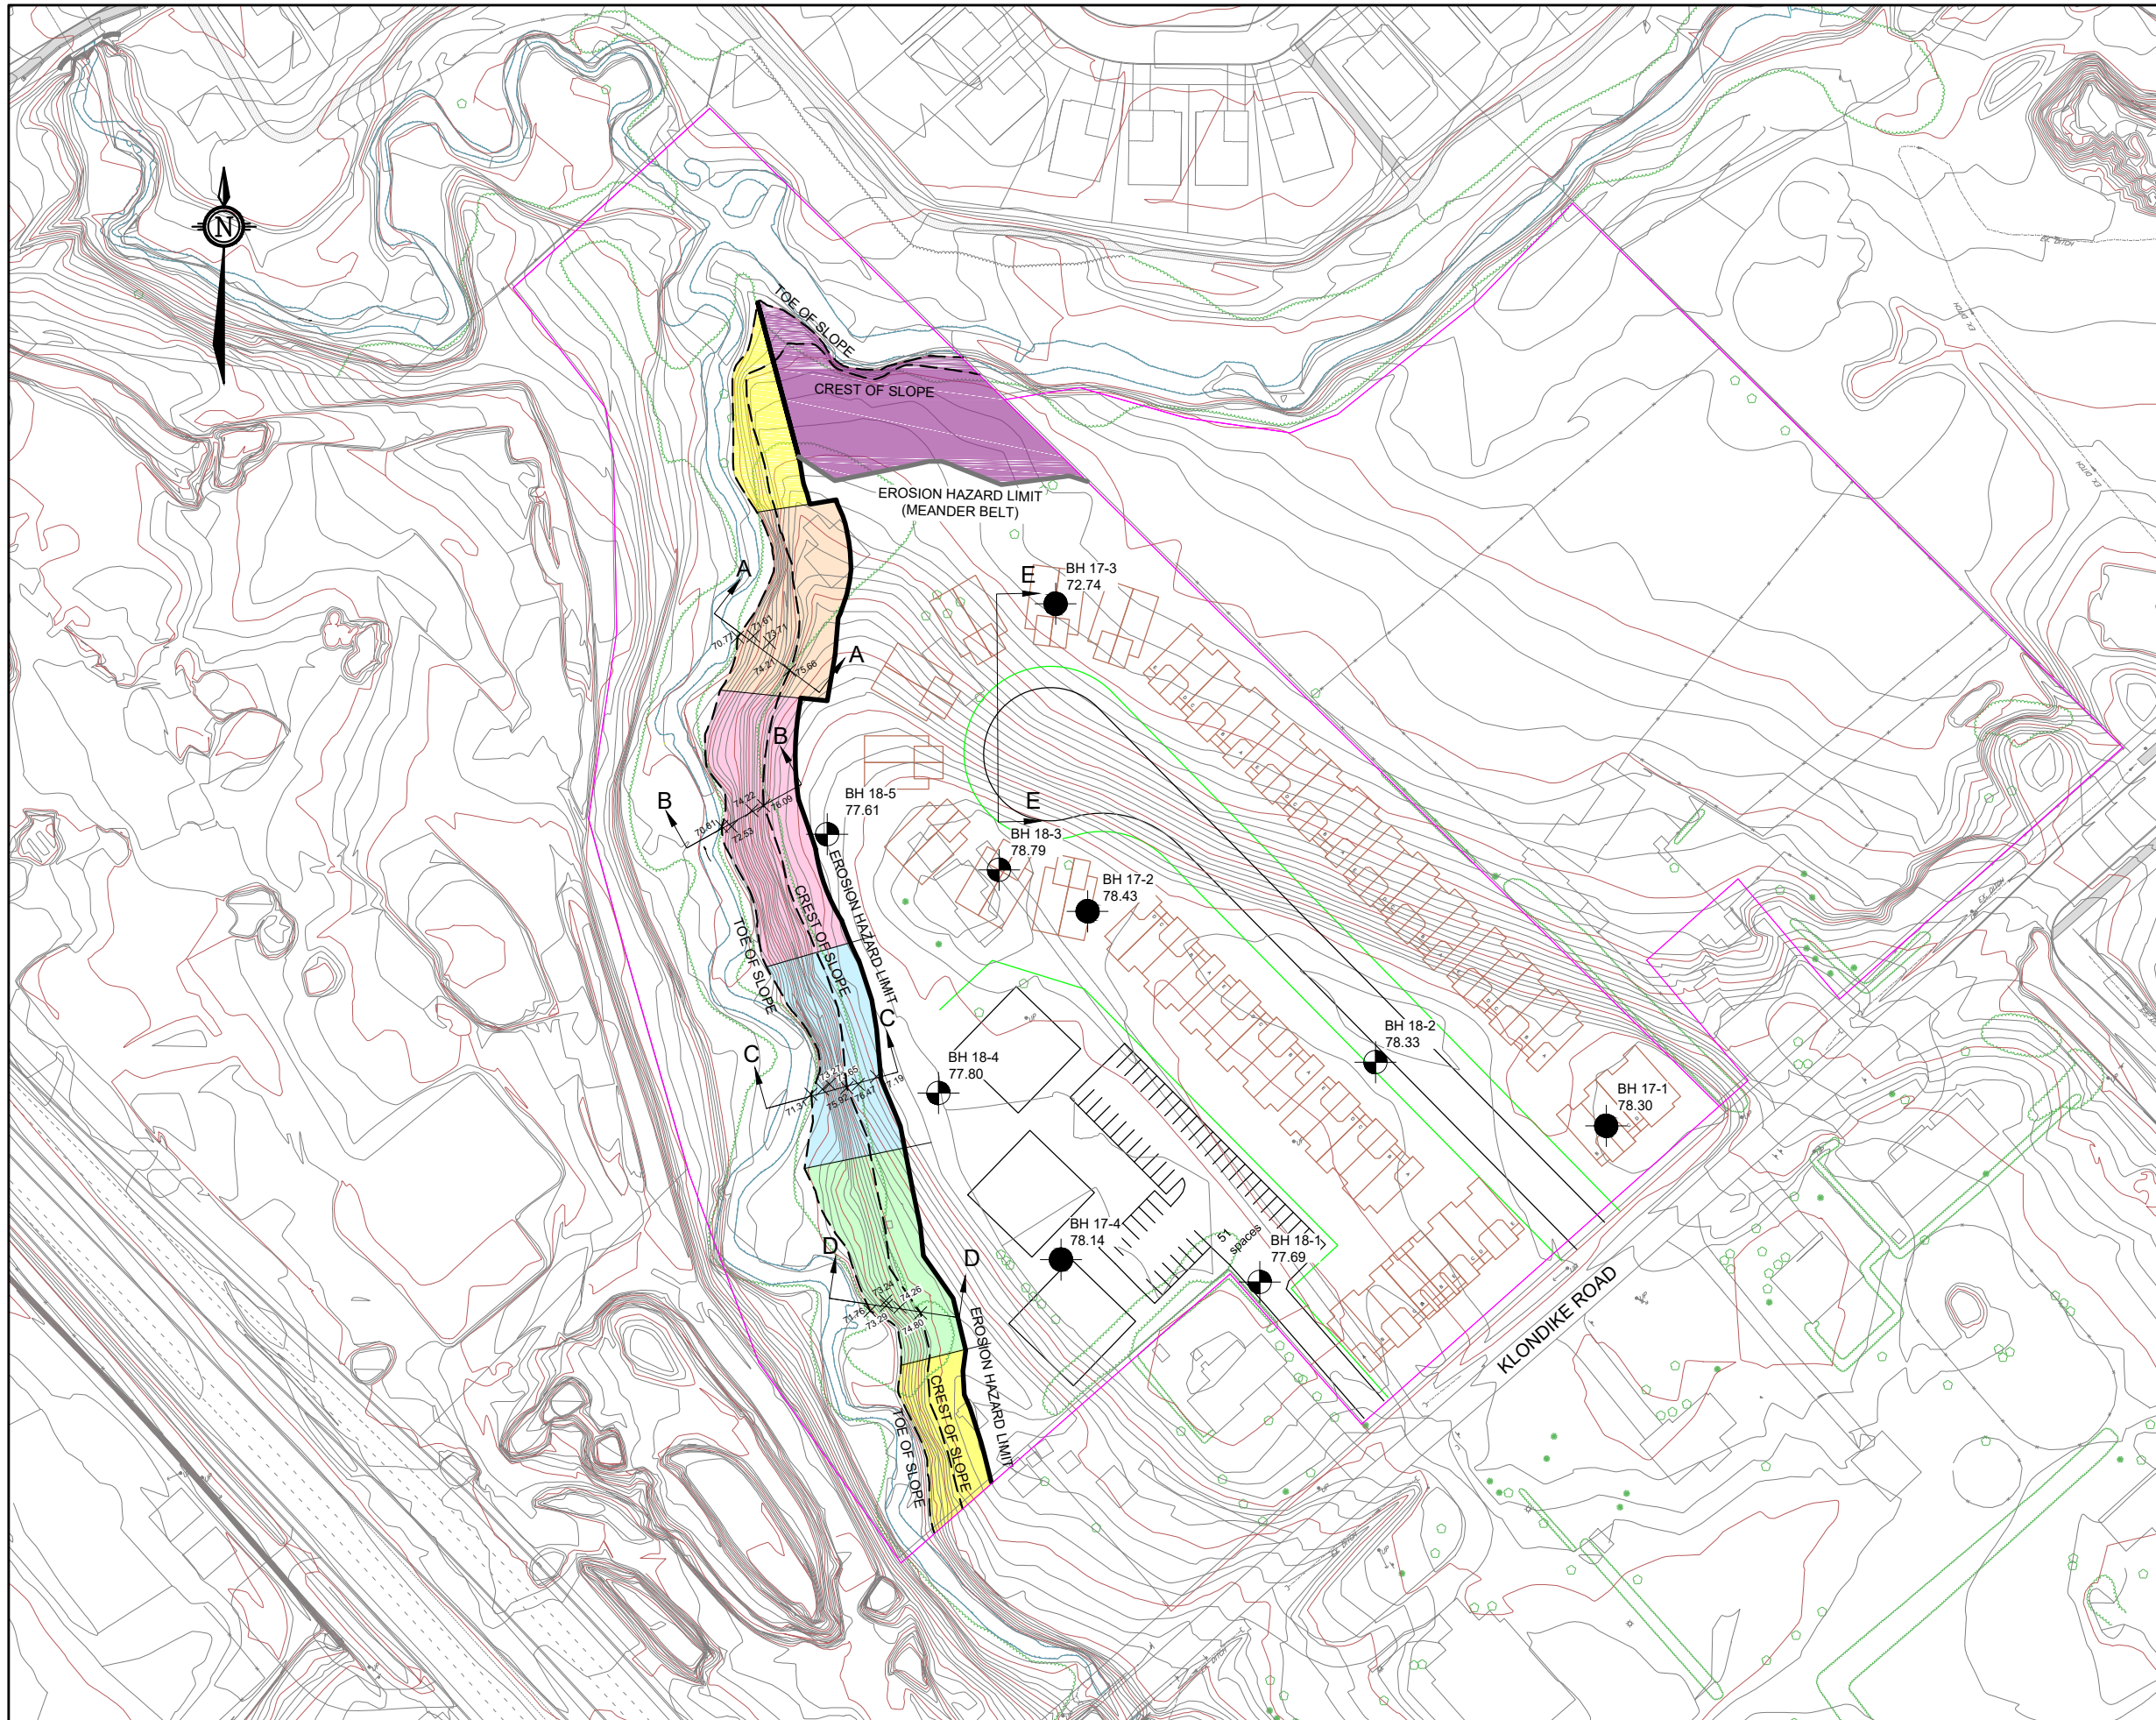
Client	NOVATECH	Project	64153.85
Location	1055 KLONDIKE ROAD OTTAWA, ONTARIO		
Drwn by	Chkd by	EROSION HAZARD LIMIT PLAN	
P.C.	G.D.		
Date	JULY 2019	Rev.	2
			<b>FIGURE 1</b>

Based on the results of the slope stability analyses, the extent of the Hazard Lands, as defined by the MNR, is summarized in Table 3 and shown on Figure 1.

- 5) Area 6 includes a 27.5 metre setback from the creek, which is half of the 55 metre Meander Belt width determined as part of previous studies by others. From a geotechnical perspective, there are no slope stability concerns in this area.

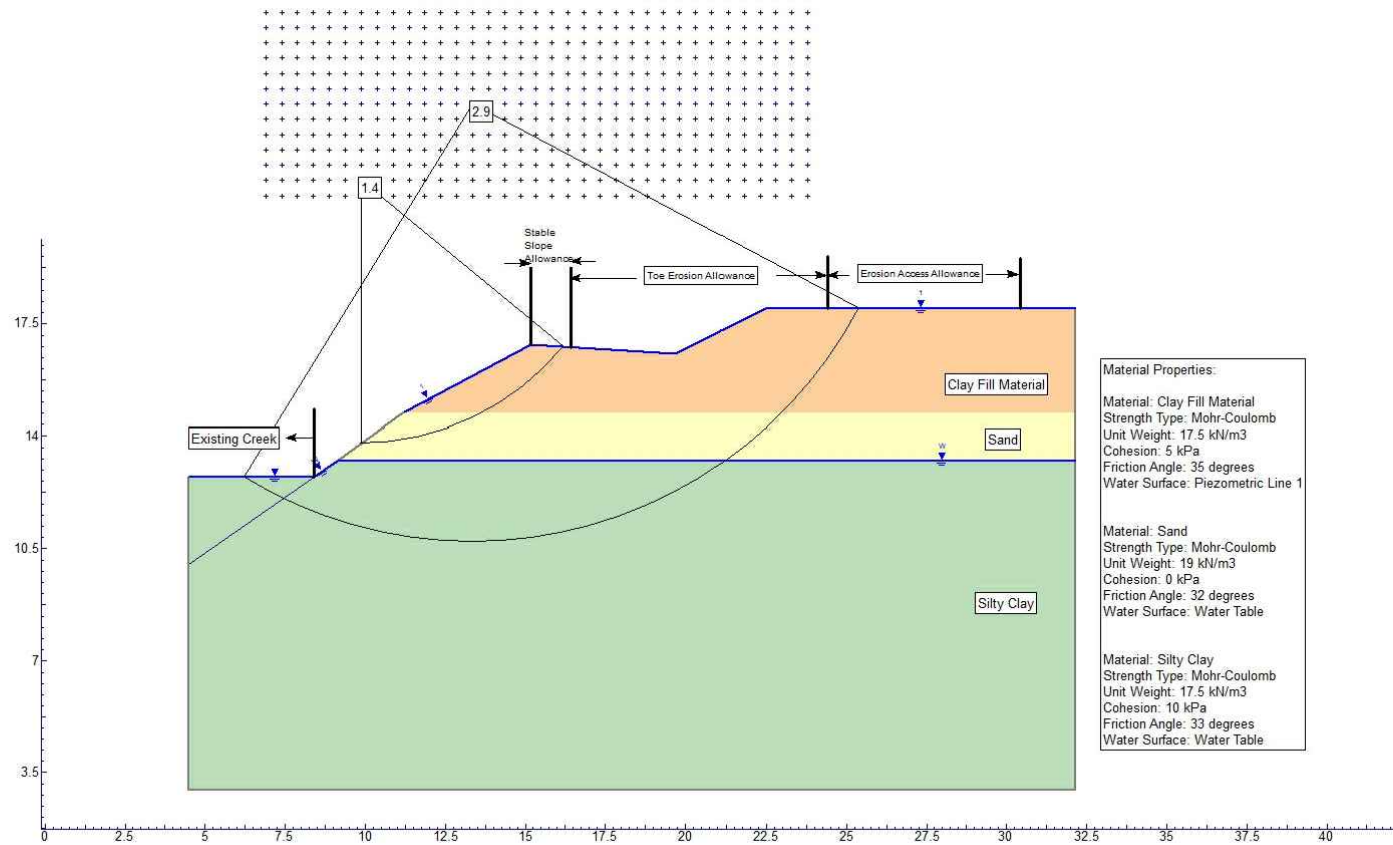
Based on the results of the analyses, the existing slopes at Sections 'B-B', 'C-C', 'D-D' and 'E-E', in their current configurations, are considered to be stable. At Section 'A-A', the calculated factor of safety against slope instability is 1.4, which is considered marginal to adequate.

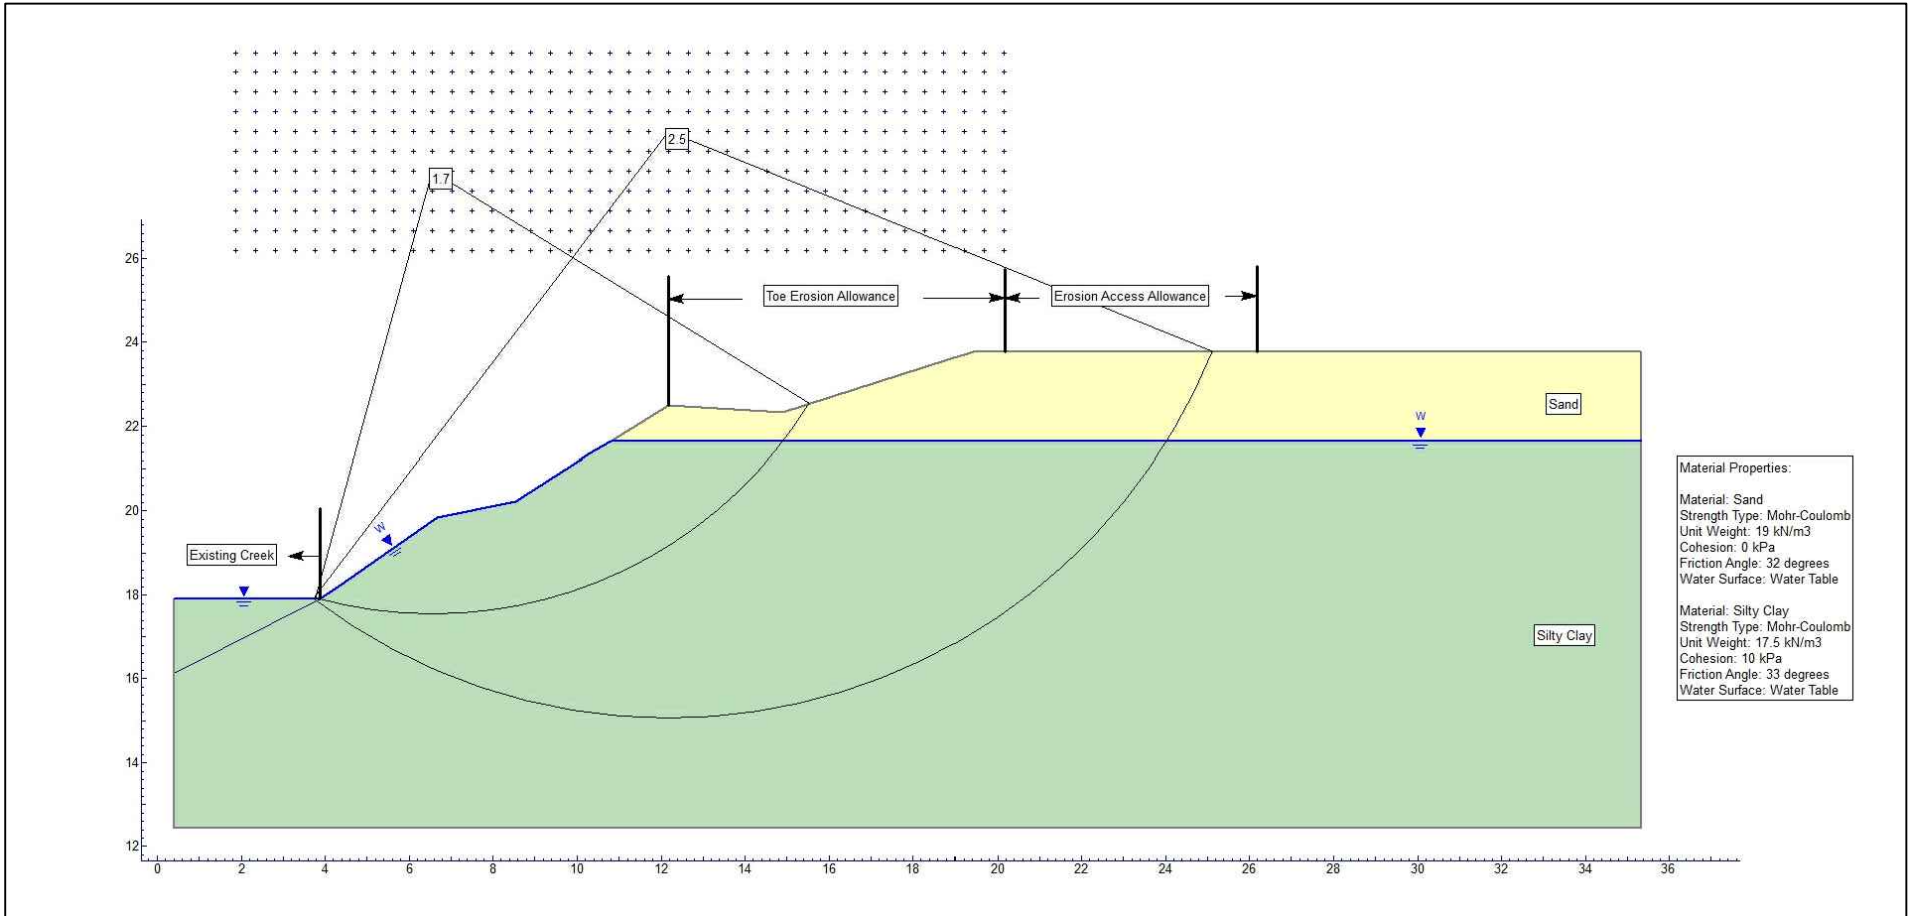
**FIGURE A3**

Existing Slope  
 (Section 'C-C')

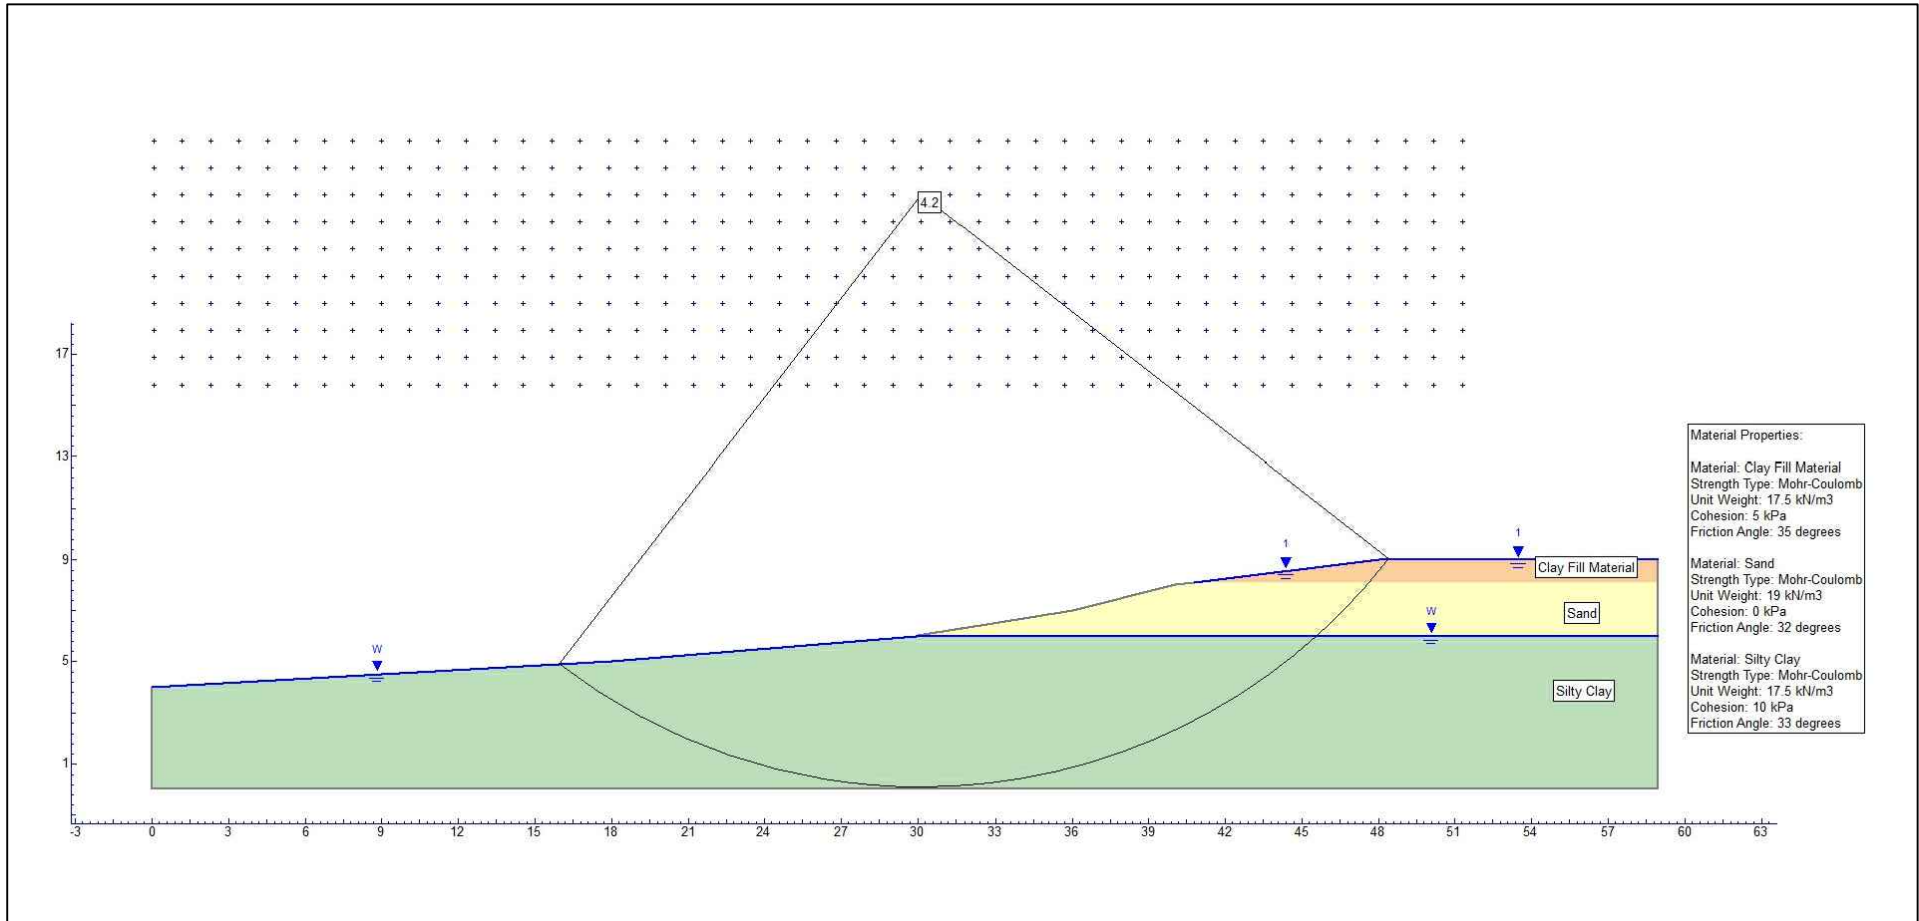
**FIGURE A5**

Based on the above information, we have included a 27.5 metre setback (half of the belt width) on the attached Figure 1 for the portion of the site where the MVCA indicated that the creek is unconfined. Also, as indicated above, we have carried out a slope stability assessment for the slope across the central portion of the site in the event that the creek migrates to the boundary of the meander belt width. The results of this assessment indicate that there are no concerns with the stability of the slope in this area (factor of safety of 4.2).

Existing Slope  
(Section 'E-E')
