**LANSDOWNE
EVENT CENTRE**

DWG. TITLE
**TREE CONSERVATION REPORT
EXISTING CONDITION**

DWG. TITLE
**TREE CONSERVATION REPORT
 PROPOSED DEVELOPMENT**

DWG. TITLE: TREE CONSERVATION REPORT
 SCALE: N.T.S.
 PROJ. NO.: CSW #1766-12
 DWG. NO.: TCR 1.2

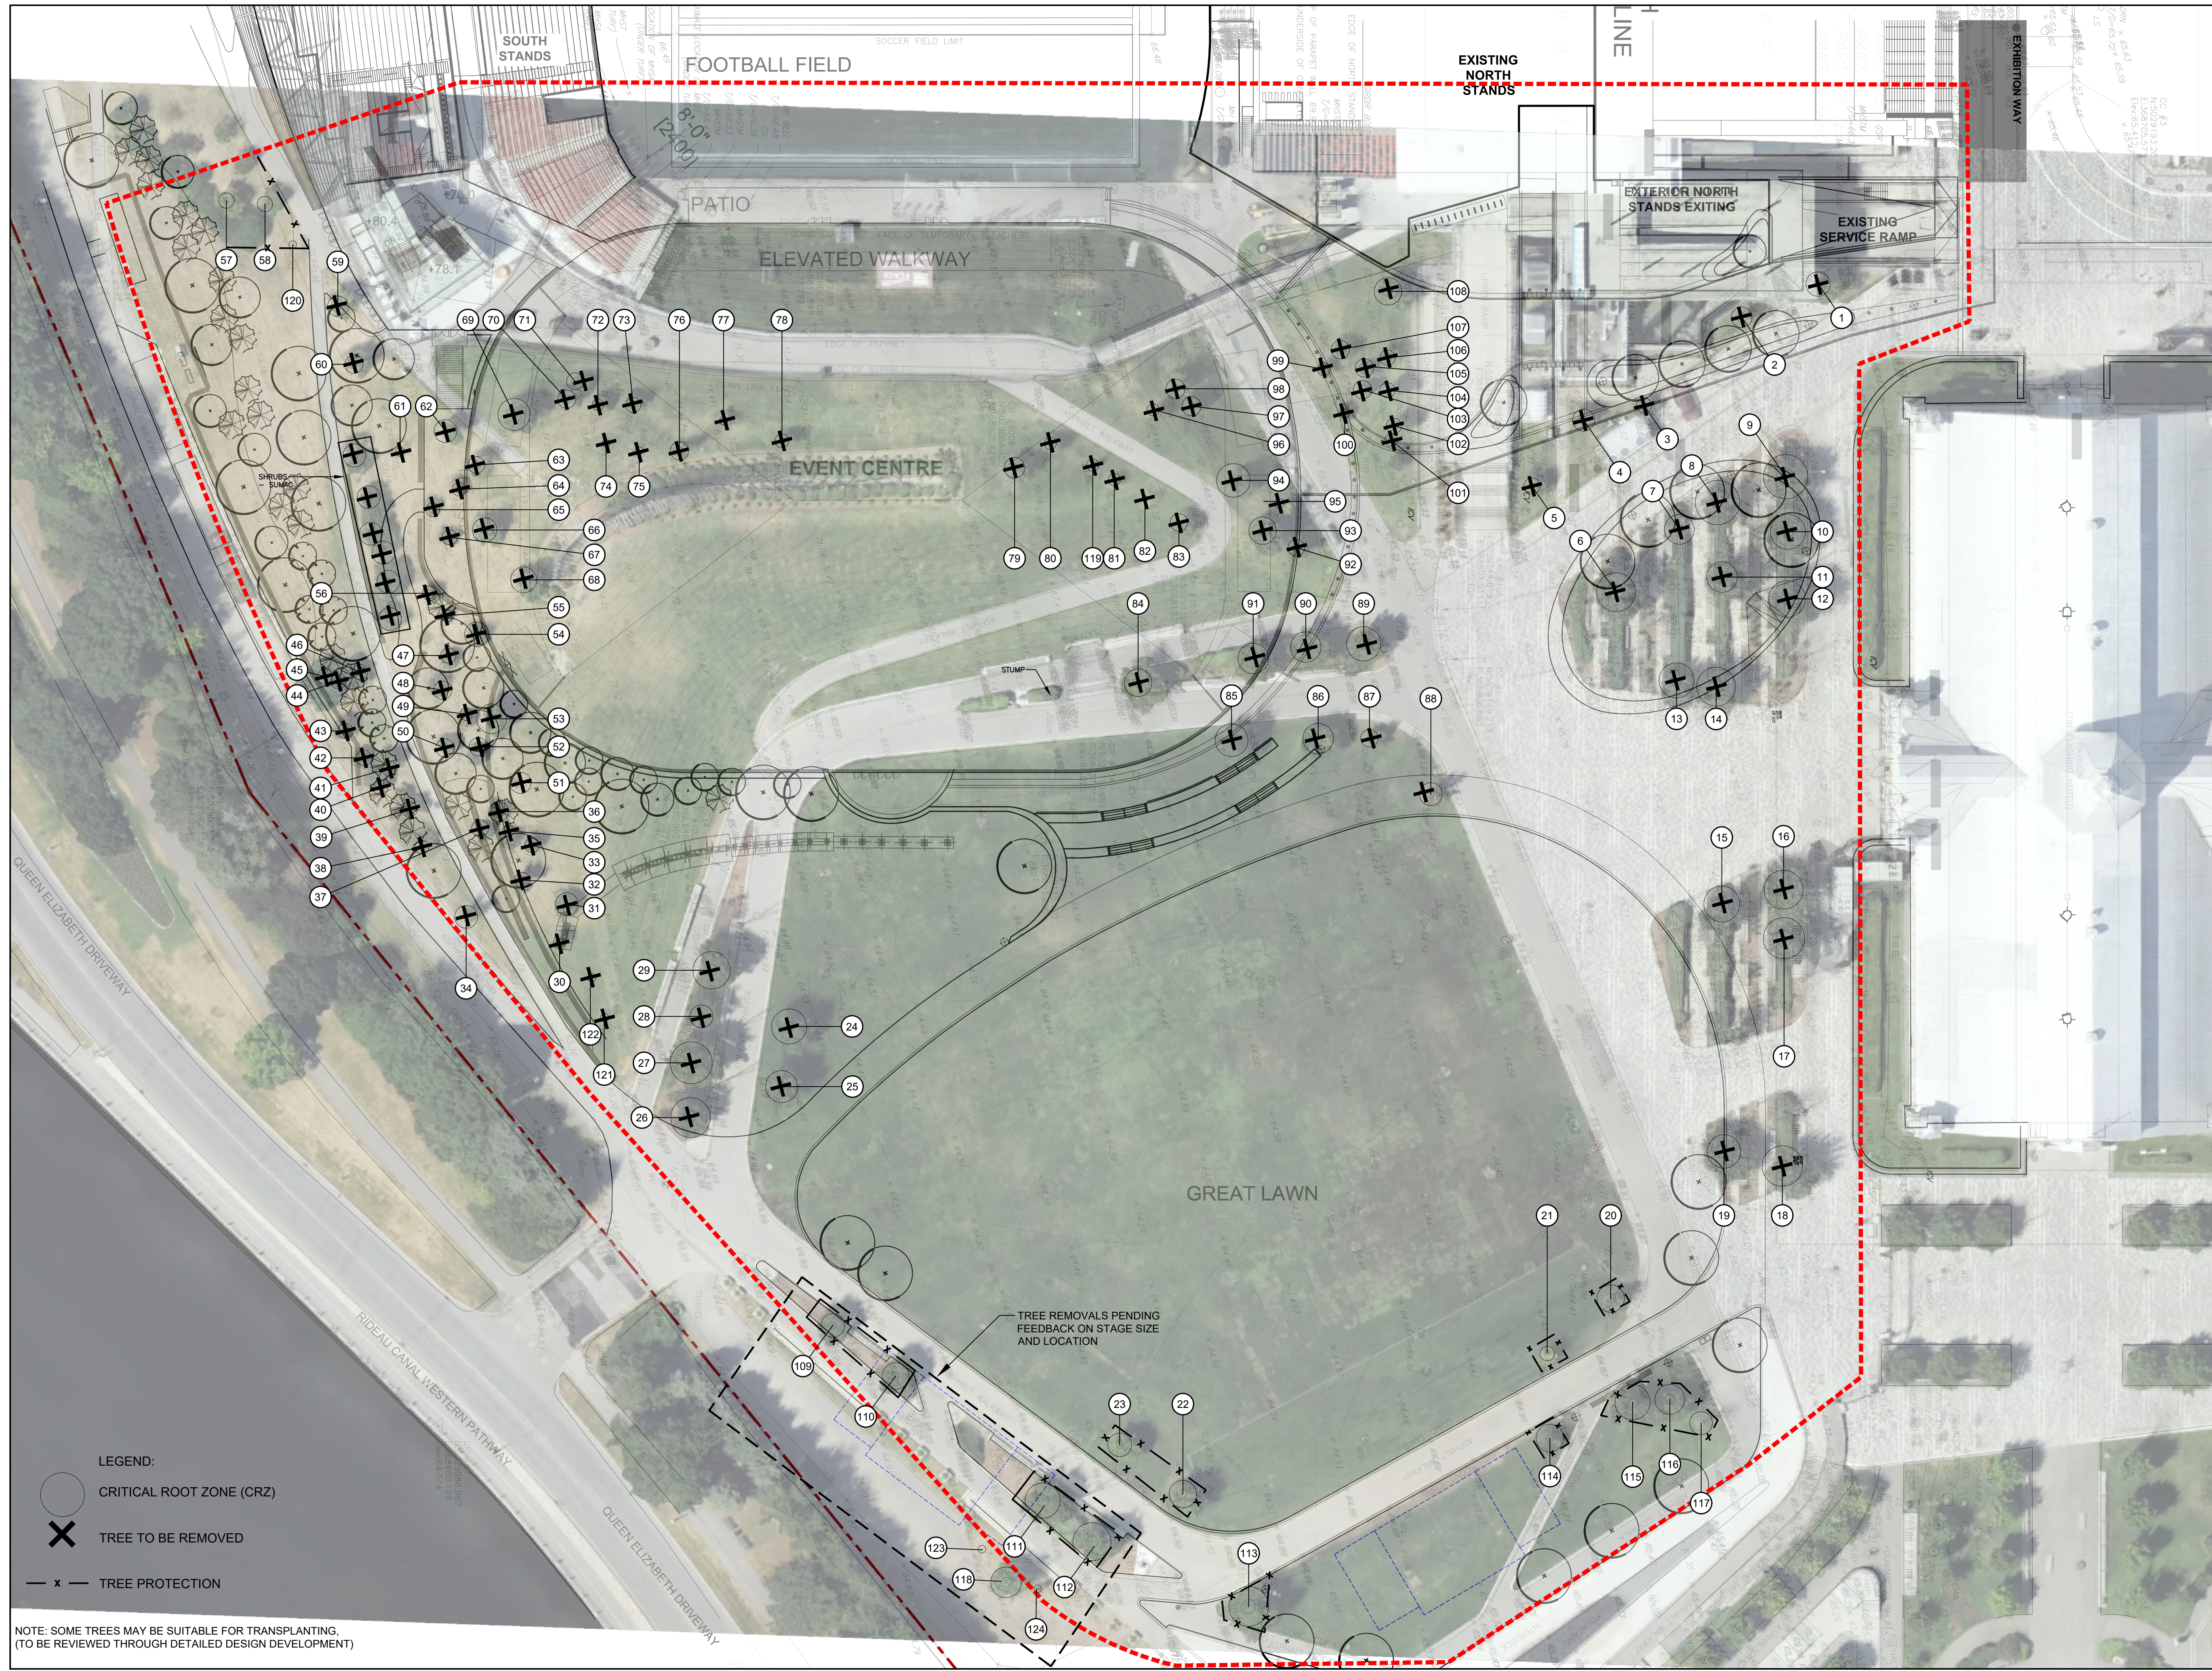
NOTE: SOME TREES MAY BE SUITABLE FOR TRANSPLANTING.
 (TO BE REVIEWED THROUGH DETAILED DESIGN DEVELOPMENT)
