Geomorphological and Erosion Assessment, Tributary of Bear Brook

6160 Thunder Road and 5368 Boundary Road
City of Ottawa

Submitted:
August 16, 2024

GEO Morphix Project No. 23111

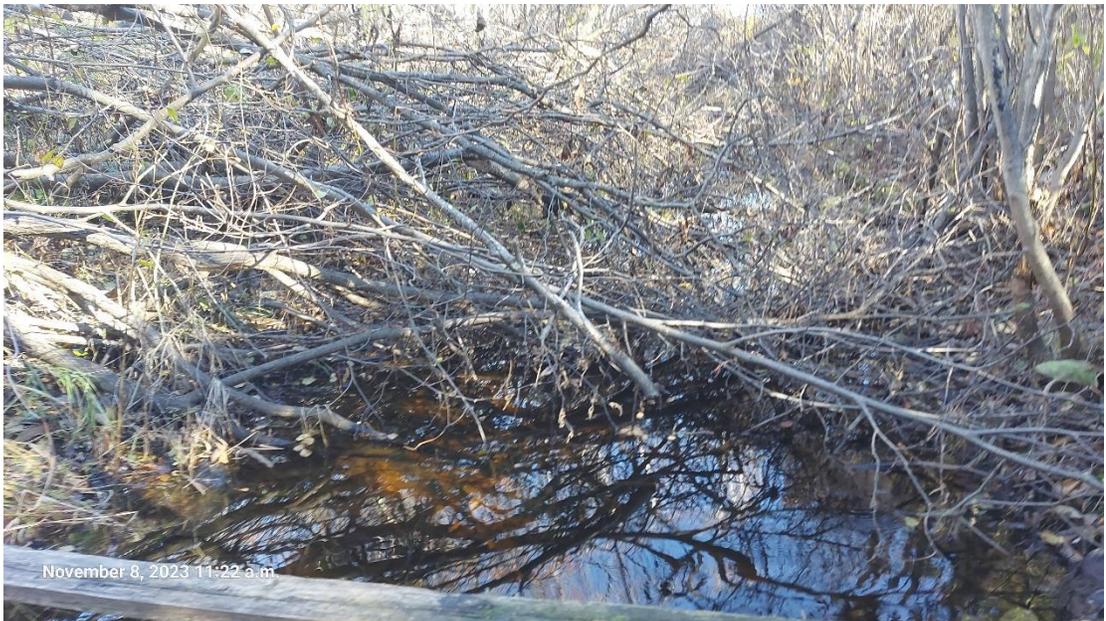
Photo 2
Tributary of Bear Brook
Reach BBT-1

Photograph taken facing downstream along **BBT-1**. Several down trees were observed along the reach and woody debris in the channel was common.

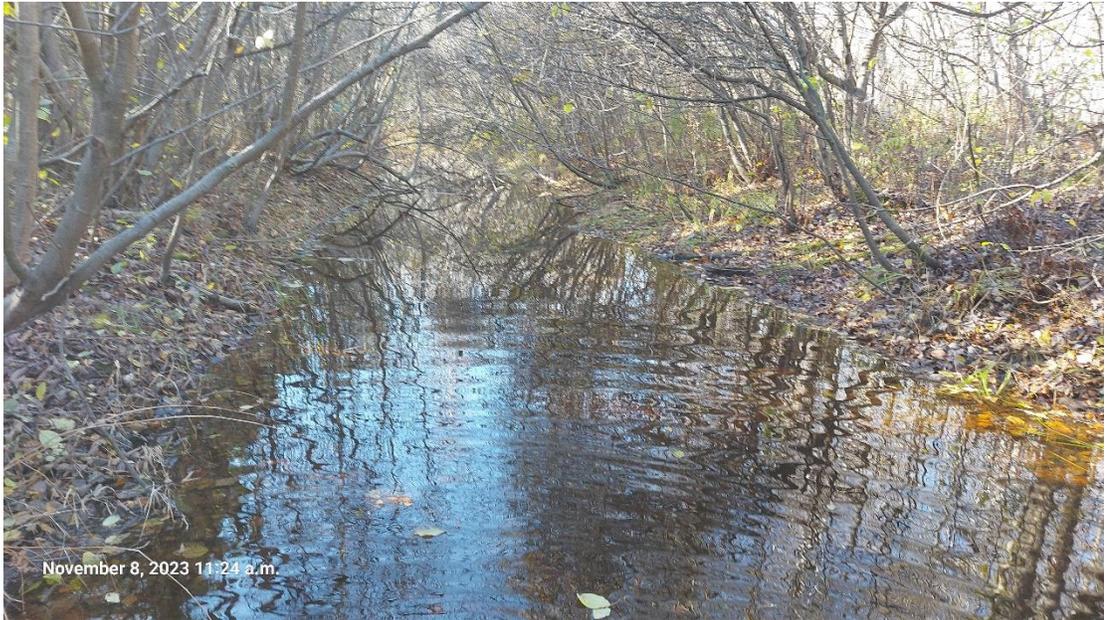
Photo 3
Tributary of Bear Brook
Reach BBT-1

Photograph taken facing downstream along **BBT-1**. The reach was historically straightened and lacked pool-riffle features.

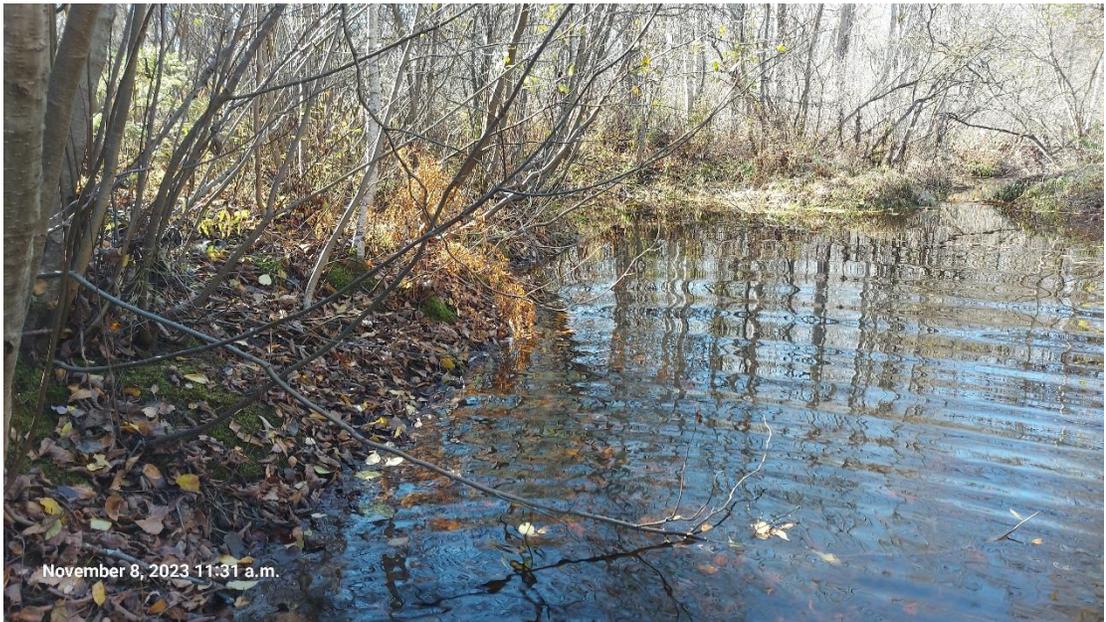
Photo 4
Tributary of Bear Brook
Reach BBT-1

Photograph taken at the downstream extent of **BBT-1**, at the confluence with a drainage ditch and **BBT-2**. A pool had formed at the confluence. Little signs of erosion were observed throughout the reach.

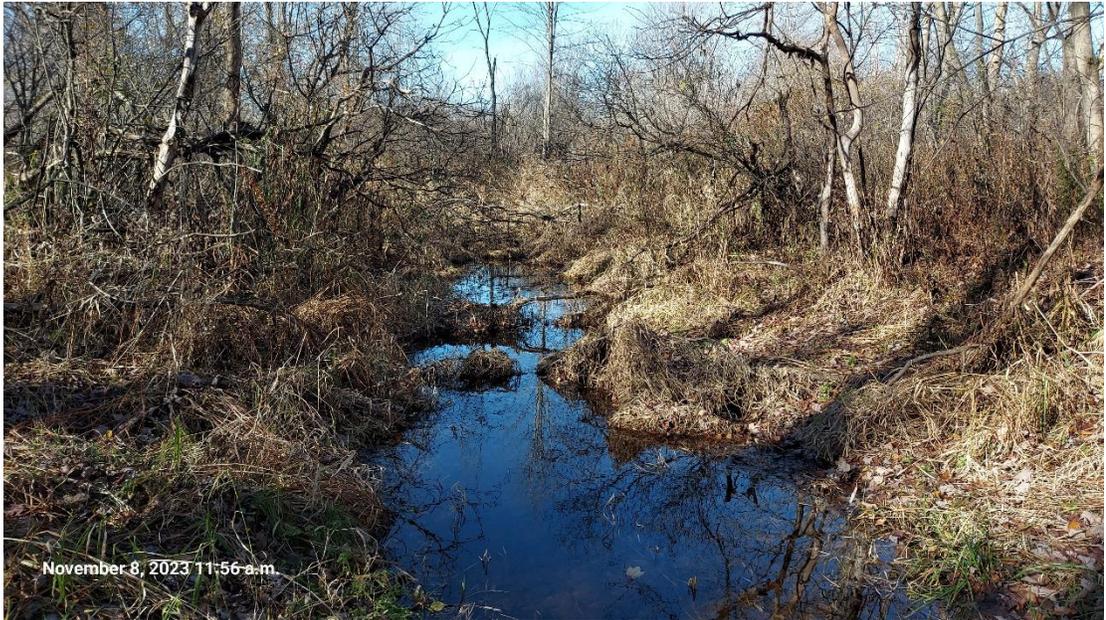
Photo 7
Tributary of Bear Brook
Reach BBT-2

Photograph taken facing downstream along **BBT-2**. Evidence of historic agricultural activity adjacent to the channel observed. The channel slightly wandered, but was evidently historically straightened.

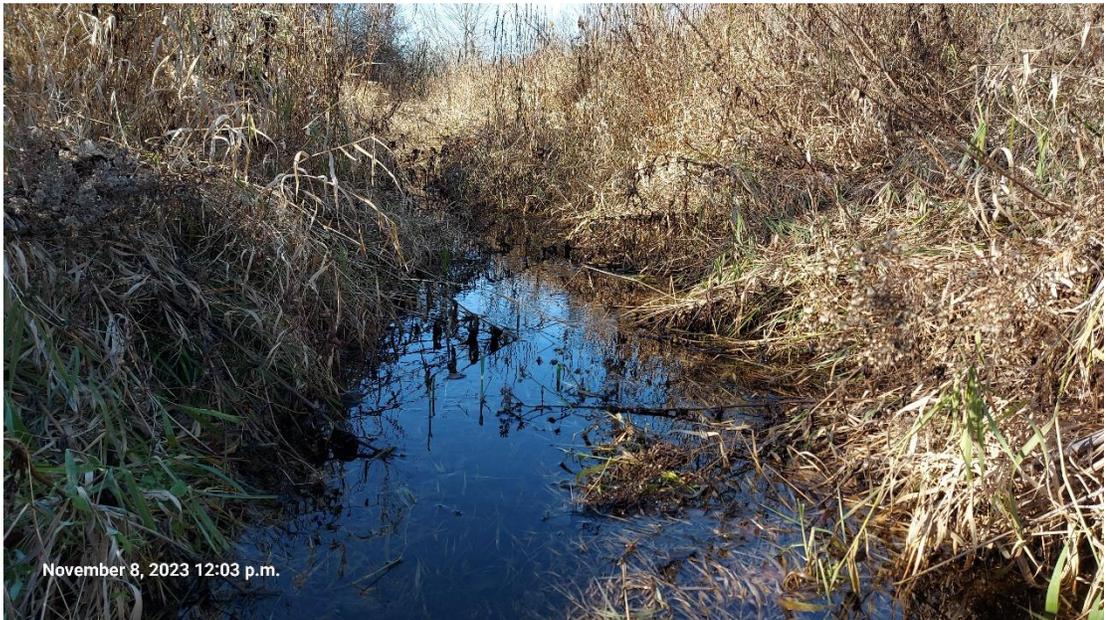
Photo 8
Tributary of Bear Brook
Reach BBT-2

Photograph taken at the downstream extent of **BBT-2**. The channel exhibited no riffle-pool formations and there was litter signs of erosion observed throughout the reach.

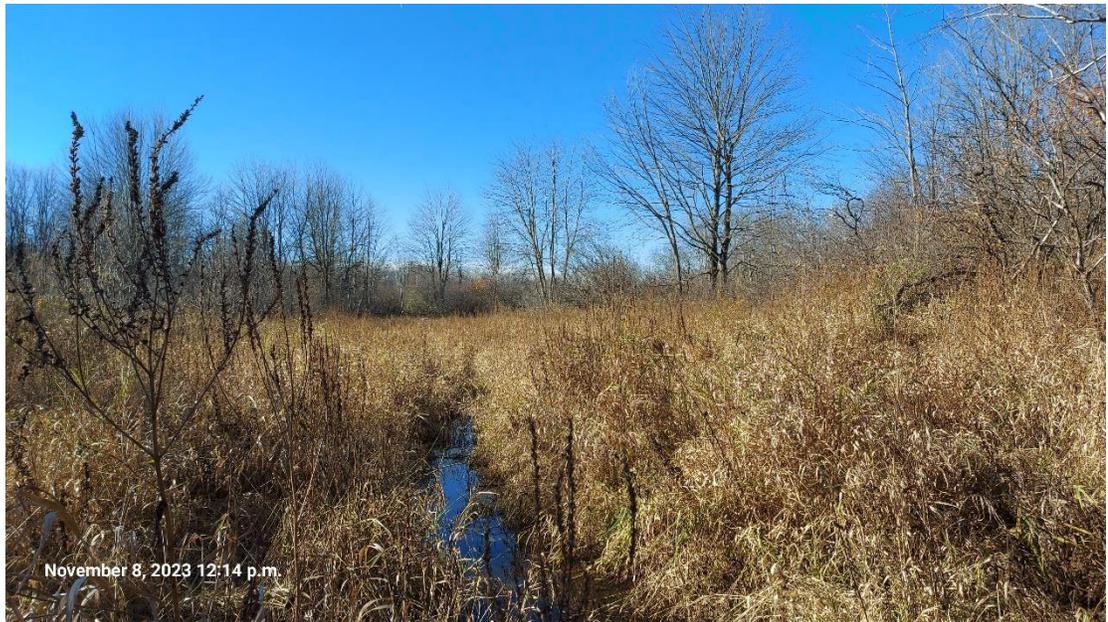
Photo 9
Tributary of Bear Brook
Reach BBT-3

Photograph taken at the upstream extent of **BBT-3**. Riparian vegetation transitions into wetland dominated species which encroached within the channel. Field observations suggest this portion of the reach was historically backwatered by downstream beaver dam.

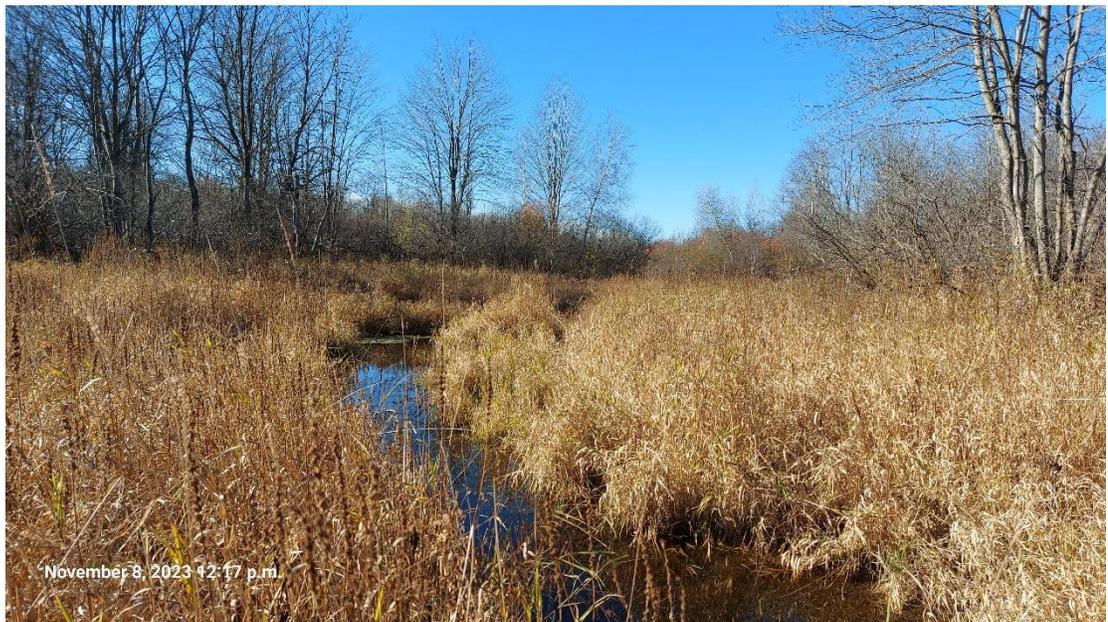
Photo 10
Tributary of Bear Brook
Reach BBT-3

Photograph taken facing downstream along **BBT-3**. The channel had low sinuosity and travelled within a wide floodplain dominated by herbaceous vegetation and grasses. Bed substrate was composed of fine silt.

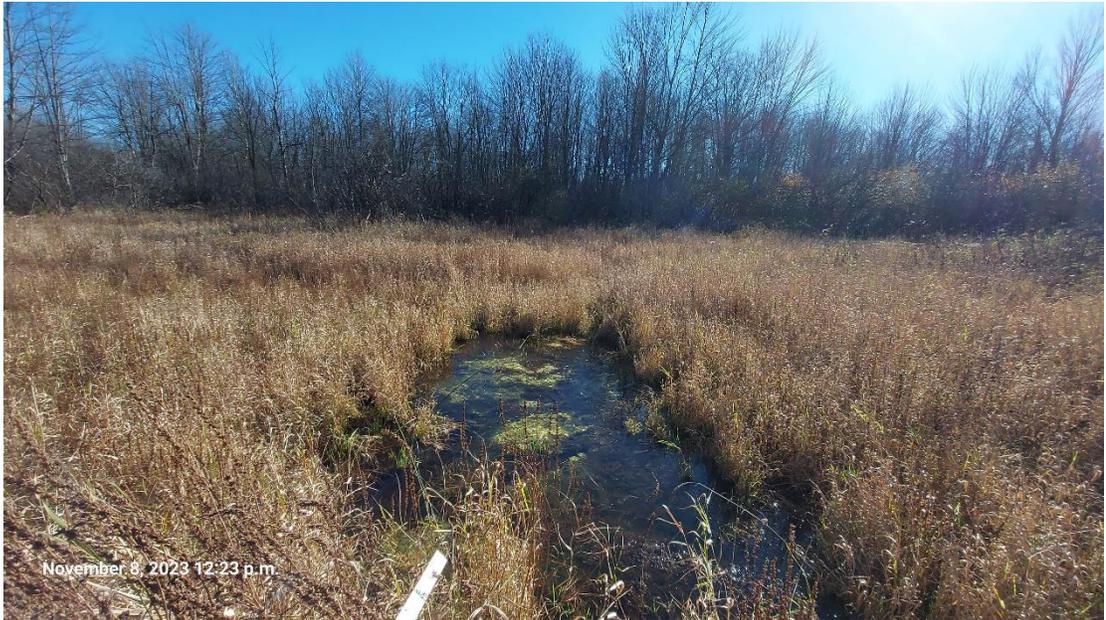
Photo 11
Tributary of Bear Brook
Reach BBT-3

Photograph taken facing south from the left bank along **BBT-3**. Several dewatering zones and secondary flow paths were observed throughout the reach.

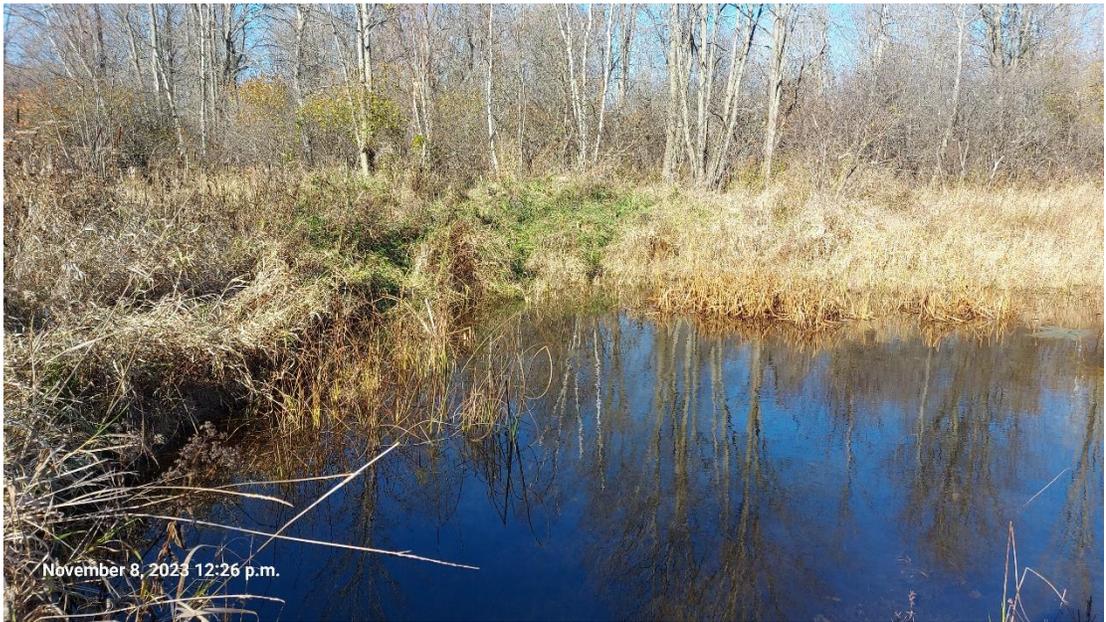
Photo 12
Tributary of Bear Brook
Reach BBT-3

Photograph taken facing south towards the right bank. The large beaver dam (1.5 tall), on the left side of the photo had a large 5-foot gap through the middle. Vegetation was well established along the top of the dam.

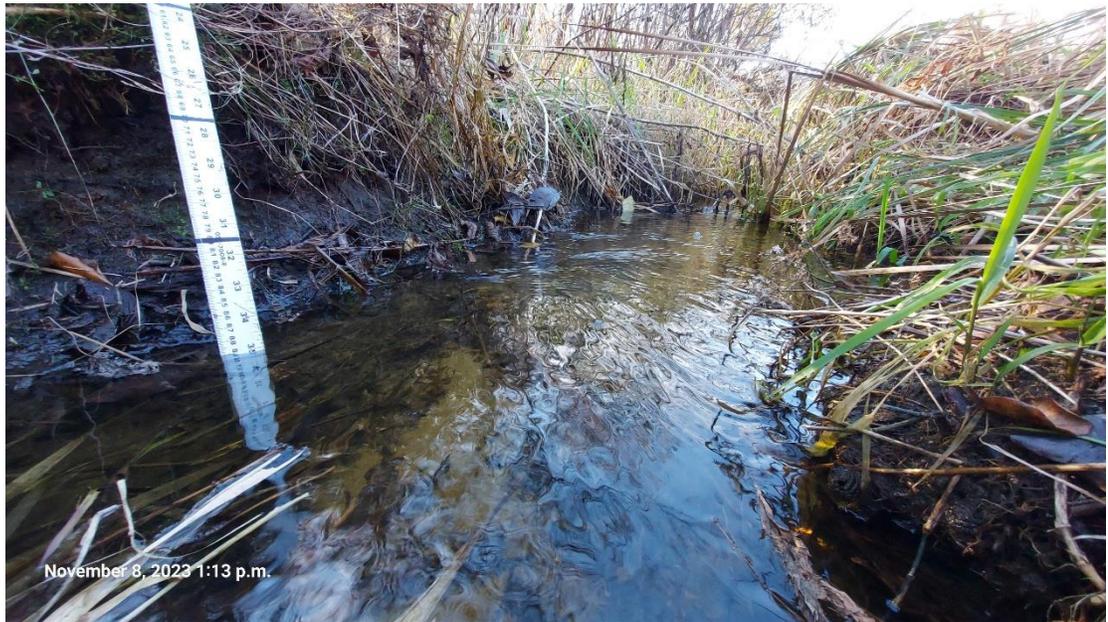
Photo 14
Tributary of Bear Brook
Reach BBT-4

Photograph taken at the downstream extent of **BBT-4**, where the channel merges back into one flow path. At the downstream extent, the gradient increases, and down cuts, resulting in observed basal scour and undercutting.

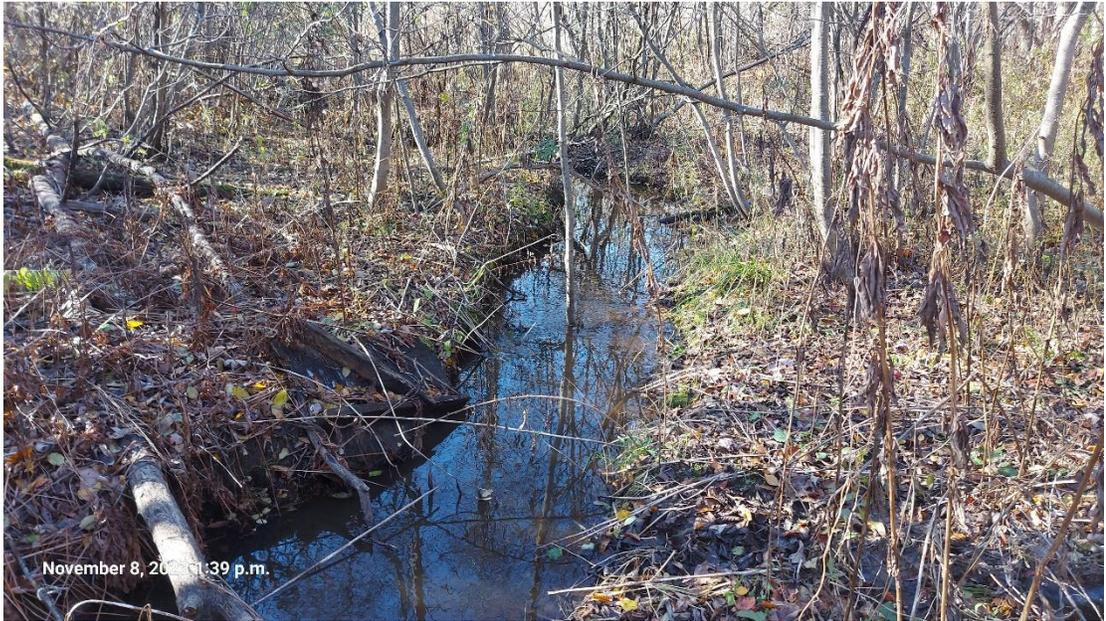
Photo 15
Tributary of Bear Brook
Reach BBT-5

Photograph taken facing downstream along **BBT-5**. The channel gains defined banks and meanders through a forest composed of established trees and grasses.

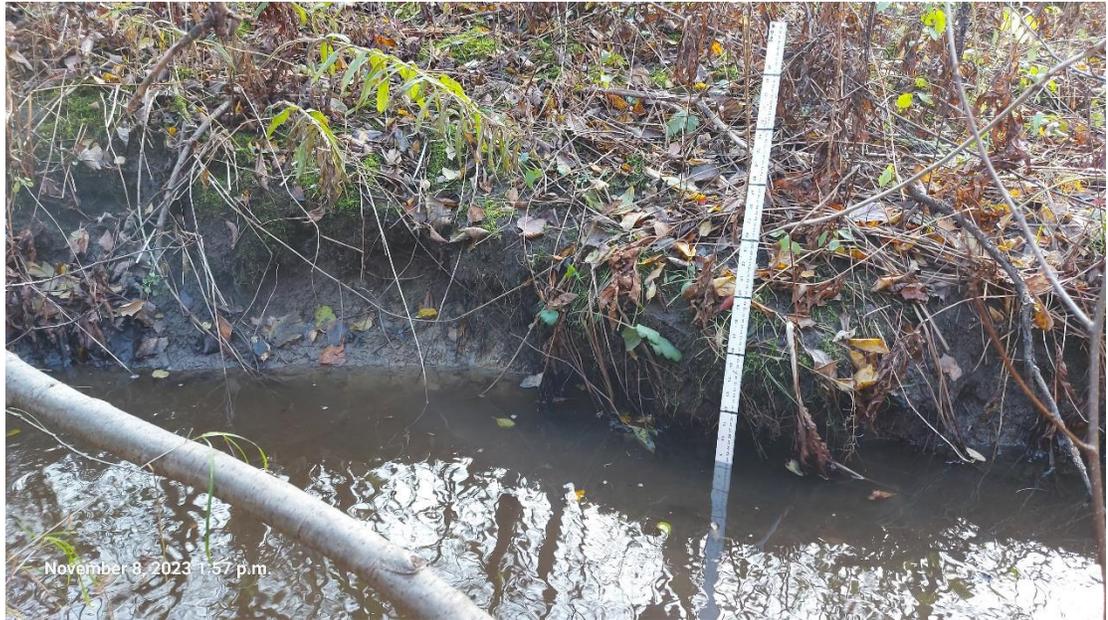
Photo 17
Tributary of Bear Brook
Reach BBT-5

Photograph taken facing the left bank along **BBT-5**. Undercutting and basal scour was observed throughout the reach, concentrated along meander bends. The most severe areas were due to debris in the channel re-directing flows.

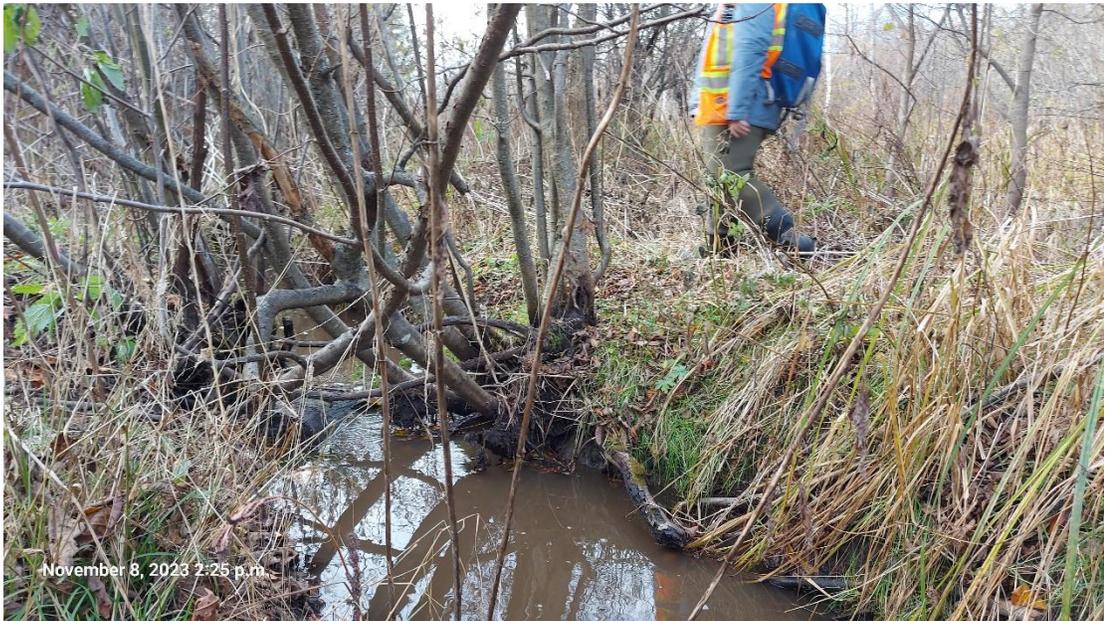
Photo 20
Tributary of Bear Brook
Reach BBT-6

Photograph taken facing downstream along **BBT-6**. Undercutting, exposed roots and 'J' hooked trees were frequently observed throughout the reach. Most of the severe areas were due to debris in the channel redirecting flows.

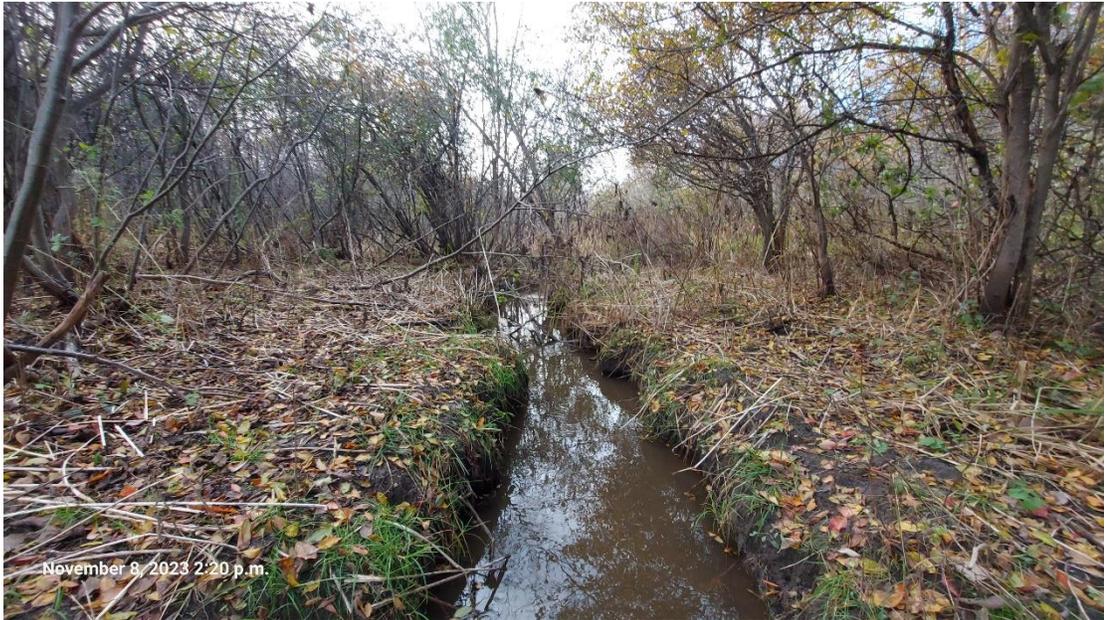
Photo 21
Tributary of Bear Brook
Reach BBT-6

Photograph taken facing downstream along **BBT-6**. The watercourse lacked pool-riffle features other than those created by instream debris. Bed substrate was composed of silt.

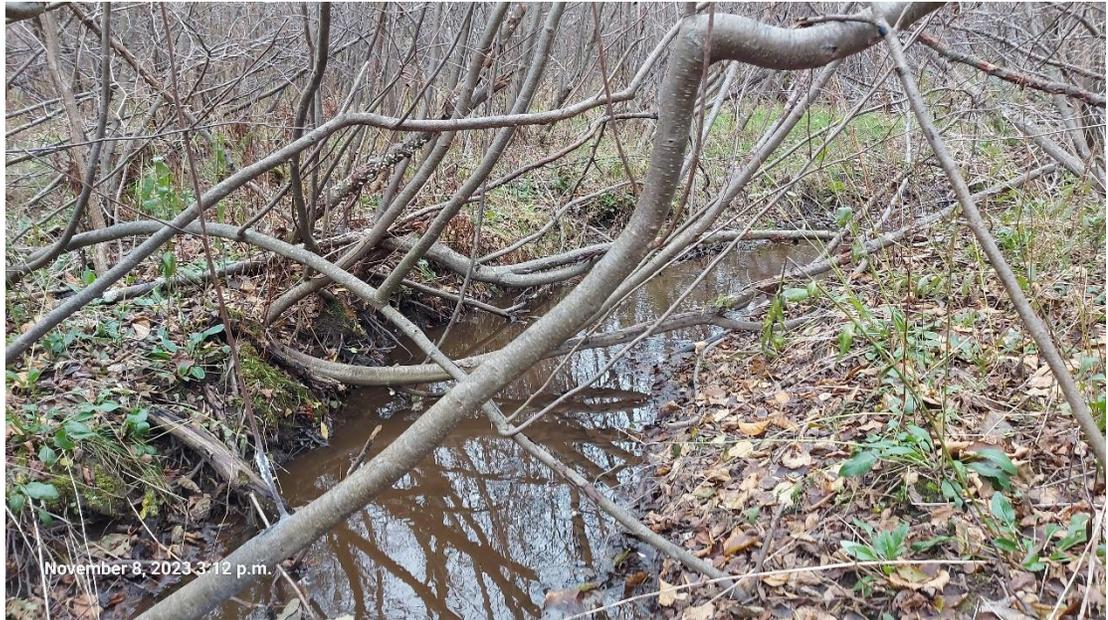
Photo 25
Tributary of Bear Brook
Reach BBT-7

Photograph taken facing upstream along **BBT-7**. Undercutting, basal scour, exposed roots and 'J' hooked trees were all commonly observed throughout the reach. Woody debris in the channel and cutbank was common.

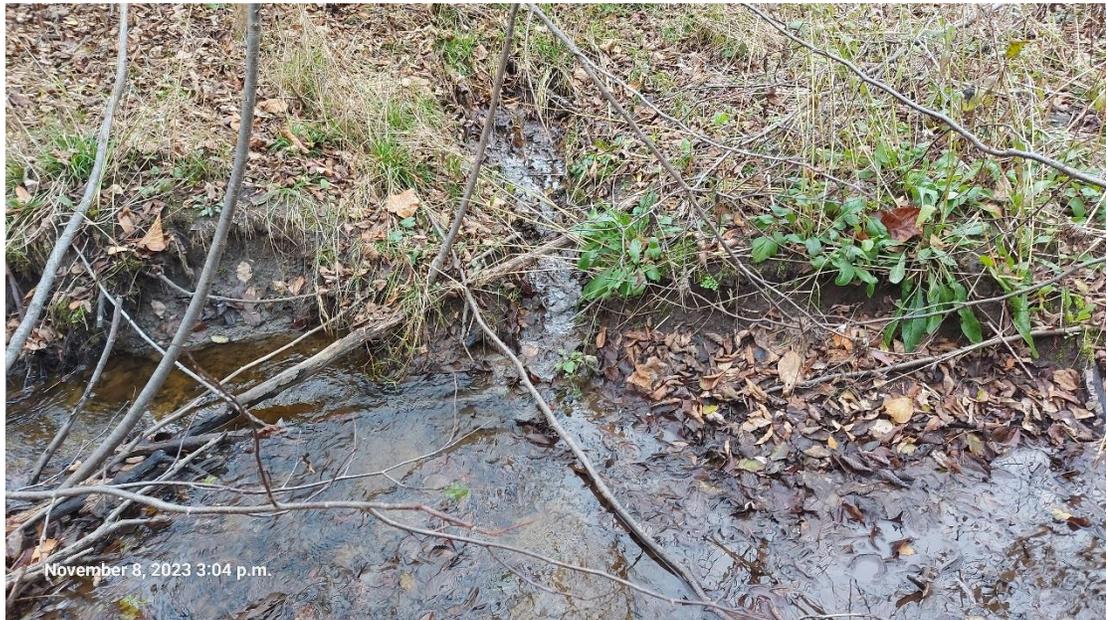
Photo 26
Tributary of Bear Brook
Reach BBT-7

Photograph taken facing the right bank along **BBT-7**. Several groundwater upwellings were observed along the channel.

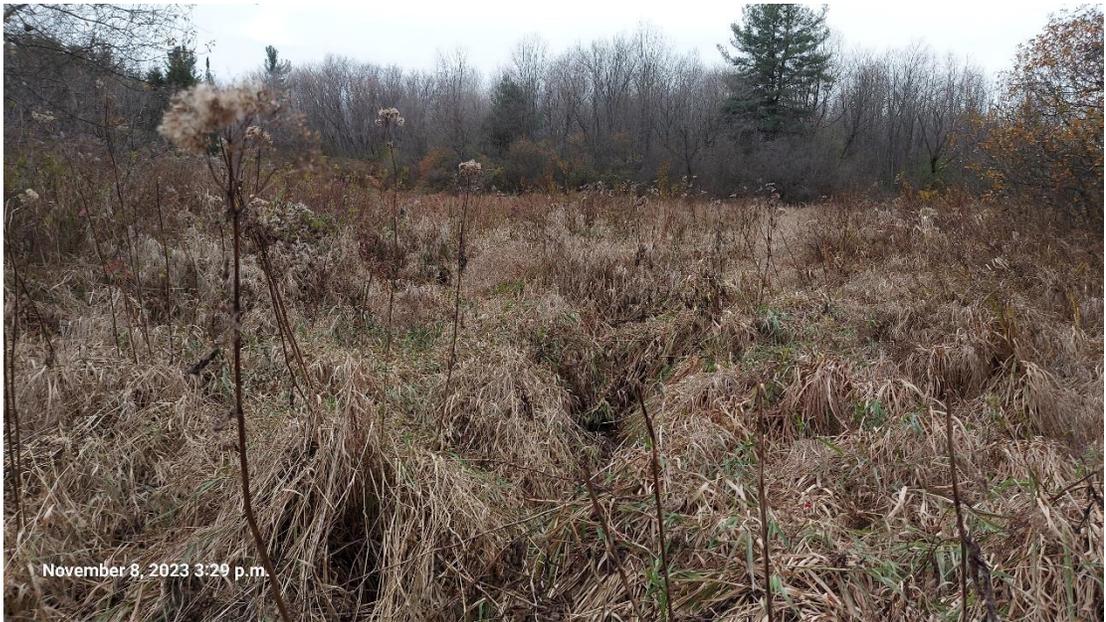
Photo 27
Tributary of Bear Brook
Reach BBT-8

Photograph taken facing downstream along **BBT-8**. The channel enters the Bear Brook corridor and riparian vegetation becomes predominantly wetland vegetation species which heavily encroach into the channel.

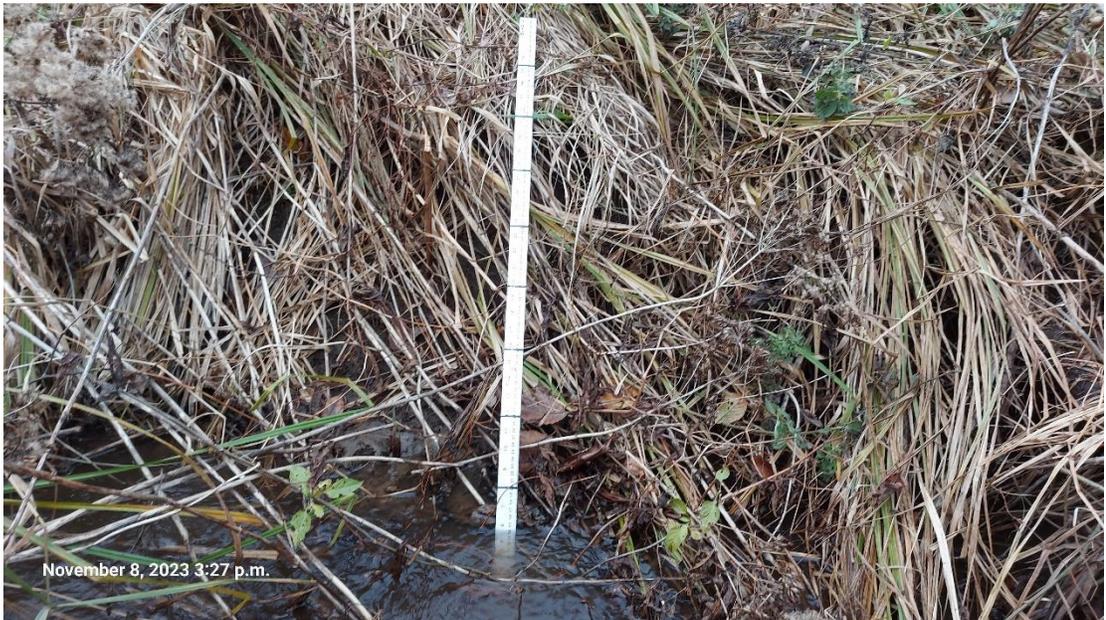
Photo 28
Tributary of Bear Brook
Reach BBT-8

Photograph taken facing the right bank along **BBT-8**. The channel banks were well vegetated. Few signs of erosion were observed.
