CANADA LANDS COMPANY CLC LIMITED
SLOPE STABILITY ASSESSMENT REPORT

Wateridge Village
Park Block 1- Phase 4
Ottawa, Ontario

March 22, 2024

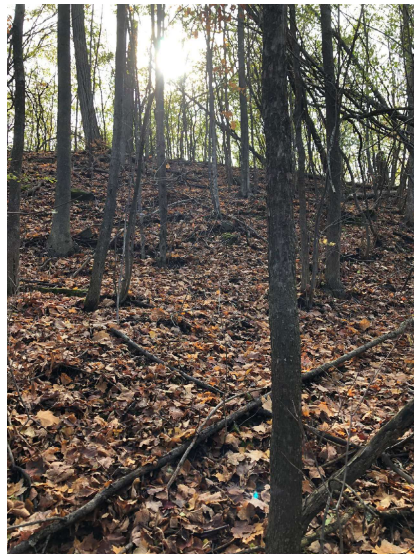
Looking up from the bottom of the slope (North to South).

The study slope is a natural slope covered with medium to dense vegetation, and treed with predominately young trees. Most of the trees appear to be straight and vertical.

There are no indications of long term movement of the near surface soils on the slope.

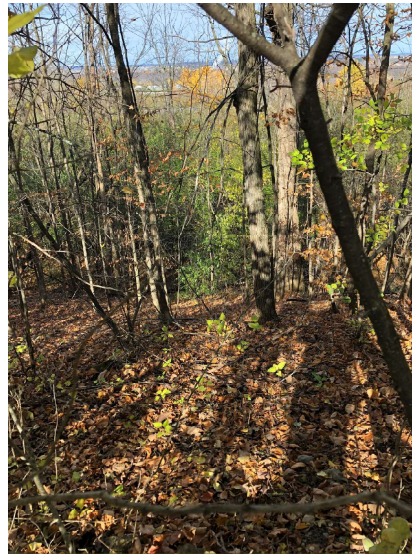
Looking down from the top to the bottom of the slope (South to North).

The top of the slope is relatively flat; which slopes down towards the east. There is currently an asphaltic roadway located approximately 3 m north of the top of the slope, beyond the road to the north is a flat vegetated area.

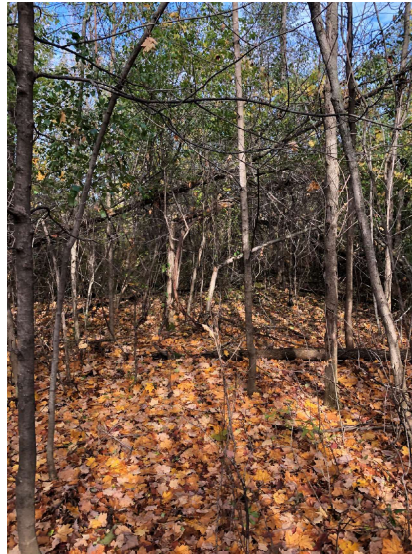
A drainage ditch is present approximately 10 m north of the toe of the slope; oriented in a west to east position. The width of the ditch ranges from 0.5 to 1 m.

At the time of our inspection, there was no water present in the ditch.

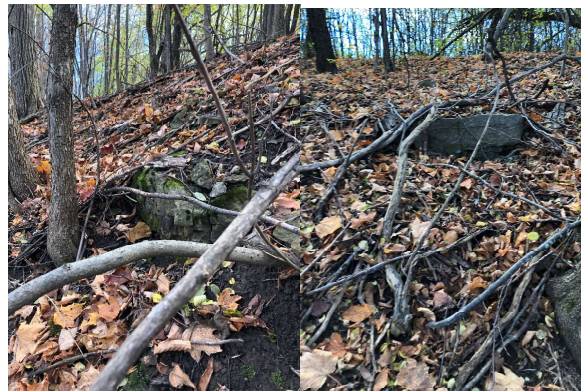
There were visible outcrops of Limestone bedrock along the face of the slope, indicating that bedrock is close to the surface. A test pit hand dug half way up the slope revealed that there was approximately 0.4 m of organic material overlying bedrock.

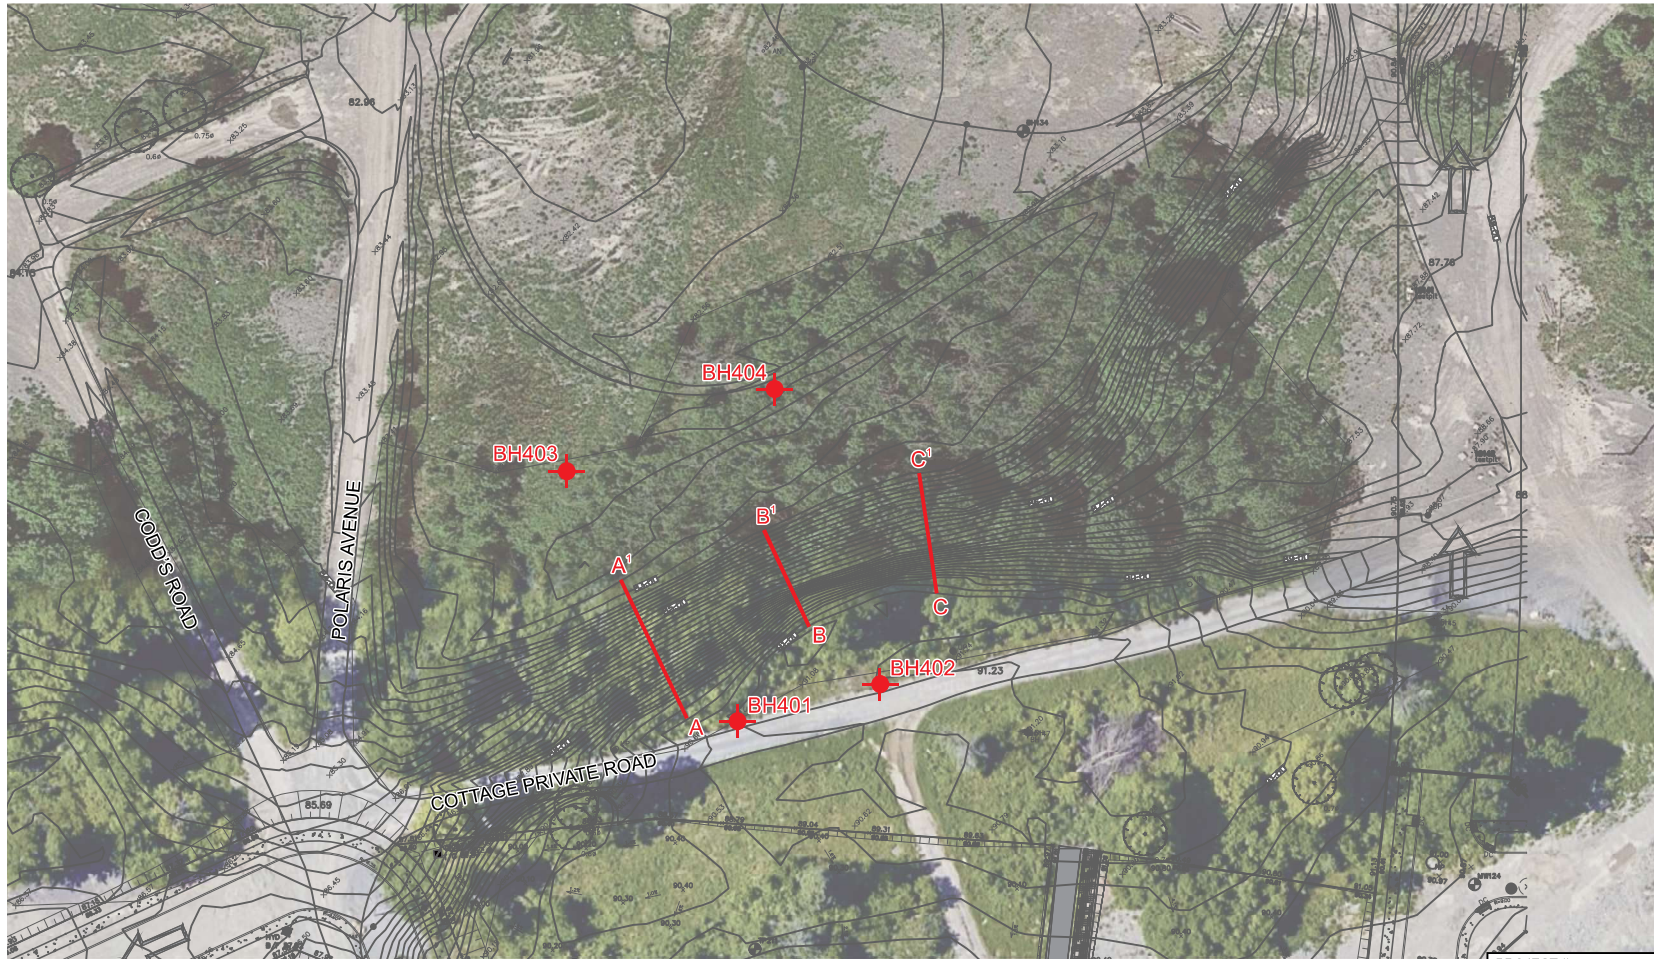
FIGURE 2

Slope Section No.	Approximate Vertical Height of Slope	Overall Slope Inclination / Degrees to Horizontal
1 (A-A')	7.0 m	1V : 3.44H / 16.2°
2 (B-B')	8.0 m	1V : 2.16H / 24.8°
3 (C-C')	8.0 m	1V : 2.7 H / 20.3 °

Slope Section	Computed Minimum Factor of Safety Against Circular Failure
1 (A-A')	2.94
2 (B-B')	1.93
3(C-C')	2.19

The analyses indicate the safety factors of the slope sections with respect to circular failure range between 1.93 and 2.94; greater than 1.5. Accordingly, the slope is considered to be stable.
