ADDENDUM #1

211-231 BANK STREET CONSERVATION PLAN

Applications D02-02-22-0127 / D07-12-22-0188 and plan number 18910

August 2024

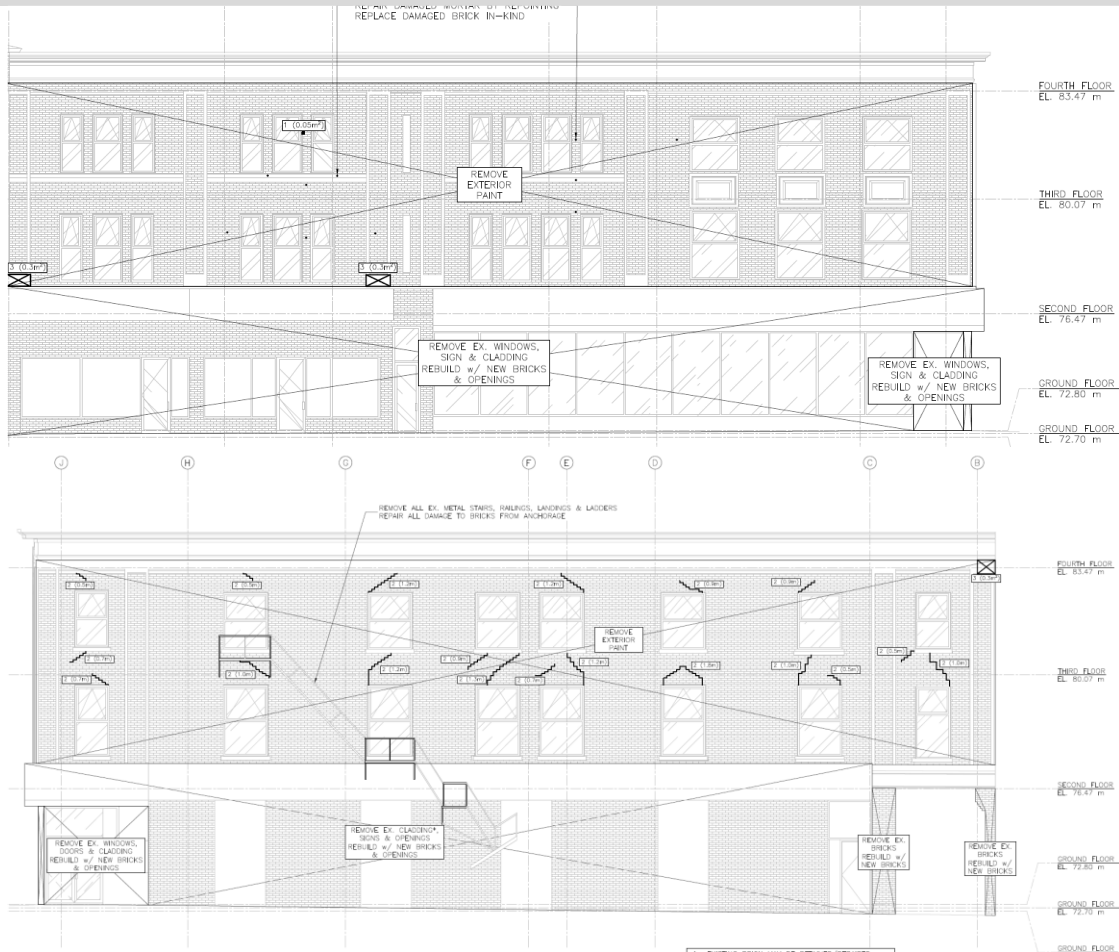
The façade of the Wallack's Building has been painted. In the detailed view the spalling of the paint is extensive suggesting that the removal of paint will not be too difficult. The extent of damage to the brick needs to be assessed. Along the face there is step cracking of the brick below third floor windows. There is some bulging in places. The pilasters at either end of the facade will have to be replaced at the street level. The large black panels at grade were originally windows that have been boarded over.

1. Undertake a detailed inspection of the metal cornice along both Bank and Lisgar streets.
2. Remove fire escapes, ladders, and platforms.
3. Remove paint from the facades on both frontages.
4. Following the removal of the paint undertake a detailed inspection of the masonry, mapping damaged brick, step cracks, and formally blocked in openings.
5. Remove variegated brick and framing from the ground floor storefront(s).
6. Undertake a detailed inspection of the remaining storefront to determine potential for reinterpretation.
7. Assess banding (Dominion signboard, 1950 photo) above the ground floor storefronts to determine if it can be removed without damaging the facade.
