Phase I Environmental Site Assessment Update

6622 Bank Street, Ottawa, Ontario

CAMM Heavy Machinery MoversFinal Report

August 26, 2024 02407549.000

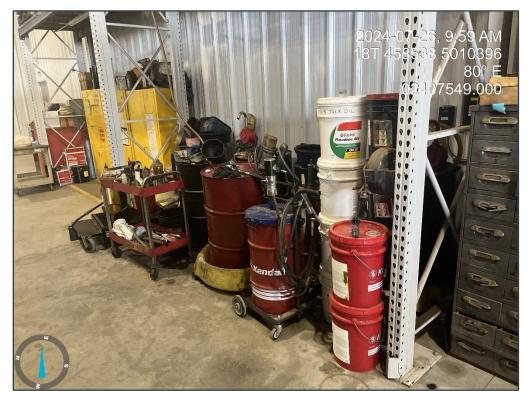
During the Site reconnaissance, Englobe observed the minor storage of various engine fuels, hydraulic oil, and waste oils at the Site, along the east wall of the Warehouse Building.

It was noted that the compressor fluid and diesel engine oil were stored in large plastic pails, which were sealed. All of the containers were observed to be in good condition, with no evidence of leaking, staining, or spills.

Based on the observed condition of the minor fuel storage and three fuel ASTs on Site, and no evidence of any surficial staining observed in the vicinity, these PCAs are not anticipated to pose a potential environmental concern to the Site at this time.

Photograph 7: Minor Fuel Storage Area (6622 Bank Street) - PCA 3.

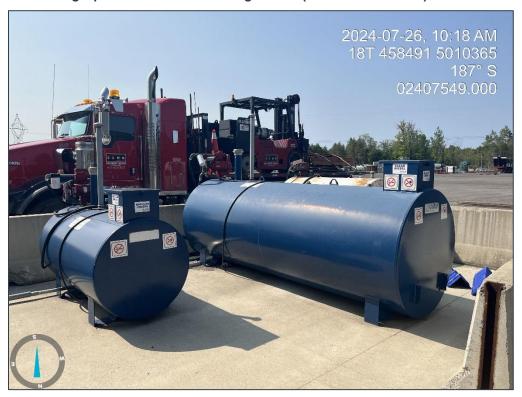
Three fuel ASTs (two diesel and one gasoline) were observed west of the warehouse building, on a concrete pad. All tanks observed appeared to be in good condition with no corrosion, punctures, or visible spills/leaks noted.

Photograph 8: Three Exterior Fuel ASTs (6622 Bank Street) - PCA 2.

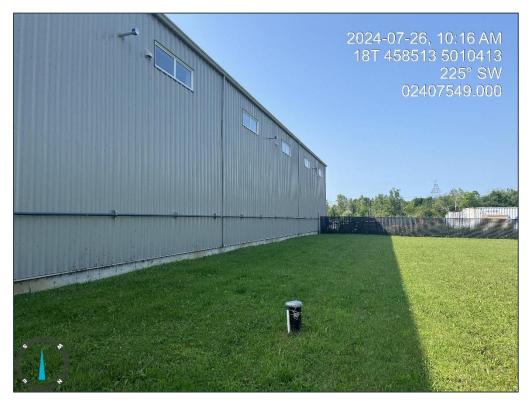
During the Site reconnaissance, Englobe observed one potable drinking water supply well north of the warehouse building.

Photograph 9: Potable Water Supply Well (6622 Bank Street).

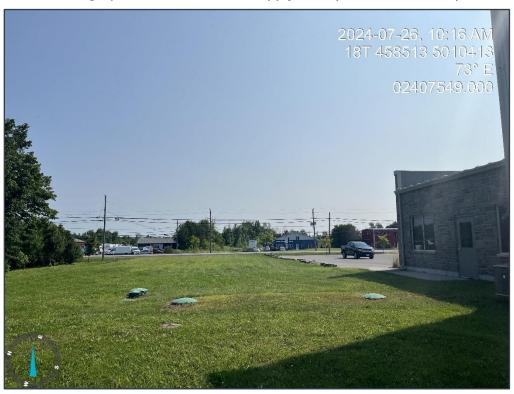
Below-ground structures at the Site included a septic tank with associated tile beds and piping. No other below-ground structures or basements were observed on Site during the Site reconnaissance.

Photograph 10: Septic Tank Area (6622 Bank Street).
