June 5, 2023

Ref. No.: 23-215-1

RE: Phase I Environmental Site Assessment Update – 788 March Road, Ottawa, Ontario

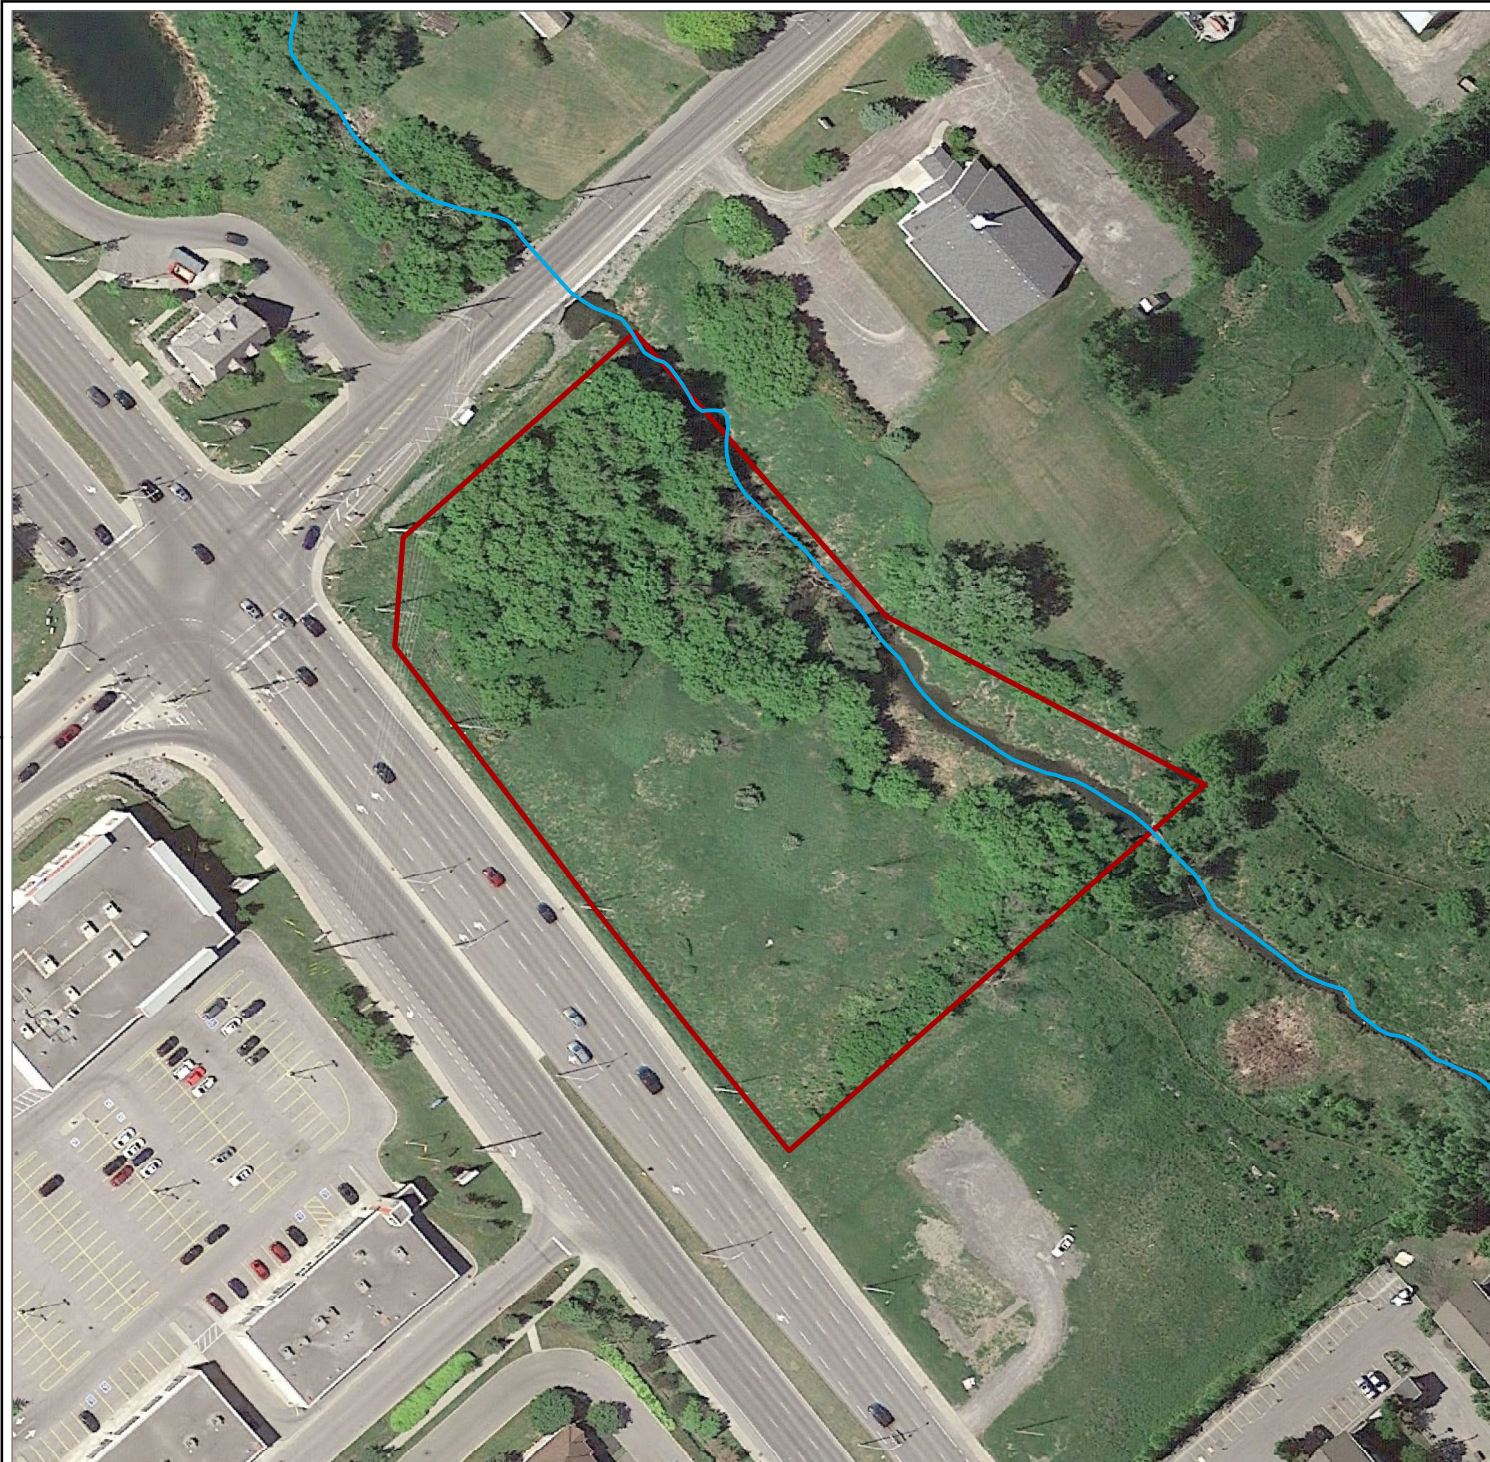
2018 Air Photo

The subject property was reviewed on the City of Ottawa's mapping website (geoOttawa), which had aerial photos from 2019 and 2021. Google Earth had air photos available from 2018, 2021 and 2023. The subject property was a vacant and partially wooded plot of land at the southeast corner of Klondike Road and March Road in 2018-2020. The 2021 air photo showed excavation beginning on the site at the southern end of the property. The Google Earth air photo from May 2023 showed the site had undergone excavation since the time of the 2021 air photo. In 2023, the footprint of the proposed building had been excavated. There were two access driveways visible for the site, one along March Road at the southern end and one along Klondike Road. Remnants of tarps are also seen throughout the floor of the excavation. From the air photos available, it did not appear that fill had been deposited on the site except for gravel for the access roads and possibly for the bottom of the excavation. The majority of the activities on the site consisted of removal of soil which is evident by the large cut in the land elevation along March Road and the western edge of the excavation.

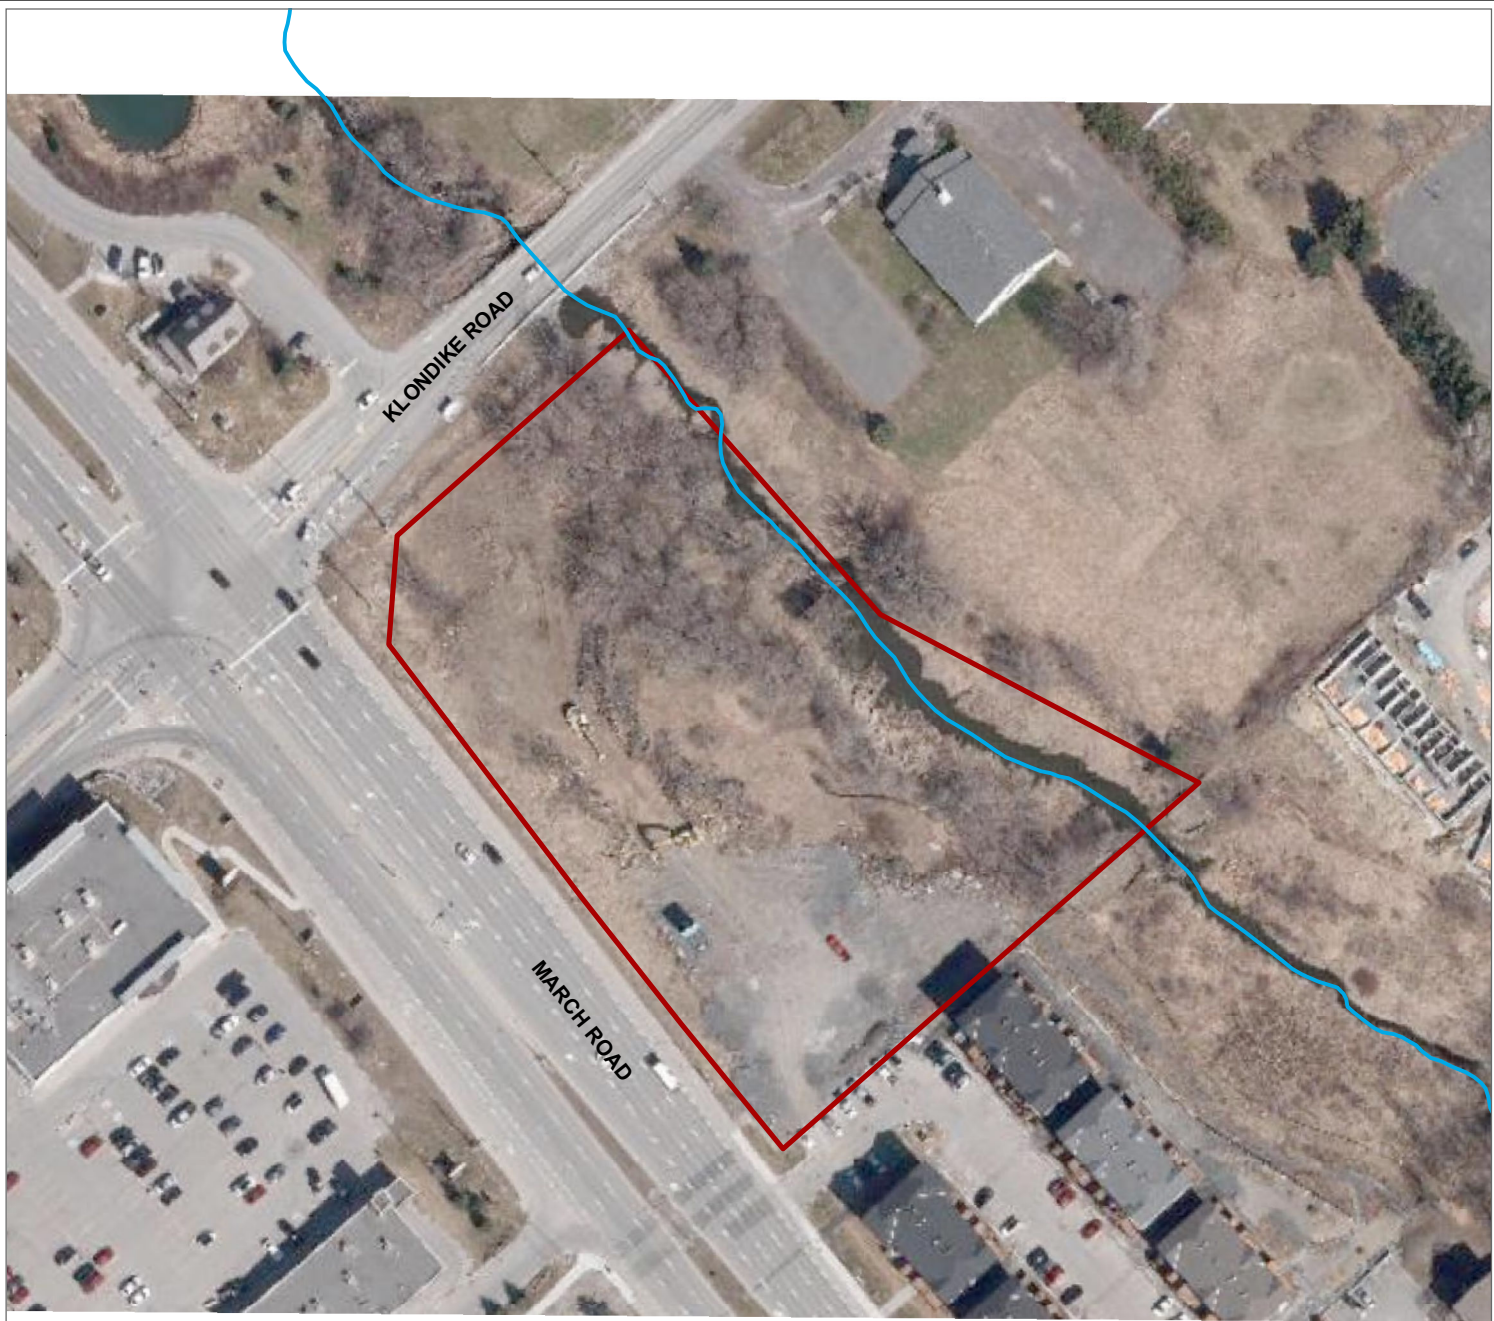
2021 Air Photo

The surrounding land appears largely unchanged since the 2018 Phase One ESA with the exception of a residential housing complex now located to the immediate south of the site. This residential complex was built between 2019 and 2021.

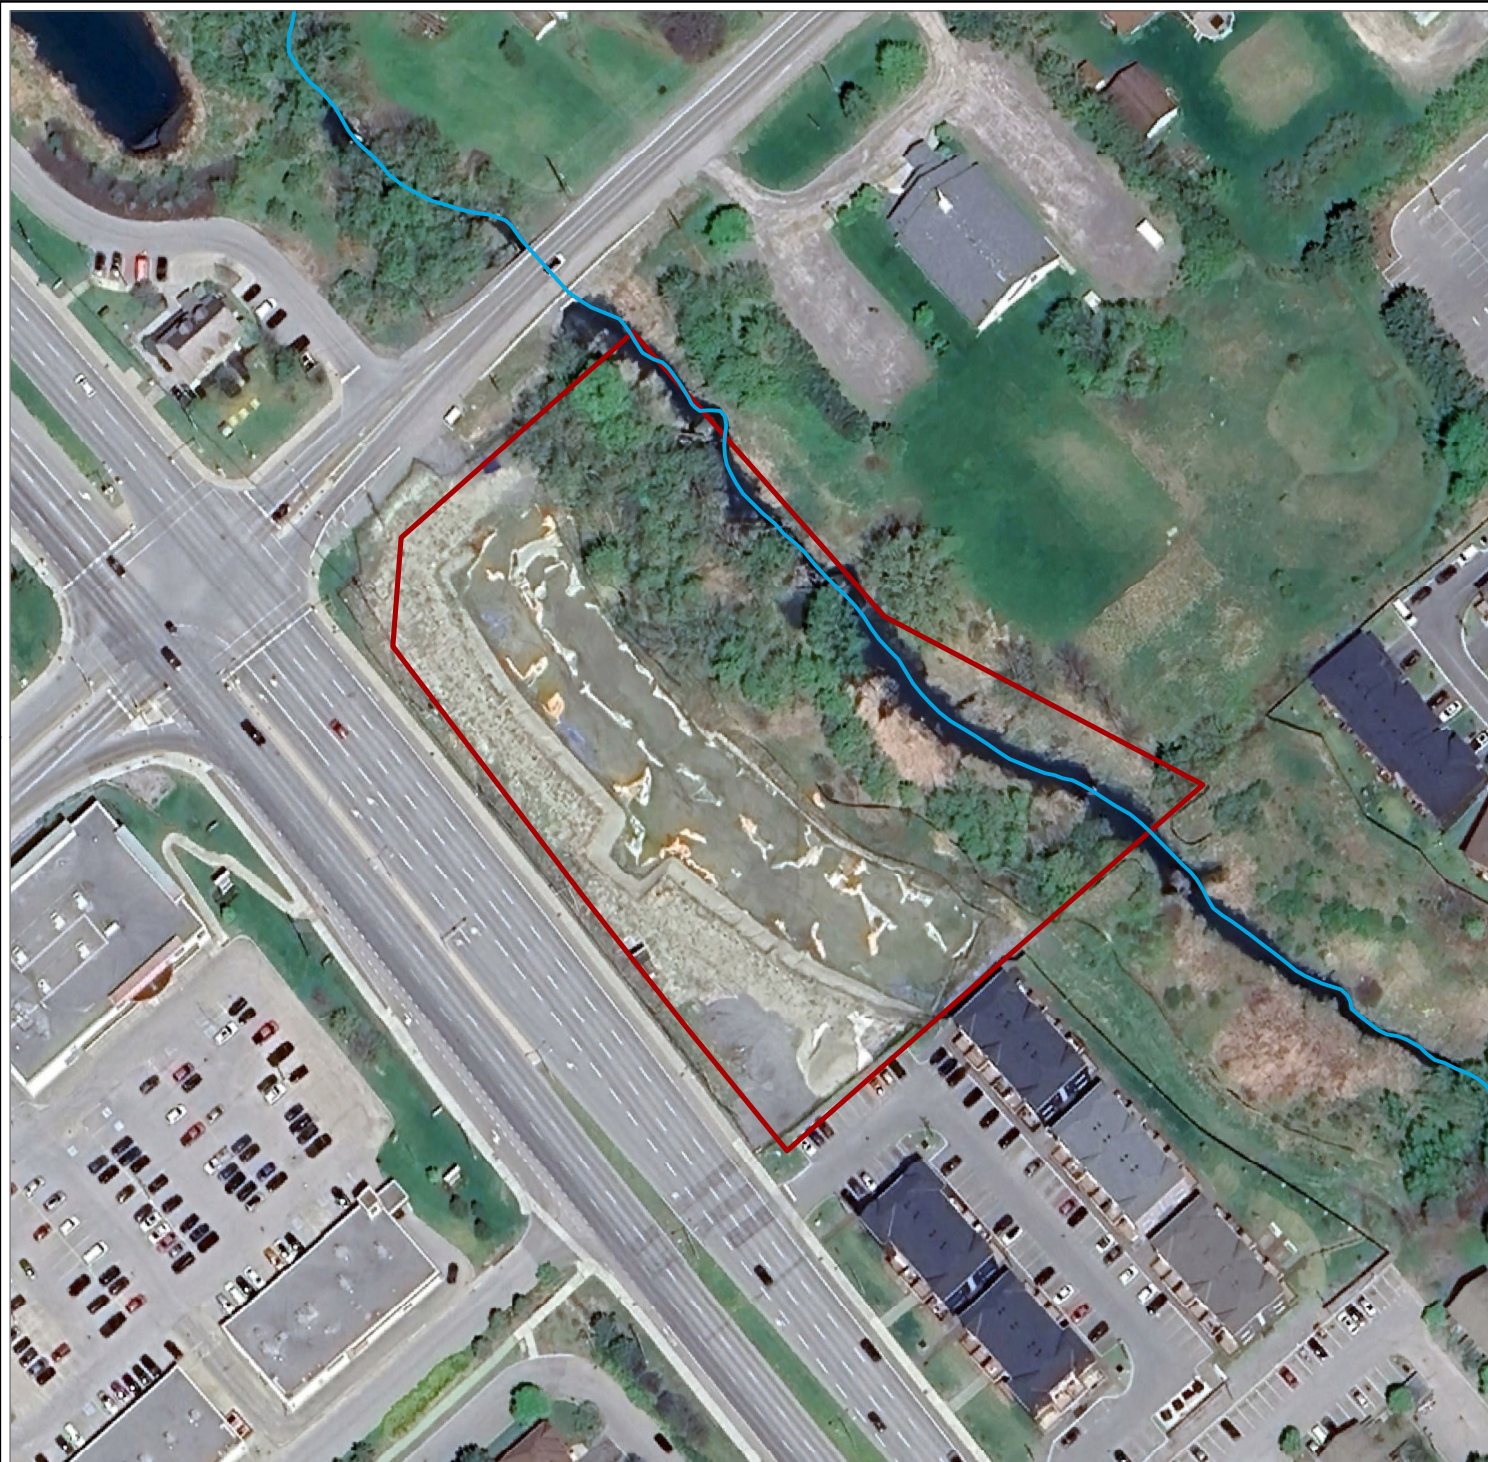
2023 Air Photo

No significant environmental concerns to the subject property were identified in the air photo review.

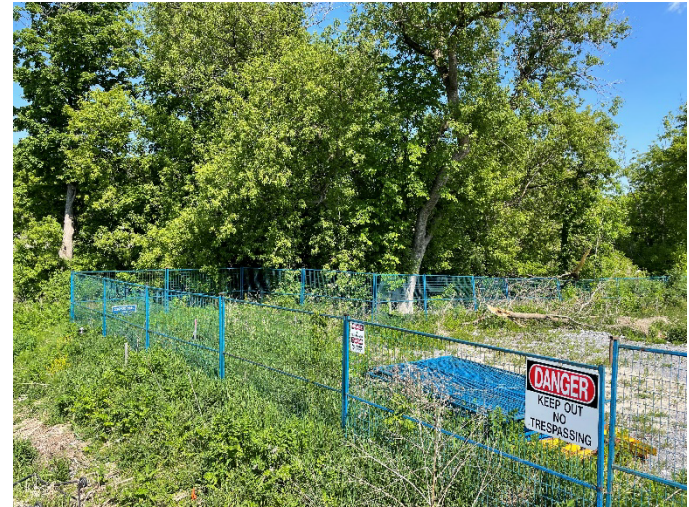
Looking at the northeast corner of the site from the access road along Klondike Road

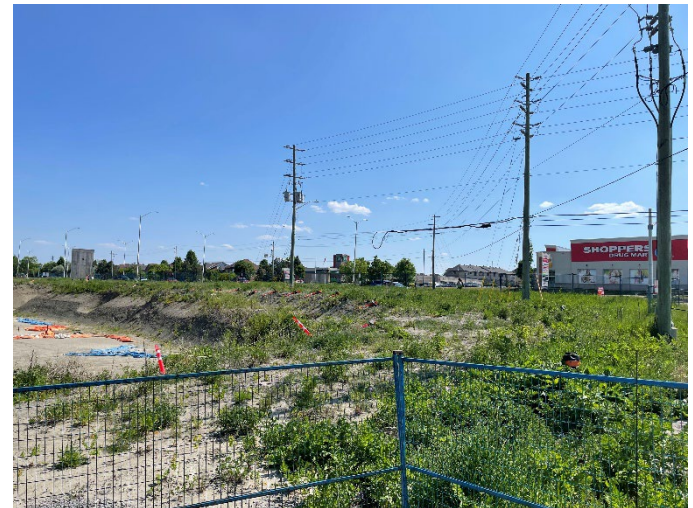
Looking west towards March Road, and the western boundary

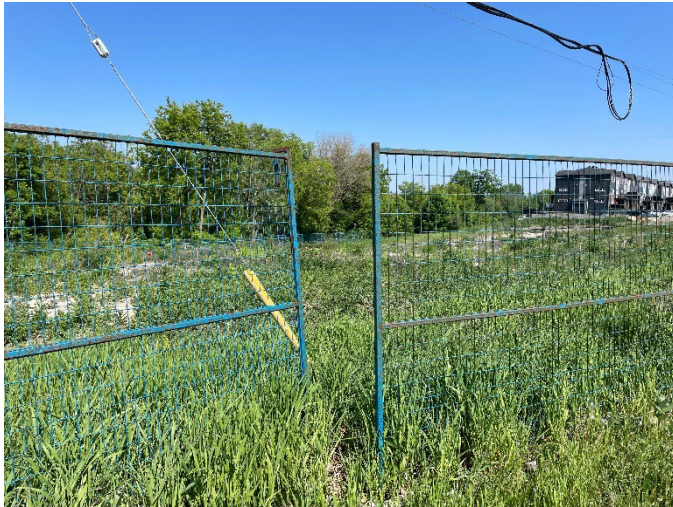
Looking southeast across the site at a break in the fence along March Road

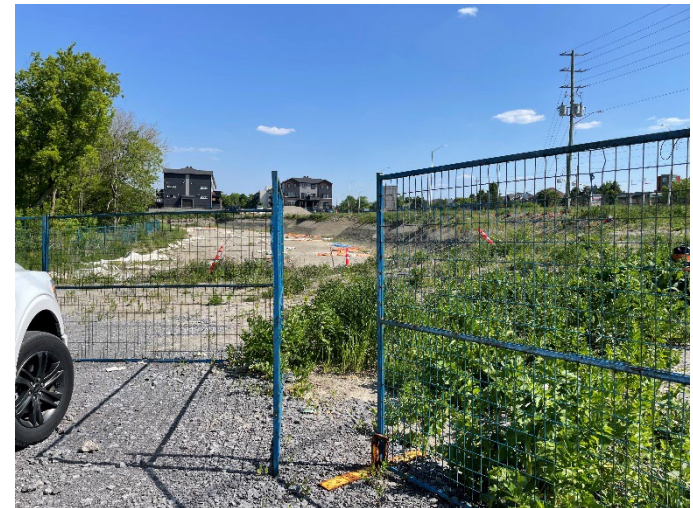
Looking south at the break in the fencing at the access road along Klondike Road
