**re: Slope Stability Review**  
**Proposed Warehouse Building**  
**96 Bill Leatham Drive, Ottawa**

**date:** March 7, 2024

**file:** PG6668-MEMO.01

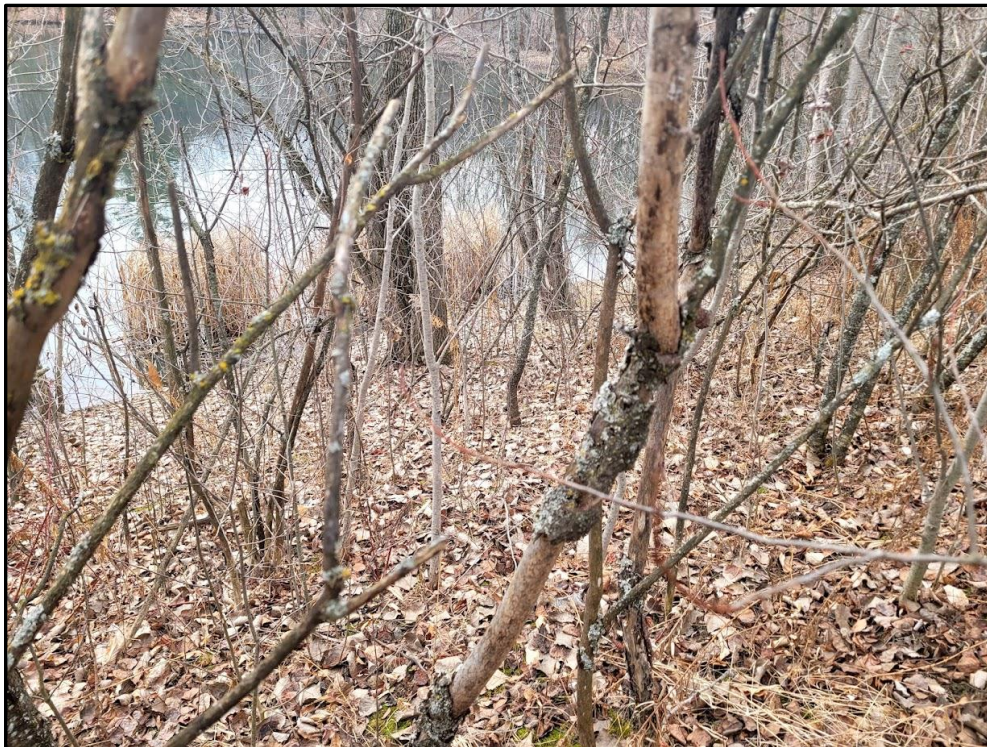
**Photo 4:** Photograph of observed slope at the elevation of the pond.

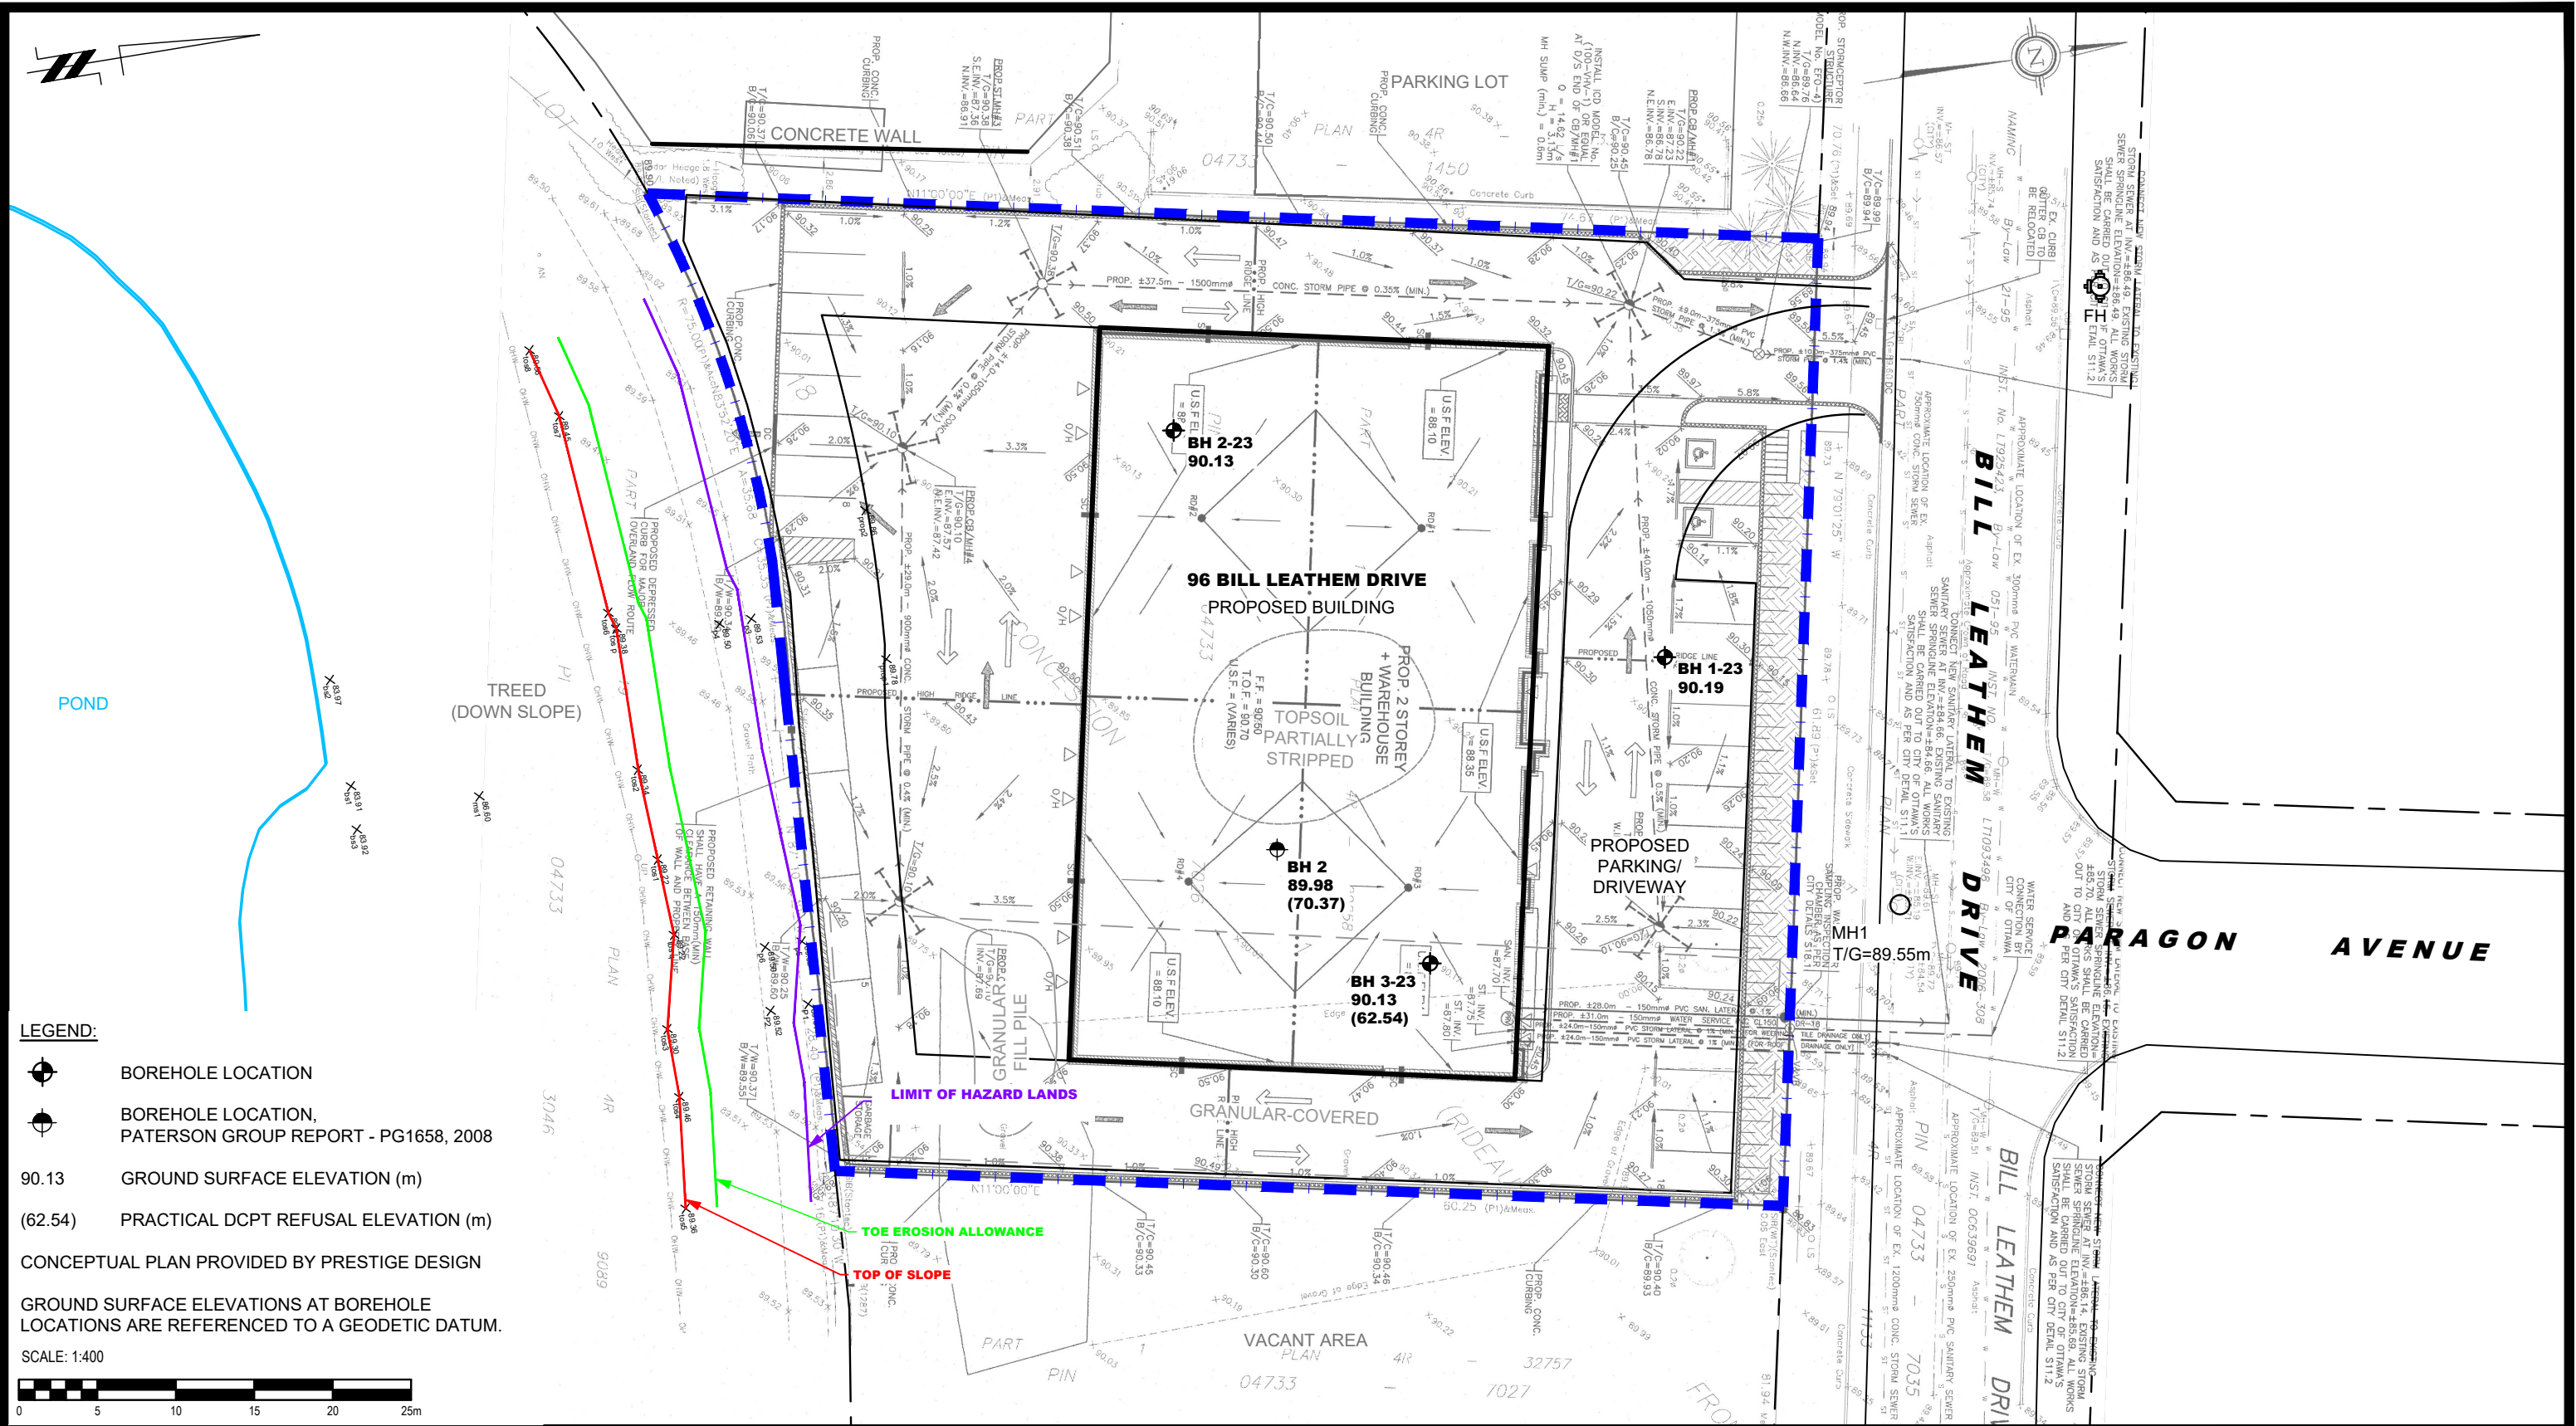
LIMIT OF HAZARD LANDS PLAN

Based on our findings, the existing slope along the Clarke Bellinger SWM facility is at an angle of 3H :1V or shallower and thus, as per the Natural Hazards Training Manual, Policy 3.1 of the Ministry of Natural Resources (MNR) guidelines, a quick setback review can be used for the site. Thus, considering the water feature is an engineered SWM pond and that the slope is vegetated with no significant signs of erosion, a stable slope allowance will not be required. However, a toe erosion allowance of 2 m in addition to an access allowance of 6 m will be applicable from the top of the slope.

Based on our cursory review, the “Limit of Hazard Lands” (8 m from the top of slope) is outside the property limits of the subject site and as such no restriction to limit of hard lands are applicable within the site.
