**TREE CONSERVATION REPORT FOR 1DOOR4CARE TREATMENT CENTRE  
401 SMYTH ROAD, CITY OF OTTAWA, ONTARIO**

**Colville Consulting Inc.**

Issued for Construction  
Date: August 16, 2024  
File: C23080

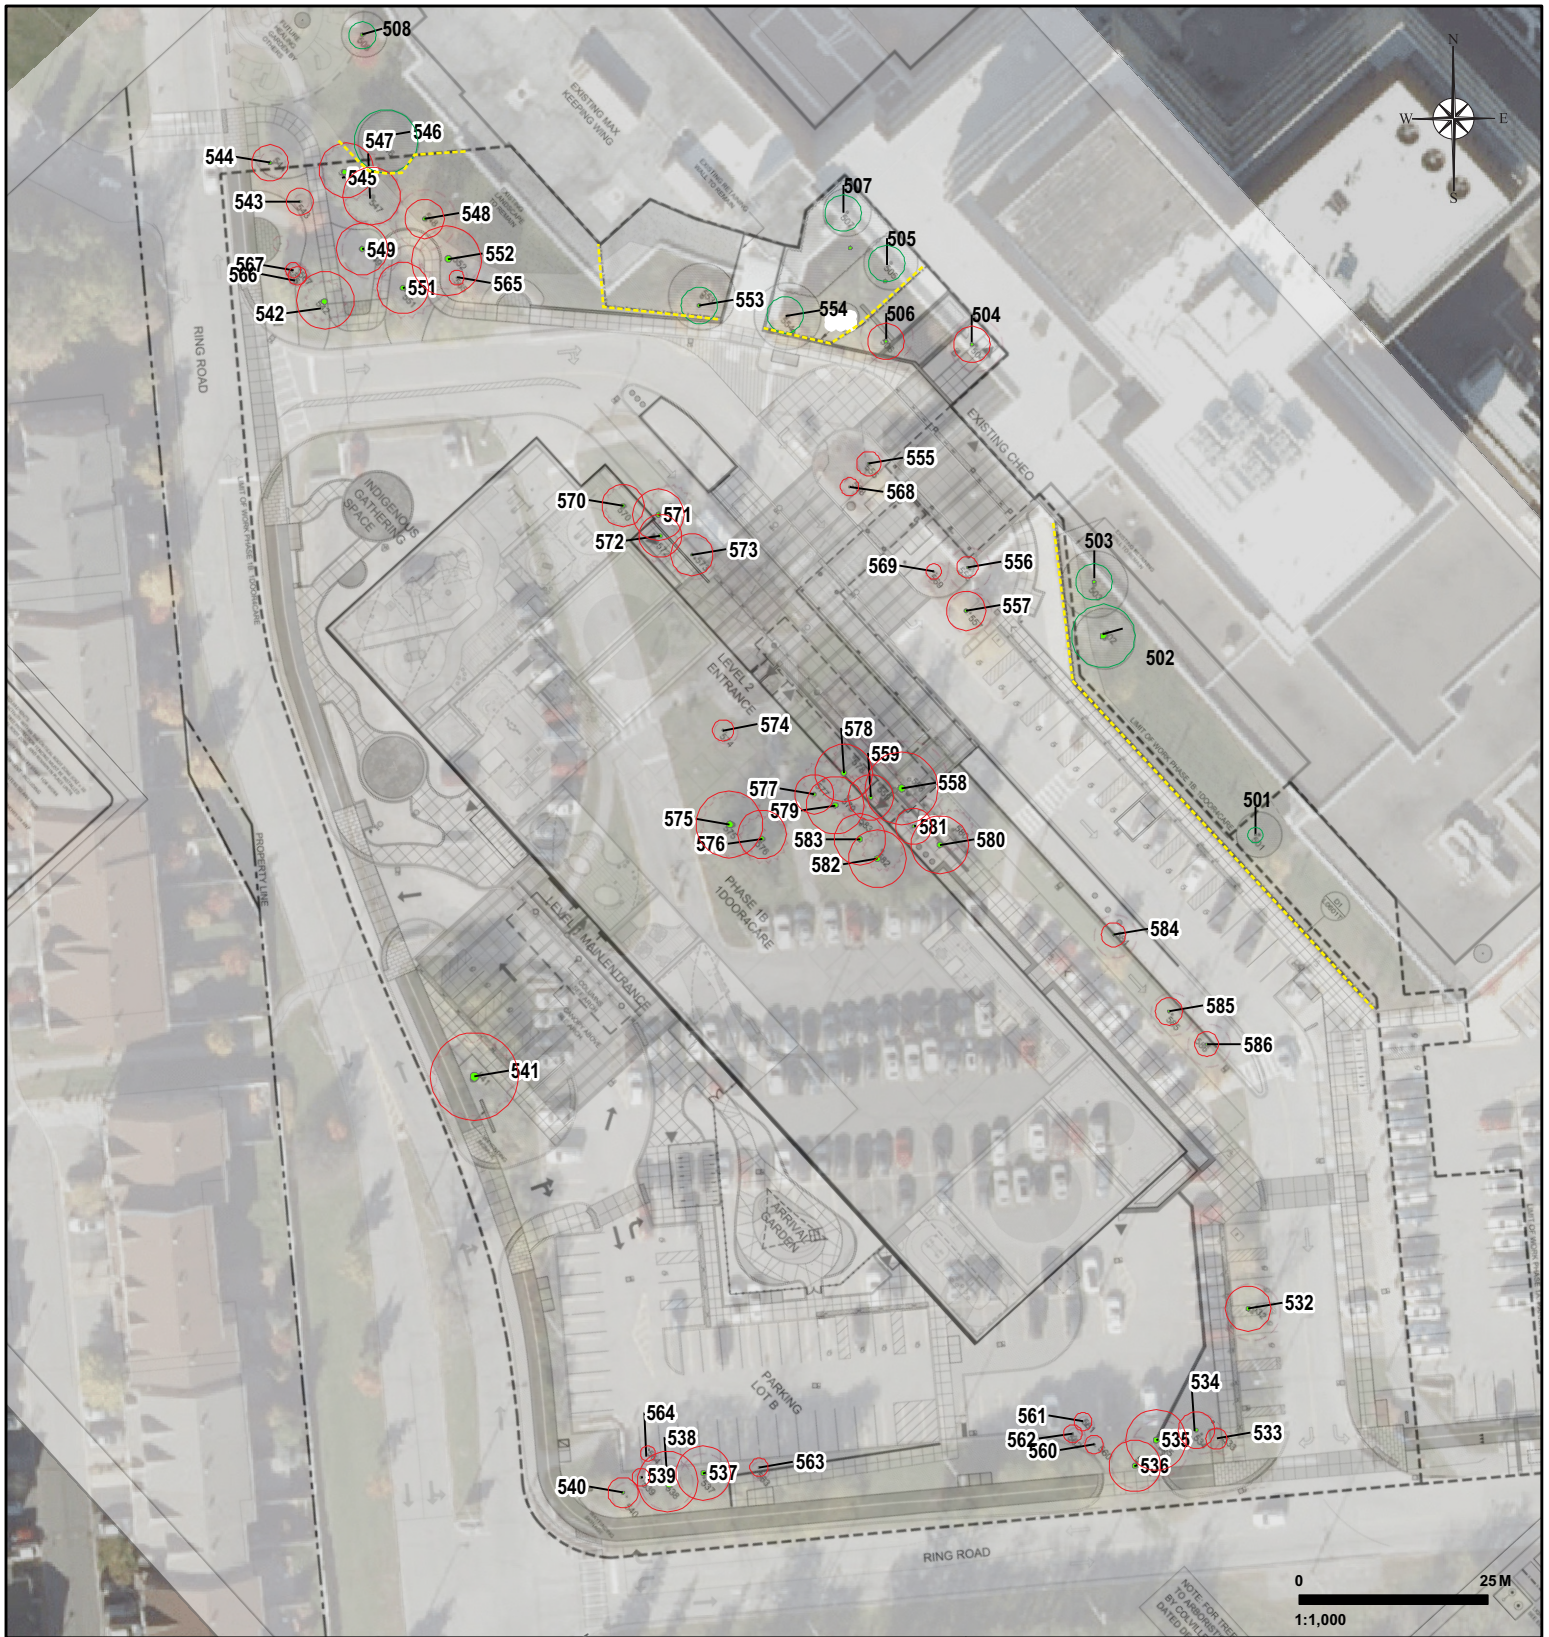
Figure #2 - Tree Inventory and CRZ for  
1DOOR4CARE Treatment Centre

Tree Inventory data for all trees surveyed as part of the proposed 1Door4Care Treatment Centre is provided in Appendix A. A total of sixty-three (63) trees were inventoried and tagged with unique tree ID numbers on and adjacent the Subject Lands during the site assessment. To facilitate the proposed development on the site, nine (9) of the trees inventoried are recommended to be retained, while fifty-one (54) are proposed for removal.

- ◆ A limit of work fence/ tree hoarding should be installed along the CRZ of trees to be retained.
- ◆ Where work within the CRZ cannot be avoided for trees recommended to be retained, mitigation measures described in the above tree care recommendations should be followed to reduce potential damage to the tree.

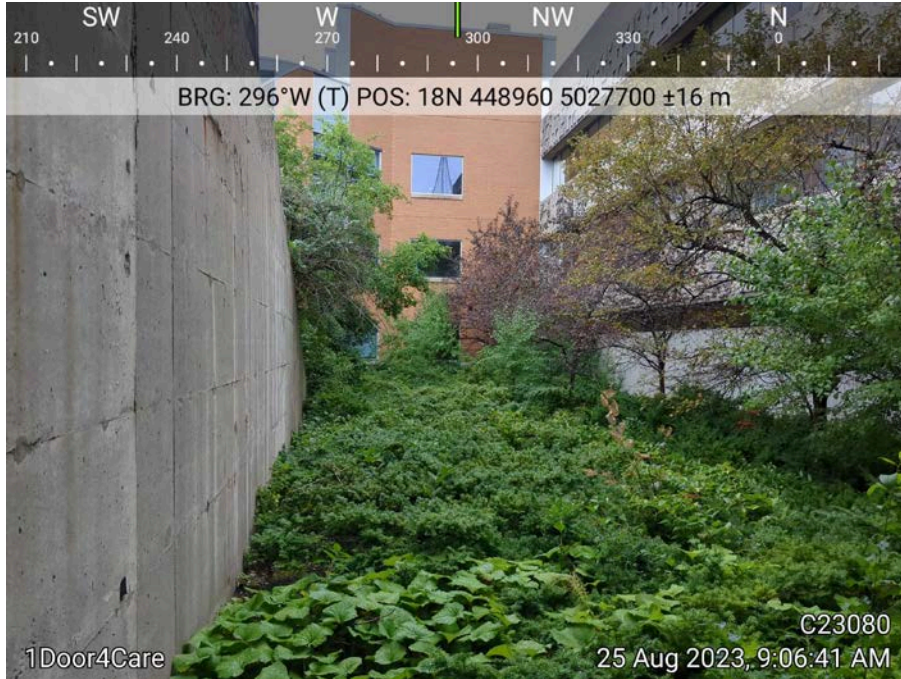
**Photo 1:** Landscaping adjacent existing hospital below drop off area.

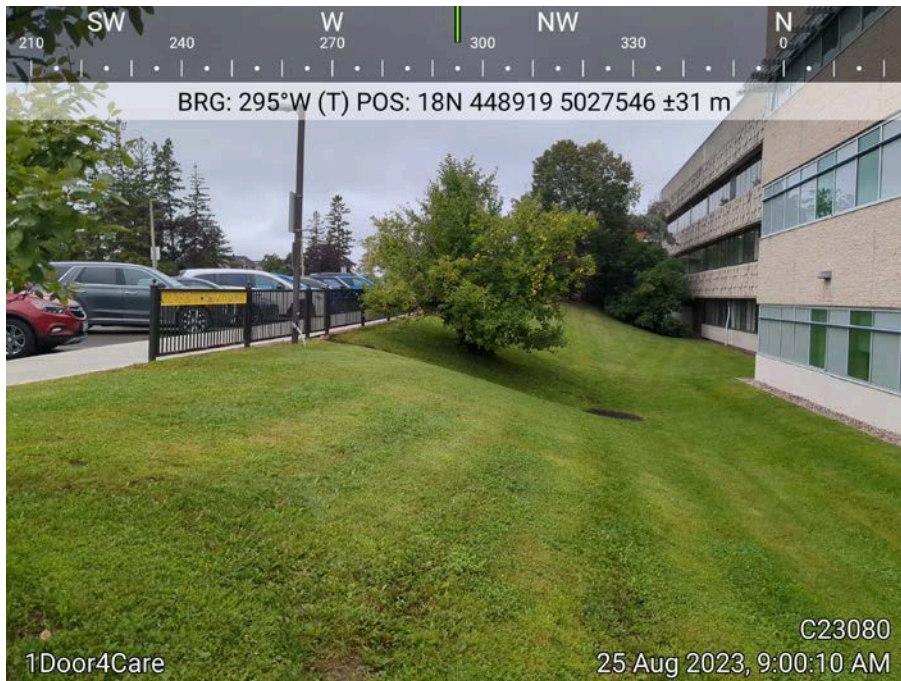
**Photo 2:** Viewing northwest at manicured area north of drop off area.

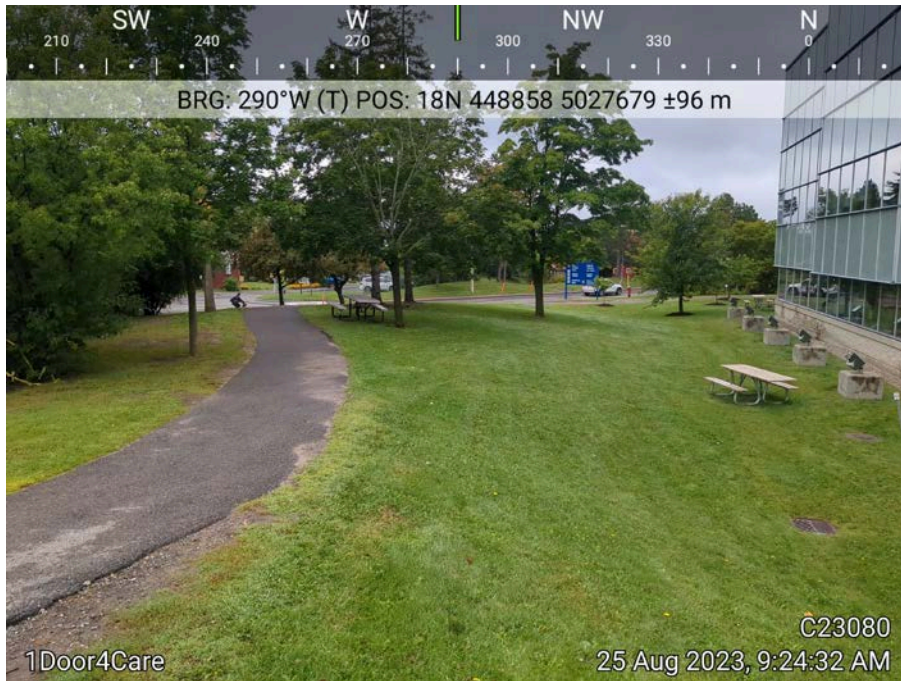
**Photo 3:** Trees adjacent walking path on northwest portion of proposed development

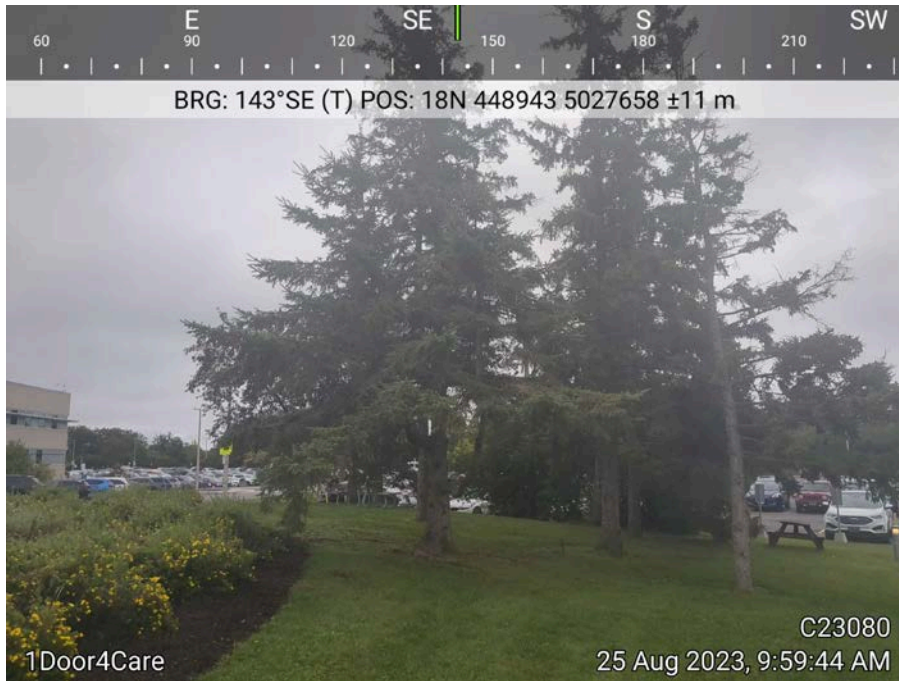
**Photo 5:** View of trees to be removed in footprint of new building.

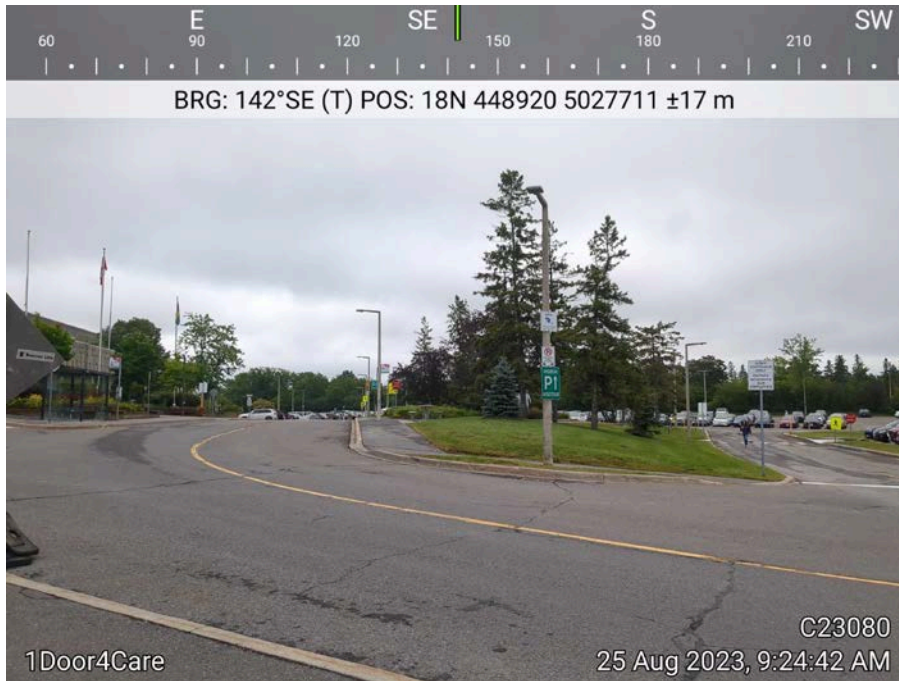
**Photo 7:** View of trees to be removed southwest of patient drop off door.

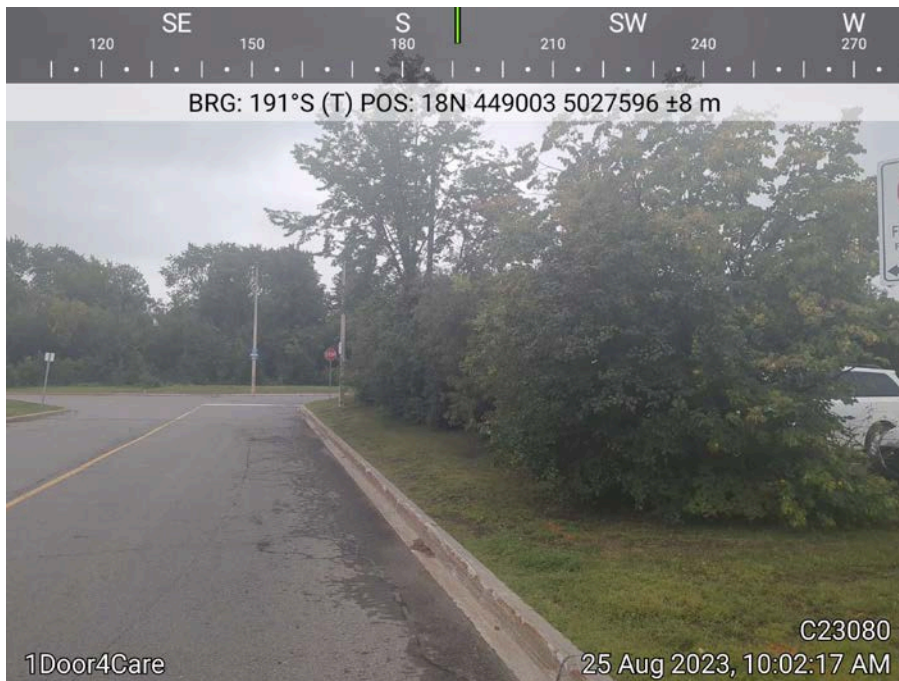
**Photo 8:** View of trees and vegetation in hedgerow adjacent Ring Road.

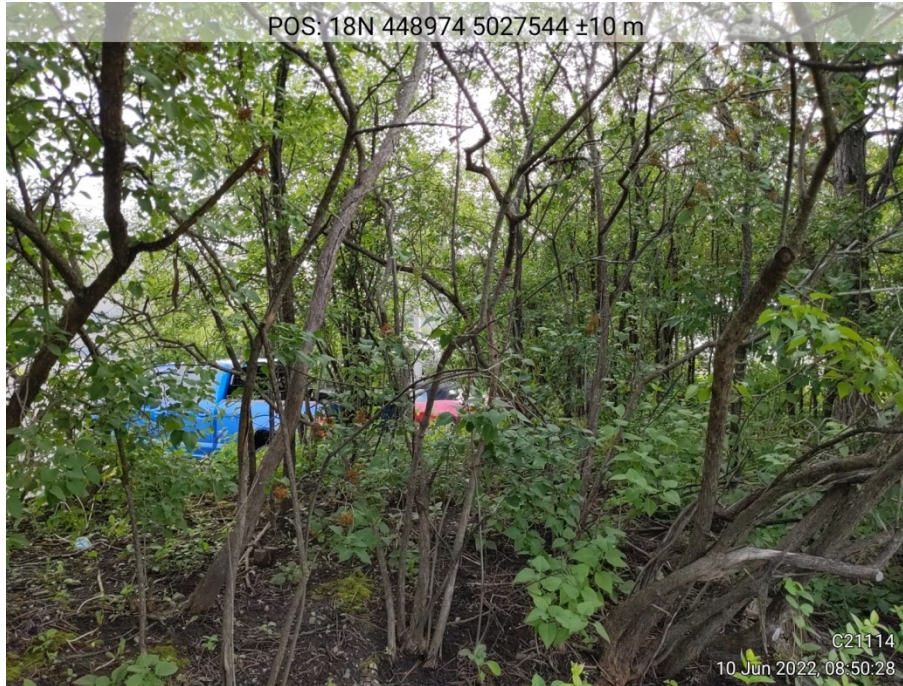
Of the trees to be removed, nine (9) are invasive common buckthorn. A significant amount of smaller common buckthorn was also observed within the thickets adjacent to Ring Road on the southern and western edges of the Subject Lands. Small thickets of Buckthorn were also observed along the northern edge of the Subject Lands.

**Photo 9:** Example of vegetation conditions within hedgerow along Ring Road.

- ◆ Any Common Buckthorn or other invasive tree species observed during construction should be removed and replaced with native species where possible.

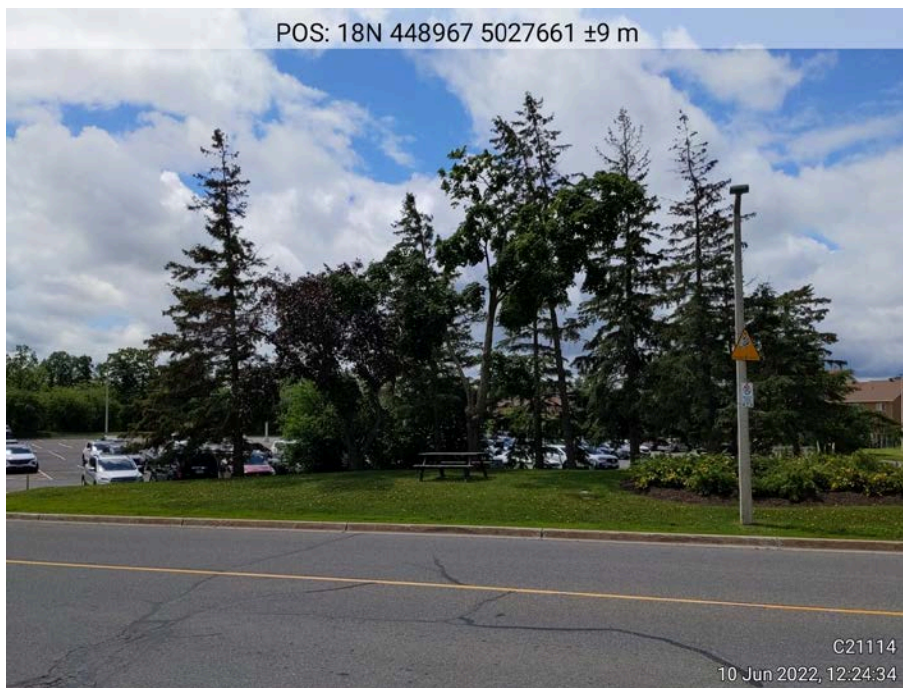
**Photo 10:** Cluster of trees in landscaped area southwest of CHEO main entrance.

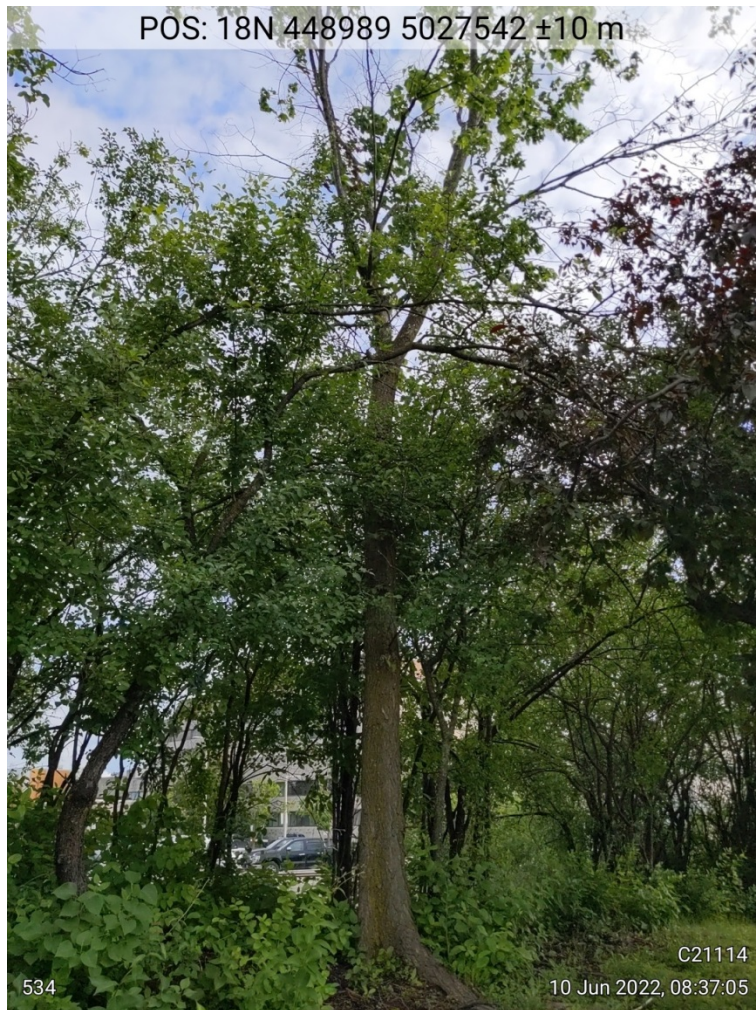
**Photo 11:** Tree #534 in poor/fair condition with significant canopy dieback.

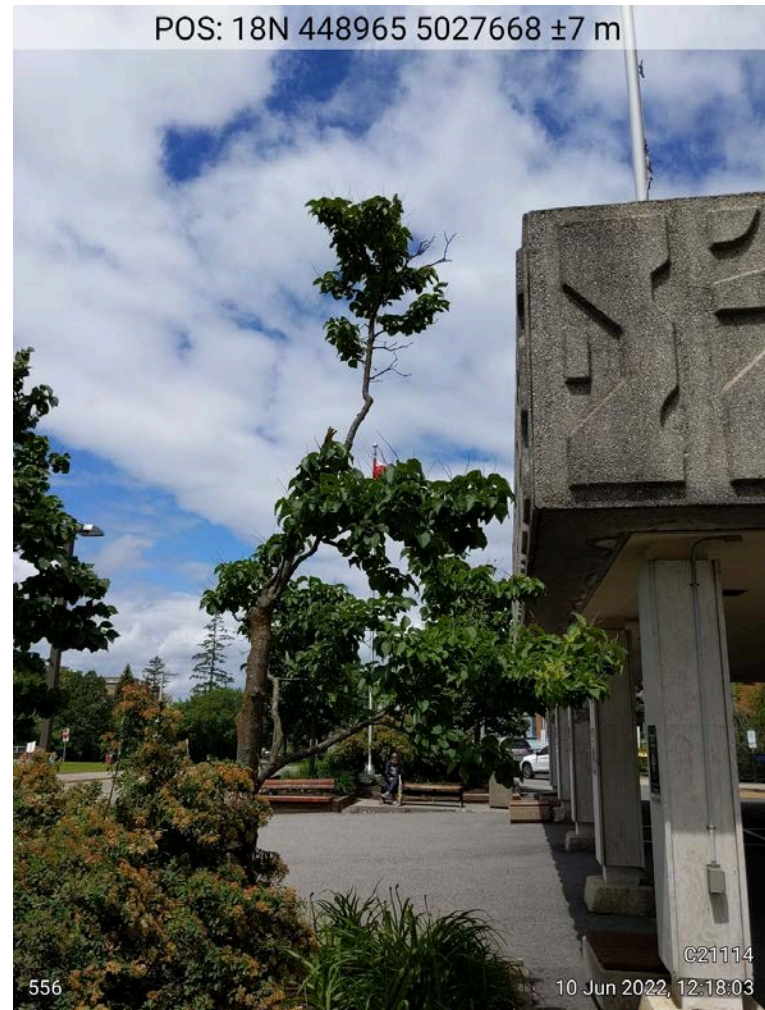
**Photo 12:** Tree #556 adjacent CHEO main entrance, fair condition with reduced canopy.

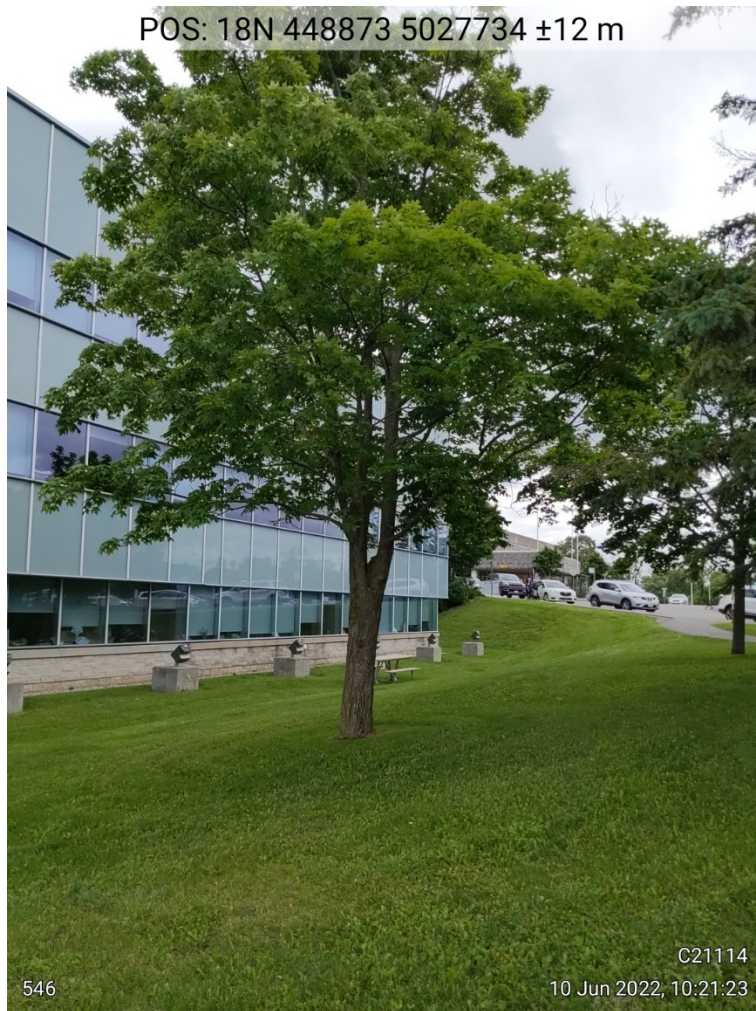
**Photo 13:** Tree #546, weak union at 1.5 metres.

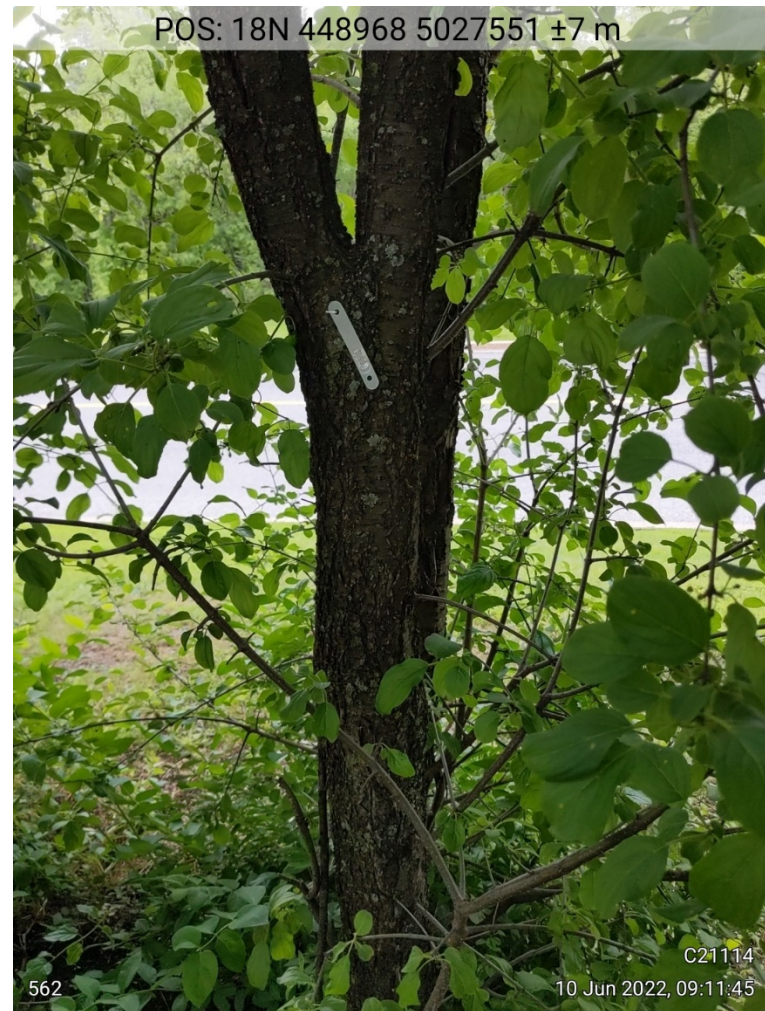
**Photo 14:** Tree #562, example of larger DBH Common Buckthorn present in hedgerows around parking area.
