October 7, 2024

# RE: TREE CONSERVATION REPORT - 384 ARLINGTON AVENUE, OTTAWA

Table 1. Species, ownership, diameter, condition, and status of trees at 384 Arlington Avenue.

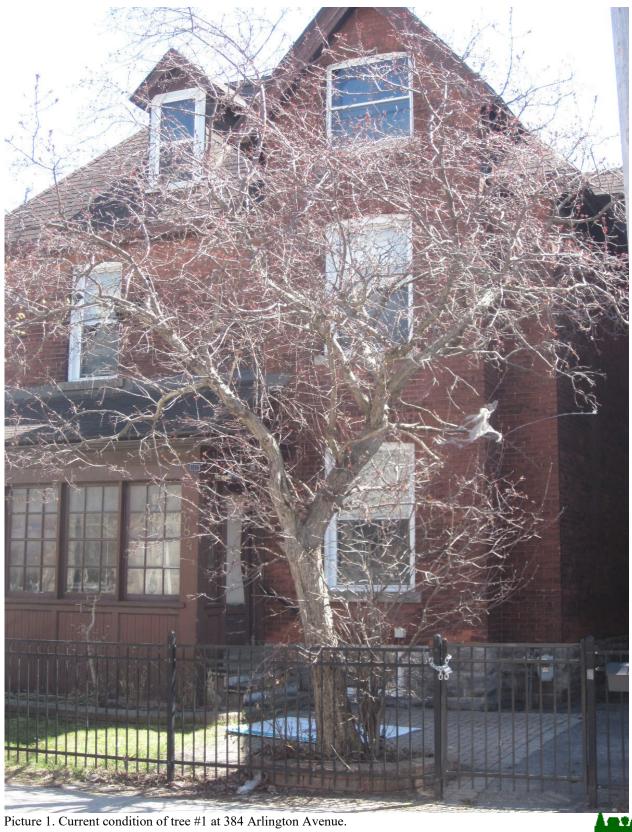
Tree	Tree	Owner-	DBH <sup>1</sup>	Tree condition, age class, condition notes &
No.	Species	ship	(cm)	<b>Preservation Status</b> (to be removed or preserved and
		•	, , ,	protected)
1	Crab apple	City	24.8	Good; mature; co-dominant stems at 2.25m; crown
	(Malus spp.)			dense with epicormic growth; generally symmetric;
				minor basal sprouting; major wound with decay and
				cavity in north stem at 2-2.5m; cultivar; to be removed
				(conflicts with construction)
2	Crab apple	City	26.4	Poor; mature; single dominant stem for most of height
	(Malus spp.)			(lateral stem at 2m on northwest is dead); heavily
				divergent towards northwest; opposing stem wounds at
				2m on northeast with decay and 2m on northwest also
				with decay; heavy basal sprouting; tree is in decline;
				cultivar; to be removed (conflicts with construction)

As noted above, neither tree can be retained because of the excavation required for the new building and access for the structural reinforcements required for the conservation of the existing church frame.

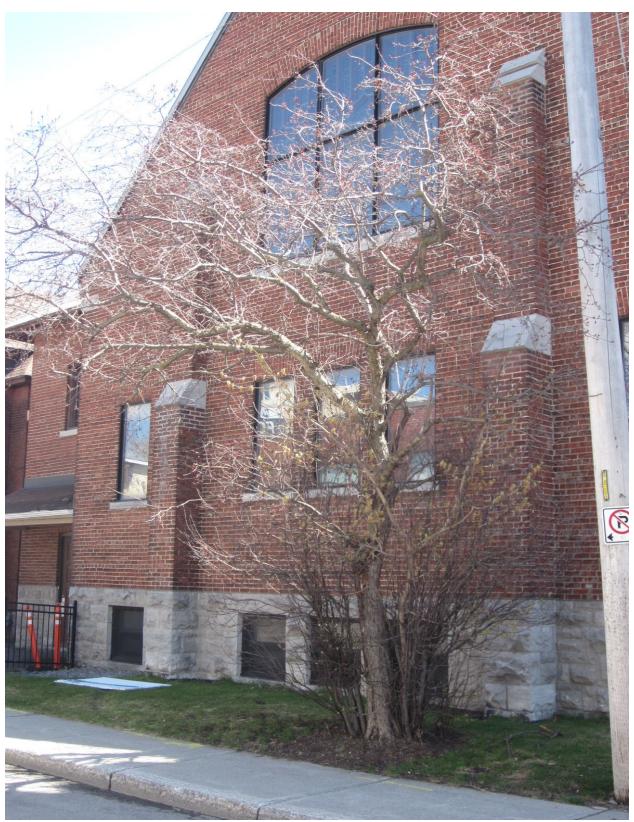
Picture 2. Current condition of tree #2 at 384 Arlington Avenue.
