July 15, 2024

**RE: TREE CONSERVATION REPORT – 2140 BASELINE ROAD, OTTAWA**

**APARTMENT  
BUILDING**  
2140 BASELINE ROAD

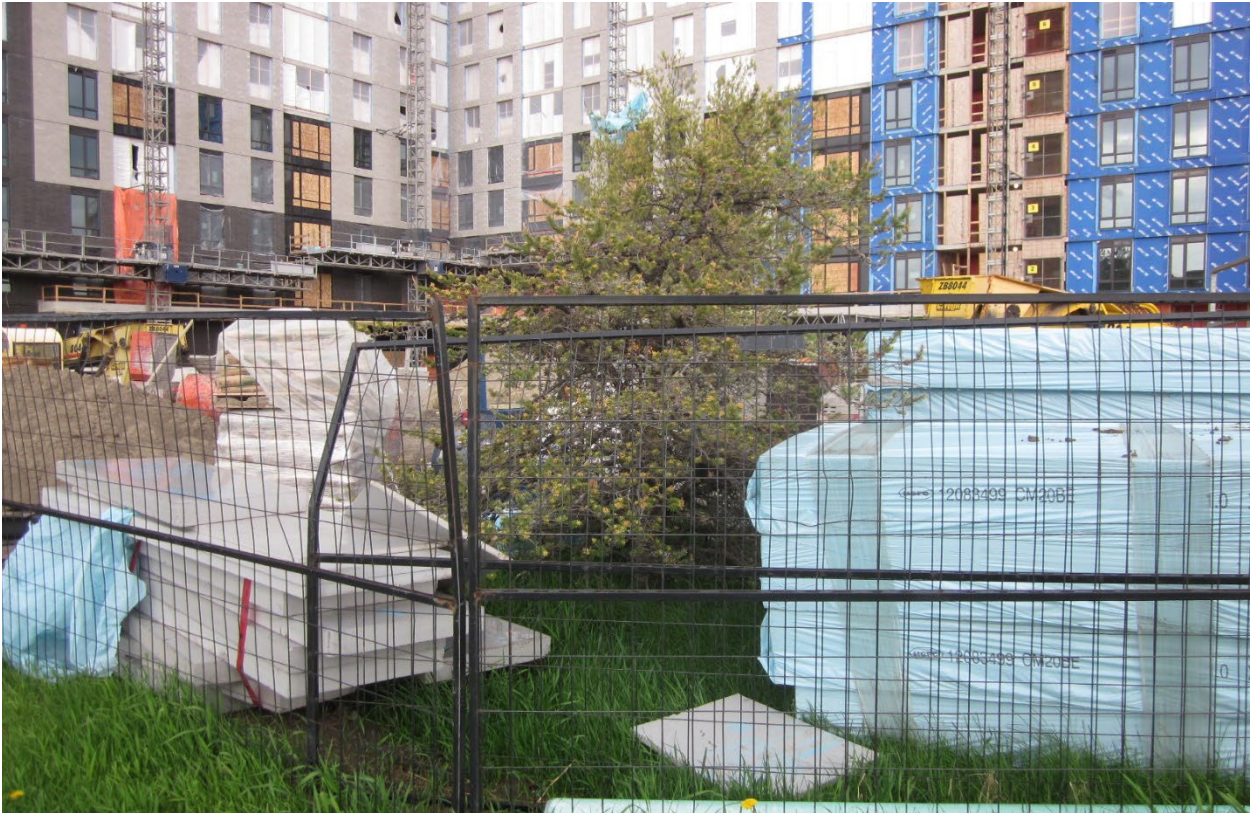
Tree No.	Tree Species	Ownership	DBH <sup>1</sup> (cm)	Tree Condition, Age class & <b>Preservation Status</b> (to be removed or preserved and protected)
1	Jack pine ( <i>Pinus banksiana</i> )	Fair	9	Fair; mature; stunted form; heavy pine needle scale infestation; native species; <b>to be preserved and protected</b>
2	Red oak ( <i>Quercus rubra</i> )	Good	24	Poor; maturing; broad, dense crown; internal deadwood only; native species; <b>to be preserved and protected</b>
3	Red oak ( <i>Quercus rubra</i> )	Fair	23	Poor; maturing; moderate amount of dead, declining branches on north side of crown; maturing; native species; <b>previously removed</b>
4	Scots pine ( <i>Pinus sylvestris</i> )	Fair	17	Fair; mature; co-dominant stems at 2m; moderate pine needle scale infestation; introduced invasive species; <b>to be preserved and protected</b>
5	Ash ( <i>Fraxinus spp.</i> )	Very poor	-	Very poor; mature; in advanced decline due to Emerald ash borer ( <i>Agrilus planipennis</i> ) – coppicing from base; native species; <b>previously removed</b>

Picture 1. Current condition of tree #1 (jack pine) at 2140 Baseline Road.

Tree #1 (jack pine): install fencing as per City of Ottawa tree protection barrier specification (see page 7); spray tree to reduce heavy infestation of pine needle scale; penetrometer tests found minimal soil compaction - remove turf within CRZ and replace with composted pine mulch spread 5-10cm deep and deep root fertilize

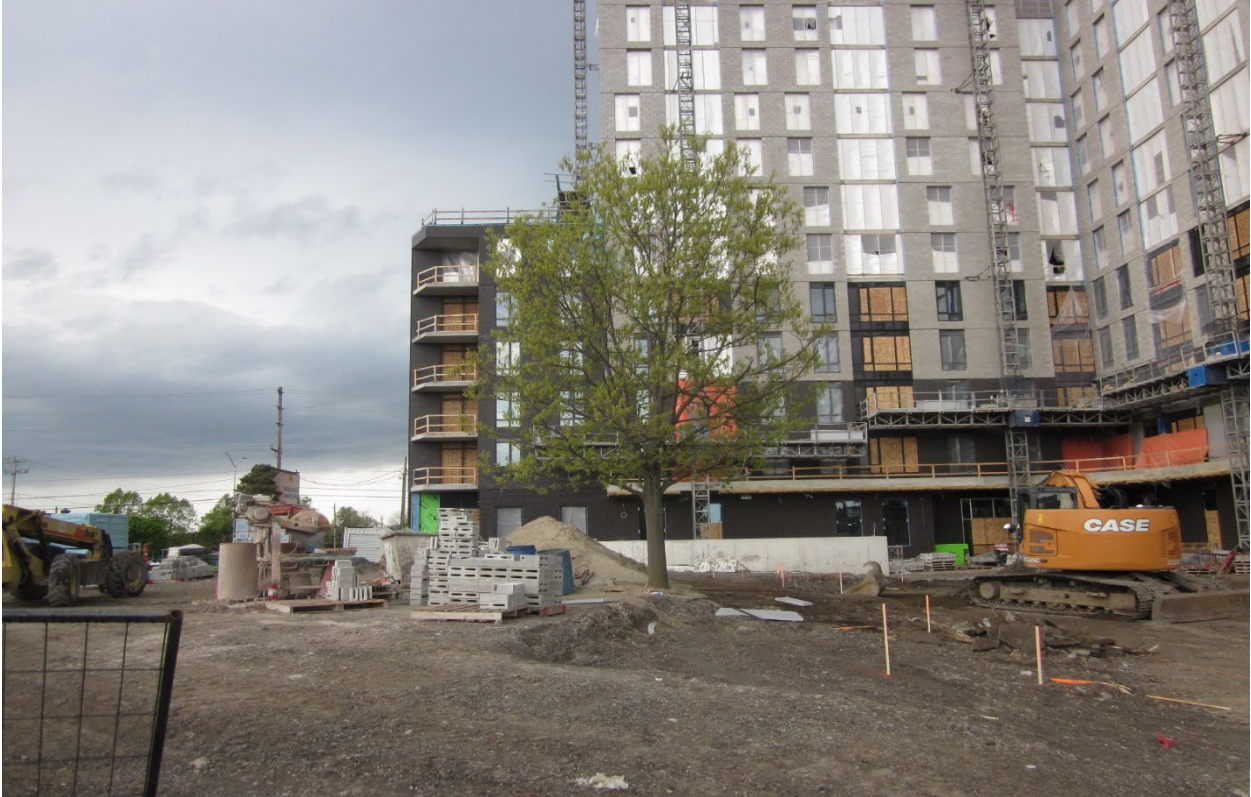
Picture 2. Current condition of tree #2 (red oak) at 2140 Baseline Road.

Tree #2 (red oak): install fencing as per City of Ottawa tree protection barrier specification; remove piled sand surrounding tree by hand down to original grade; penetrometer tests found extreme soil compaction - radial trenching by air knife to de-compact soils, backfill with horticultural soil, cover by 5-10cm of mulch and deep root fertilize

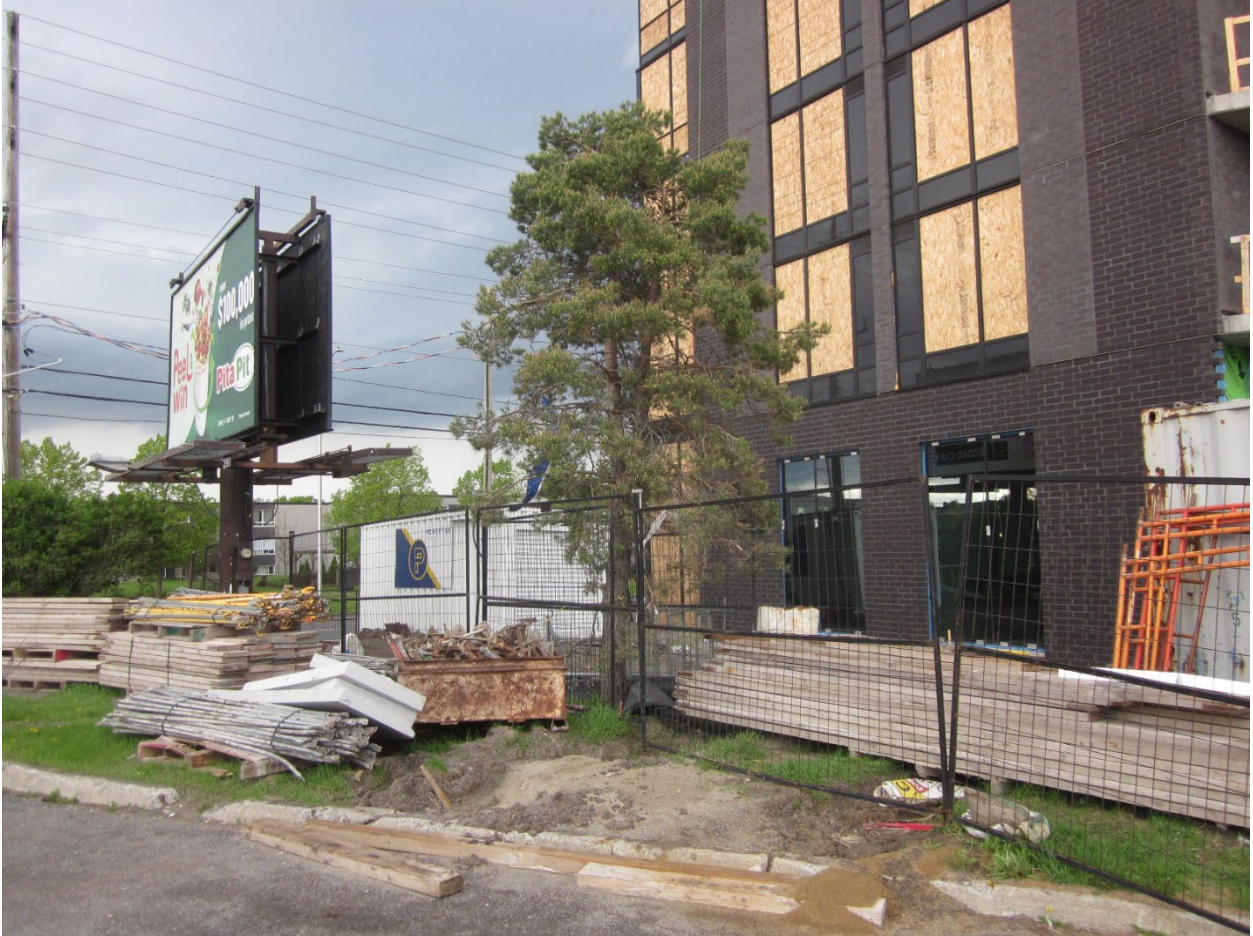
Picture 3. Current condition of tree #4 (Scots pine) at 2140 Baseline Road.

Tree #4: (Scots pine): install fencing as per City of Ottawa tree protection barrier specification; spray tree to reduce moderate infestation of pine needle scale; penetrometer tests found moderate soil compaction - vertical mulch in a diamond pattern within CRZ, backfill with a combination of peat moss and vermiculite, remove turf within CRZ and replace with composted pine mulch spread 5-10cm deep and deep root fertilize
