Phase I Environmental Site Assessment Update

6622 Bank Street, Ottawa, Ontario

CAMM Heavy Machinery MoversFinal Report

August 26, 2024 02407549.000

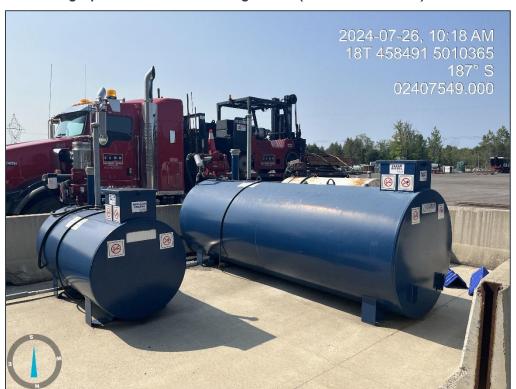
Three fuel ASTs (two diesel and one gasoline) were observed west of the warehouse building, on a concrete pad. All tanks observed appeared to be in good condition with no corrosion, punctures, or visible spills/leaks noted.

Based on the observed condition of the minor fuel storage and three fuel ASTs on Site, and no evidence of any surficial staining observed in the vicinity, these PCAs are not anticipated to pose a potential environmental concern to the Site at this time.

Photograph 8: Three Exterior Fuel ASTs (6622 Bank Street) - PCA 2.

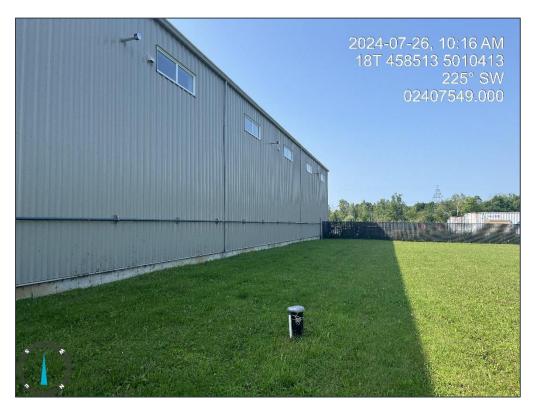
During the Site reconnaissance, Englobe observed one potable drinking water supply well north of the warehouse building.

Photograph 9: Potable Water Supply Well (6622 Bank Street).

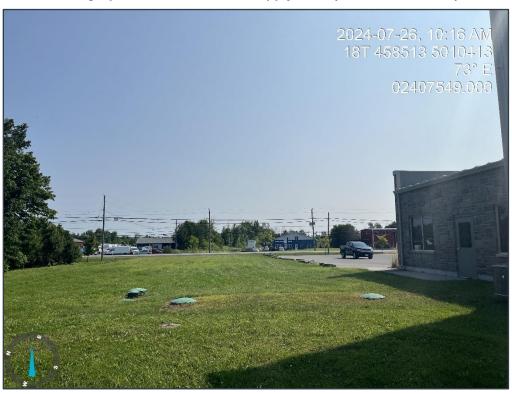
Below-ground structures at the Site included a septic tank with associated tile beds and piping. No other below-ground structures or basements were observed on Site during the Site reconnaissance.

Photograph 10: Septic Tank Area (6622 Bank Street).
