TREE CONSERVATION REPORT

168-174 Murray Street

**Tree Conservation Report
submitted as Partial
Requirements for a Site Plan
Control Application, March 30,
2022**

Date: March 30, 2022

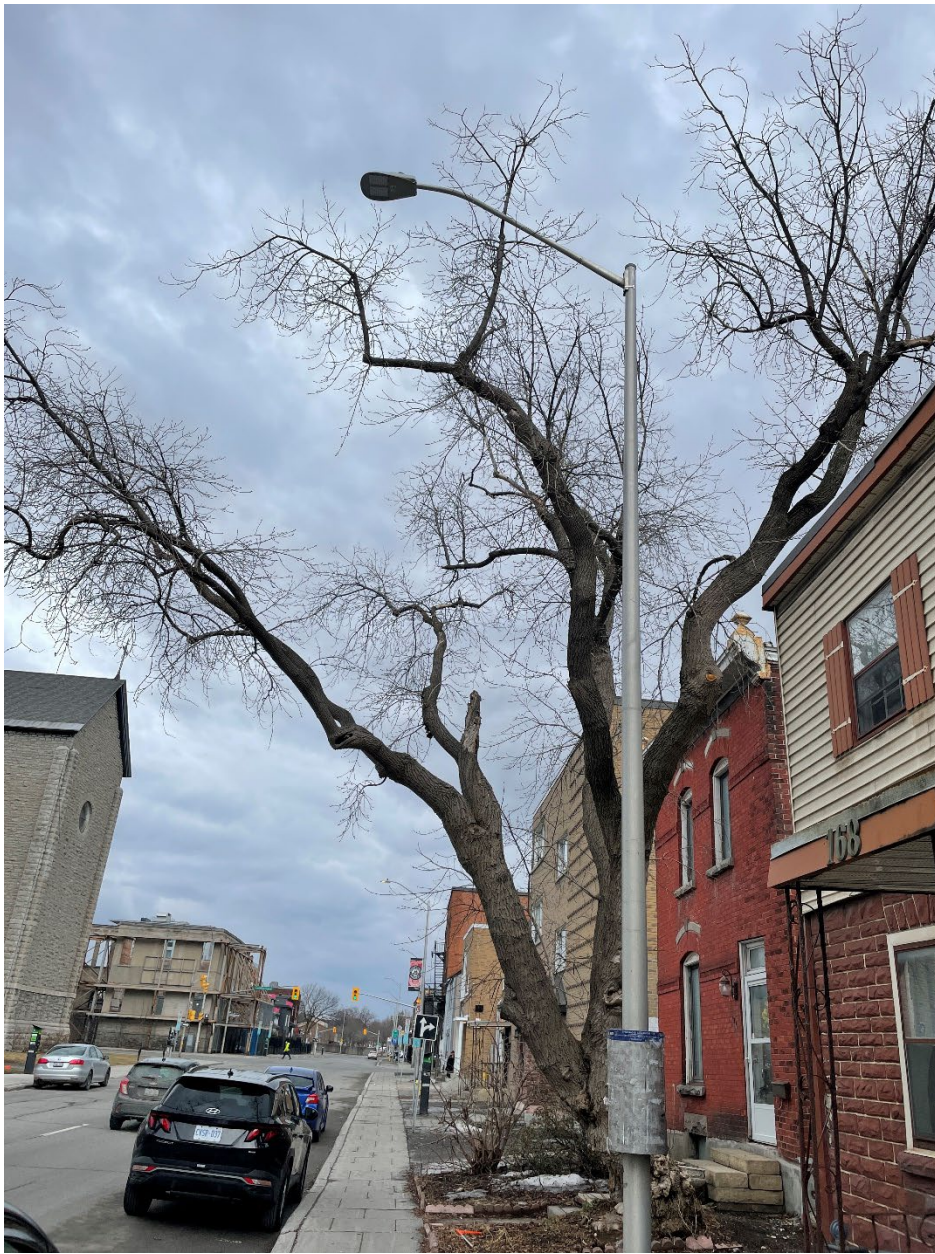
Tree ¹	Species	Diameter at breast height (dbh)	Ownership ²	Condition	Action
1	Manitoba maple (<i>Acer negundo</i>)	88 cm	City	Poor; extensive crown dieback throughout, decay at base and at junction of two stems, risk of branches and/or stem failing onto road	Remove prior to any site works; Tree Permit required for removal or request removal by City Forestry department
2 ³	Manitoba maple (<i>Acer negundo</i>)	40, 40 cm (estimate)	Private – 174 Murray	Poor, extreme lean over garage, possibly relying on garage for support, significant fissure on upper side of one stem	Remove prior to any site works, particularly garage demolition; Tree Permit required for removal

The two Manitoba maples at this site are both short lived species that are in the later stages of their life cycle and are in decline. Tree 1 is city owned and has likely been maintained by the city in the past. There is excellent coverage in Google Streetview since 2007 showing the decline of this tree based on the progression of crown dieback. Removal of this tree prior to any site works is recommended due to the risk of failure of branches combined with the close proximity of the existing residence that will undergo significant renovations.

Figure 1: Tree 1, Manitoba maple in poor health to be removed

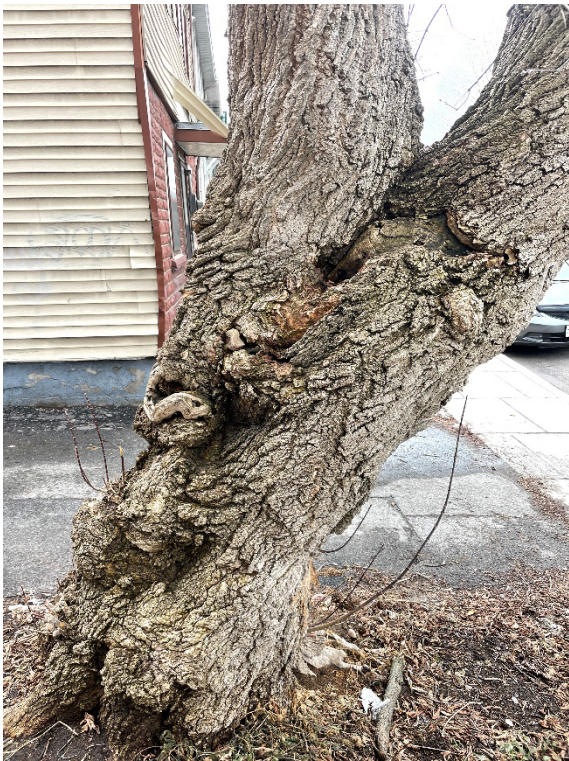
Figure 3: Close up on the east side of tree 1, showing decay and included bark in the main junction of the two stems

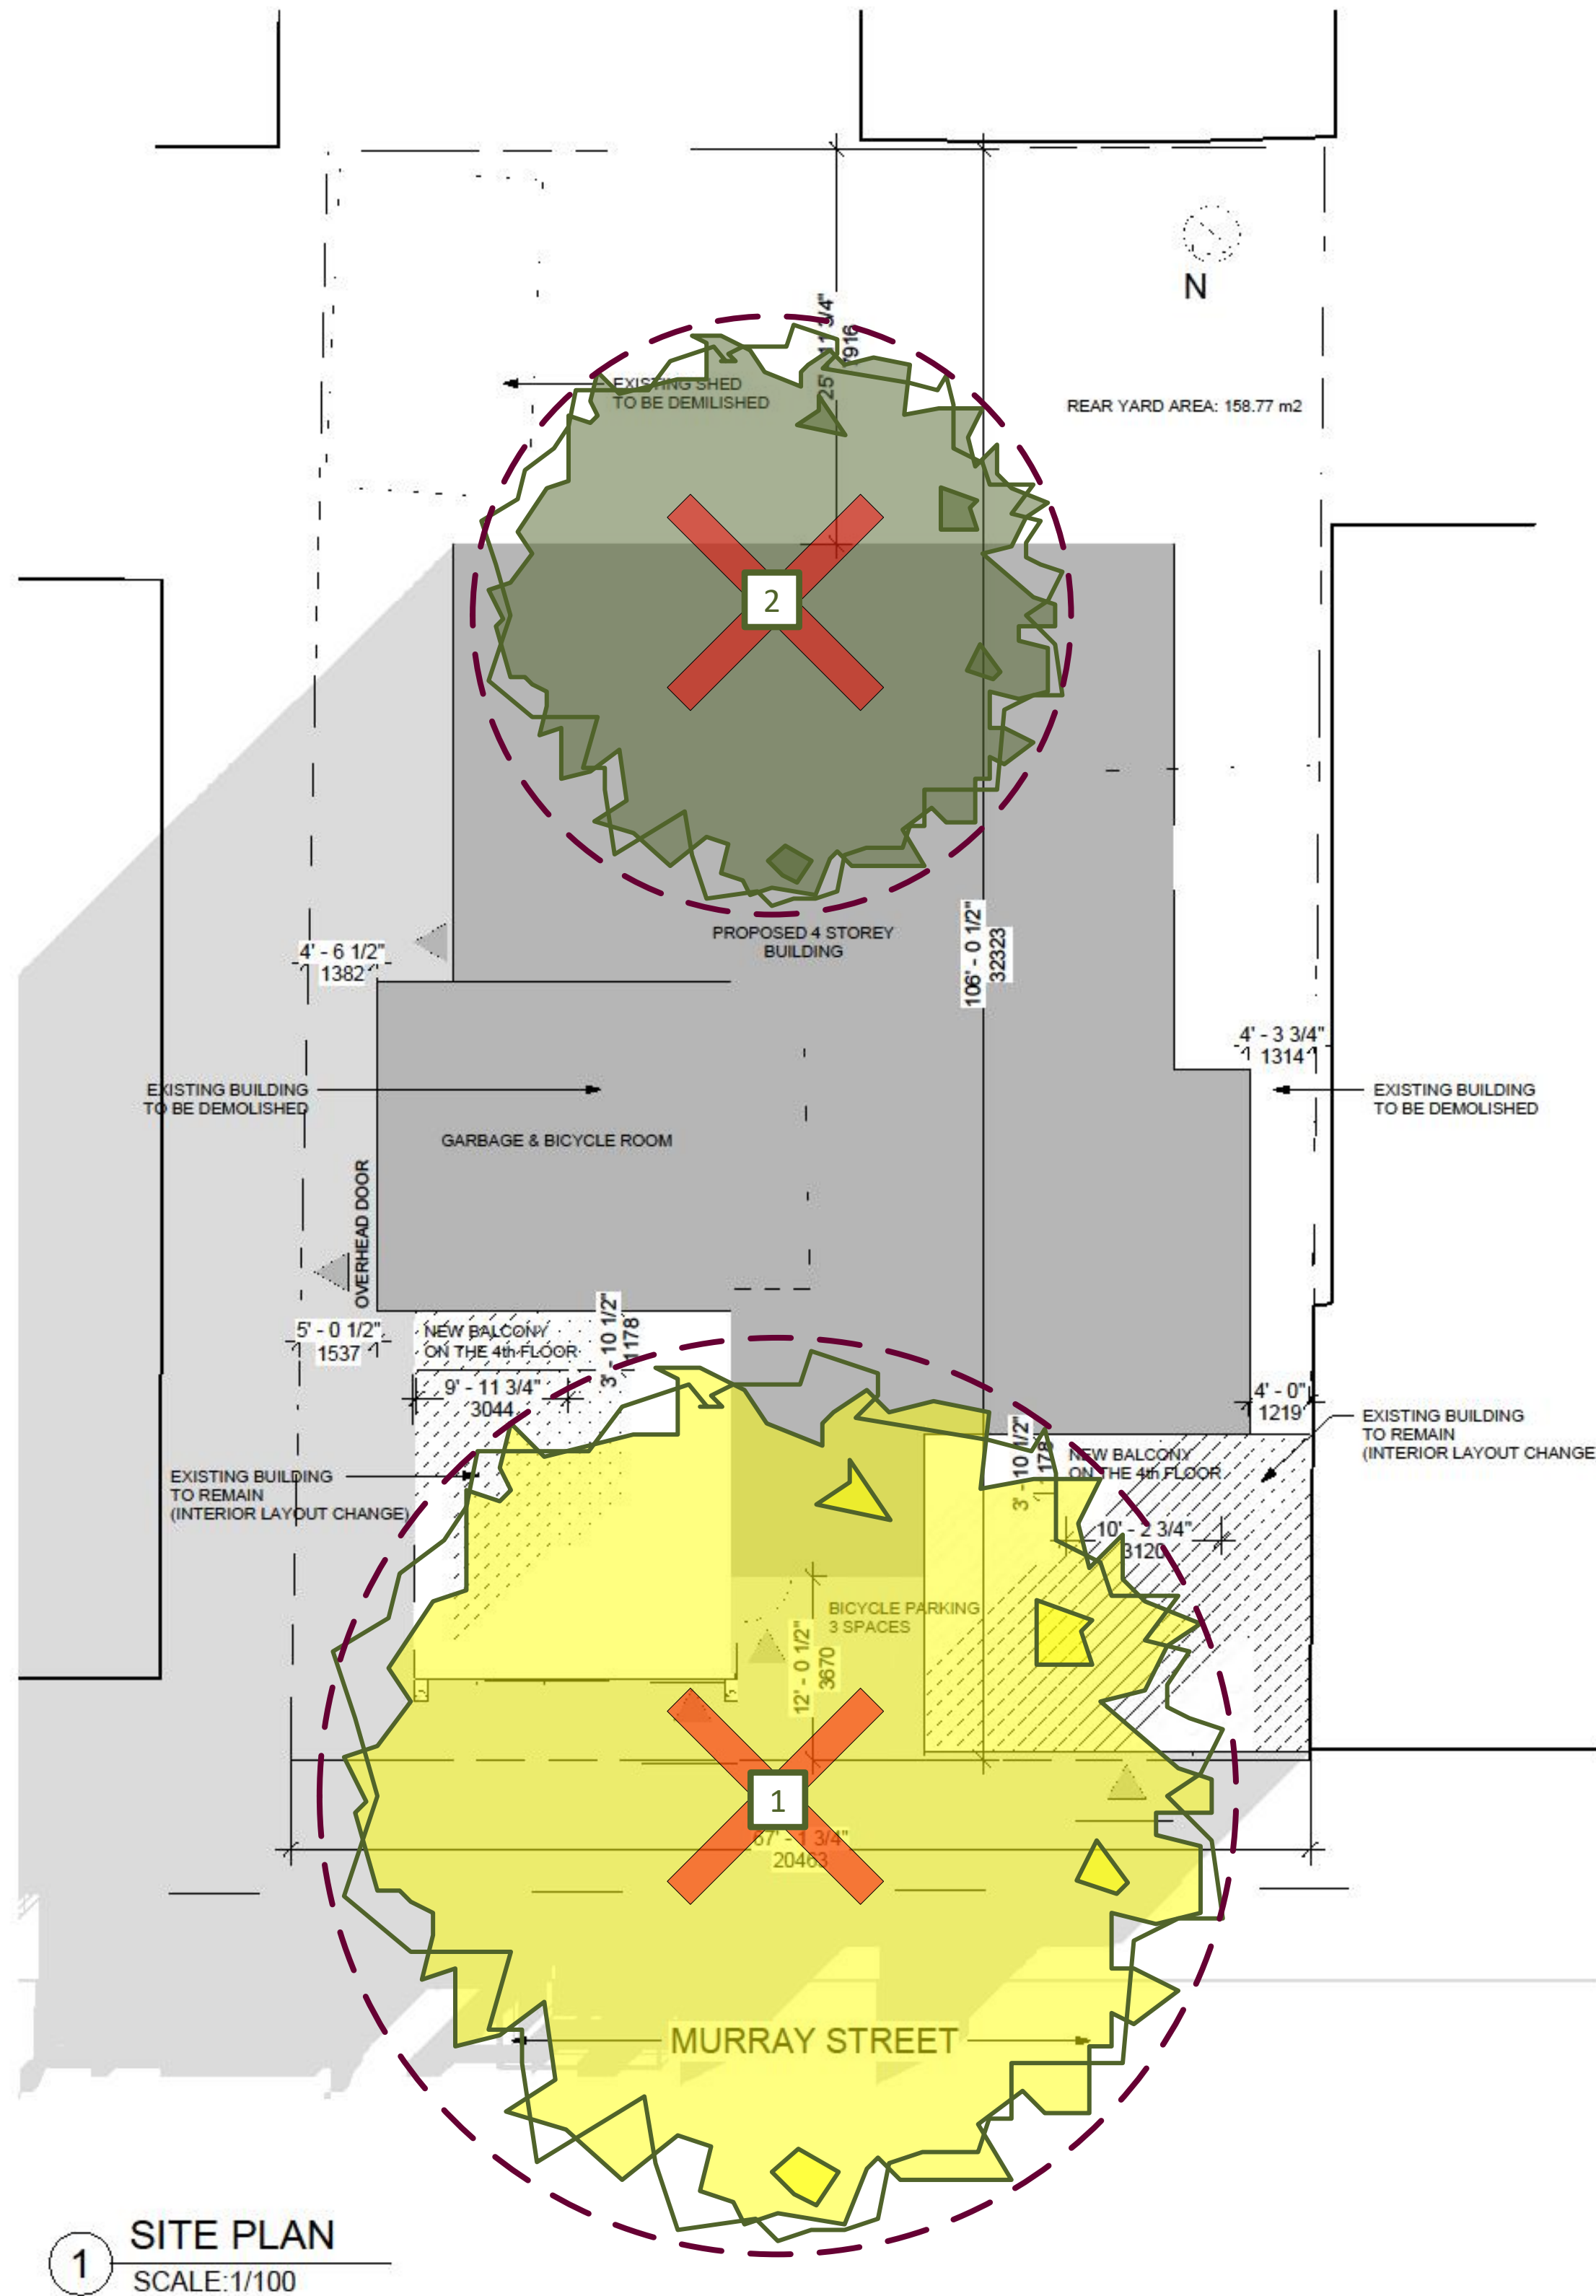
1 SITE PLAN
SCALE: 1/100

Tree ¹	Species	Diameter at breast height (dbh)	Condition	Action
1	Manitoba maple (<i>Acer negundo</i>)	88 cm	Poor; extensive crown dieback throughout, decay at base and at junction of two stems, risk of branches and/or stem failing onto road	Remove prior to any site works; Tree Permit required for removal or request removal by City Forestry department
2 ³	Manitoba maple (<i>Acer negundo</i>)	40, 40 cm (estimate)	Poor, extreme lean over garage, possibly relying on garage for support, significant fissure on upper side of one stem	Remove prior to any site works, particularly garage demolition; Tree Permit required for removal
