December 19, 2024

CM3 File: SDC1009

Phase I Environmental Site Assessment Update
Ste-Cecile Street Project
73-79, 83 Ste-Cecile Street, Ottawa, Ontario

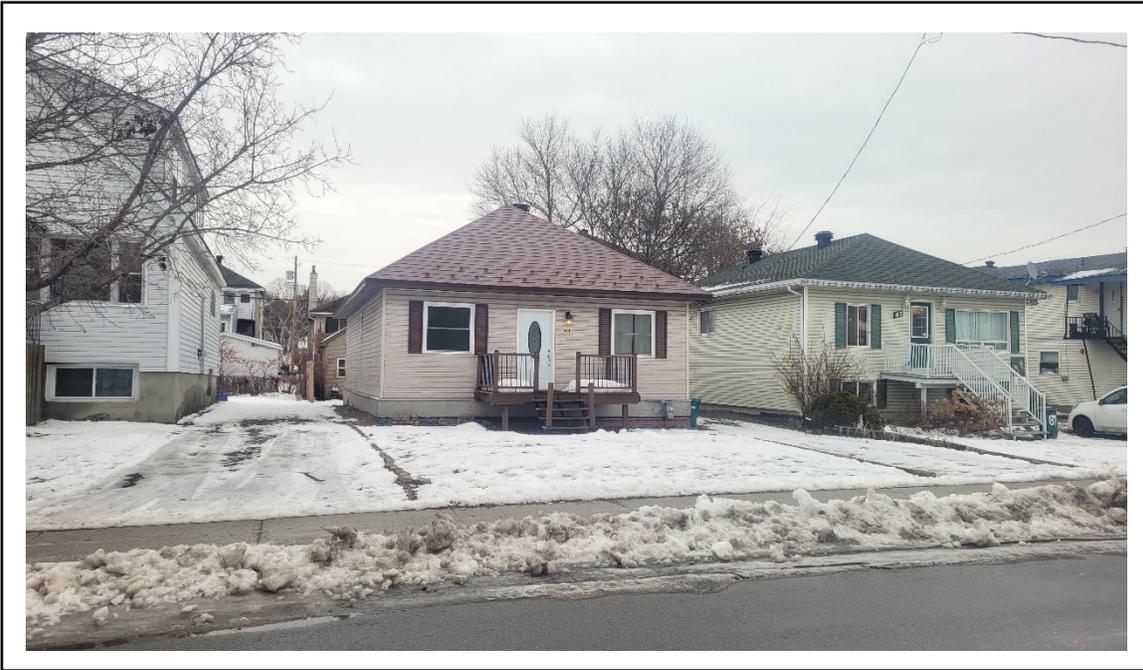
Photograph 1: Looking north at south end (front) of 83 Ste-Cecile Street. Neighboring property 87 Ste-Cecile to the east.

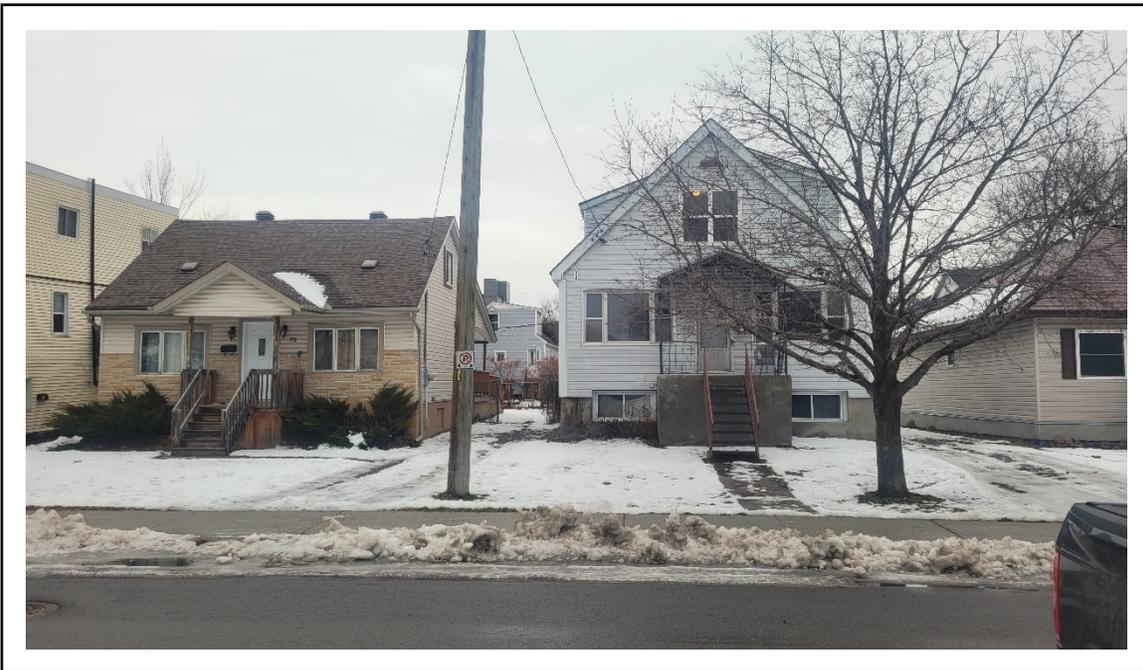
Photograph 2: Looking north at south ends (front) of 73 and 79 Ste-Cecile.

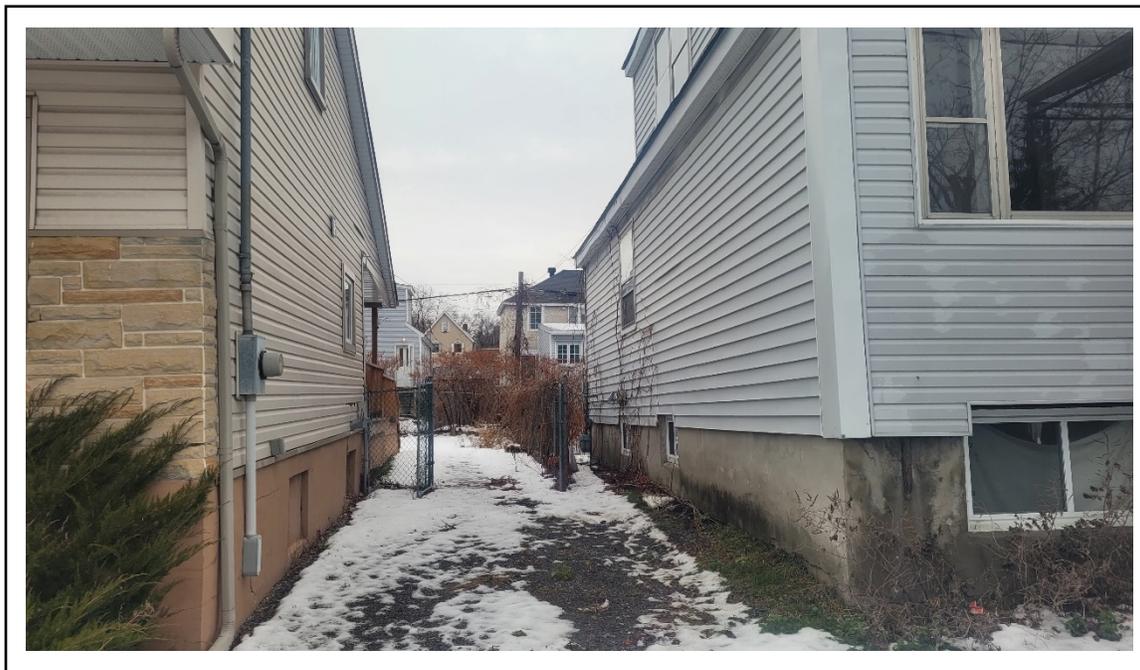
Photograph 3: Looking north into the backyard of 73 and 79 Ste-Cecile.

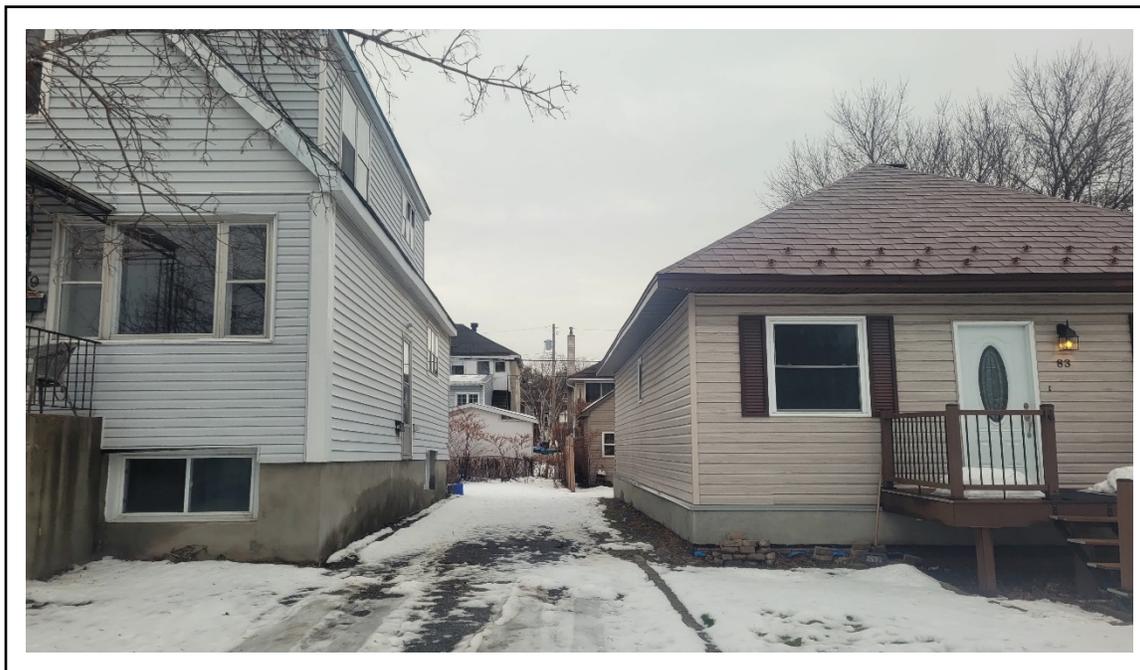
Photograph 4: Looking north into the backyard of 79 and 83 Ste-Cecile.

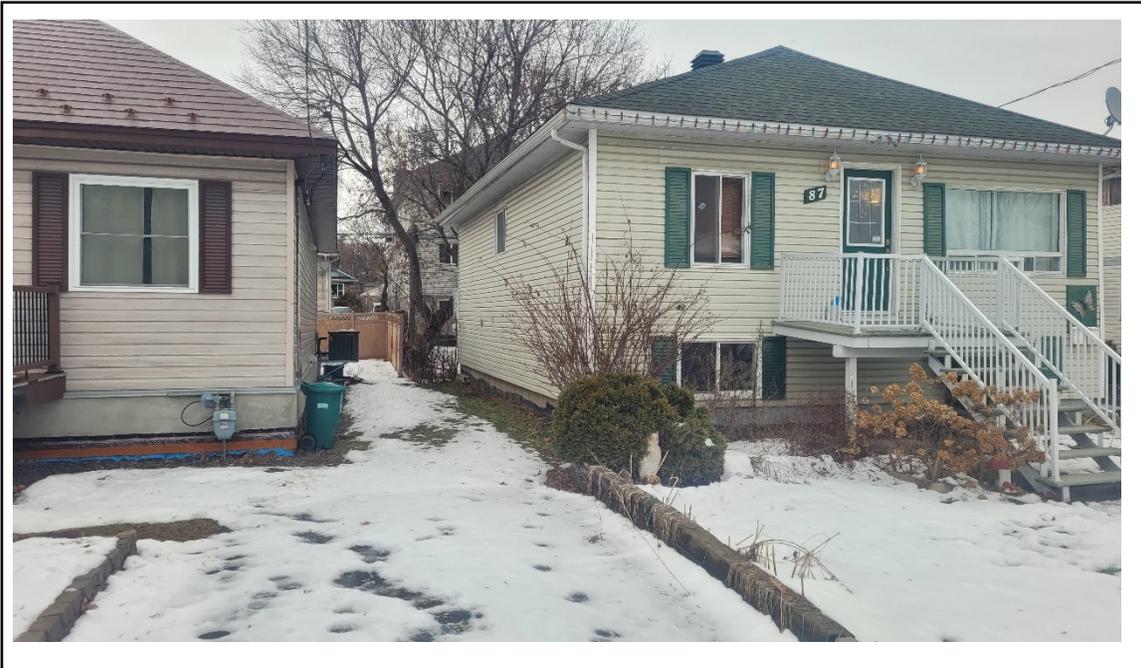
Photograph 5: Looking north at east side of 83 Ste Cecile with 87 Cecile on east. Noted residential properties to the north.

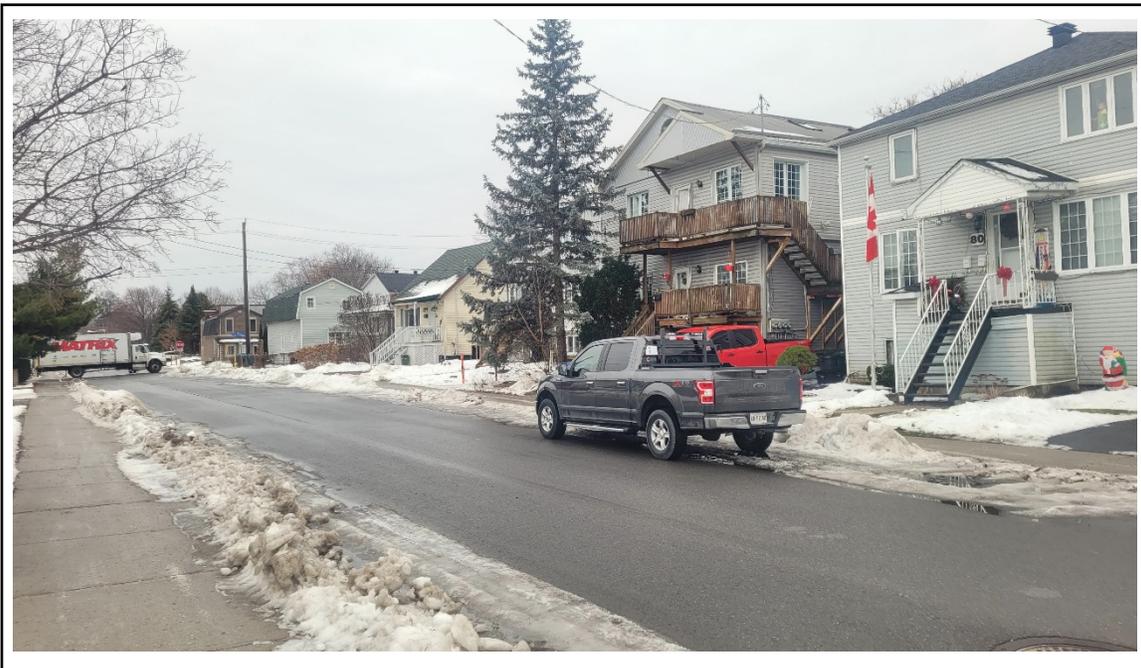
Photograph 6: Photograph looking south-east on north side of Ste-Cecile Street across from subject properties.

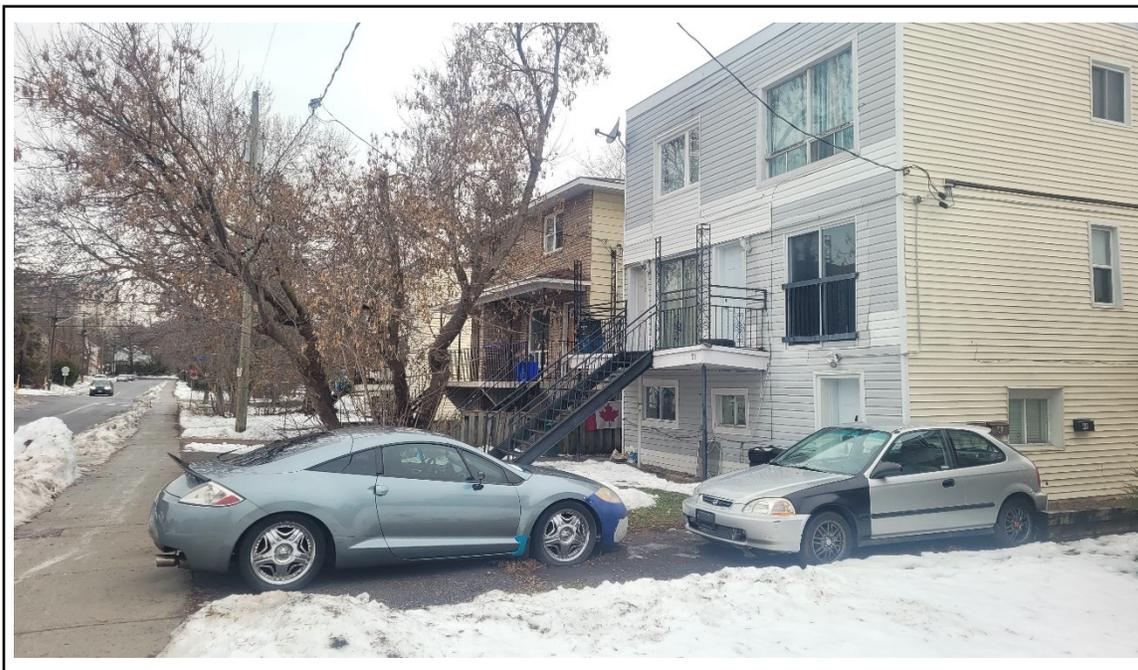
Photograph 7: Looking east from north side of Ste-Cecile at residential properties to the east of site.

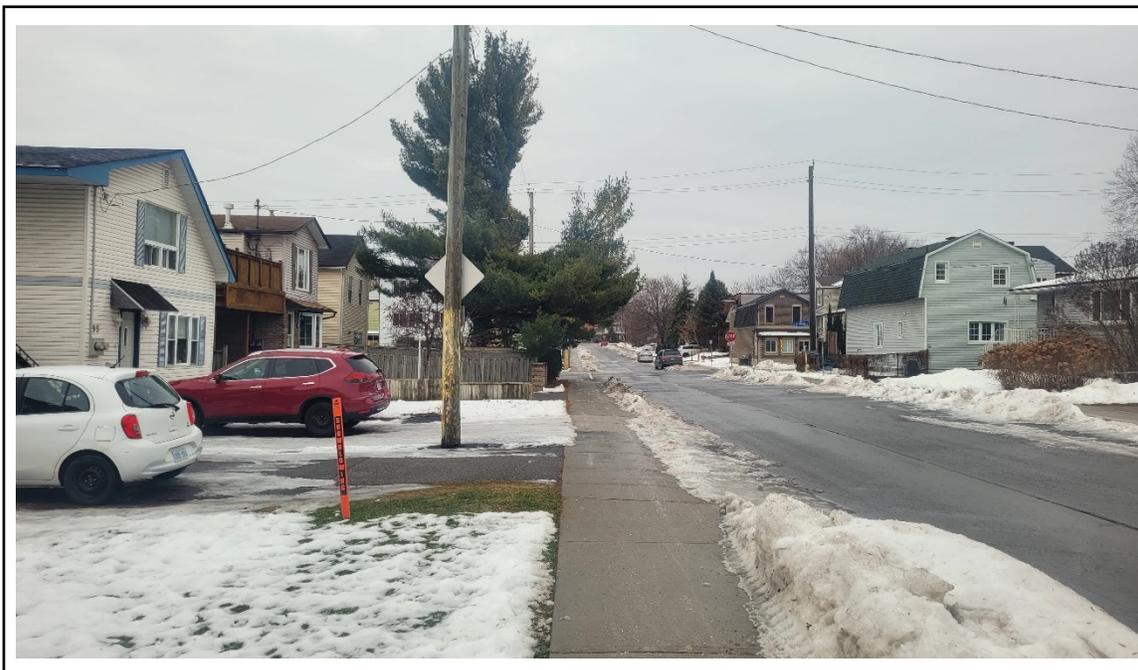
Photograph 8: Looking west from north side of Ste-Cecile Street at adjacent residential properties to the west and south-east.

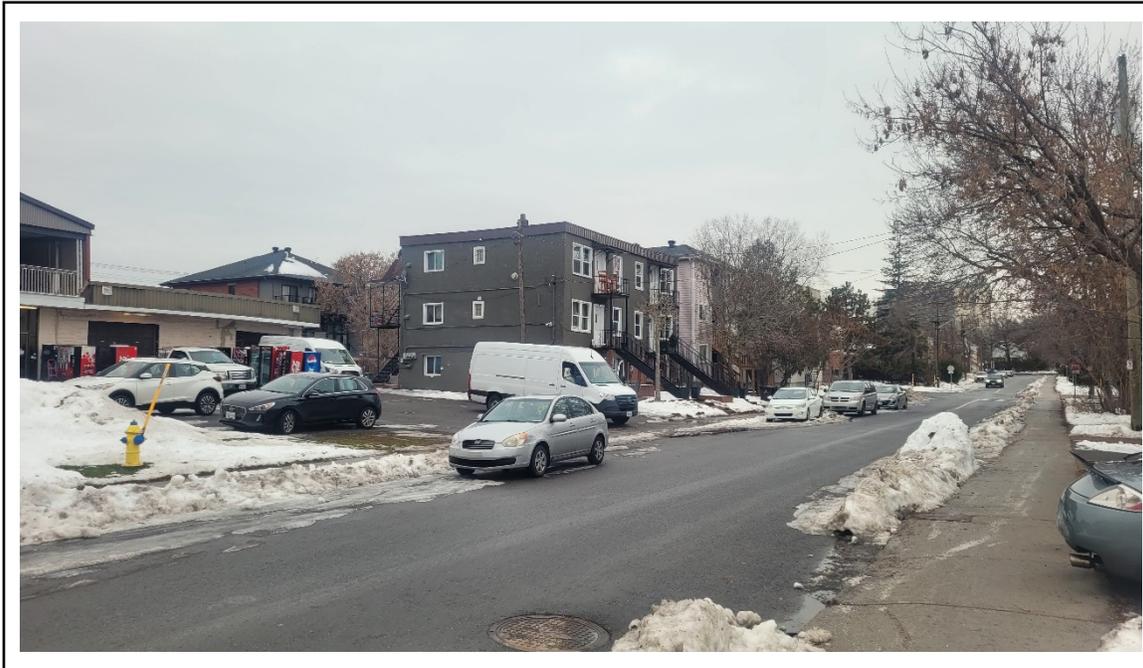
Borehole soil sample MW1 SA7 and groundwater sample MW1 were collected to identify any possible impacts due to the historic presence of a metal fabrication shop located across the street from the subject property. The results identified the presence of metals and PHCs in soil and metal impacts in groundwater that comply with the SCS. Groundwater flow analysis also confirmed that the former metal fabrication facility is downgradient of the subject sites, making the possibility of contamination unlikely.

Photograph 11: View south-west from north side of Ste-Cecile Street in front of 73 Ste-Cecile. Storm drain catch basin is on lower right and 82 Ste-Cecile is in center, (former metal fabrication, current vending machine repair).
