September 25, 2024
File: PE2709-LET.20

Subject: **Soil and Groundwater Remediation Program**
137-141 George Street and 110-116 York Street
Ottawa, Ontario

Title: **SITE REMEDIATION PLAN**

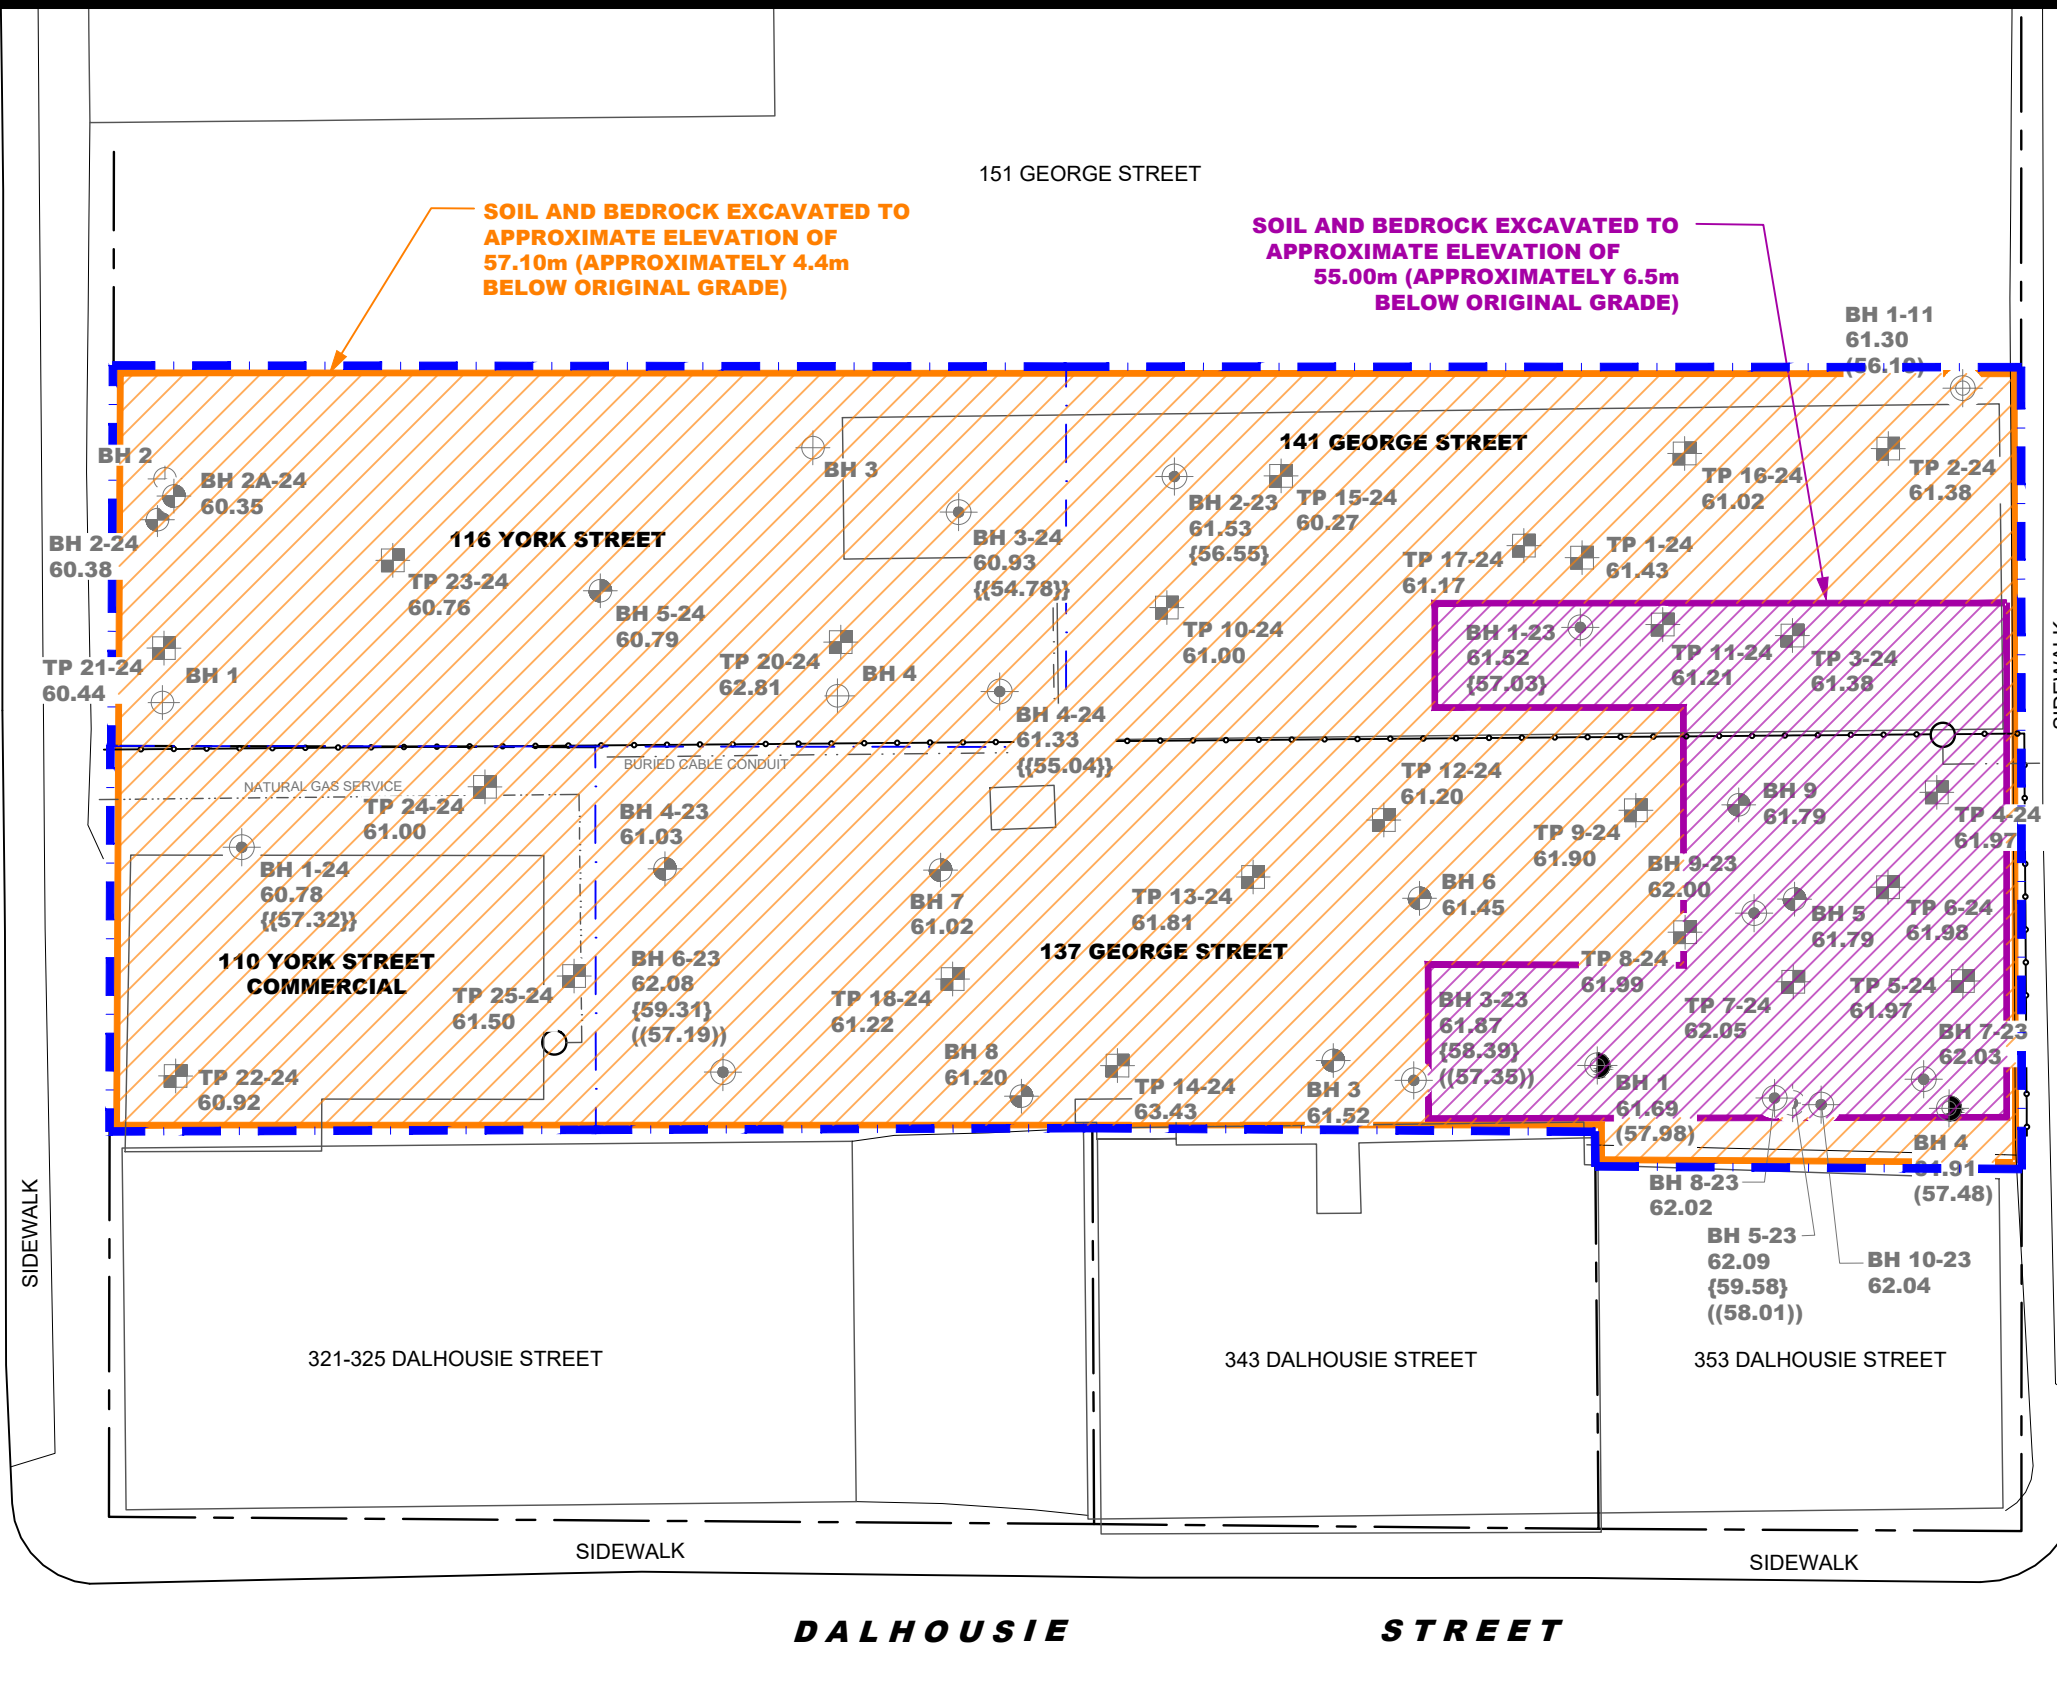
Based on the findings of the test pit programs in combination with grab sampling carried out in conjunction with the excavation program, full lateral and vertical delineation of contaminants exceeding the MECP Table 3 standards was achieved. Impacts extended laterally to the property boundaries. Impacts extended laterally to the bedrock on the southwestern portion of the site only; otherwise, a clean excavation base was achieved, and the soil was subsequently removed for off-site beneficial reuse.

The remediation excavation extended to the property boundaries in all directions. All soil was removed from the subject property. As such, no sidewall excavation or base samples were collected for analysis.

Bedrock on the southern portion of the site has been removed to approximately 55.00m asl (or approximately 6.5 m below original grade). The bedrock across the site will be removed to final excavation base of 50.40m asl (or approximately 11.10m below original grade).
