September 8, 2023 File: PE4169-LET.02

Subject: Phase II-Environmental Site Assessment Update Noise and Vibration Studies

5505 and 5545 Albion Road

Ottawa, Ontario

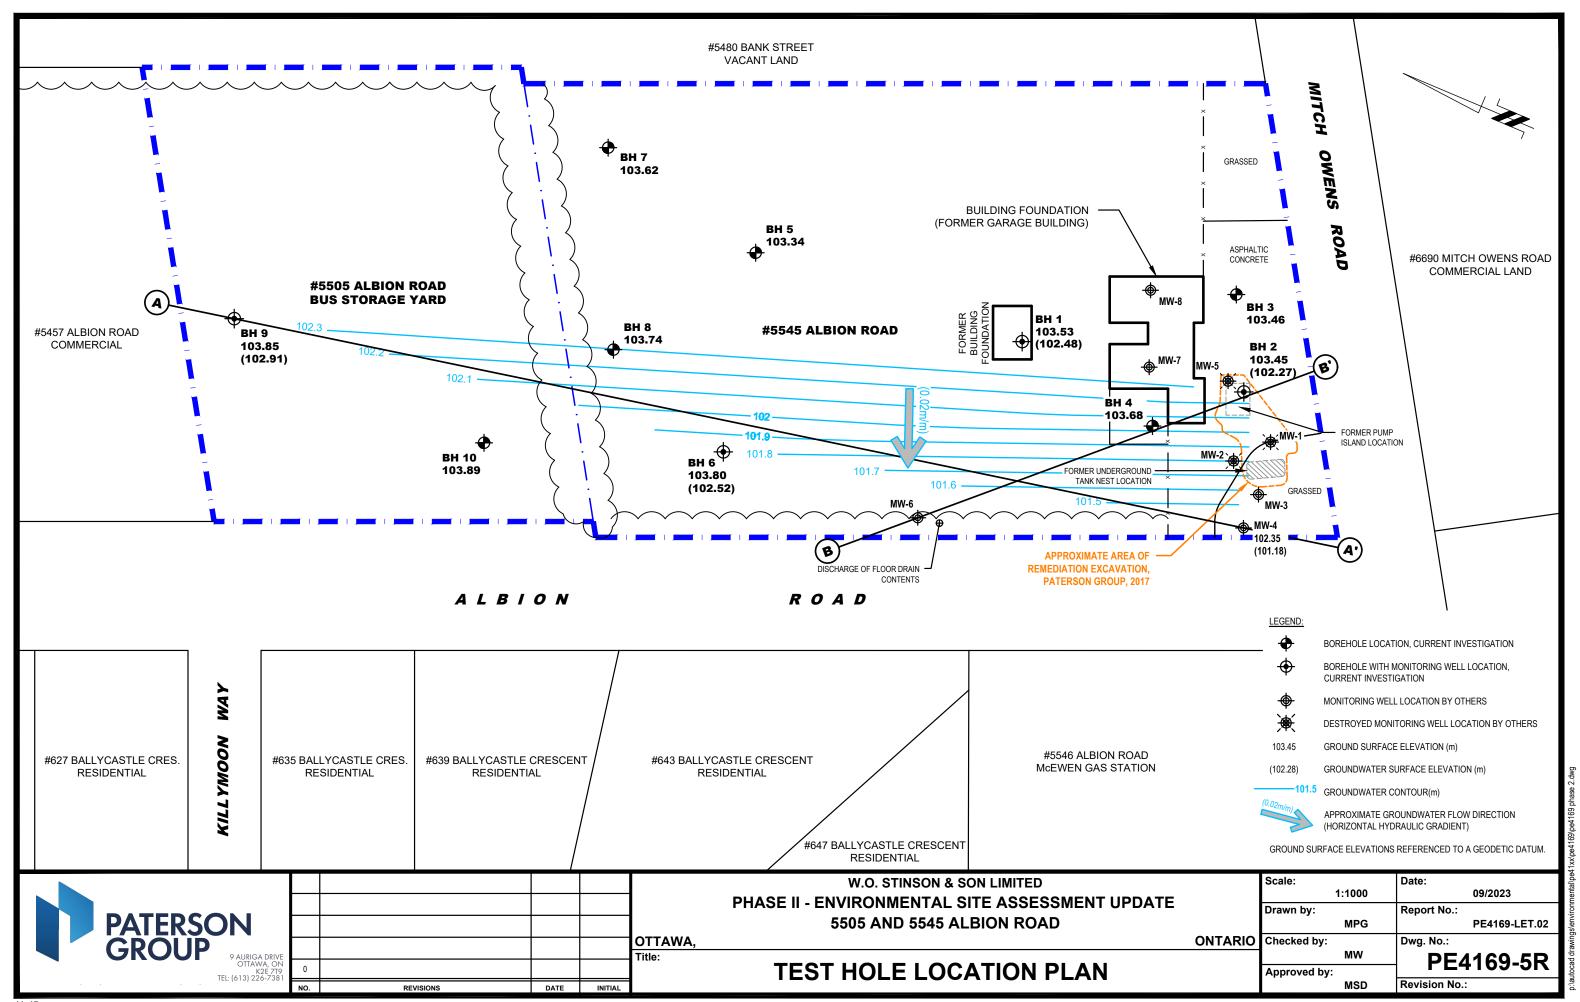
☐ Drawing PE4169-5R – Test Hole Location Plan

A Phase II ESA was completed by Pinchin in September 2017 and consisted of drilling eight (8) boreholes on the subject site, all of which were completed as groundwater monitoring wells. Four (4) boreholes were placed along the east (MW-1 and MW-2) and west (MW-3 and MW-4) sides of the UST nest; one on the east side of the pump island (MW-5); one in the immediate area of the garage discharge drain on the central west side of the property (MW-6); and two (2) in the truck repair building (MW-7 and MW-8) to address the potential concerns. The locations of these boreholes are shown on Drawing PE4169-5R – Test Hole Location Plan, which is appended with this letter report.

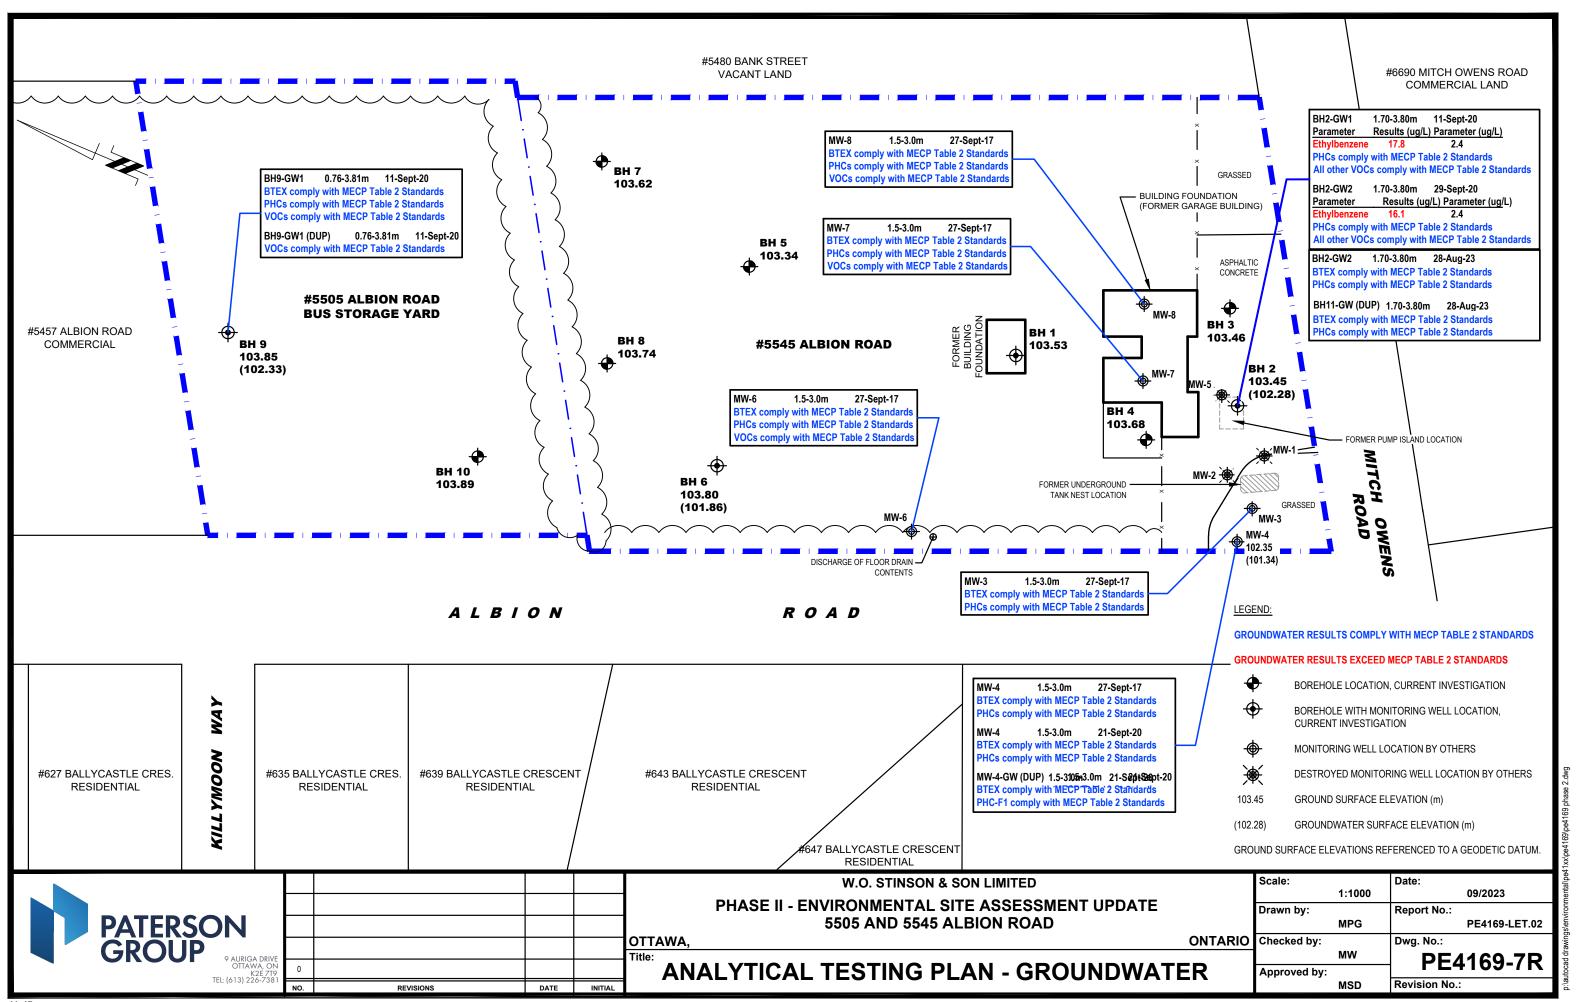
☐ Drawing PE4169-7R – Analytical Testing Plan – Groundwater

No BTEX or PHCs concentrations were detected in the groundwater sample analyzed. The analytical results comply with the MECP Table 2 standards.
