Landslide Hazard Assessment

Proposed Residential Development

2983, 3053 and 3079 Navan Road
Ottawa, Ontario

Report PG6142-1 Revision 2 dated January 30, 2025

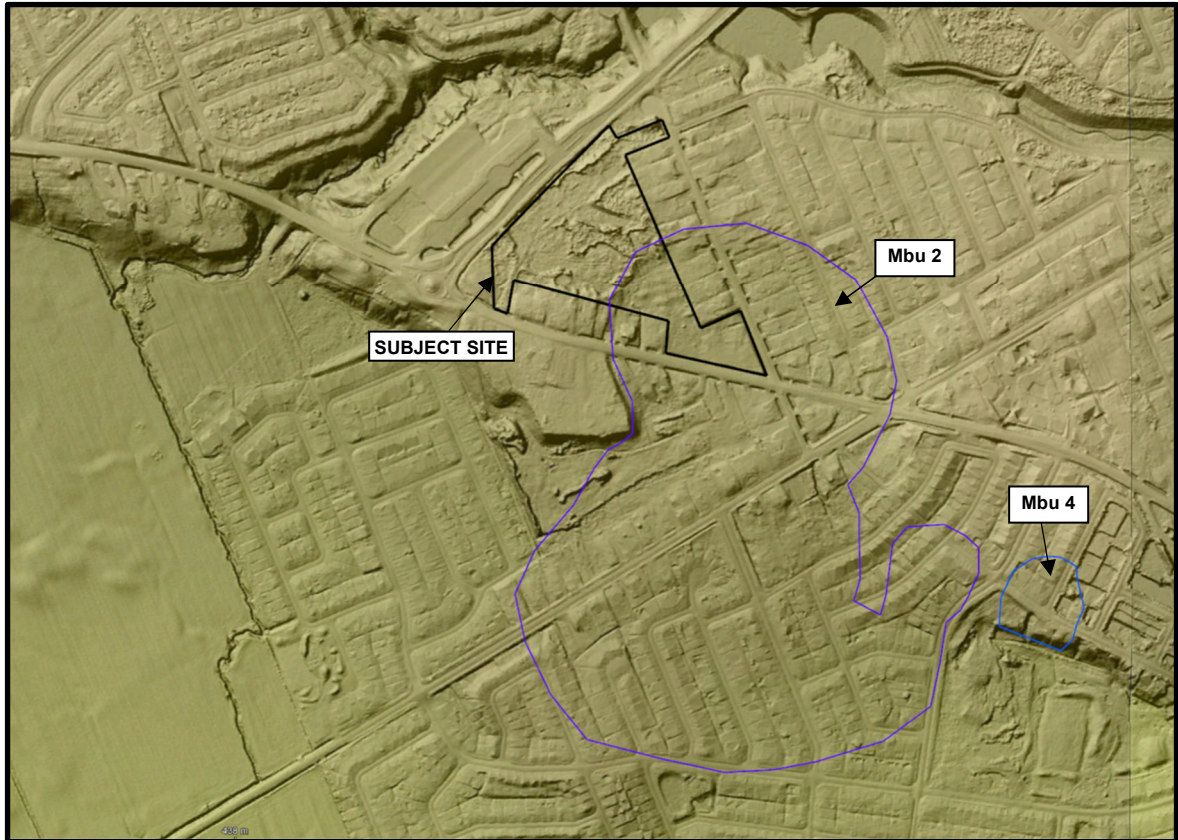
Figure 1 – LiDAR Image of Subject Site and closest documented landslides.

Given the above, there are several other landslide scars in relatively close proximity to the subject site which could indicate landslide susceptibility in the area of the subject site based on historical landslide inventory. Therefore, it is considered appropriate to increase the baseline probability for landslides to occur throughout the subject site by a factor of 2 in Section 4.3 – Hazard Assessment of this report.

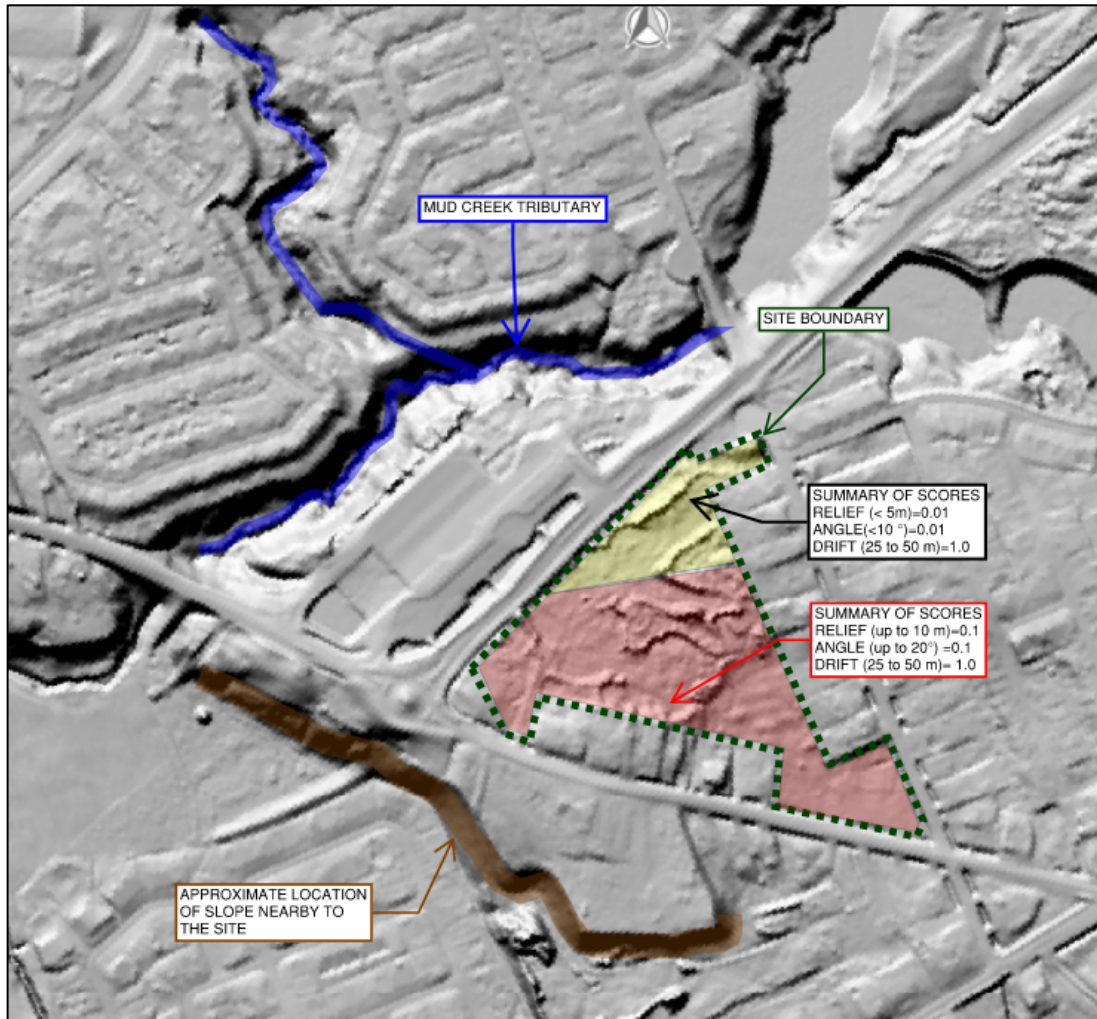
Figure 3 - Summary of Drift Thickness, Surface Relief, and Slope Angle Weight Factors

Based on this, the probability for a landslide to occur throughout the subject site would be the cumulative site-specific probability which has been adjusted for the drift thickness, topographic relief and slope angle weight factors applicable throughout each portion of the subject site. Since these attributes vary along the property, the associated weight would be modified for each considered portion of the site, and as discussed in Section 4.2.2 of this report.

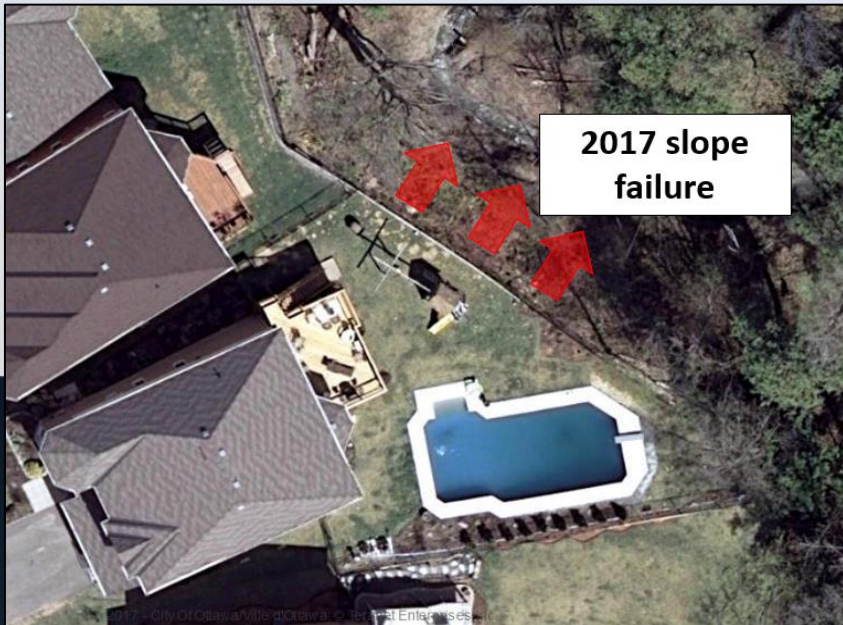
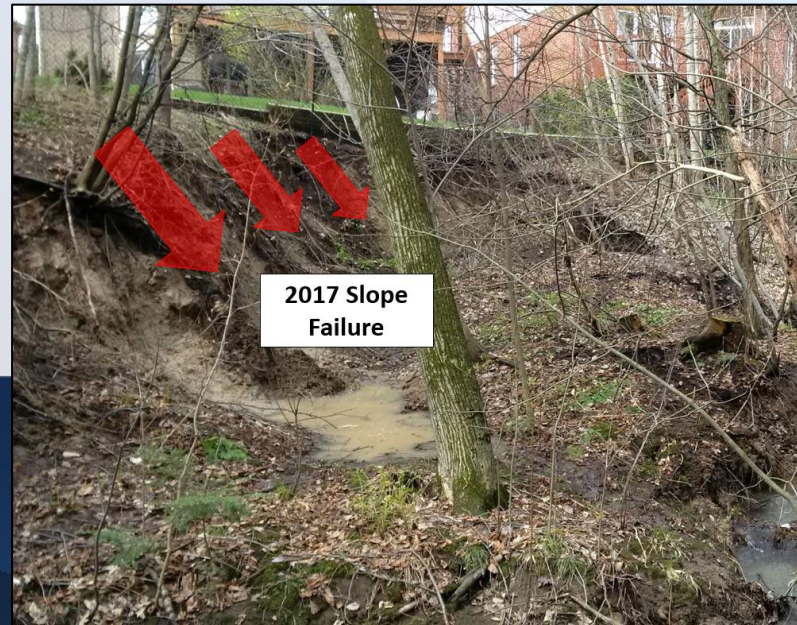
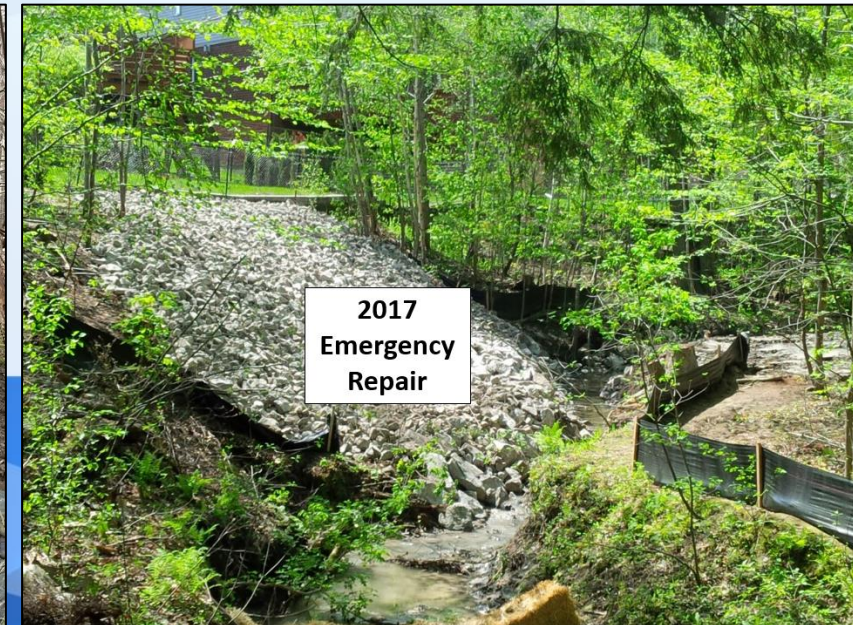
- 2017 slope failure
 - Emergency repair: rock fill material
 - Blue Willow Class Environmental Assessment initiated in 2020
- Rupture de pente en 2017
 - Réparation d'urgence (enrochement)
 - Évaluation environnementale municipale de portée générale du parc Blue Willow entreprise en 2020

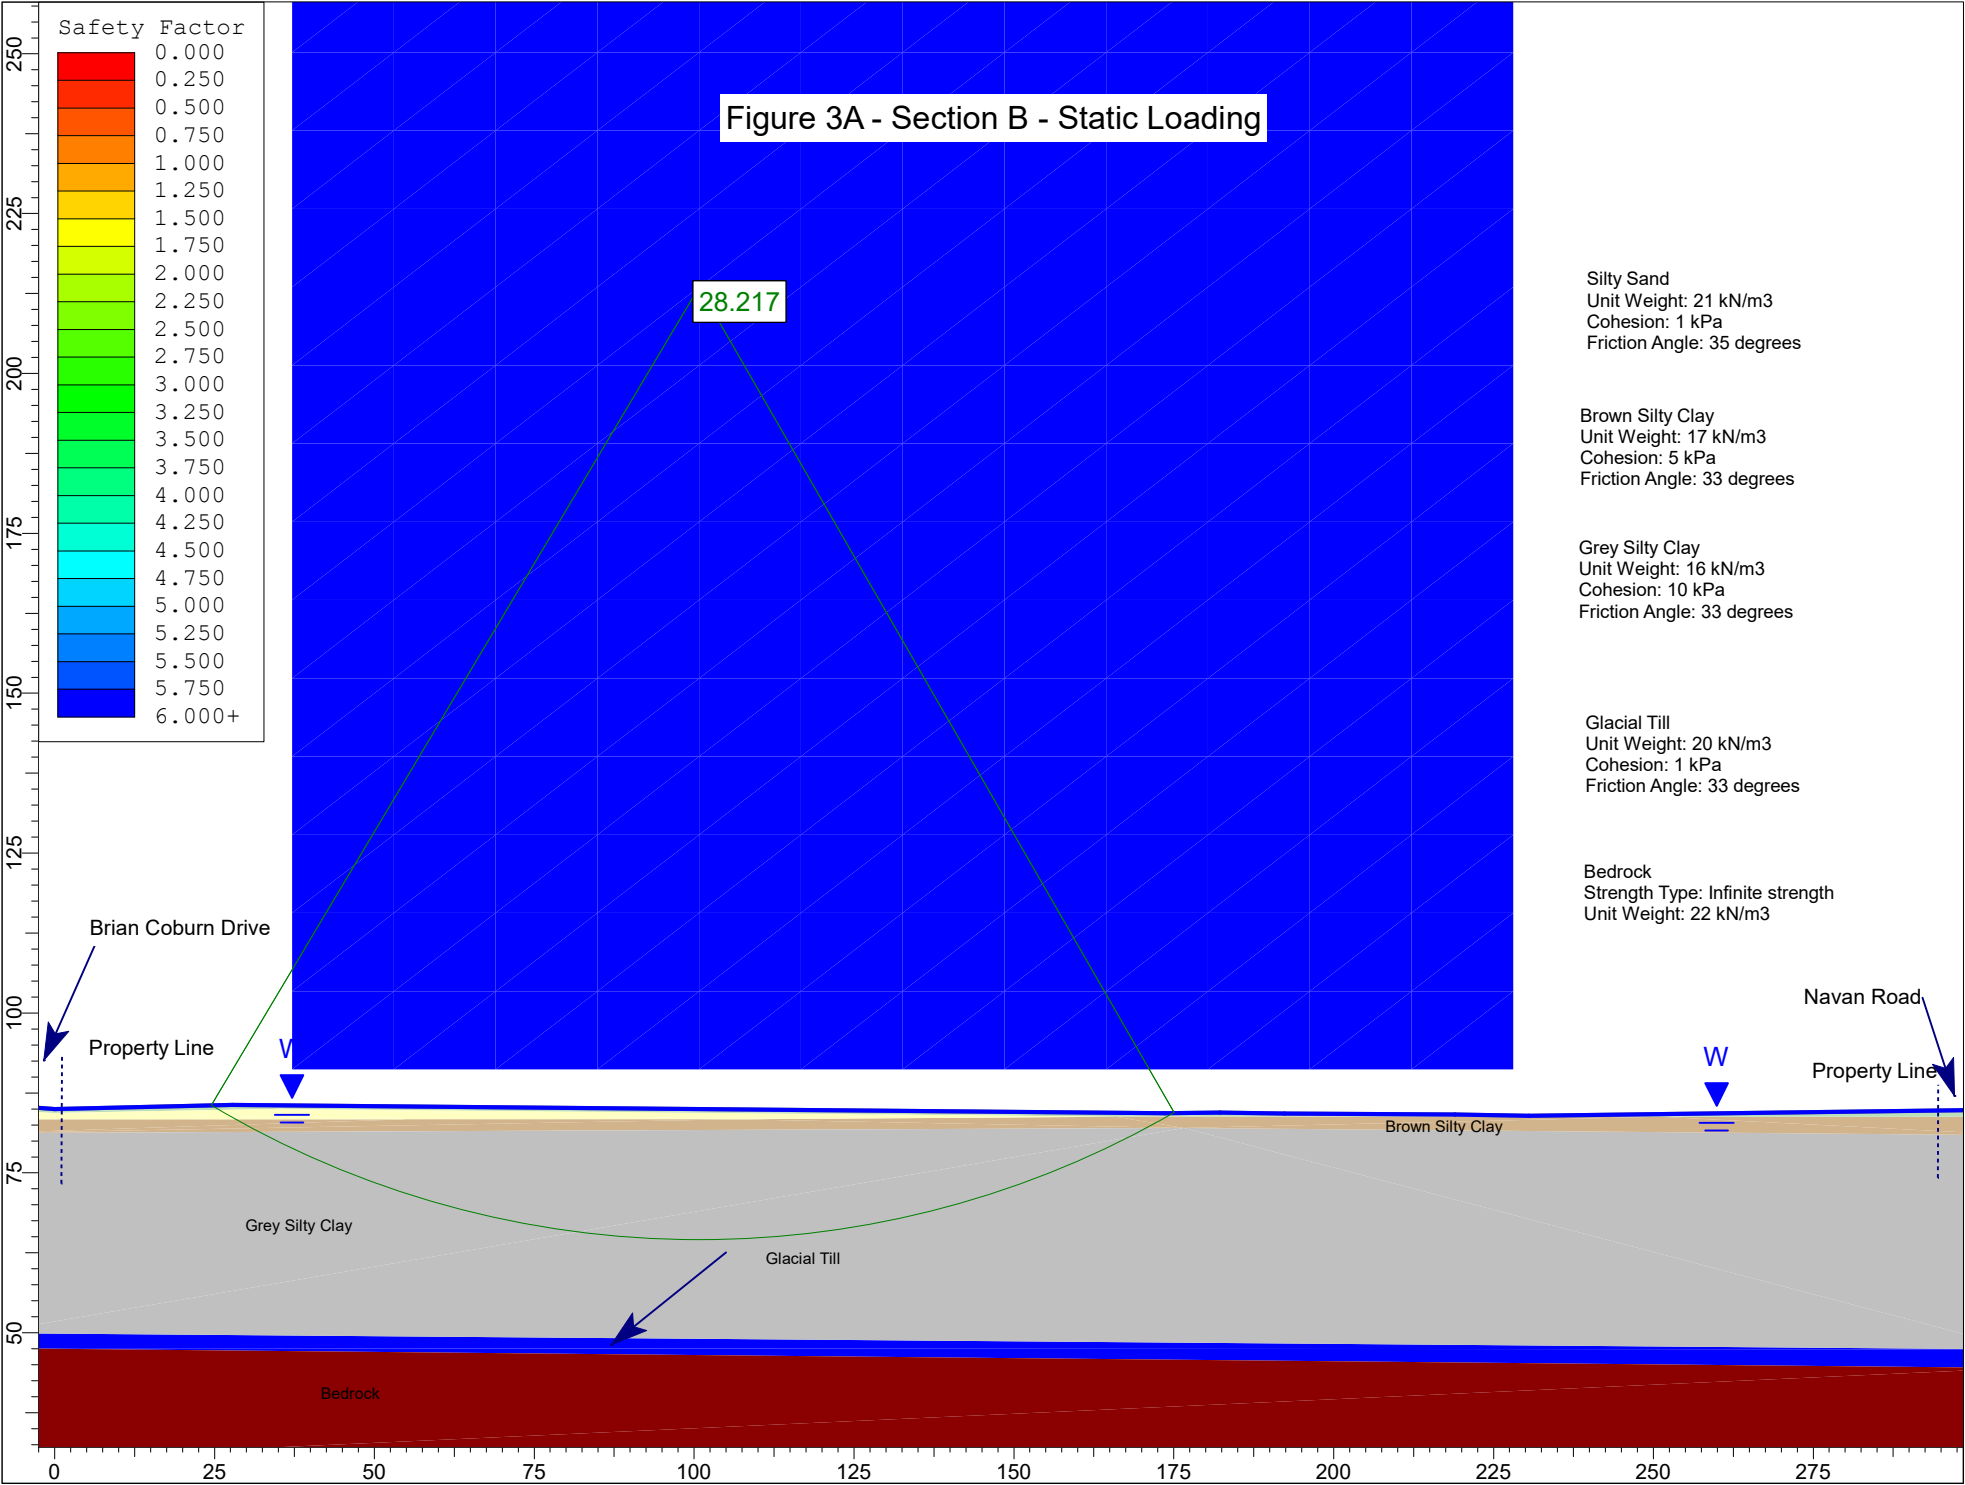
Figure 3A - Section B - Static Loading

The results of the static analysis for the proposed slope under fully saturated conditions (worst-case-scenario) are shown in Figure 2A and 3A attached to the current report. The minimum analysed slope stability factor of safety under fully saturated conditions (worst case scenario) were calculated to be greater than 1.5.

As a result, the two slope cross-sections analyzed were all above the recommended Factor of Safety of 1.5 and are considered stable under static conditions.

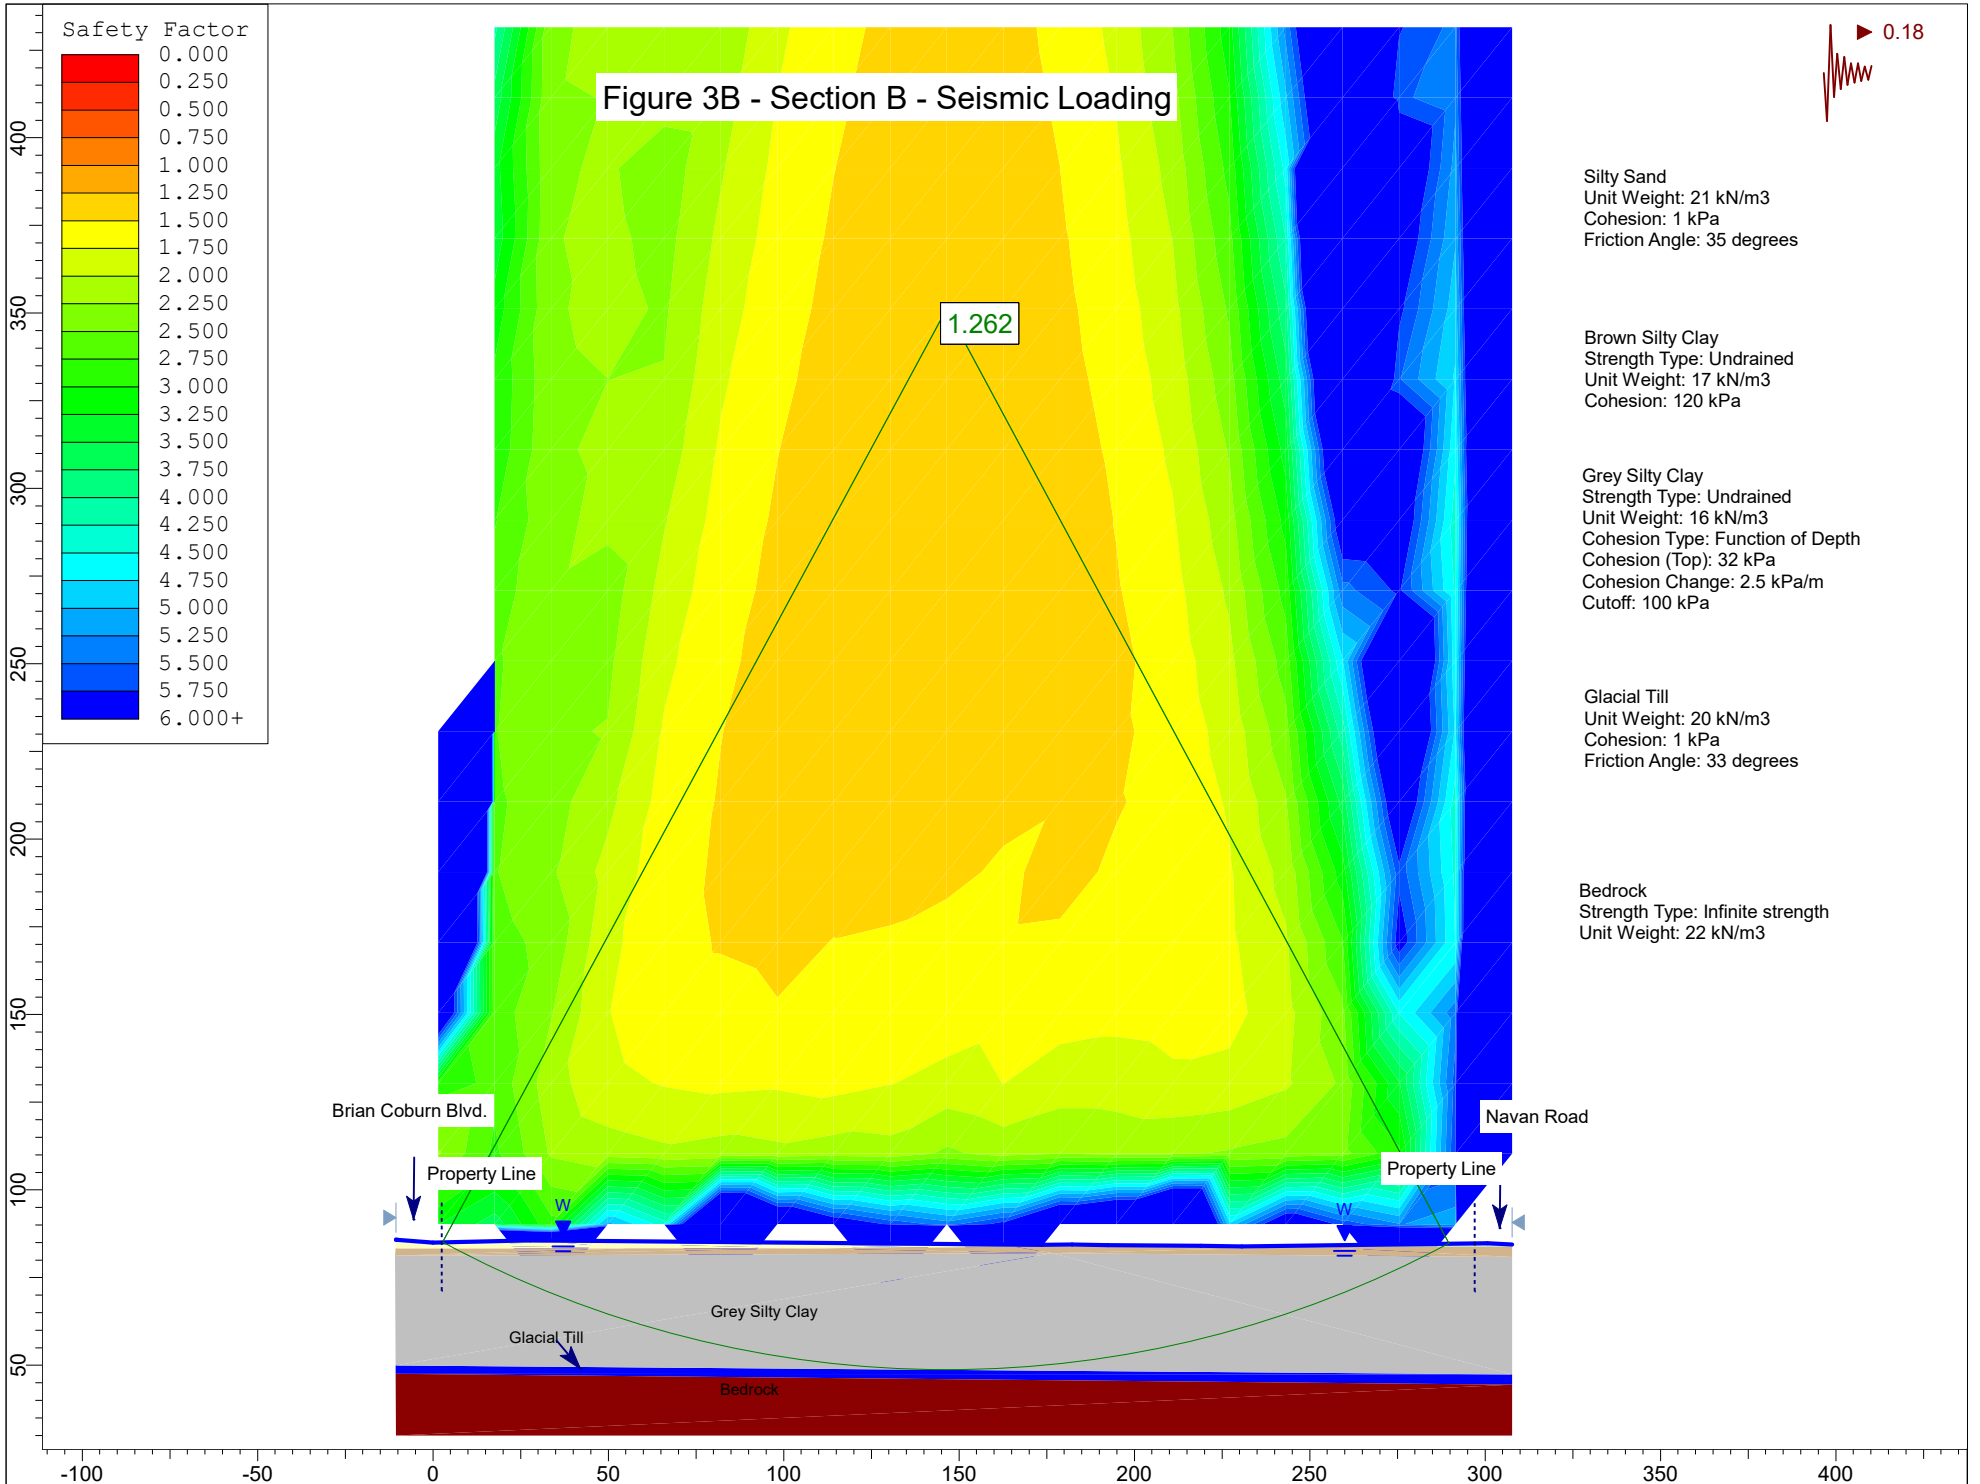
Figure 3B - Section B - Seismic Loading

The results of the analysis including seismic loading fully saturated conditions (worst-case-scenario) are shown in Figure 2B and 3B attached to the current report.

The overall slope stability factor of safety at the three slope cross-sections when considering seismic loading was found to be greater than 1.1 which is considered to be stable under seismic loading.
