TREE CONSERVATION REPORT

5580 Manotick Main Street

February 3, 2025

Tree Conservation Report v2.0

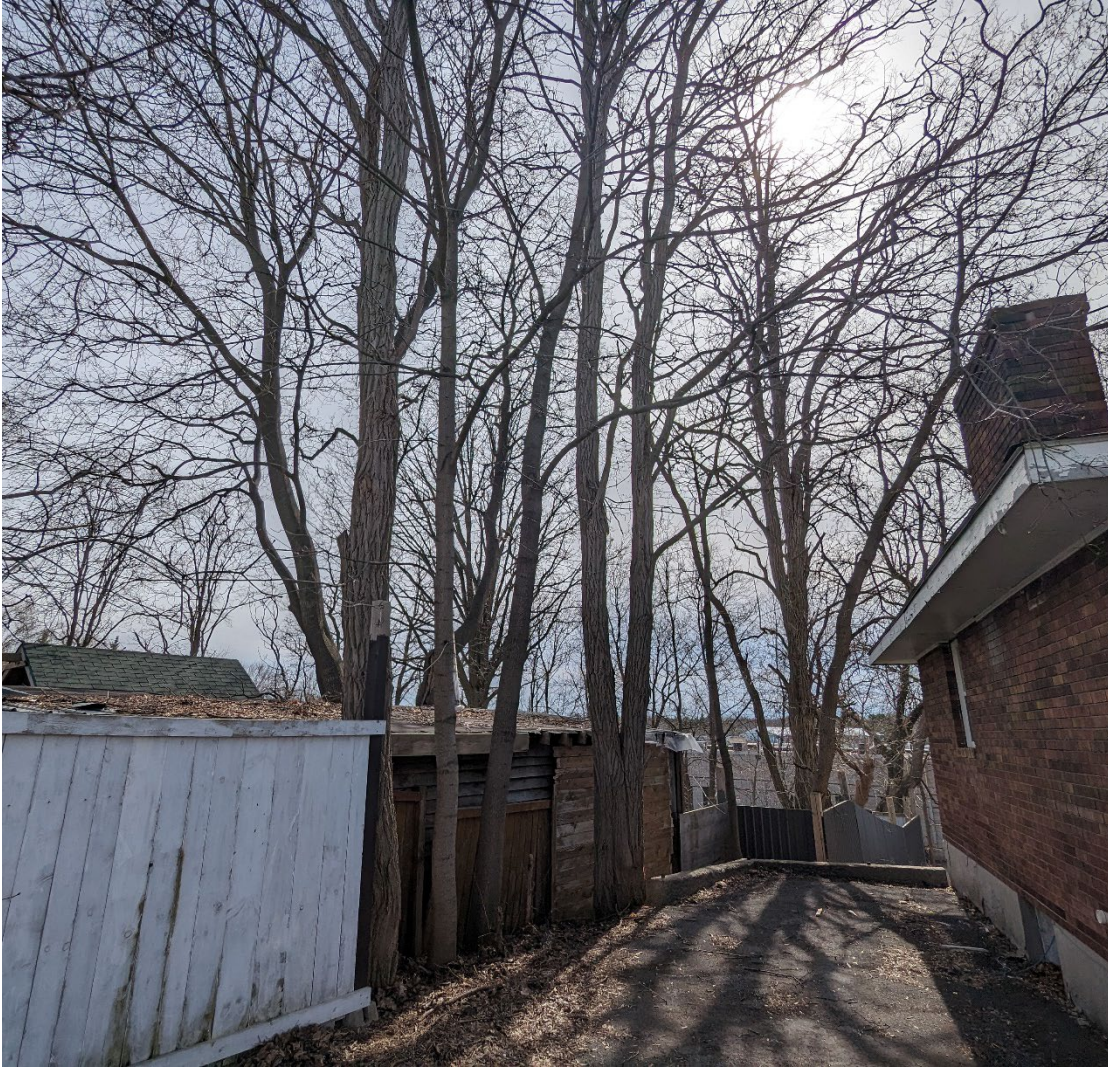
Trees 4-8 – boundary black locust and Norway maples to be removed.

Opportunities may exist to protect **Trees 4 and 5**, but this would require further details about on-site construction methods and in-situ mitigations, including root cutting and sensitive removal of other trees. The trees are not in excellent condition as they are currently suppressed by larger adjacent trees.
