## TREE CONSERVATION REPORT FOR 1DOOR4CARE TREATMENT CENTRE 401 SMYTH ROAD, CITY OF OTTAWA, ONTARIO

Date: March 31, 2025

File: C23080

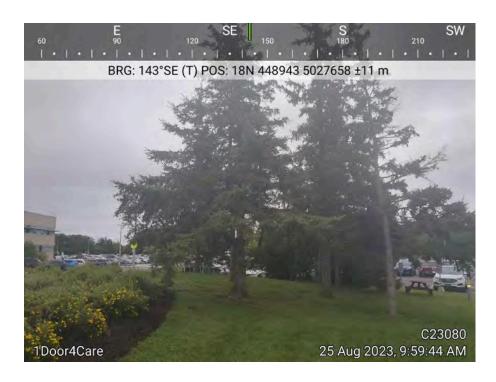
**Photo 5:** View of trees to be removed in footprint of new building.

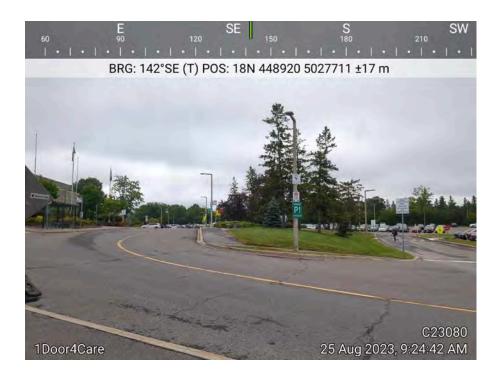
**Photo 7:** View of trees to be removed southwest of patient drop off door.

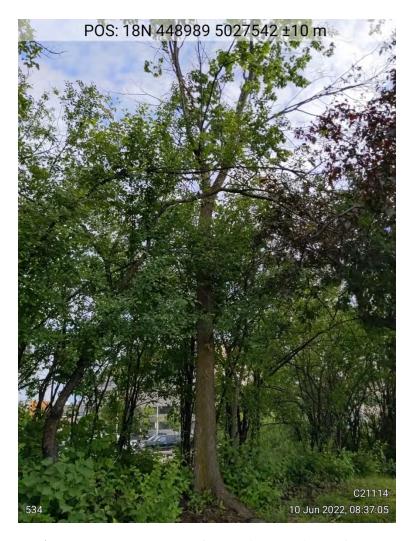
**Photo 11**: Tree #534 in poor/fair condition with significant canopy dieback.

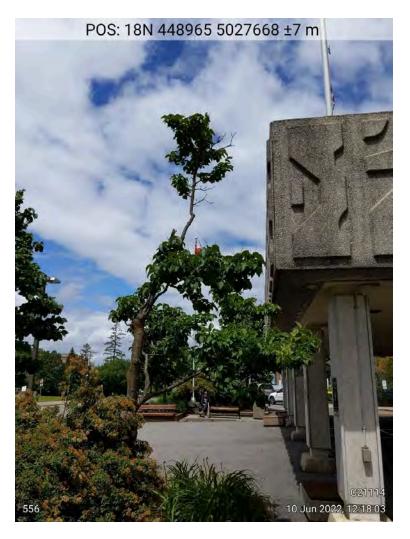
**Photo 12**: Tree #556 adjacent CHEO main entrance, fair condition with reduced canopy.

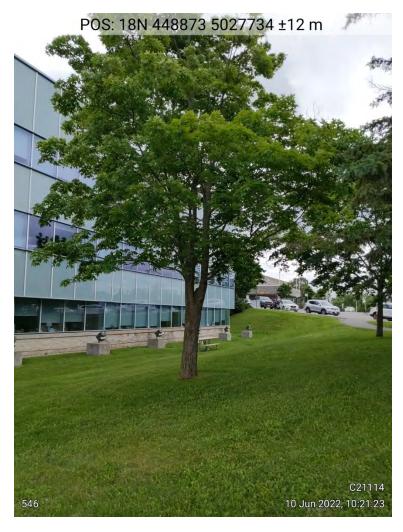
Photo 13: Tree #546, weak union at 1.5 metres.

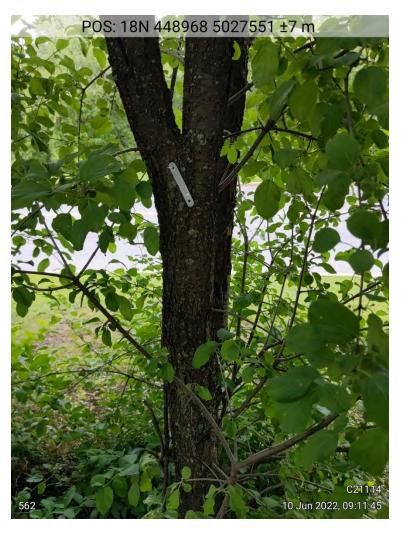
**Photo 14**: Tree #562, example of larger DBH Common Buckthorn present in hedgerows around parking area.
