HERITAGE IMPACT ASSESSMENT & CONSERVATION PLAN*

168 -174 MURRAY STREET, OTTAWA

Owner: David Yoo
Address: 168 – 174 Murray Street, Ottawa, Ontario

Revised March 2025

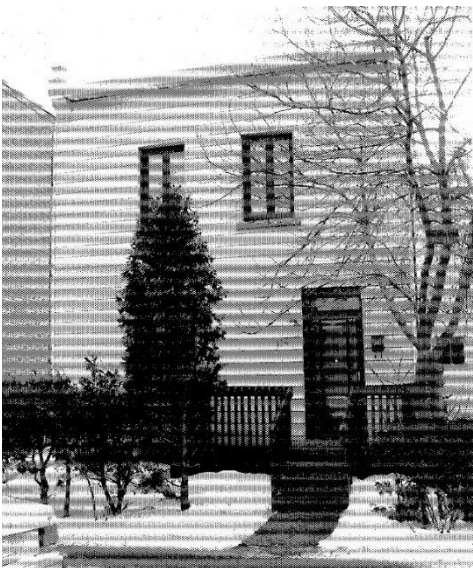
Figure 42 and 43: Two views 1992 and 2021 174 Murray (left) prior to the vinyl siding being removed and rehabilitated front. Note: A section of the cornice will need to be replicated. There is bulging of the brick along the 2nd floor between the windows. Also noted is the different brick at the corner (both size and colour consistency) and the lack of corbelled banding and the transom treatment. Earlier photos document a decorative hood over the door has been removed.
