# TREE CONSERVATION REPORT V3.0

2104 Roger Stevens Drive

**Dendron Forestry Services**

April 15, 2025

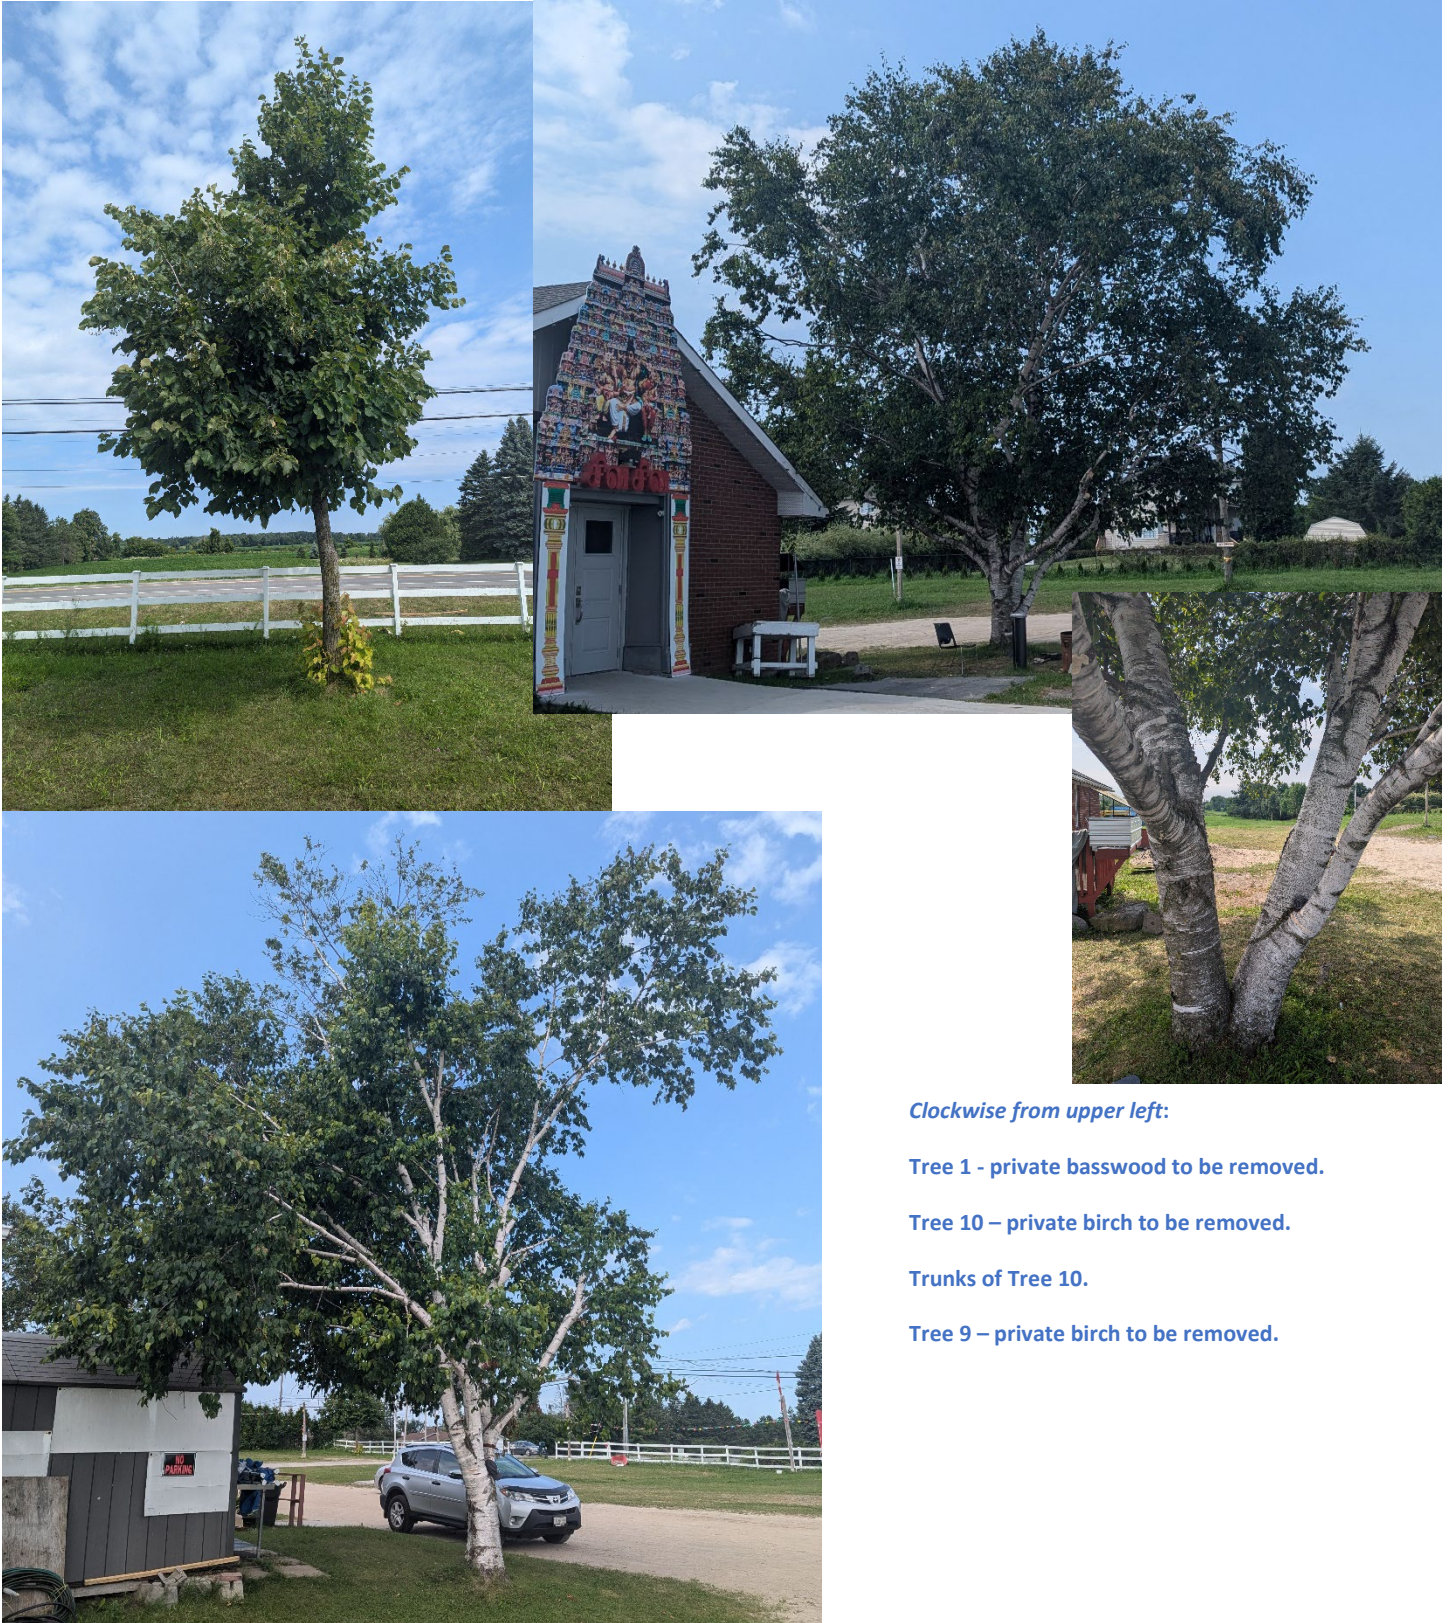
| Tree <sup>1,4</sup> | Species | DBH (cm) | Ownership <sup>2</sup> | Tree Condition | Forester recommendation |
|---|---|---|---|---|---|
| 1 | Basswood ( <i>Tilia americana</i> ) | 22 | Subject property | Fair: sprouts from base; broken branches – missing approx. 1/6 of canopy; stem-girdling root possible | Remove based on level of site activity. |
| 9 | White birch ( <i>Betula papyrifera</i> ) | 27, 27 | Subject property | Fair: poor pruning wounds – 1/3 canopy missing; one stem dying at top; included bark at main union – divot collecting moisture – decay possible | Remove based on level of site activity. |
| 10 | White birch ( <i>Betula papyrifera</i> ) | 35, 17, 34 | Subject property | Fair/Poor: fungal bodies on 15cm lateral – decay possibly extends into 34cm stem; ~10% dieback on east side | Remove based on level of site activity. |

Tree 1 - private basswood to be removed.

Tree 10 – private birch to be removed.

Trunks of Tree 10.

Tree 9 – private birch to be removed.

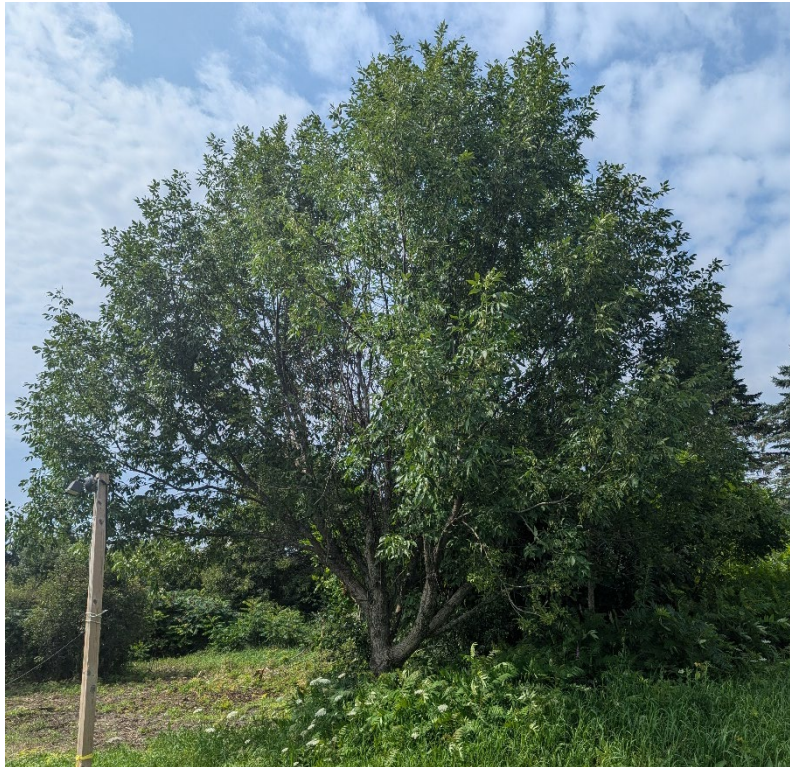
| Tree <sup>1,4</sup> | Species | DBH (cm) | Ownership <sup>2</sup> | Tree Condition | Forester recommendation |
|---|---|---|---|---|---|
| 2 | White ash ( <i>Fraxinus americana</i> ) | 26 | Subject property | Fair/Poor: dead central leader – laterals compensating; wounds and debarking; EAB likely (galleries in exposed sapwood) | Remove: within footprint of priest residence. |

Above: Tree 2 - private ash to be removed.

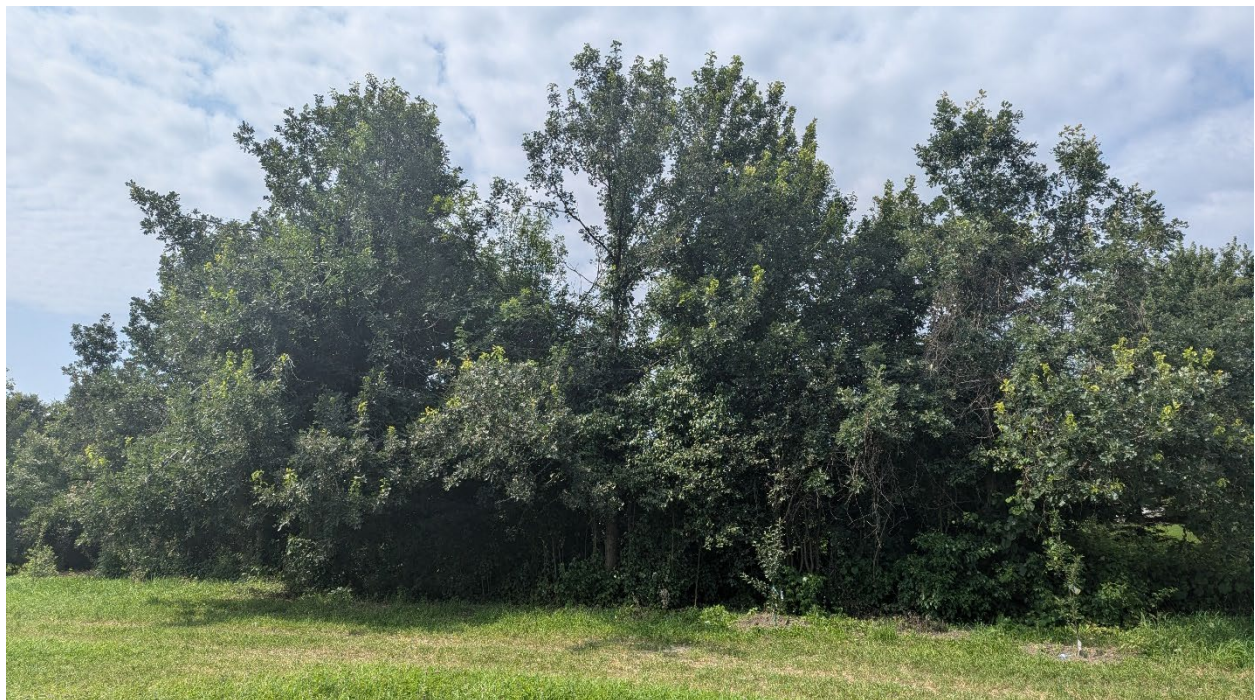
| Tree <sup>1,4</sup> | Species | DBH (cm) | Ownership <sup>2</sup> | Tree Condition | Forester recommendation |
|---|---|---|---|---|---|
| G1 | Bur oaks ( <i>Quercus macrocarpa</i> ) | 10 stems 20-45cm | Subject property | Good | Northernmost stem or two may have to be removed to accommodate septic bed. Rest of the stand is to be retained and protected. Fencing to be erected in front of group to delineate limit of site works. |

Below: Group 1 - bur oaks, the majority of which are to be retained and protected.

The grading for the proposed septic bed will likely necessitate removal of one or two stems of **Group 1** – the exact number can be determined once extent of excavation is marked in the field. To best protect the remainder of the stand, the extent of required excavation is to be marked in the field and fencing erected at that line. All roots along that line are to be revealed and cleanly severed by hand so that roots of the remaining trees are not torn. The required trees can then be removed. The fence should then remain in place during the remainder of site works. Past this fence, the following should apply:
