# TREE CONSERVATION REPORT V3.0

2104 Roger Stevens Drive

**Dendron Forestry Services**

June 19, 2025

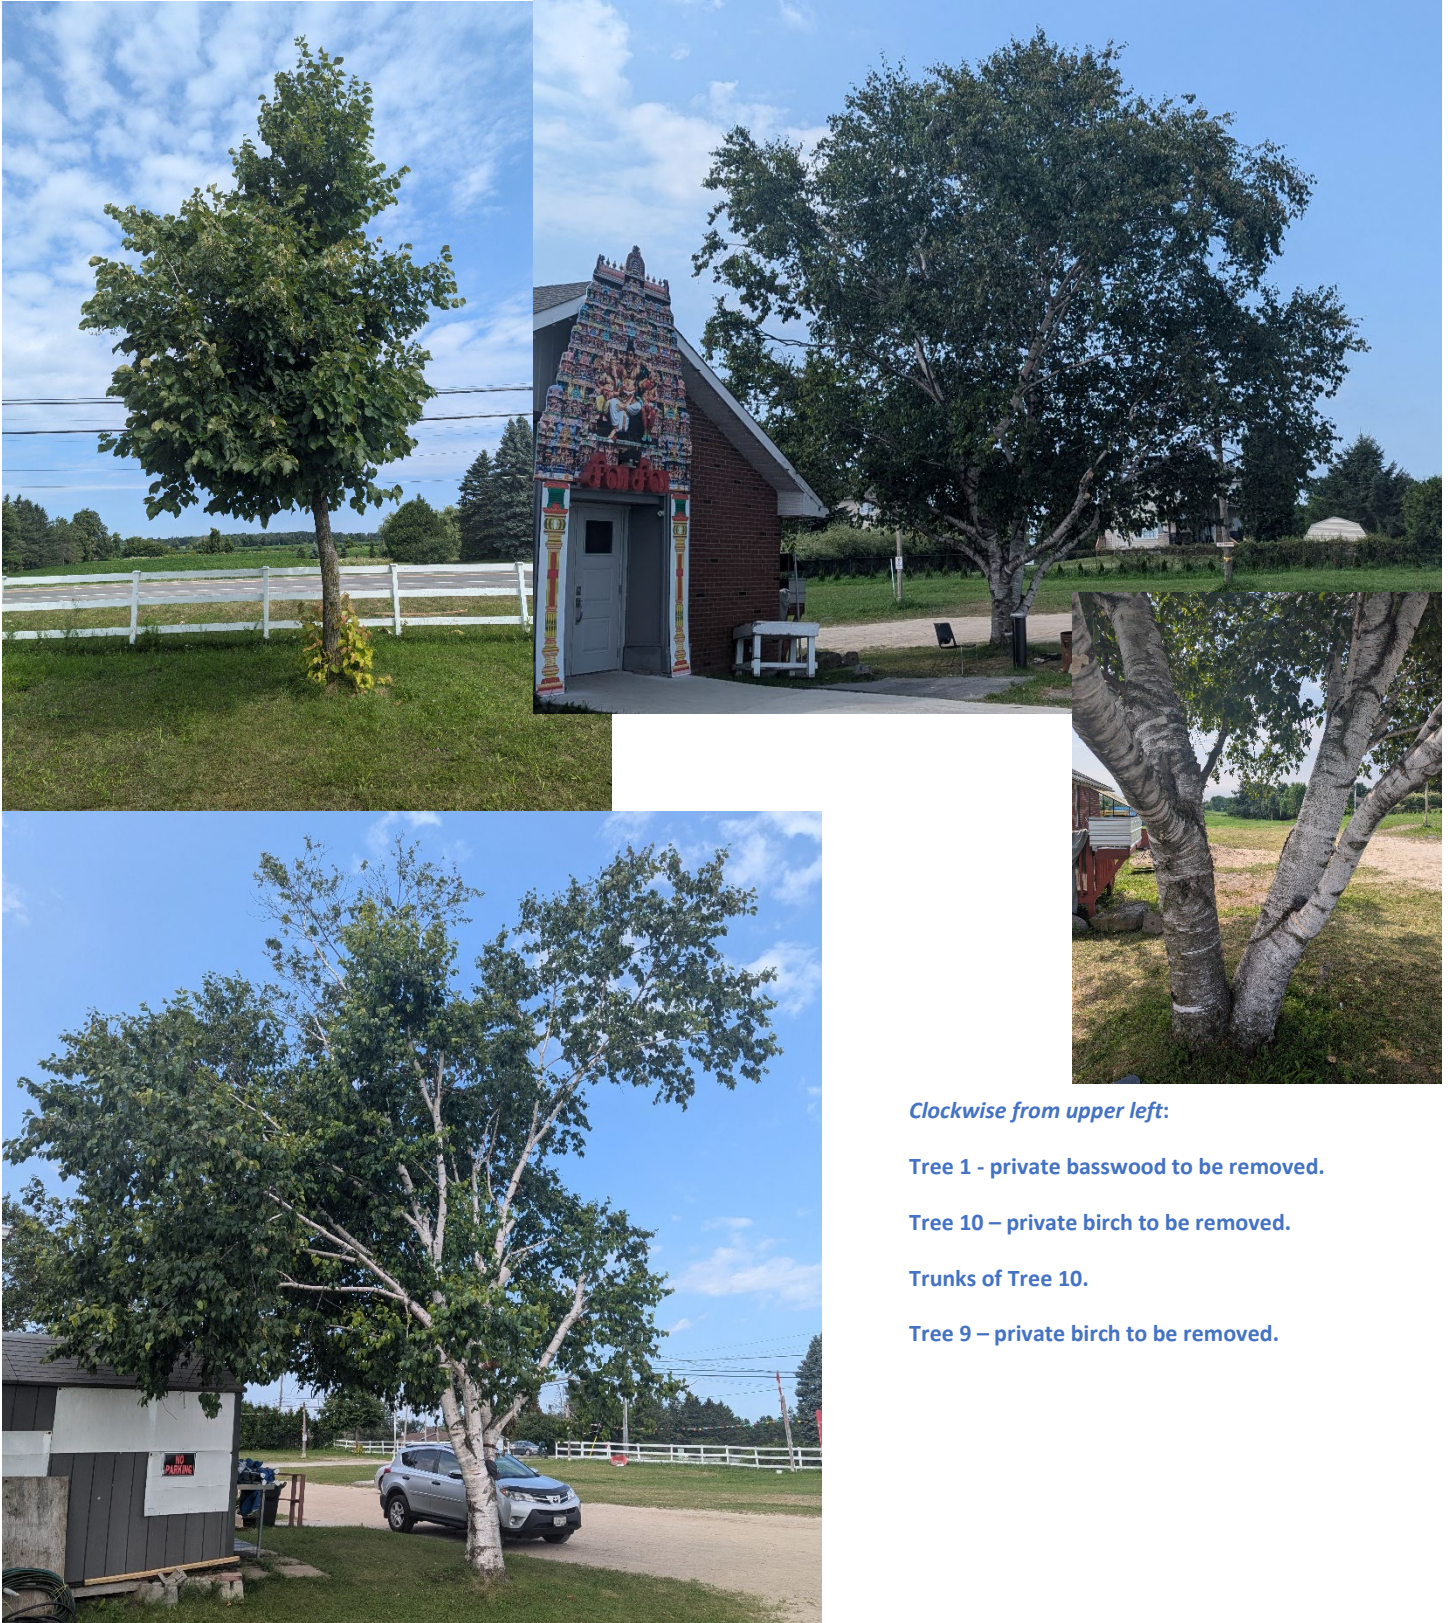
| Tree <sup>1,4</sup> | Species | DBH (cm) | Ownership <sup>2</sup> | Tree Condition | Forester recommendation |
|---|---|---|---|---|---|
| 1 | Basswood ( <i>Tilia americana</i> ) | 22 | Subject property | Fair: sprouts from base; broken branches – missing approx. 1/6 of canopy; stem-girdling root possible | Remove based on level of site activity. |
| 9 | White birch ( <i>Betula papyrifera</i> ) | 27, 27 | Subject property | Fair: poor pruning wounds – 1/3 canopy missing; one stem dying at top; included bark at main union – divot collecting moisture – decay possible | Remove based on level of site activity. |
| 10 | White birch ( <i>Betula papyrifera</i> ) | 35, 17, 34 | Subject property | Fair/Poor: fungal bodies on 15cm lateral – decay possibly extends into 34cm stem; ~10% dieback on east side | Remove based on level of site activity. |

*Clockwise from upper left:*

Tree 1 - private basswood to be removed.

Tree 10 – private birch to be removed.

Trunks of Tree 10.

Tree 9 – private birch to be removed.

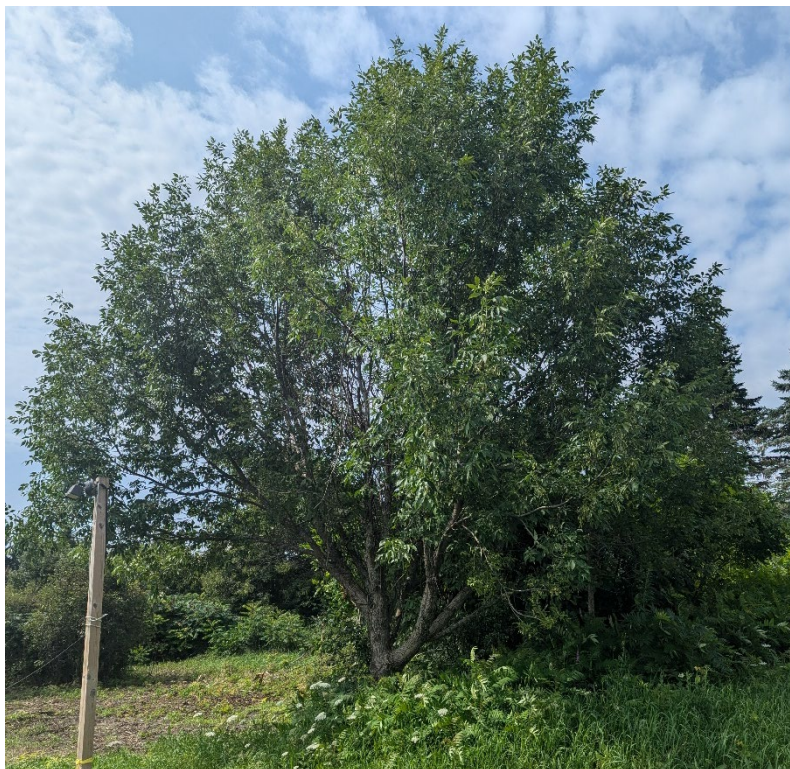
| Tree <sup>1,4</sup> | Species | DBH (cm) | Ownership <sup>2</sup> | Tree Condition | Forester recommendation |
|---|---|---|---|---|---|
| 2 | White ash ( <i>Fraxinus americana</i> ) | 26 | Subject property | Fair/Poor: dead central leader – laterals compensating; wounds and debarking; EAB likely (galleries in exposed sapwood) | Remove: within footprint of priest residence. |

Above: Tree 2 - private ash to be removed.

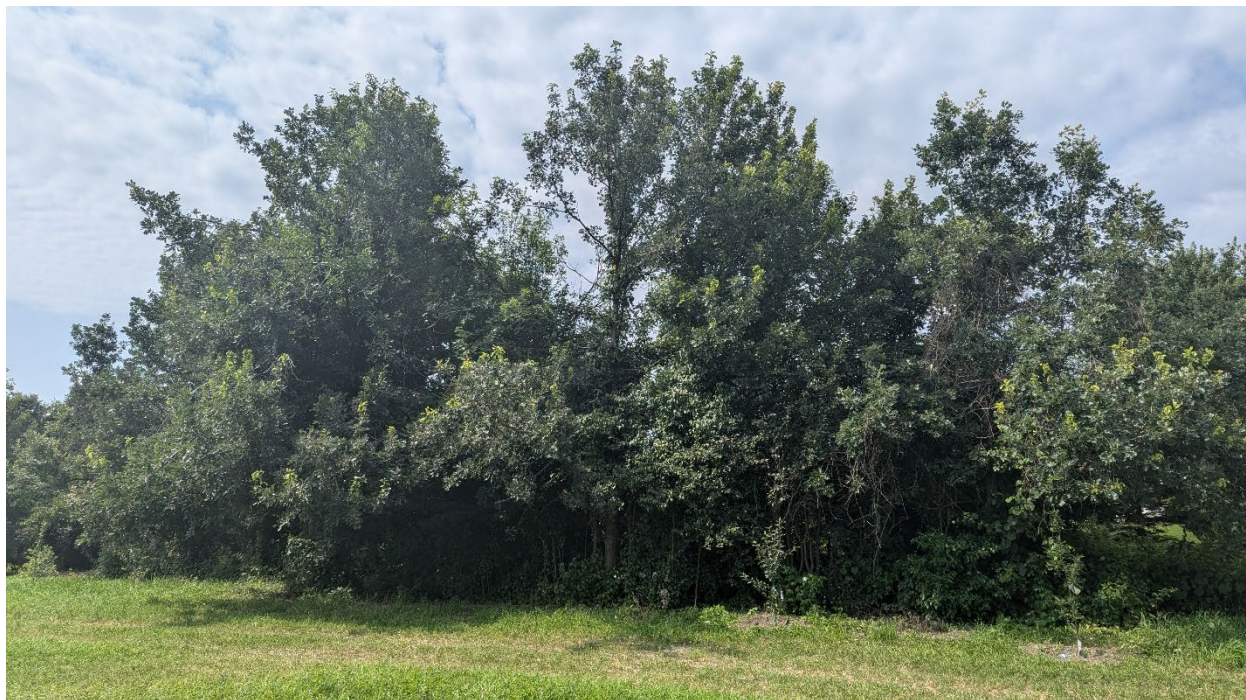
| Tree <sup>1,4</sup> | Species | DBH (cm) | Ownership <sup>2</sup> | Tree Condition | Forester recommendation |
|---|---|---|---|---|---|
| G1 | Bur oaks ( <i>Quercus macrocarpa</i> ) | 10 stems 20-45cm | Subject property | Good | Northernmost stem or two may have to be removed to accommodate septic bed. Rest of the stand is to be retained and protected. Fencing to be erected in front of group to delineate limit of site works. |

Below: Group 1 - bur oaks, the majority of which are to be retained and protected.

The grading for the proposed septic bed will likely necessitate removal of one or two stems of **Group 1** – the exact number can be determined once extent of excavation is marked in the field. To best protect the remainder of the stand, the extent of required excavation is to be marked in the field and fencing erected at that line. All roots along that line are to be revealed and cleanly severed by hand so that roots of the remaining trees are not torn. The required trees can then be removed. The fence should then remain in place during the remainder of site works. Past this fence, the following should apply:
