**Tree Conservation Report
for 6259, 6267, 6271 and 6273 Renaud Road, Ottawa**

June 26, 2025

Final Report

Project Number: RICH 1637.4

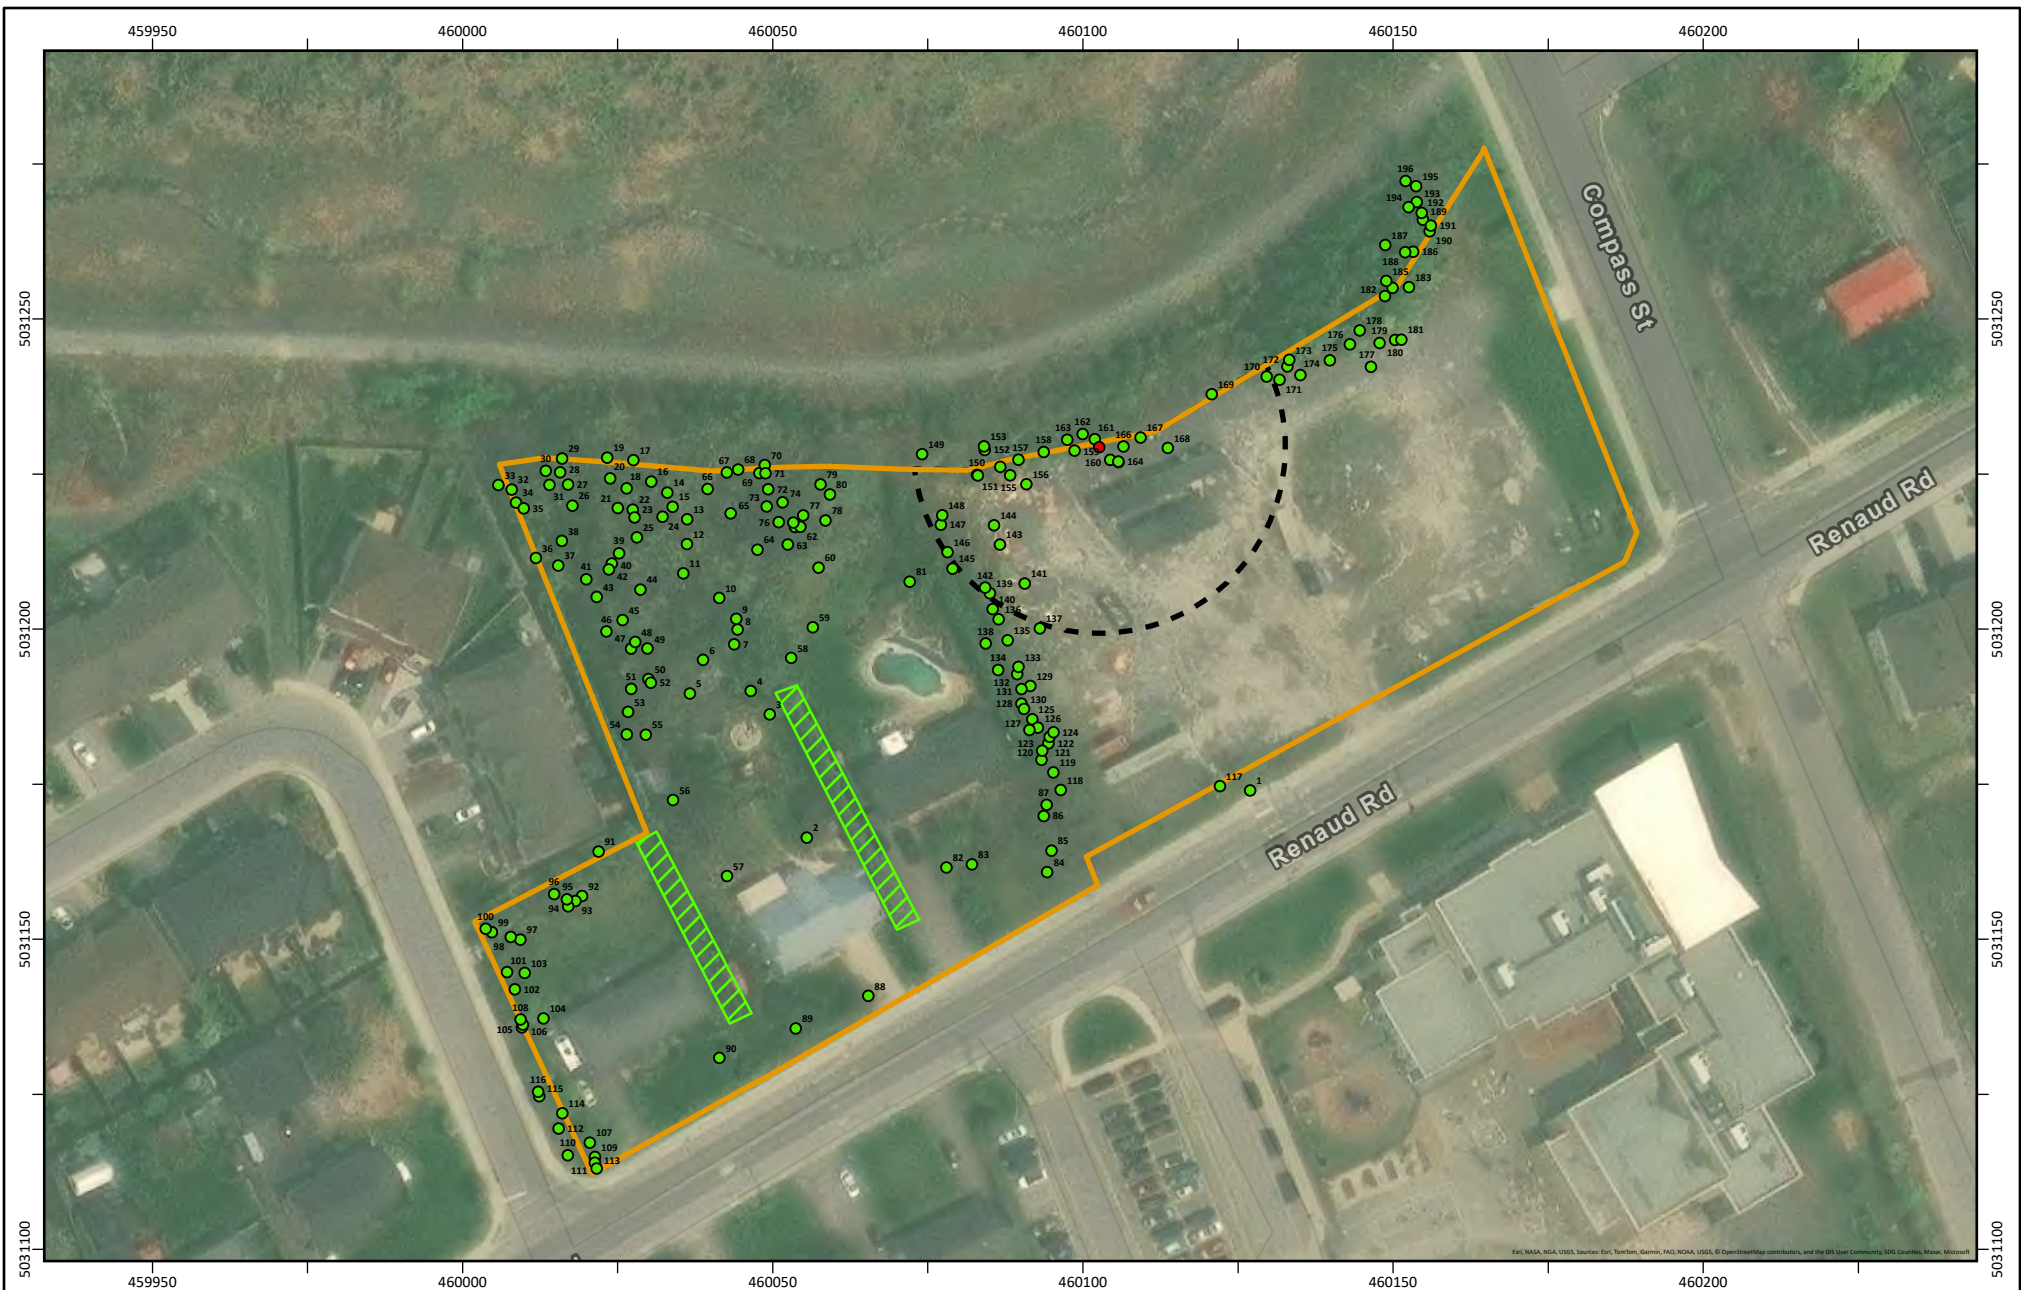
Figure 2. Site trees

In total, 197 trees were identified, situated onsite or immediately adjacent to site boundaries. Existing trees on the Site range in size from 9 cm to 91 cm DBH and represent 24 different species. The majority of trees (158) assessed are situated entirely within Site boundaries and owned by Richcraft. Five trees are situated along the Site boundaries and reflect shared ownership between Richcraft and adjacent landowners. Thirty-four (34) trees are situated on adjacent lands, 32 of which are City-owned trees on adjacent public lands, while two are privately owned. Two cedar hedgerows are present on the Site that do not meet tree size requirements (Figure 2).

The Site does not contain any Butternut trees (*Juglans cinerea*; listed as Endangered under the ESA and SARA). One Black Ash tree (*Fraxinus nigra*; Endangered under the ESA) was observed onsite, situated adjacent to the north property boundary (Figure 2, Figure 3). The Black Ash tree measured 9 cm DBH; winter conditions precluded a comprehensive assessment. Based on initial observations on size and condition, species and habitat protections under the ESA are anticipated to apply per O.Reg. 6.24 and O.Reg. 7.24.

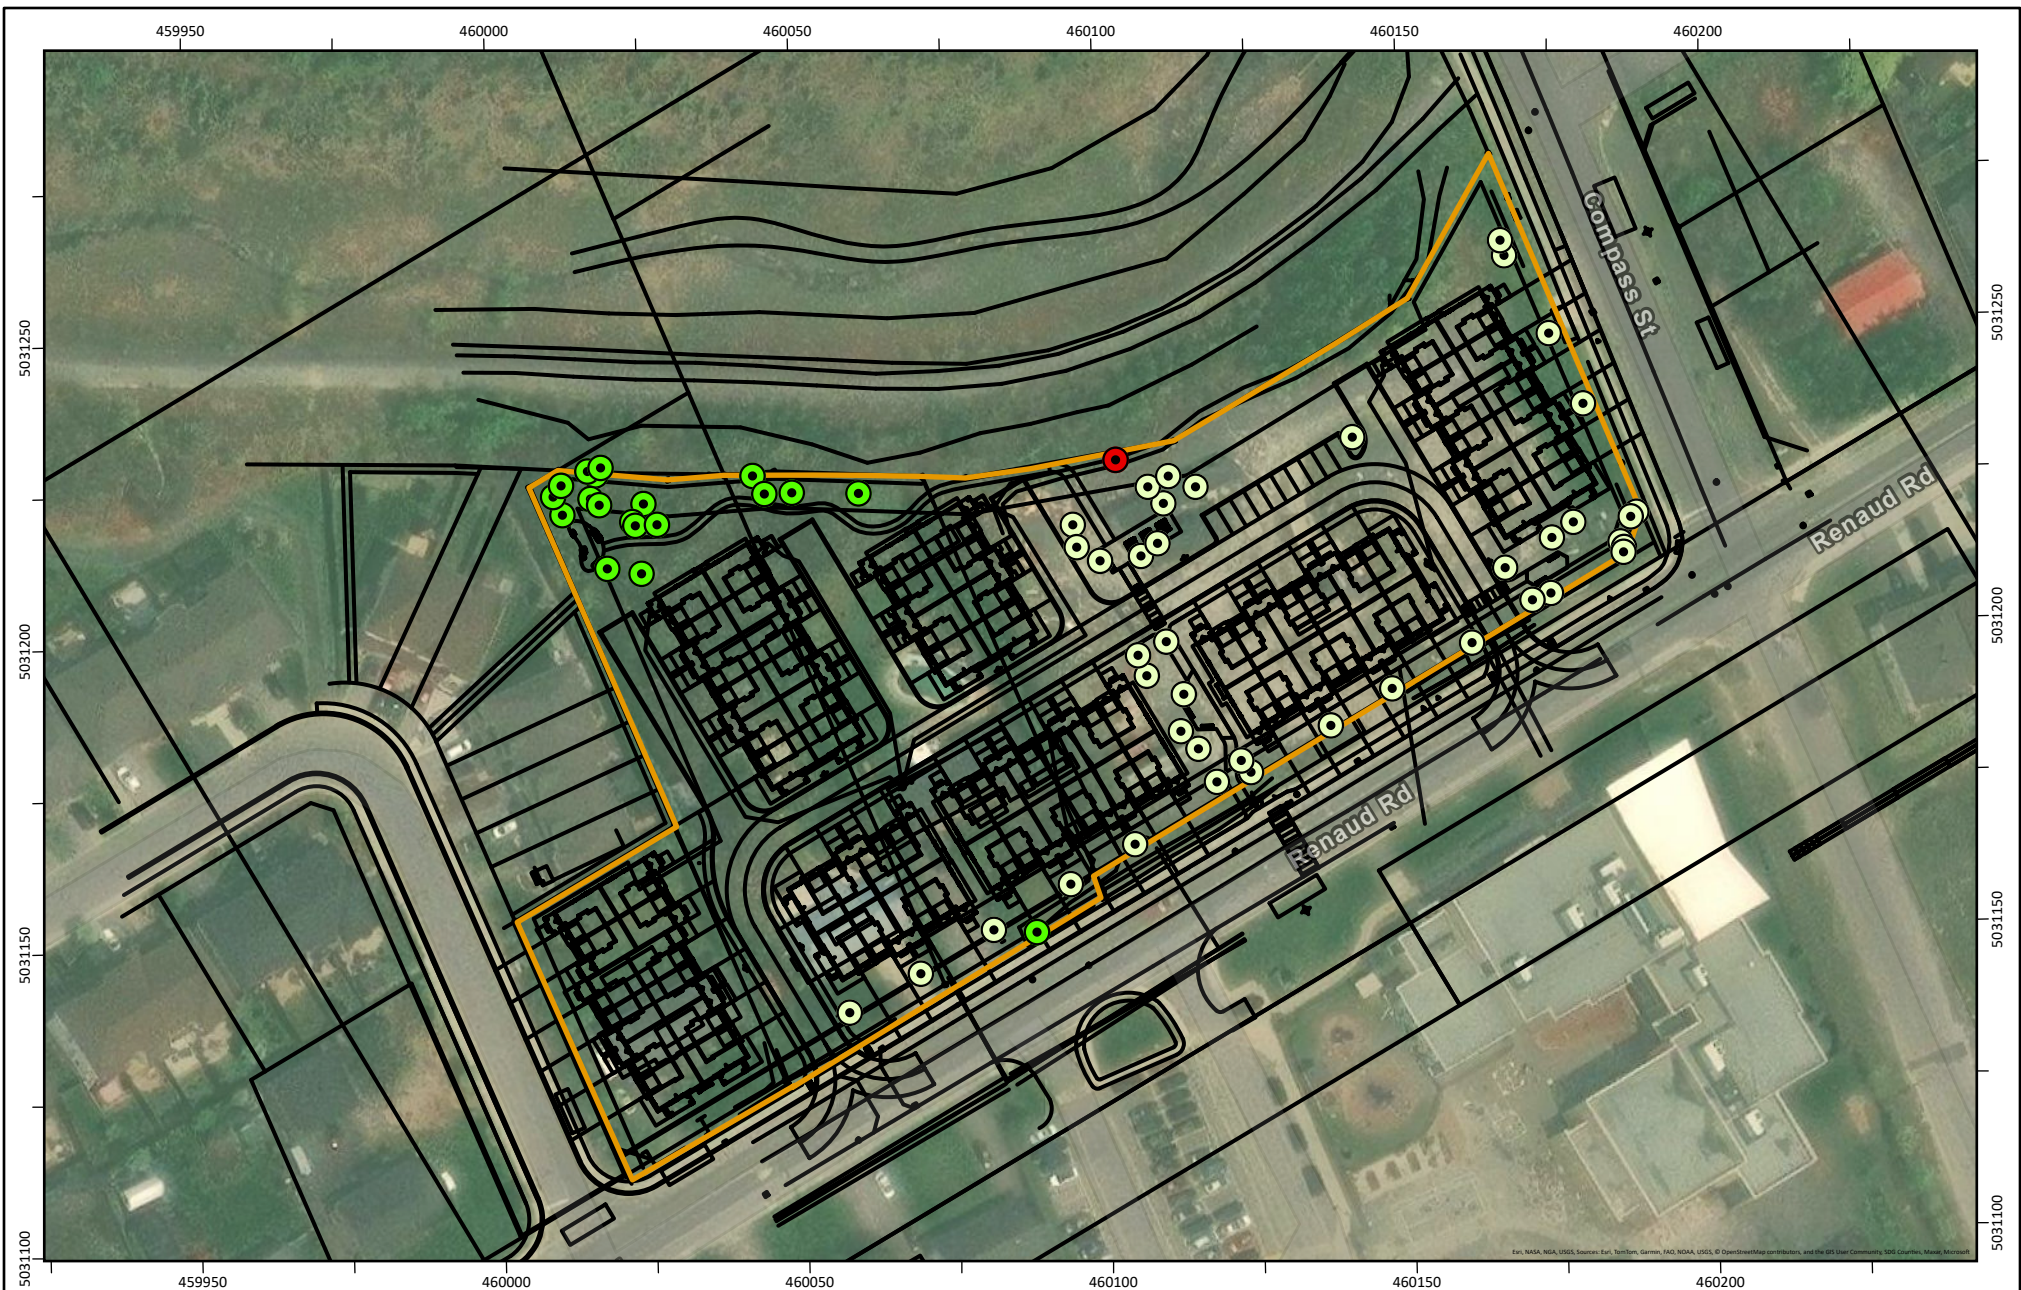
Figure 3. Proposed Development

The proposed Zoning Bylaw Amendment would rezone the Site as R3Z to accommodate future residential development. The proposed development plan for the Site comprises seven back-to-back townhome blocks, for a total of 76 townhome units. Roadway access will extend through the Site with two points of access along Renaud Road. Additional components include an amenity area, paved surface parking, a landscape feature, naturalized areas with a walkway along the north edge of the Site. Some existing trees, primarily in the northwest corner of the Site, are proposed to be retained as part of the naturalized area, remaining trees are anticipated to be removed; additional trees will be planted throughout the Site.

It is expected that all trees within the development footprint, except for those retained existing trees within the naturalized and landscaped areas, will need to be cleared to accommodate development. Vegetation removal on the Site should be limited to that which is necessary to accommodate construction. All retainable trees on the Site outside of the development footprint, including those off-site but adjacent to the property boundary and development footprint, should follow the general protection measures recommended during site preparation and construction (City of Ottawa, 2015):

- Erect a fence beyond the critical root zone (CRZ; i.e., 10x the diameter at breast height) of trees to be retained. The fence should be highly visible (orange construction fence) and paired with erosion control fencing. Pruning of branches is recommended in areas of potential conflict with construction equipment;
- Do not place any material or equipment within the CRZ of trees.
